# **Asbestos and Hazardous Materials Pre-Demolition Assessment V2**

Broadwater Public School

9 Byrnes Street

14/09/2023

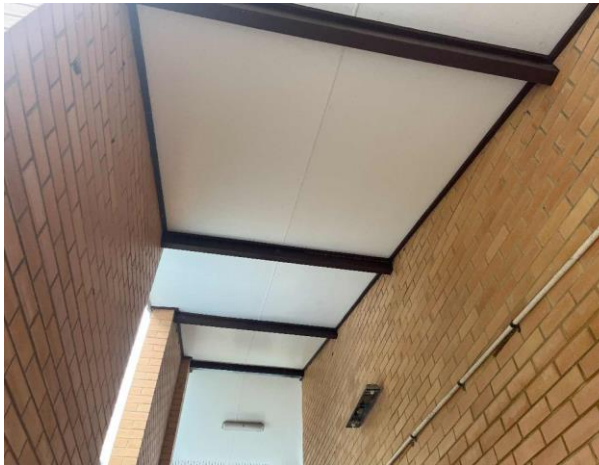
Line ID 1: External, Building A, Level 1, Stairs, Ceiling, Fibre Cement Sheet - Chrysotile Asbestos Detected

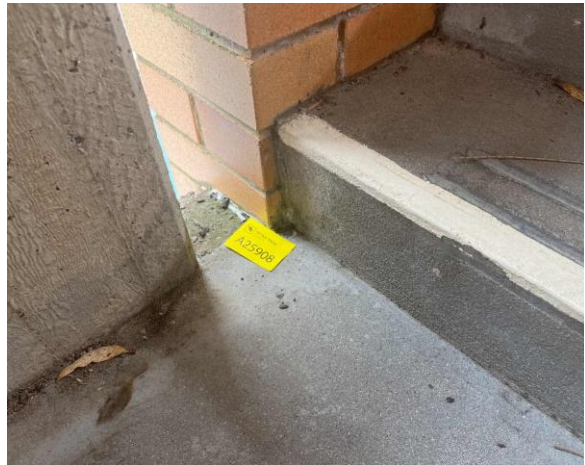
Line ID 2: External, Building A, Level 1, Stairs, To Floor, Mastic - Chrysotile Asbestos Detected

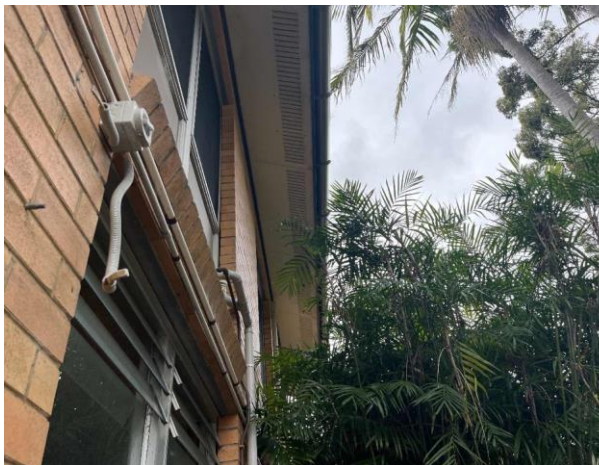
Line ID 3: External, Building A, Level 1, Throughout, Eaves, Fibre Cement Sheet - Chrysotile Asbestos Detected

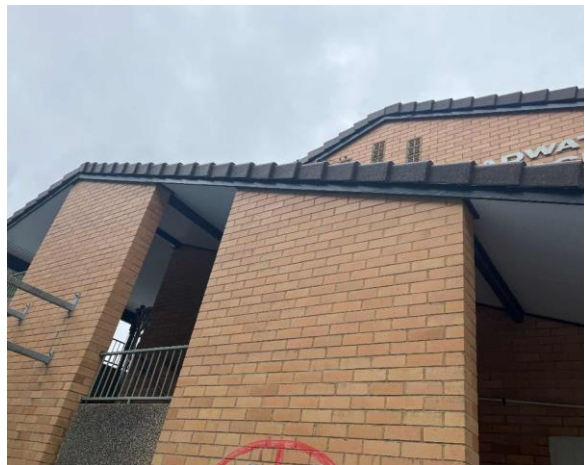
Line ID 4: External, Building A, Level 1, Throughout, Gable Verge Lining, Fibre Cement Sheet - Suspected Asbestos

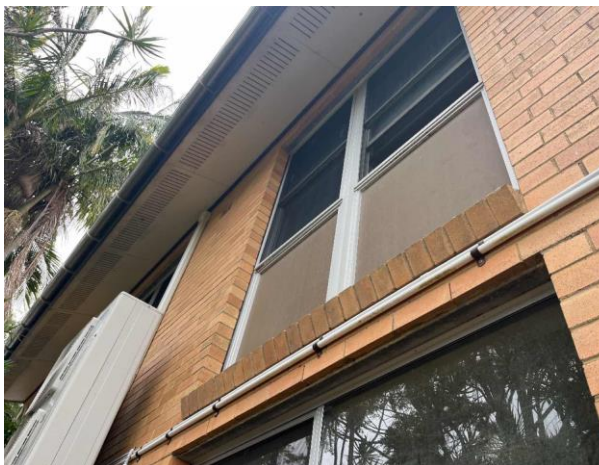
Line ID 5: External, Building A, Level 1, Throughout, Infill Panels, Below Windows, Compressed Cement Sheeting - Chrysotile Asbestos Detected

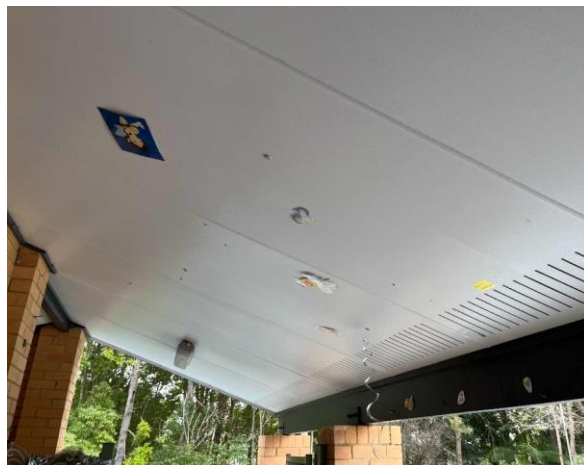
Line ID 6: External, Building A, Level 1, Verandah, Ceiling, Fibre Cement Sheet - Chrysotile Asbestos Detected

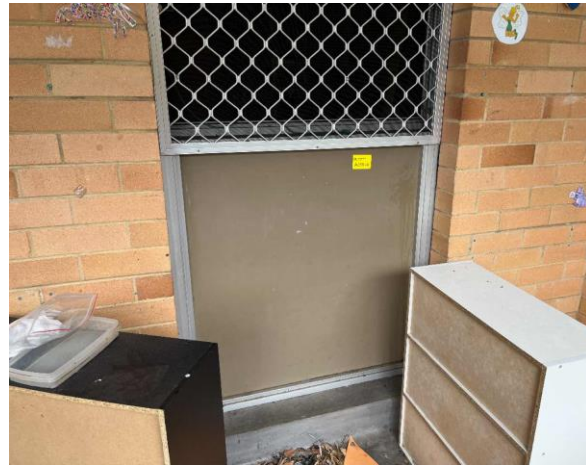
Line ID 8: External, Building A, Level 1, Verandah, Infill Panel, Below Window, Compressed Cement Sheetting - Chrysotile Asbestos Detected

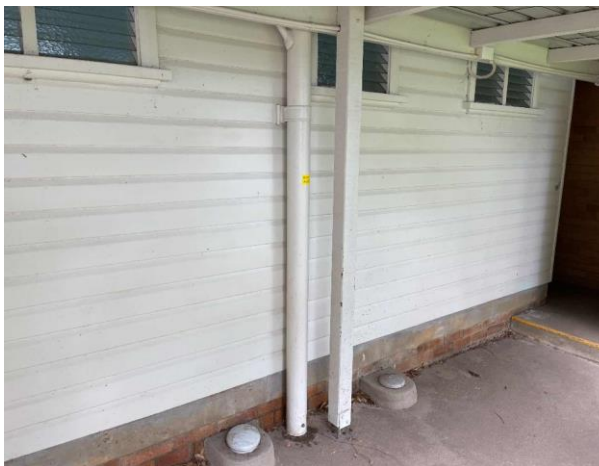
Line ID 9: External, Building B, Throughout, Down Pipe to Western Wall, Moulded Fibre Cement - Chrysotile Asbestos Detected

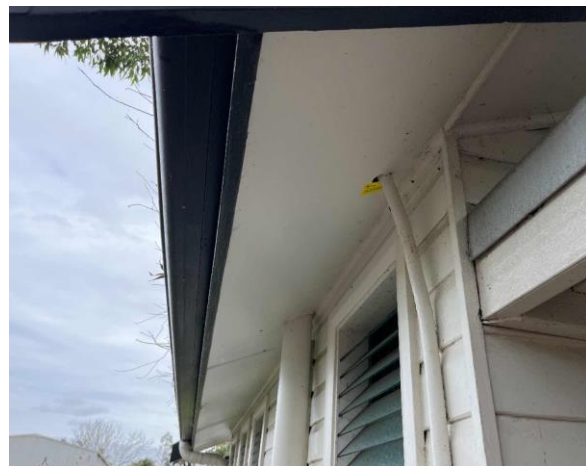
Line ID 10: External, Building B, Throughout, Eaves, Fibre Cement Sheetting - Chrysotile Asbestos Detected

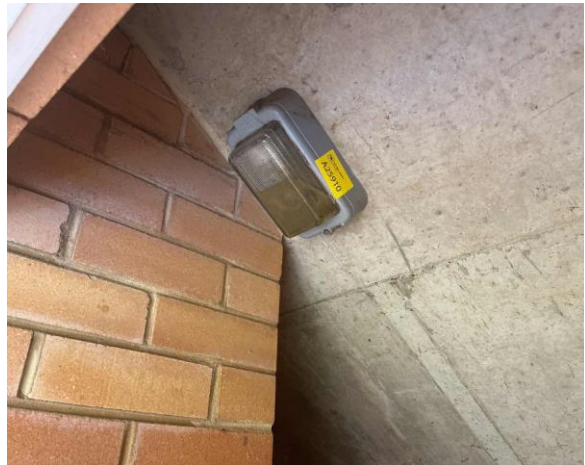
Line ID 20: Internal, Building A, Ground Floor, Storage Room Under Stairs, Between Metal and Glass of Wilco Light, Mastic - Chrysotile Asbestos Detected

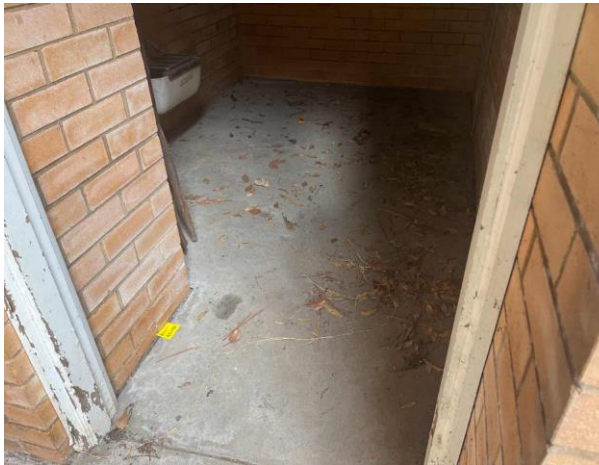
Line ID 21: Internal, Building A, Ground Floor, Storage Room Under Stairs, To Floor, Expansion Joint - Chrysotile Asbestos Detected

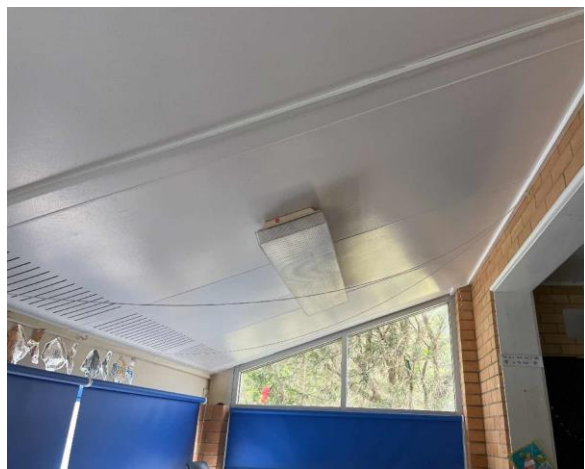
Line ID 24: Internal, Building A, Level 1, Enclosed Verandah, Ceiling, Fibre Cement Sheet - Chrysotile Asbestos Detected

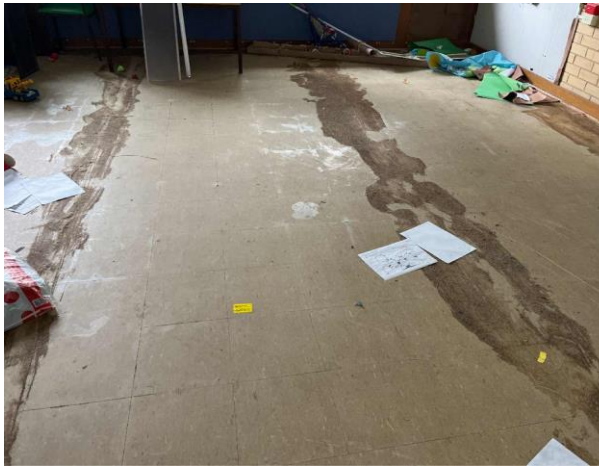
Line ID 27: Internal, Building A, Level 1, Throughout, Floor, Cream Vinyl Floor Tiles - Chrysotile Asbestos Detected

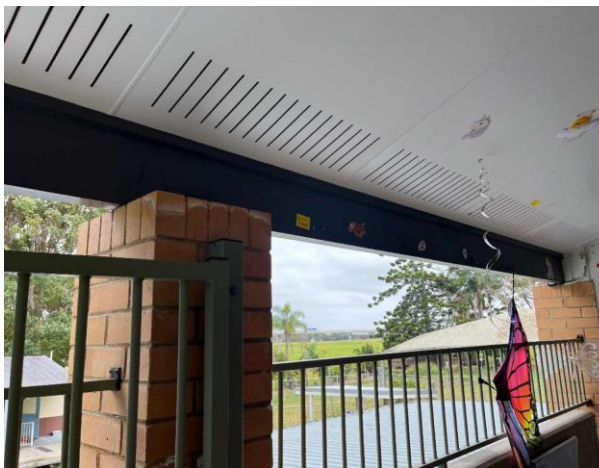
Line ID 34: External, Building A, Level 1, Verandah, Beams and Trim, Dark Grey Paint - Lead Detected (0.03% w/w)

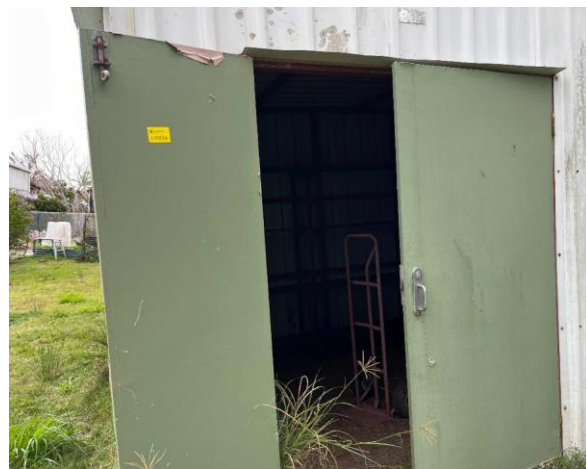
Line ID 37: External, Building C, Throughout, Doors, Green Paint - Lead Detected (0.12% w/w)

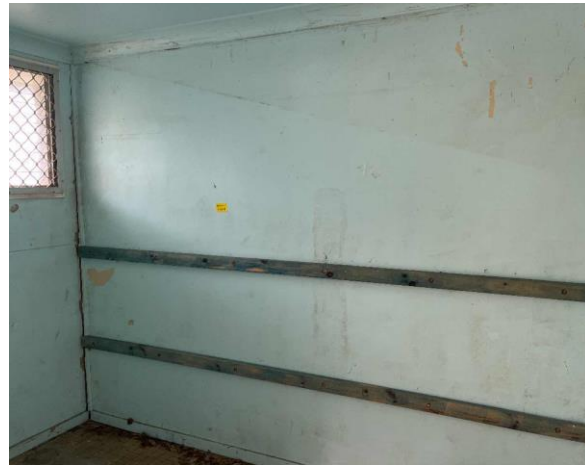
Line ID 45: Internal, Building B, Northern and Central Room, Walls and Ceiling, Blue Paint - Lead Detected (0.061% w/w)

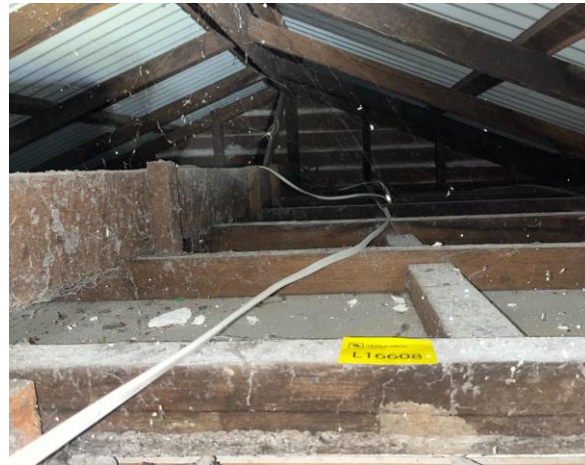
Line ID 47: Internal, Building B, Ceiling Space, Throughout, Dust - Lead Detected (330mg/kg)

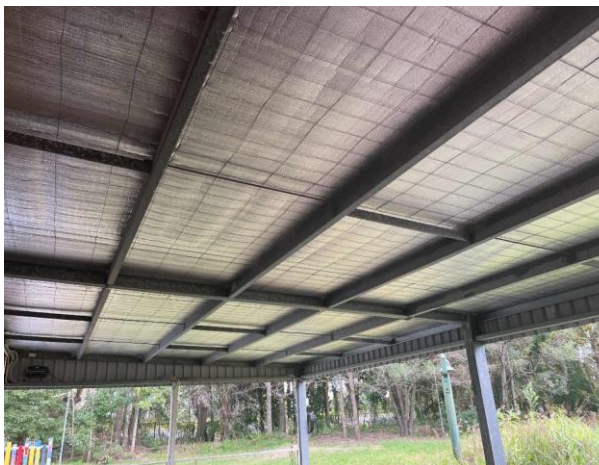
Line ID 48: External, Building A, Ground Floor, Covered Area, To Ceiling, Sarking Insulation - Suspected SMF

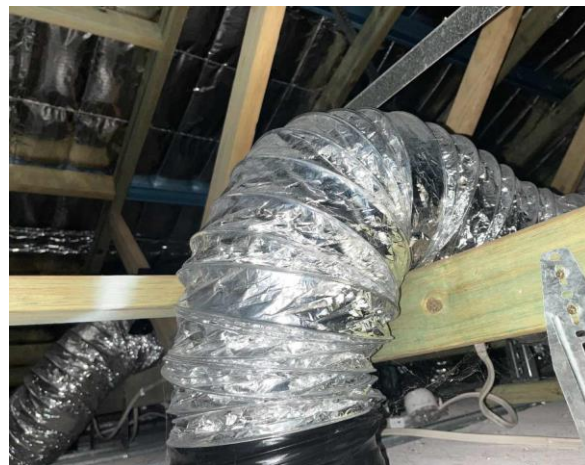
Line ID 49: Internal, Amenities Block, Ceiling Void, Flexible Air Conditioning Ductwork Throughout, Insulation Material - Suspected SMF

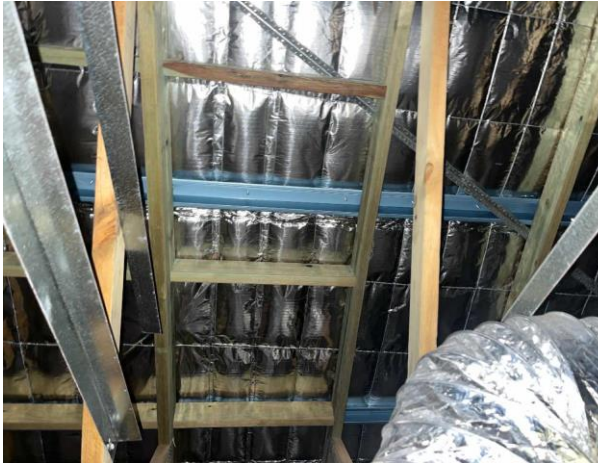
Line ID 50: Internal, Amenities Block, Ceiling Void, Throughout, Sarking Insulation - Suspected SMF

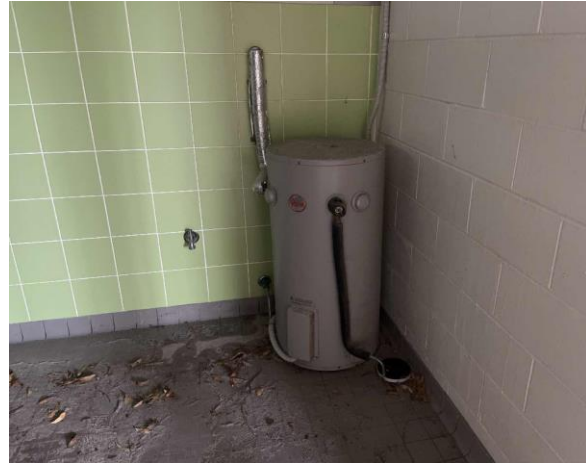
Line ID 51: Internal, Amenities Block, Female Ambulant Toilets, Within Hot Water Heater, Internal Insulation - Suspected SMF

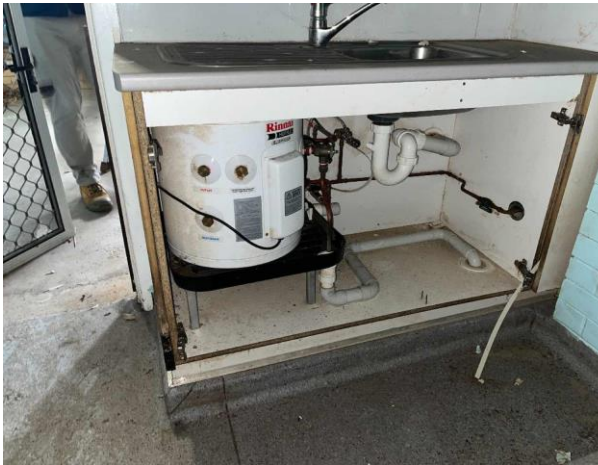
Line ID 52: Internal, Building A, Ground Floor, Canteen, Hot Water Heater Under Bench, Internal Insulation - Suspected SMF

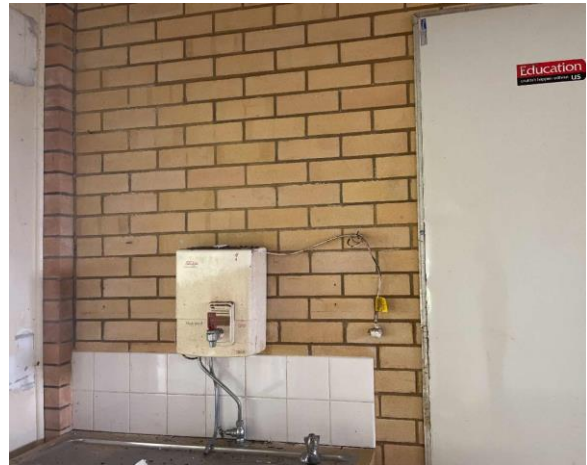
Line ID 53: Internal, Building A, Ground Floor, Eastern Room, Hot Water Boiler, Above Sink, Internal Insulation - Suspected SMF

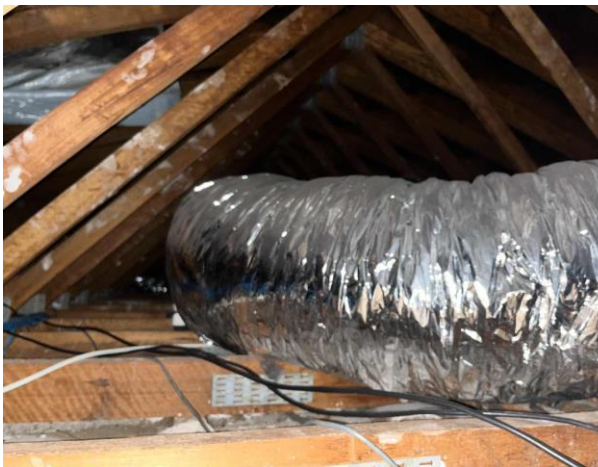
Line ID 54: Internal, Building A, Level 1, Ceiling Void, Flexible Air Conditioning Ductwork Throughout, Internal Insulation - Suspected SMF

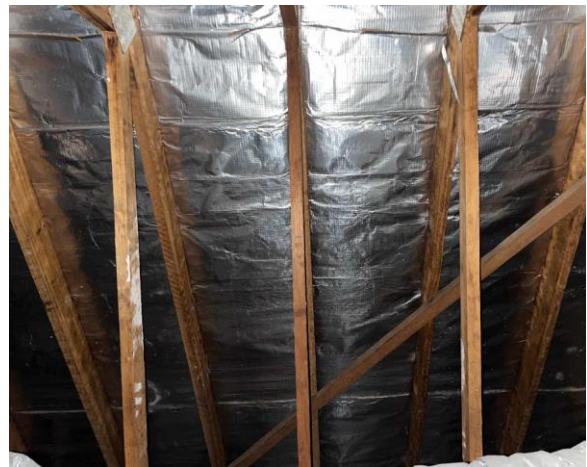
Line ID 55: Internal, Building A, Level 1, Ceiling Void, Throughout, Sarking Insulation - Suspected SMF

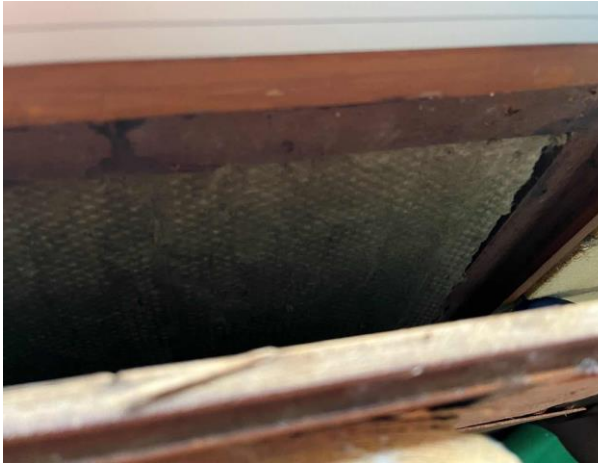
Line ID 56: Internal, Building A, Level 1, Throughout, Southern Wall, Behind Wooden Panels, Below Windows, Insulation Material - Suspected SMF

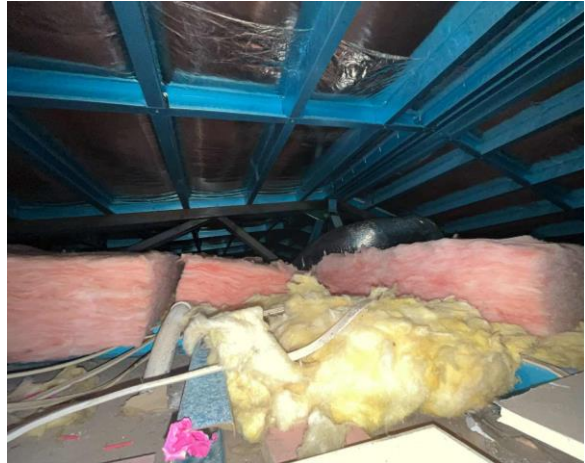
Line ID 57: Internal, Building E Ground Floor, Ceiling Space, Throughout, Loose Insulation - Suspected SMF

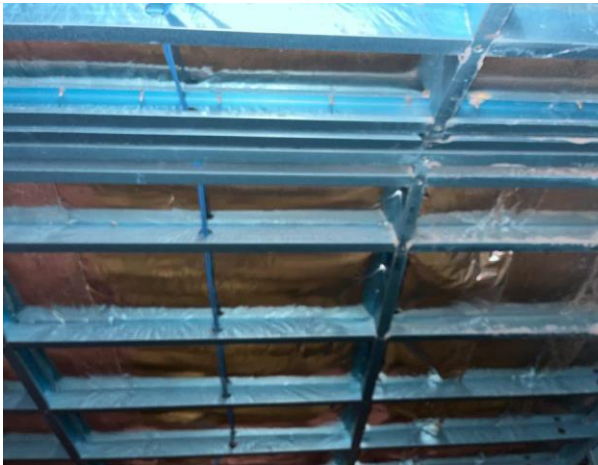
Line ID 58: Internal, Building E Ground Floor, Ceiling Space, Throughout, Sarking Insulation - Suspected SMF

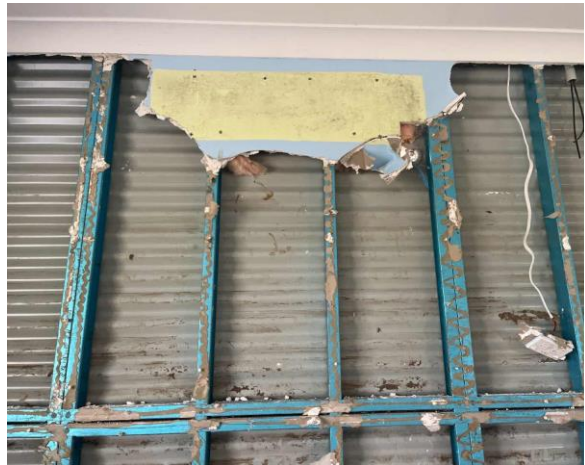
Line ID 59: Internal, Building E Ground Floor, West side, Behind Remanding Wall, Insulation Batts - Suspected SMF

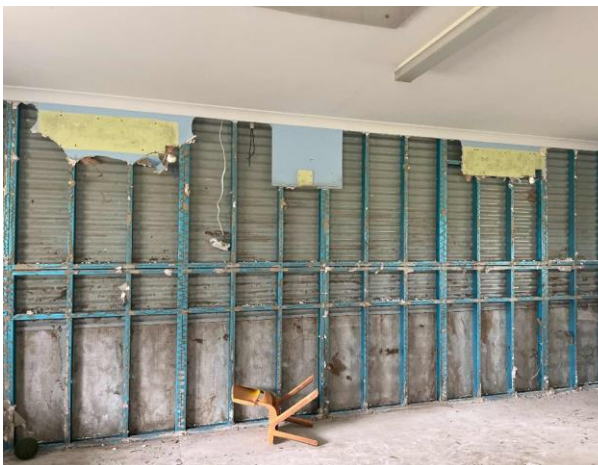
Line ID 59.1: Internal, Building E Ground Floor, West side, Behind Remanding Wall, Insulation Batts - Suspected SMF

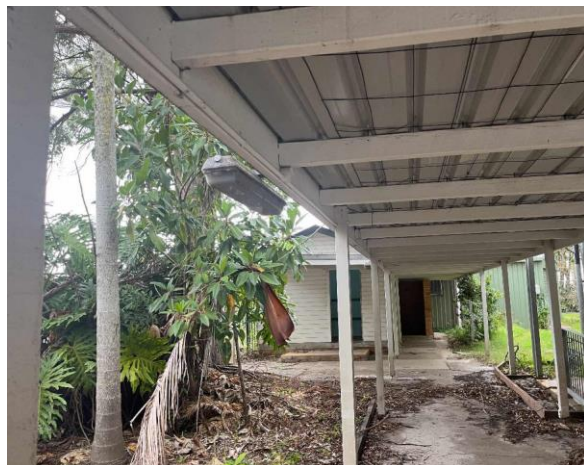
Line ID 60: External, Throughout, Throughout, Light Fittings, Ballast(s) - Suspected PCB

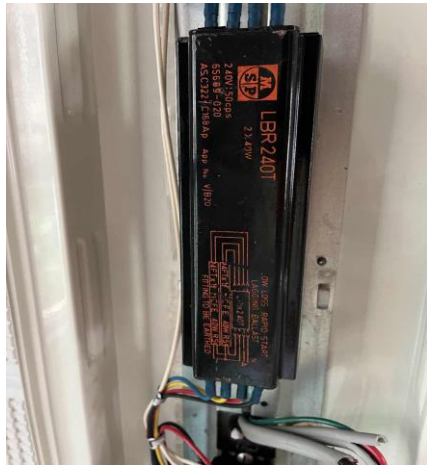
Line ID 61: Internal, Building A, Level 1, Throughout, Light Fittings, Ballast(s) - Suspected PCB

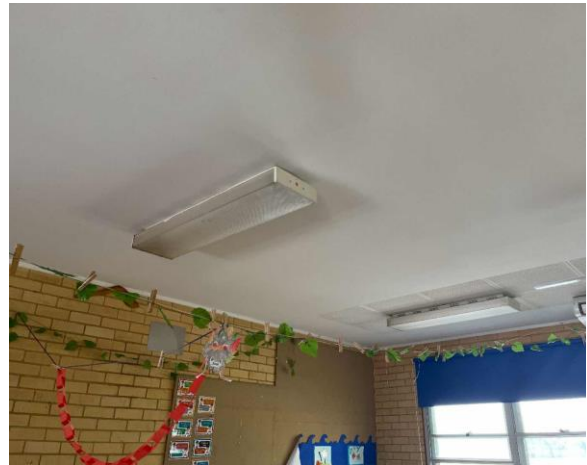
Line ID 61.1: Internal, Building A, Level 1, Throughout, Light Fittings, Ballast(s) - Suspected PCB

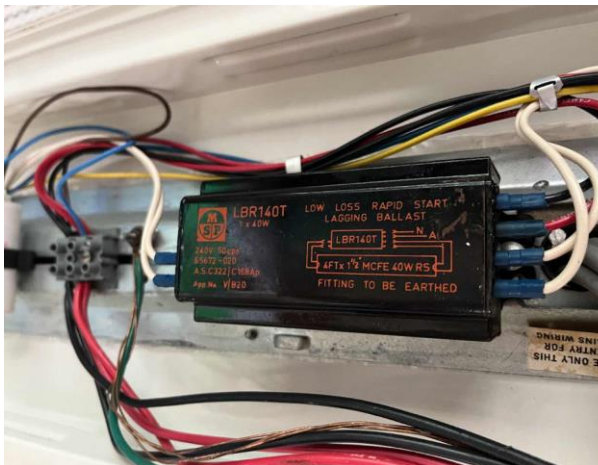
Line ID 61.2: Internal, Building A, Level 1, Throughout, Light Fittings, Ballast(s) - Suspected PCB

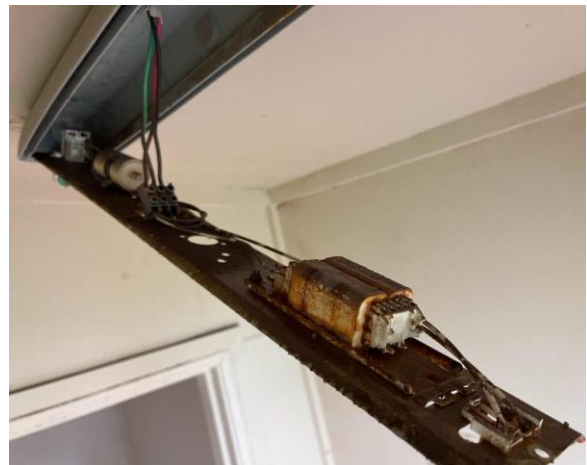
Line ID 62: Internal, Building B, Toilet Rooms, Ceiling, Capacitor(s) - Suspected PCB

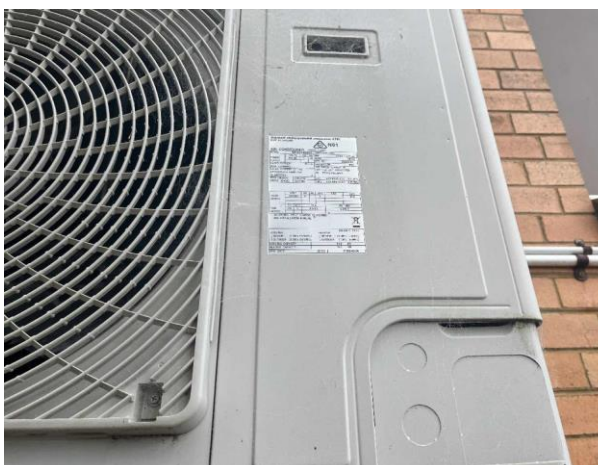
Line ID 63: External, Building A, Level 1, South Side, Daikin Air Conditioning unit, R410A Hydrofluorocarbon (HFC) - Non ODS Refrigerant
