# PRELIMINARY SITE INVESTIGATION

PROPOSED SHOP-TOP DEVELOPMENT

**HMC2023.531.04**

**RE: Lot 7 DP 14089, 17 McDonald Place, Evans Head NSW.**

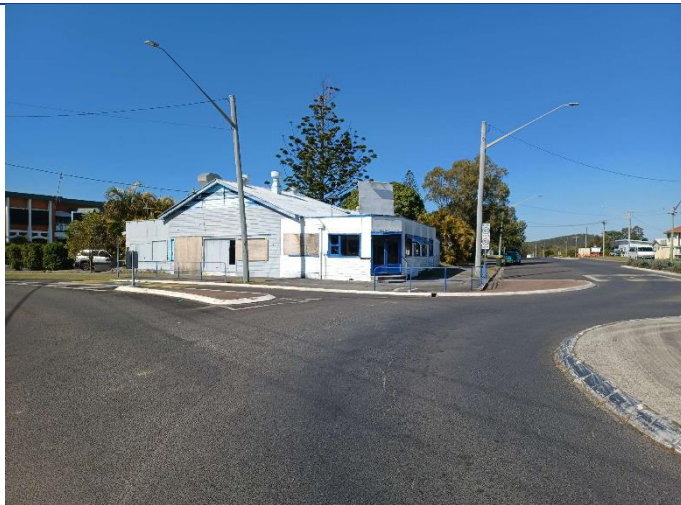
Photo No. 1	Date 31.08.2023
-------------	-----------------

**Description:**  
View South: Existing structure to be demolished

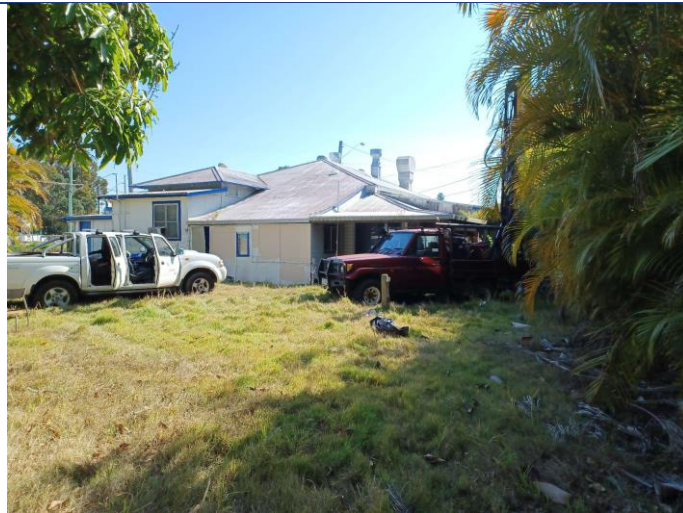
Photo No. 2	Date 31.08.2023
-------------	-----------------

**Description:**  
View North: Rear of existing structure to be demolished
