# Arboricultural Impact Assessment Report

## Broadwater Public School

File No: 2324  
Version: Final  
13 Sept 2023

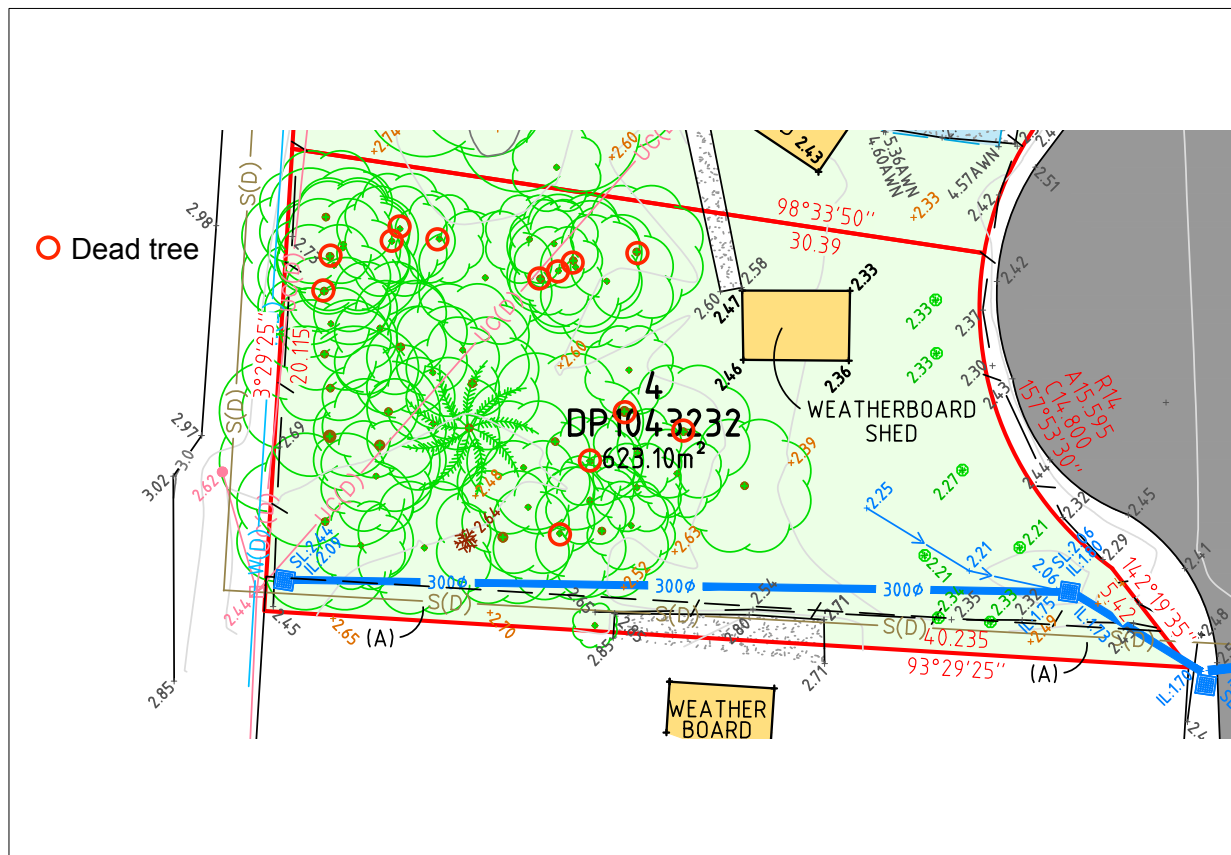
4.4 The group of trees # 22 has thirteen dead trees in the group. The trees in the group that are dead are shown in Figure 1 below. There are also two trees that are planned to be removed to allow installation of a services trench.

7.5 The group of trees # 22 have 13 trees that are dead. There are a further 2 trees that will be required to be removed to allow construction of a services trench.

8.1 It is recommended that the new school buildings and related infrastructure should be constructed as planned. The trees required to be removed to allow construction of the new building trees # 3a, 3b, 4a, 4b, 14a, 14b, , 15, 16, 18a, 18b, 23 and 24. There are 15 trees in Group 22 that also should be removed. Thirteen of these trees are dead and another two trees should be removed to allow construction of a services trench. The other trees growing on the school grounds should be retained and protected during construction.

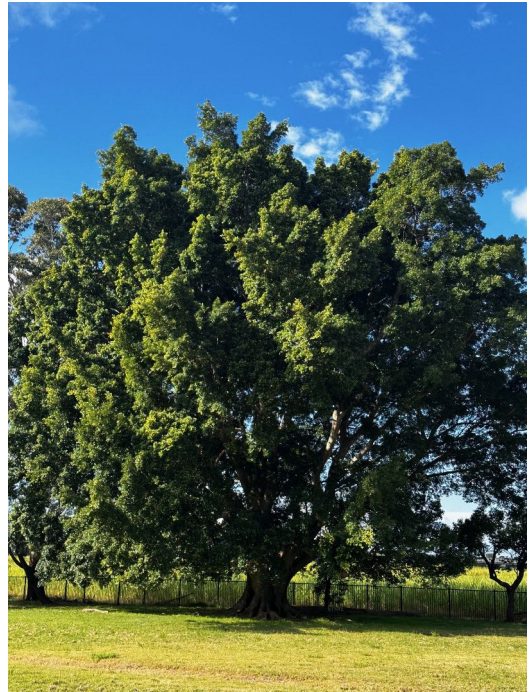
Photo 4. Tree # 5  
Weeping Fig

7.3 There are two trees that have an encroachment into their TPZ. These are trees # 5 and 13. The encroachment into tree # 5 is calculated to be 3%. The encroachment in to tree # 13 is calculated to be 1%. The encroachment into trees # 5 and 13 are minor encroachments and are allowed according to the Standard.

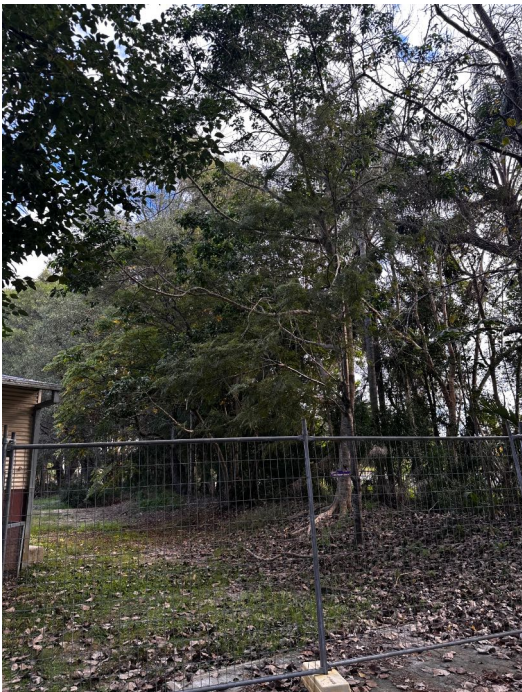
Photo 11. Tree # 18  
Group of 62 trees

7.4 An underground power line is proposed to be installed from the power pole in the road through the group of trees # 18. This will require two trees, # 18a and 18b to be removed. Tree # 8b is dead.

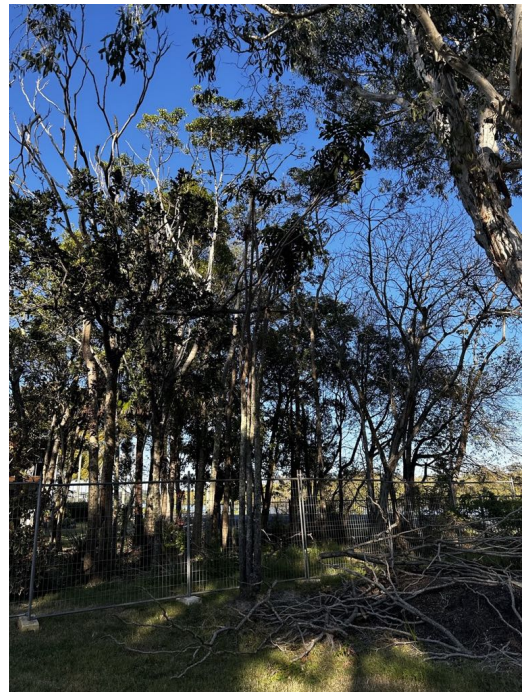
Photo 12. Tree # 22  
Group of trees. Many have died.
