GEOTECHNICAL SITE INVESTIGATION

17 McDonald Pace, Evans Head, NSW 2473.

H23-3755.

Re: Proposed Multi Use Development at 17 McDonald Place, Evans Head, NSW 2473.

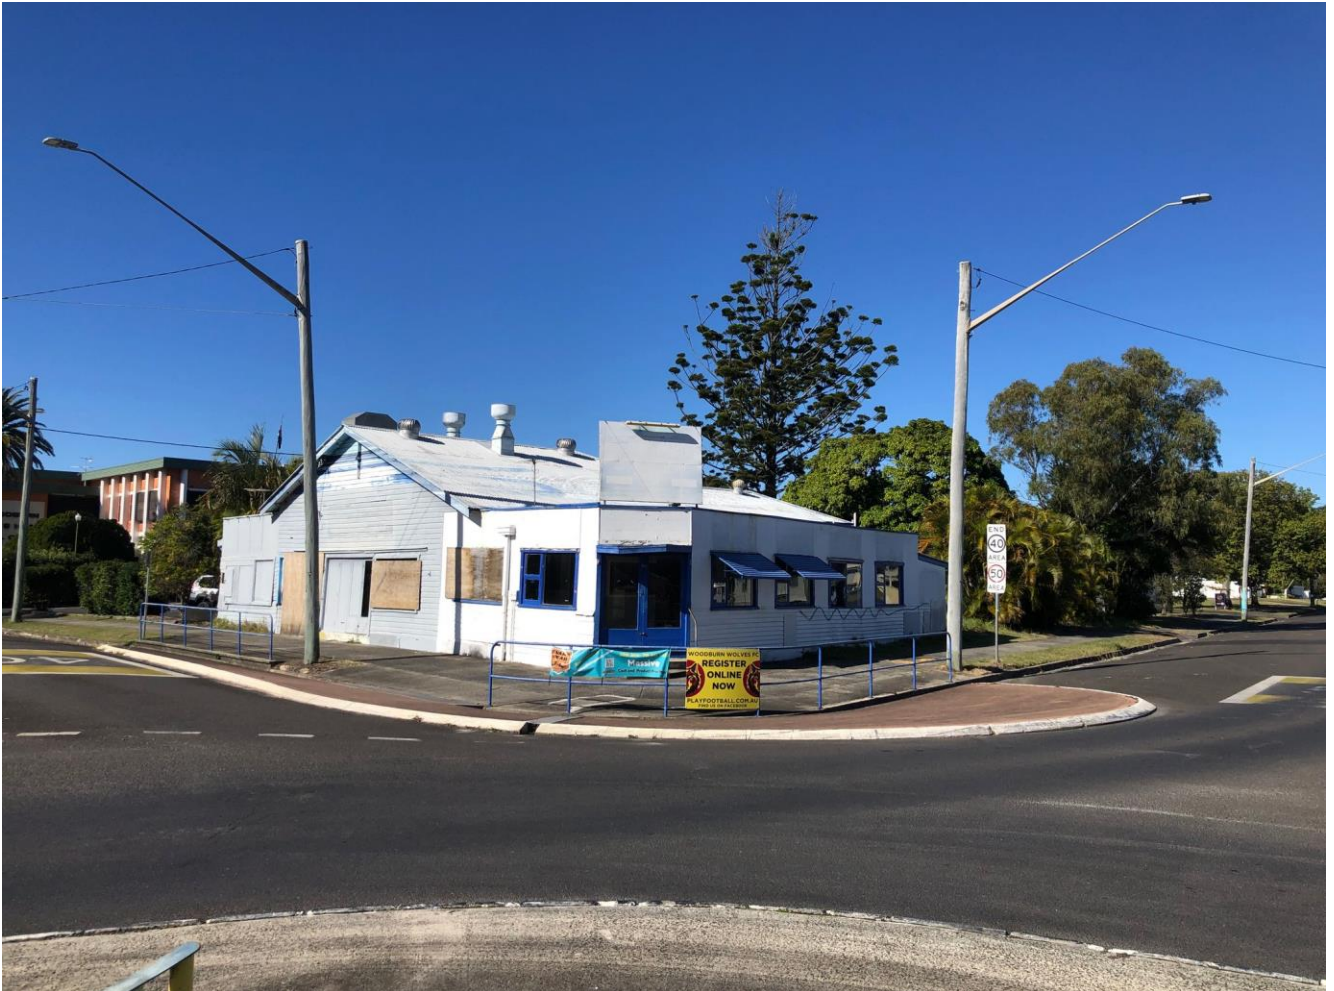
View of the site facing a south easterly direction.

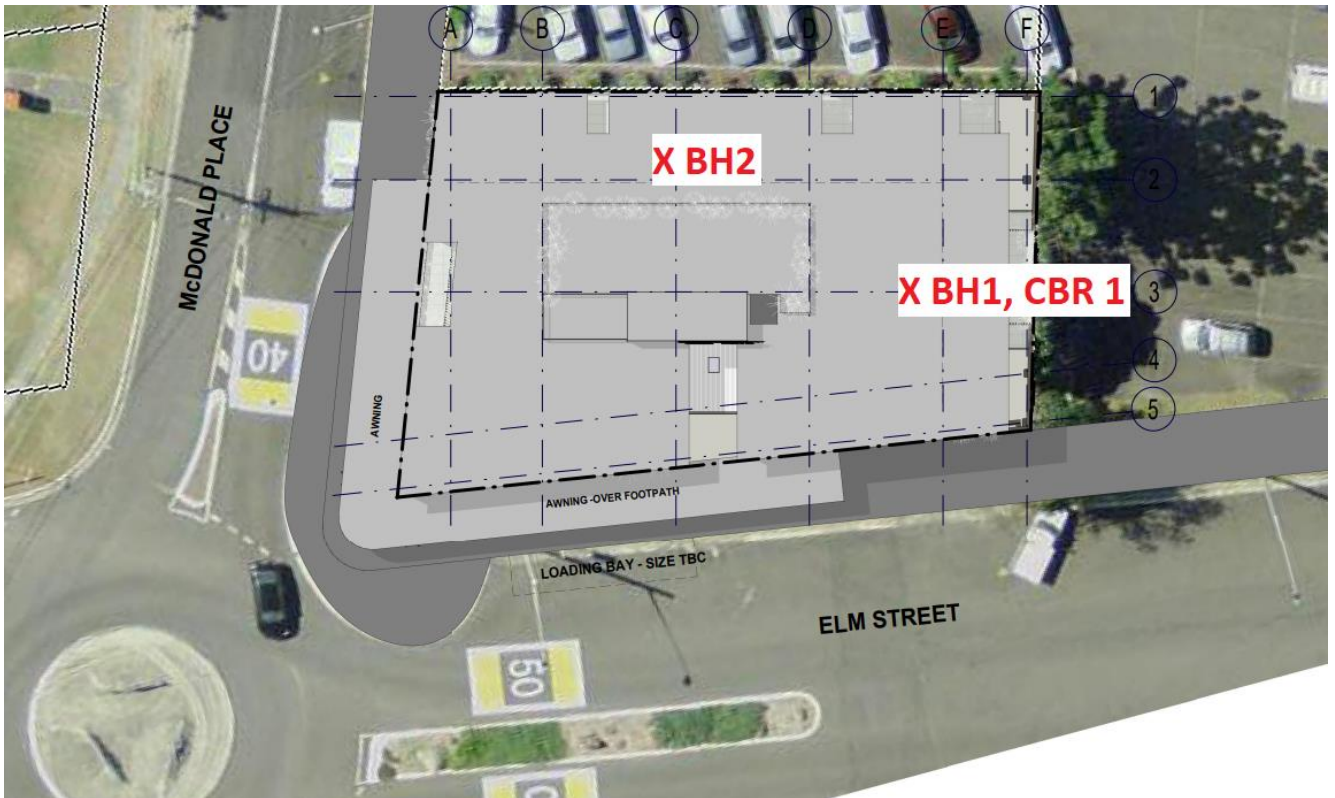
Plan of the site, with ASCT test positions.
