Salty Lagoon

Post Closure Monitoring

Project Management and Ecosystem Health Report

June 2018

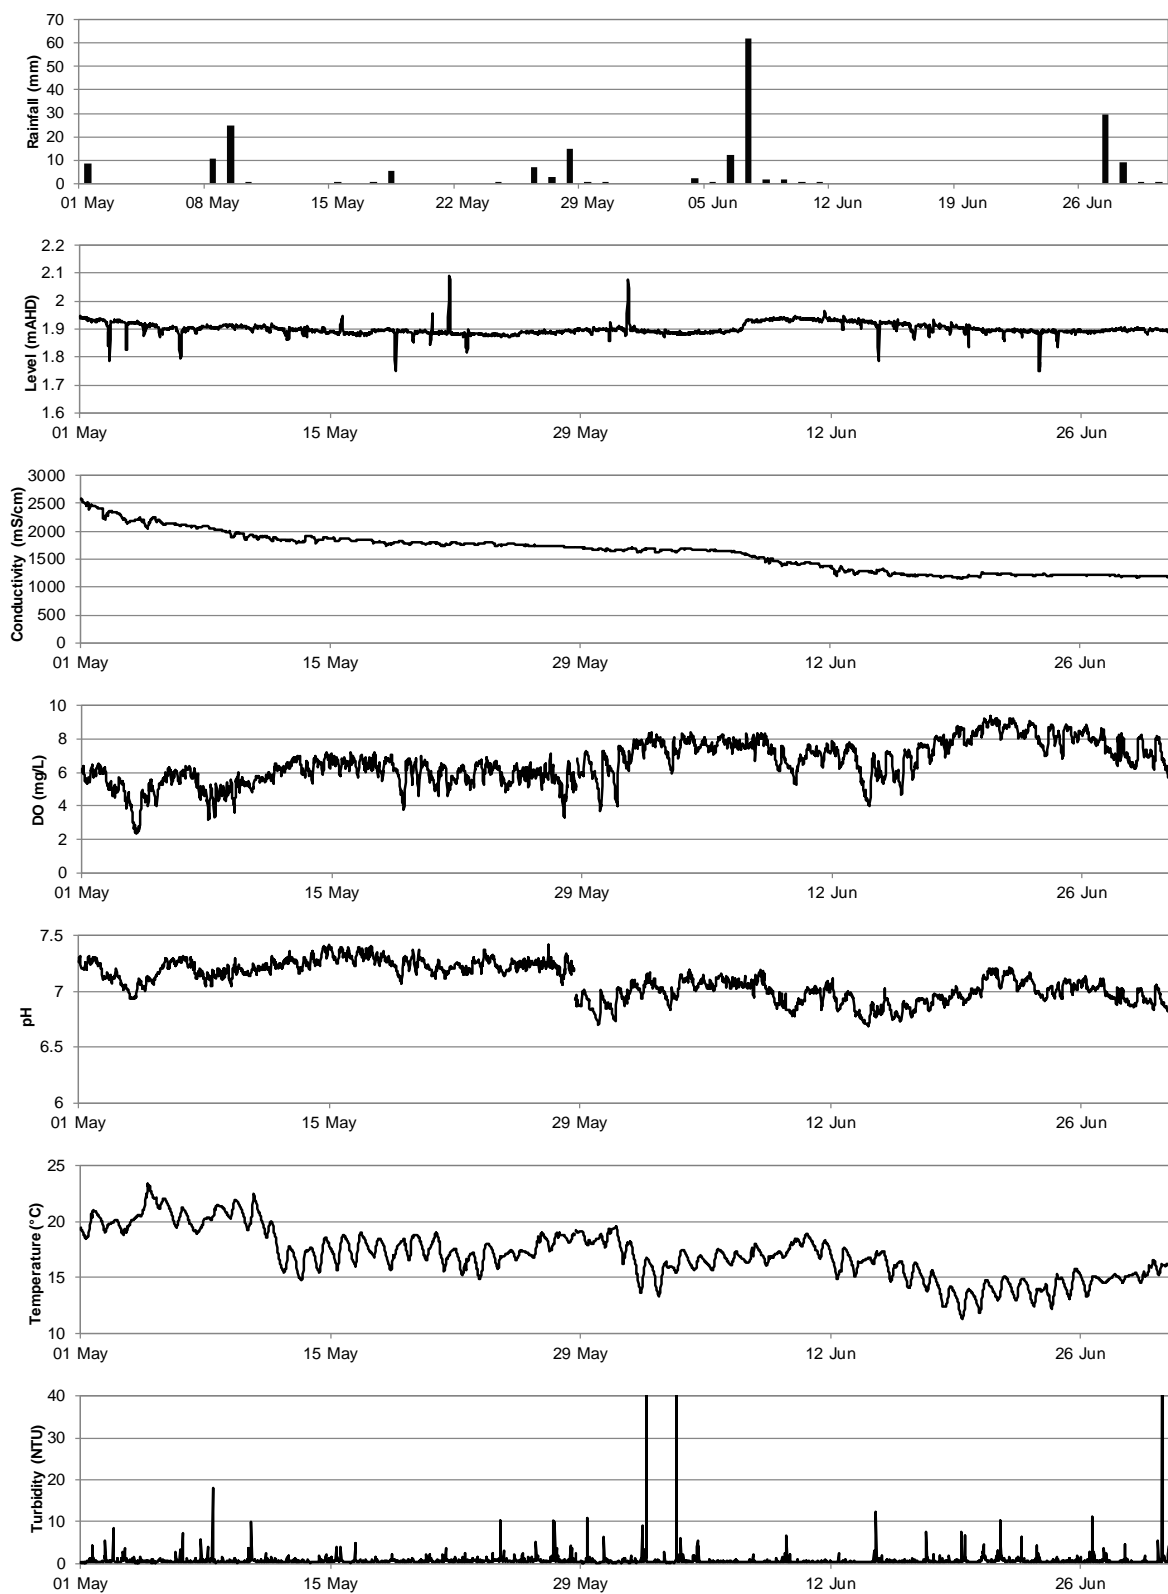
Illustration 3.1 Salty Lagoon Rainfall and Water Quality Monitoring Station Data 1 May 2018 until 30 June 2018

There were several small to moderate rainfall events during this reporting period and one heavy rainfall event (on 6 June 2018). The water level in Salty Lagoon remained relatively stable throughout the monitoring period but the water level in Salty Creek was dynamic, fluctuating in response to a combination of rainfall runoff, seawater ingress, the state of the entrance and tidal movements. Only the heavy rainfall event appears to have had an impact upon water levels and quality in Salty Creek. The data from the Salty Creek PWQMS indicates that the entrance to Salty Creek was open and tidal for some of the reporting period and closed on at least two occasions. Water appears to have flowed out of Salty Lagoon into Salty Creek for the entire monitoring period. At the time of the site inspection on 2 July 2018, the entrance to Salty Creek was open and there was evidence of tidal movements.

Conductivity measurements from the PWQMS in Salty Lagoon and Salty Creek clearly show the impact of rainfall, seawater ingress and saline water movements on Salty Creek and Salty Lagoon. Conductivity in Salty Lagoon reduced gradually for the second consecutive reporting period and has now returned to levels commonly associated with freshwater environments. At the time of the site inspection the water column was well mixed at the Salty Lagoon sites. Results from the Salty Creek PWQMS show that the conductivity in Salty Creek fluctuated dynamically throughout the reporting period in response to rainfall, seawater ingress, entrance conditions and tidal movements. On 2 July 2018 at the Salty Creek site the water column was distinctly stratified into a fresh upper layer and saline lower layer. This is typical in Salty Creek when seawater ingress is followed by rainfall runoff.

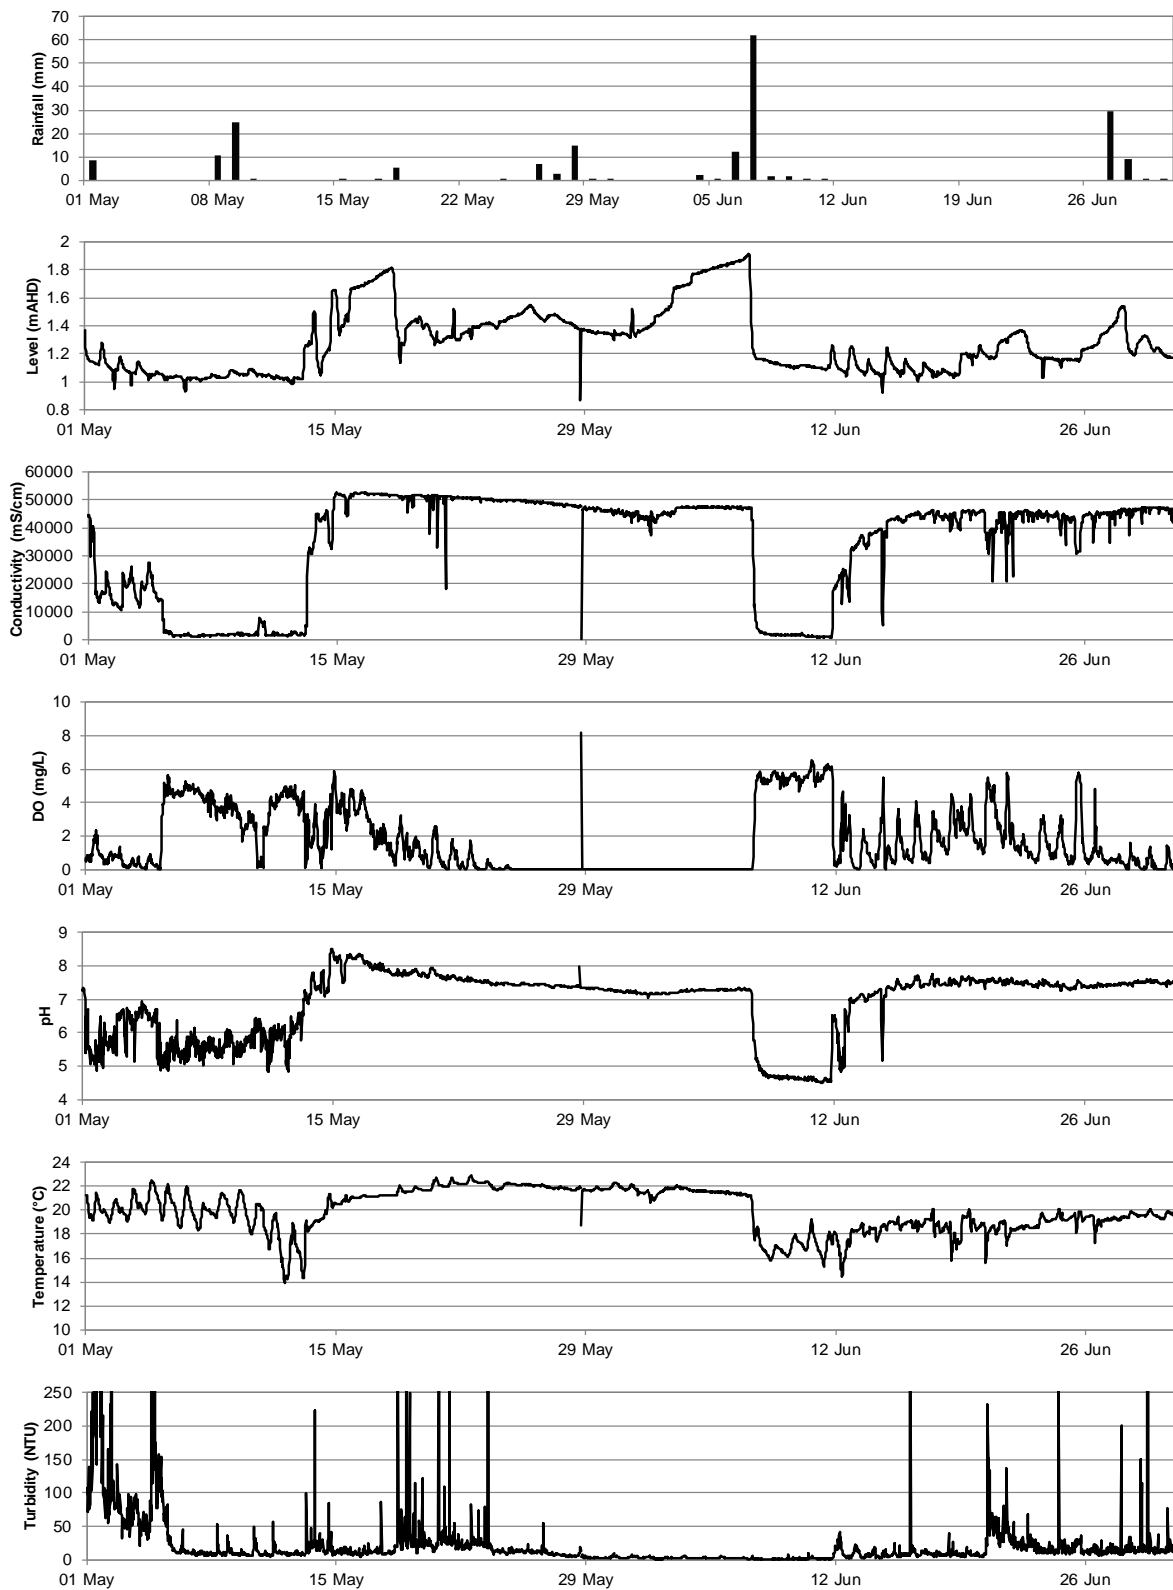
Illustration 3.2 Salty Creek Rainfall and Water Quality Monitoring Station Data 1 May 2018 until 30 June 2018

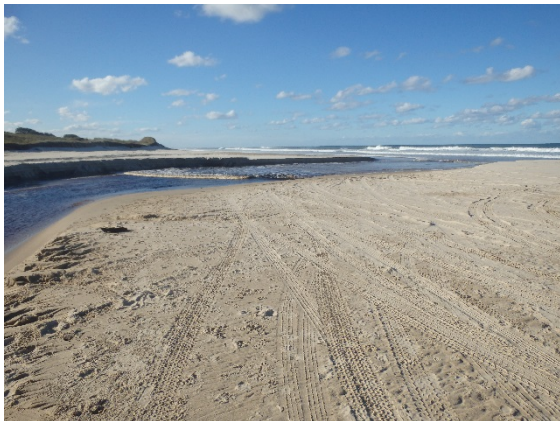
The entrance to Salty Creek was open on 02 July 2018 (**Plate 4.1**). A variety of birds were observed incidentally during the site inspection including Pacific Black Duck, Australasian Grebe, Eurasian Coot, Black Swan, Pelican, Great Egret, Darter and Little Black Cormorant.

Plate 4.1 Water draining from the open entrance to Salty Creek on 2 July 2018

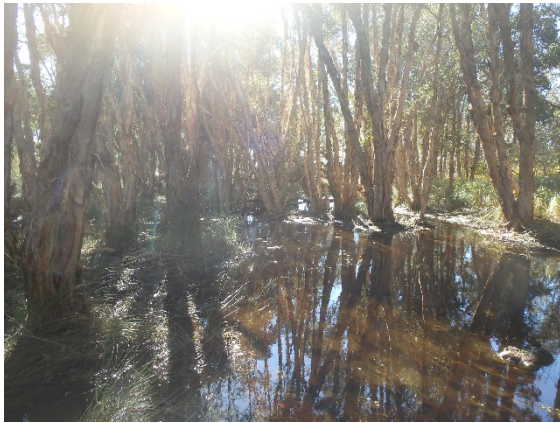
Plate 4.3 Erosion monitoring site E5 in July 2017

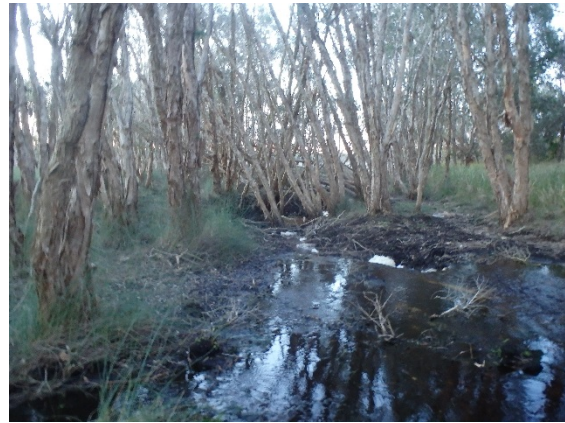
Erosion monitoring indicated that the head cut has advanced between 1.15 and 5.9 m since July 2017 in three distinct locations. Measurements collected during this reporting period indicate that the head cut advanced significantly in the past two months, up to 3.3m at one site. There has been little or no advancement of the head cuts at the control sites. This indicates that, either the control sites are inherently more stable or that water is leaving Salty Lagoon preferentially through the pathway to the east of the old artificial channel.

The impact headcuts advanced significantly during this monitoring period while there was no movement at the control headcuts. There has been a total advance of between 1.15 m and 5.9 m in the impact headcuts since the monitoring points were established in July 2017 and an increase in the past two months of up between 0.1 and 3.3m.

Plate 4.4 Erosion monitoring site E5 in July 2018, showing an advance of 5.9m
