Salty Lagoon

Post Closure Monitoring

Project Management and Ecosystem Health Report

October 2018

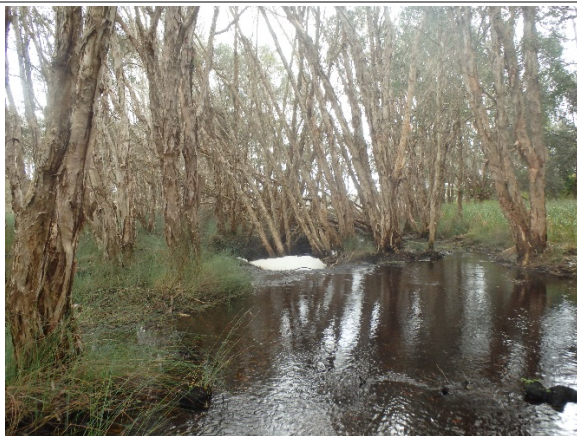
Plate 3.1 Fixed point photo from ER5 on 1 May 2018

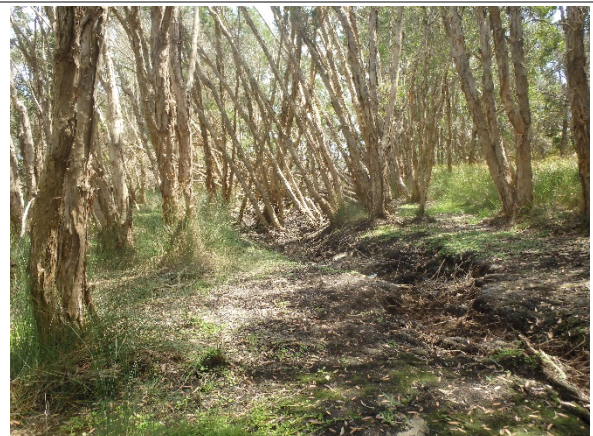
The data collected at the erosion monitoring stations is presented in **Table 3.2**. There was a significant advance of the head cut at the three impact stations in relation to the previous measurements in September 2018. The head cut has advanced at least 9.95 m towards Salty Lagoon since the monitoring began in July 2017.

Plate 3.2 Fixed point photo from ER5 on 7 November 2018

Erosion monitoring indicated that the head cut has advanced at least 9.95 m since July 2017. There has been little or no measured advance of the head cuts at the three control sites. The advance of the head cut during this reporting period was between 1.05 m (ER4) and 4.15 m (ER5). The consistent heavy rainfall in October 2018 would have caused the advancing erosion and the size of the advance during this reporting period demonstrates how quickly the system can change under such conditions.
