Salty Lagoon

Post Closure Monitoring

Project Management and Ecosystem Health Report

June 2019

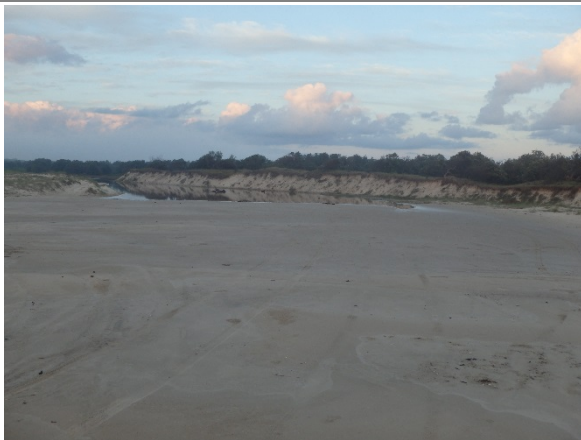
The entrance to Salty Creek was closed on 3 July 2019. A variety of birds were observed incidentally during the site inspection including Pacific Black Duck, Pelican, Black Swan, Little Pied Cormorant, White-faced Heron and Masked Lapwing. Large areas of rushes in the open water of Salty Lagoon, mostly *Typha orientalis*, *Schoenoplectus validus* and *Phragmites australis*, were observed to be dying back. This is most likely to be in response to saline conditions. There were lots of floating rafts of green algae (species unidentified but probably of marine origin) observed in the open water of Salty Lagoon.

Plate 4.1 The closed entrance to Salty Creek on 3 July 2019

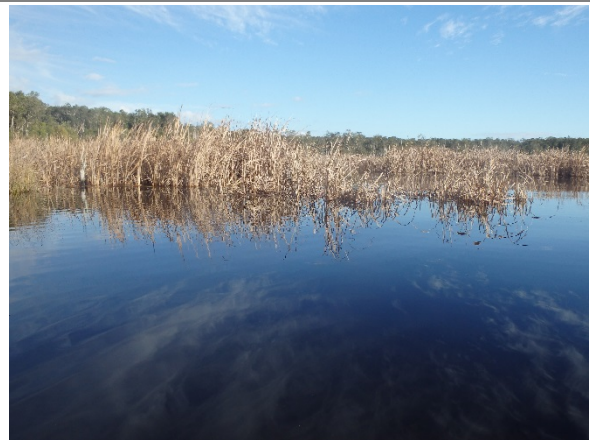
Plate 4.2 Senescing rushes in Salty Lagoon on 3 July 2019

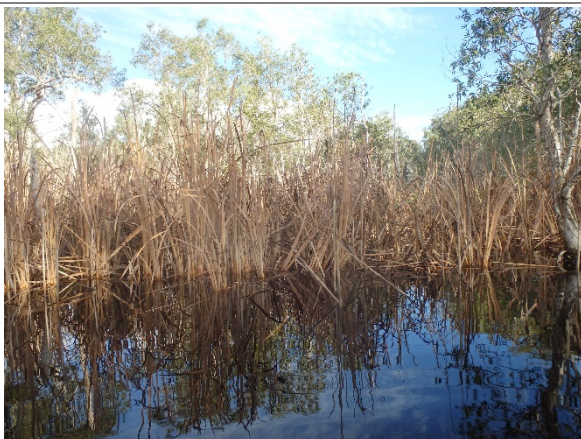
Plate 4.3 Fixed point photo from S2 on 3 July 2019 showing higher water levels and rushes dying back

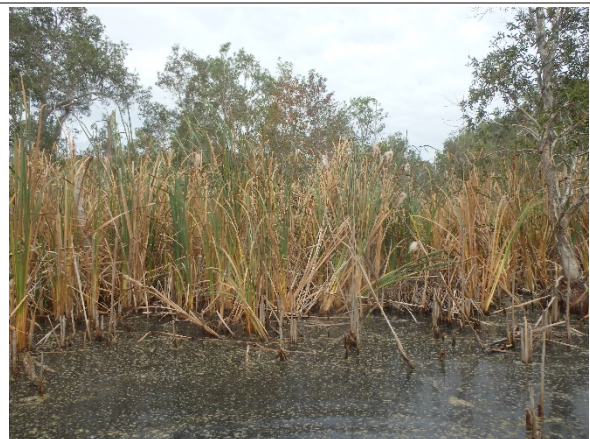
Plate 4.4 Fixed point photo from S2 on 11 March 2019 showing very low water levels and healthy rushes
