Salty Lagoon

Post Closure Monitoring

Project Management and Ecosystem Health Report

December 2019

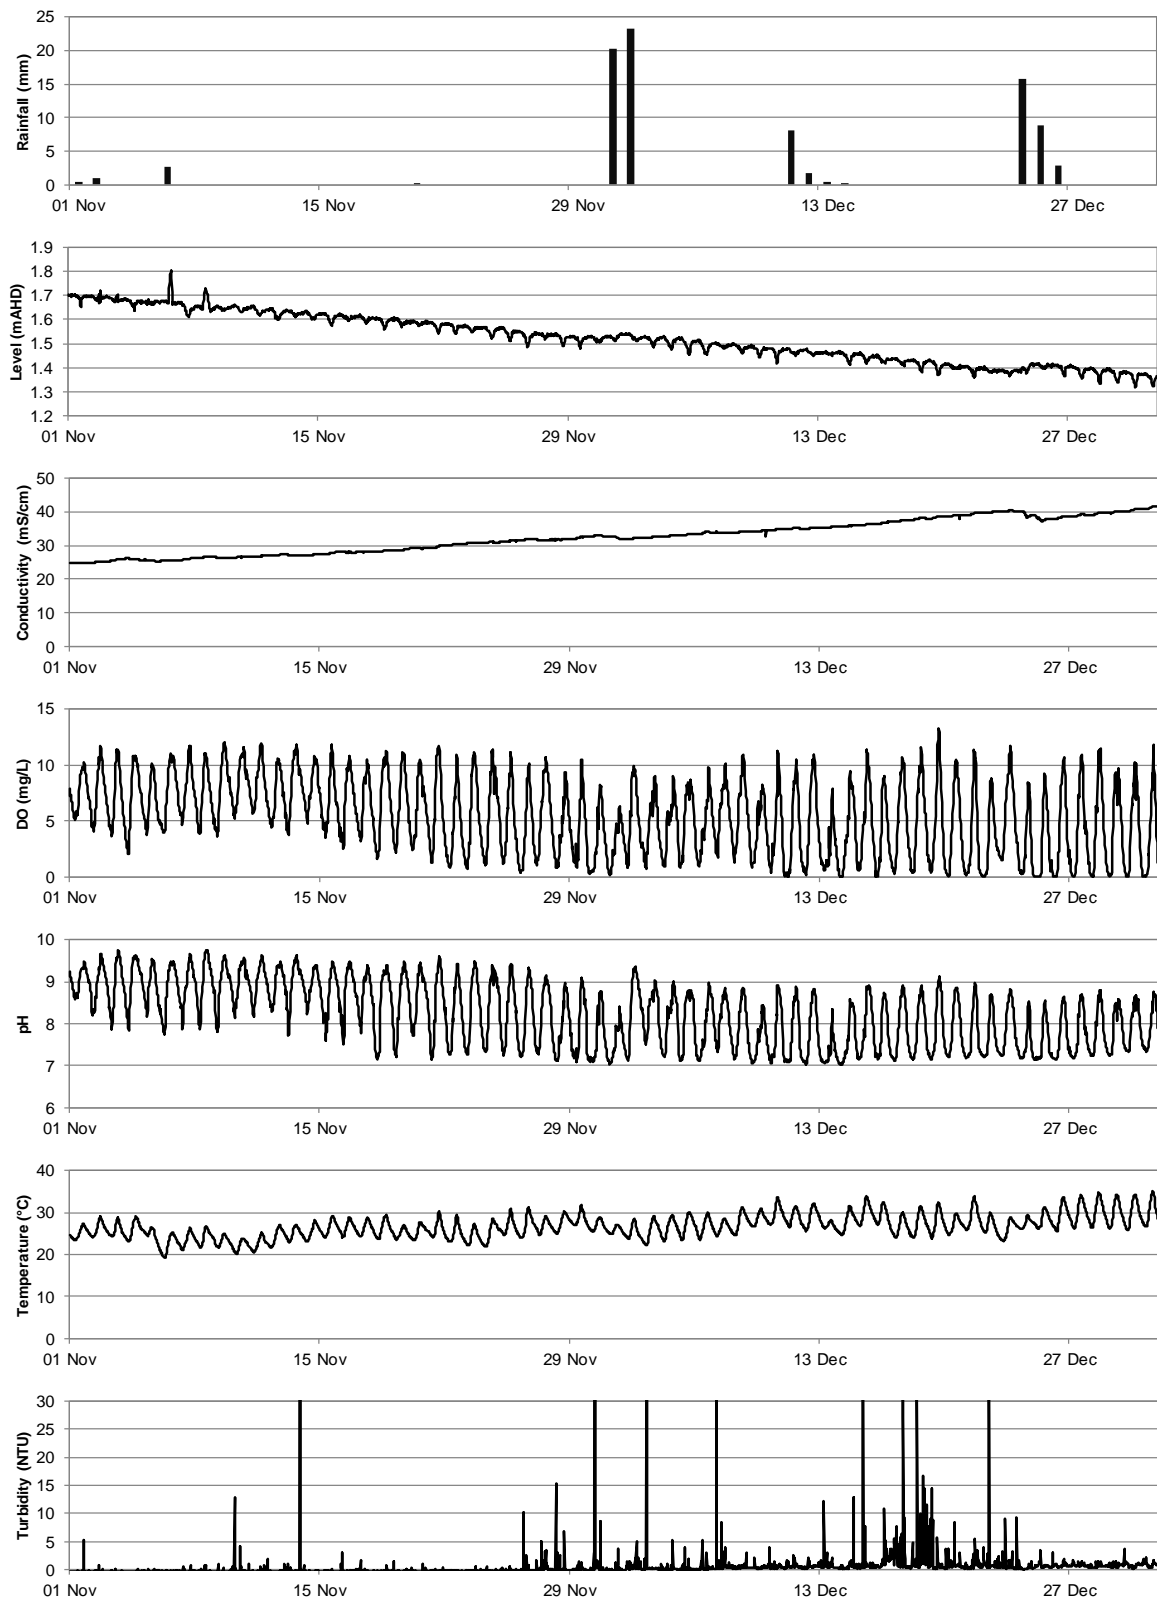
Illustration 3.1 Salty Lagoon Rainfall and Water Quality Monitoring Station Data 1 November 2019 to 31 December 2019

The data collected at the PWQMS, and rainfall data correlating to the reporting period are presented in **Illustration 3.1** and **Illustration 3.2**.

- The pH measurements from all sites, except S2, where it has remained low historically. The pH measurements recorded at the Salty Lagoon PWQMS showed very strong diurnal fluctuations during this reporting period, perhaps indicating a response to light availability, oxygen availability or temperature. The very high measurements from S3, collected near the middle of the day, reflects the daily changes at the time.
- The temperature measurements from all sites. This is a combination of seasonality, depth and the colour of the water.
- The enterococcus concentration at S2, probably related to bird use of the area.
- The turbidity measurements at S3.

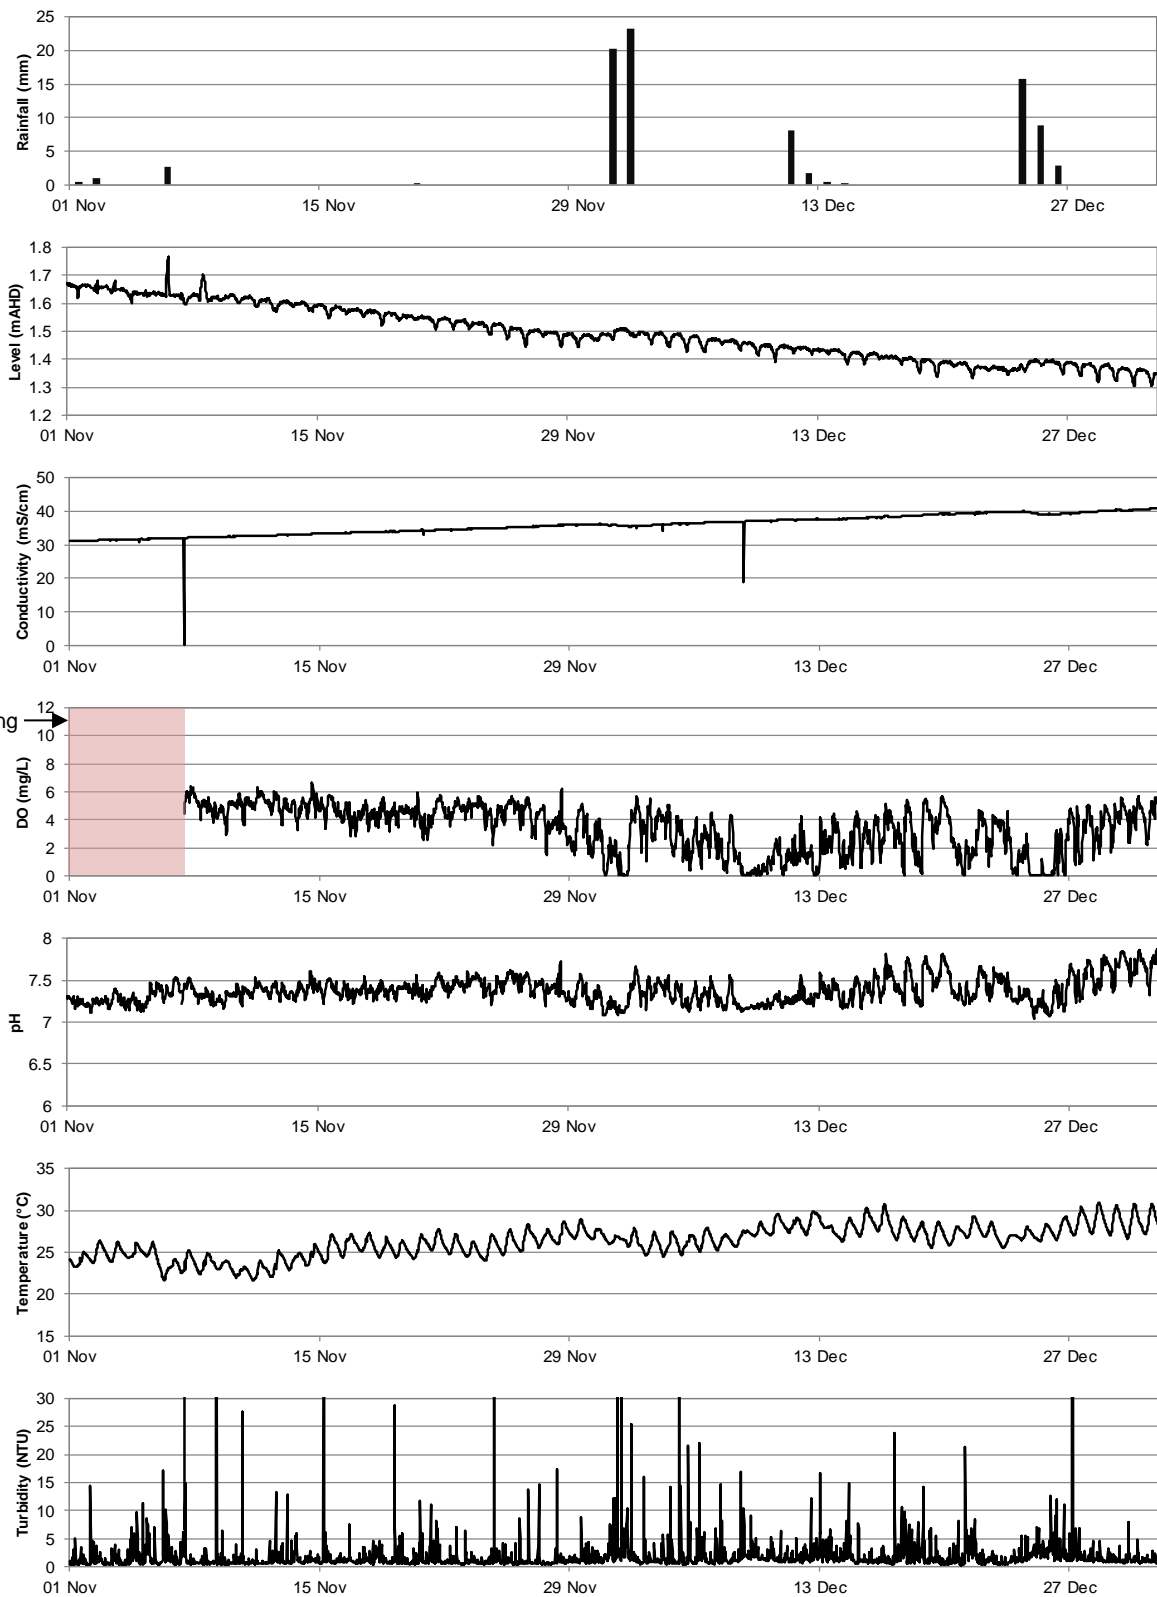
Illustration 3.2 Salty Creek Rainfall and Water Quality Monitoring Station Data 1 November 2019 to 31 December 2019

Total rainfall for this reporting period was 41 per cent of the long-term average (1998 - 2019). The rain fell in two moderate events and a few small events. The conductivity and level data from the Salty Creek PWQMS indicate that the entrance to Salty Creek remained closed for the entire reporting period. It also shows that the water level in Salty Creek reduced consistently throughout the monitoring period and that rainfall had little impact. At the time of the site inspection on 22 January 2020, the entrance to Salty Creek was still closed. The water level in Salty Lagoon also reduced consistently over the course of this monitoring period. The levels in both waterways fell by more than 0.3 m between 1 November and 31 December 2019. At the time of the site inspection there was not enough water at S4 to sample. Interestingly, daily water level fluctuations of more than 0.5 cm were measured in Salty Lagoon and Salty Creek on the hottest days when water temperatures were fluctuating by as much as 10 °C. It is likely that the dark tannin staining and large surface area to depth ratio of the water contributes to these fluctuations through expansion and contraction but also that they may reflect groundwater fluctuations in response to evapotranspiration. The conductivity measured at the Salty Lagoon and Salty Creek PWQMS increased steadily over the course of the monitoring period, indicating that evaporation was a major factor driving water quality. At the time of the site inspection on 22 January 2020 the salinity in Salty Lagoon was approximately 80 per cent seawater, the highest it has been in the post-channel monitoring. The conductivity measurements collected on 22 January 2020 were higher than the guiding values at all sites.

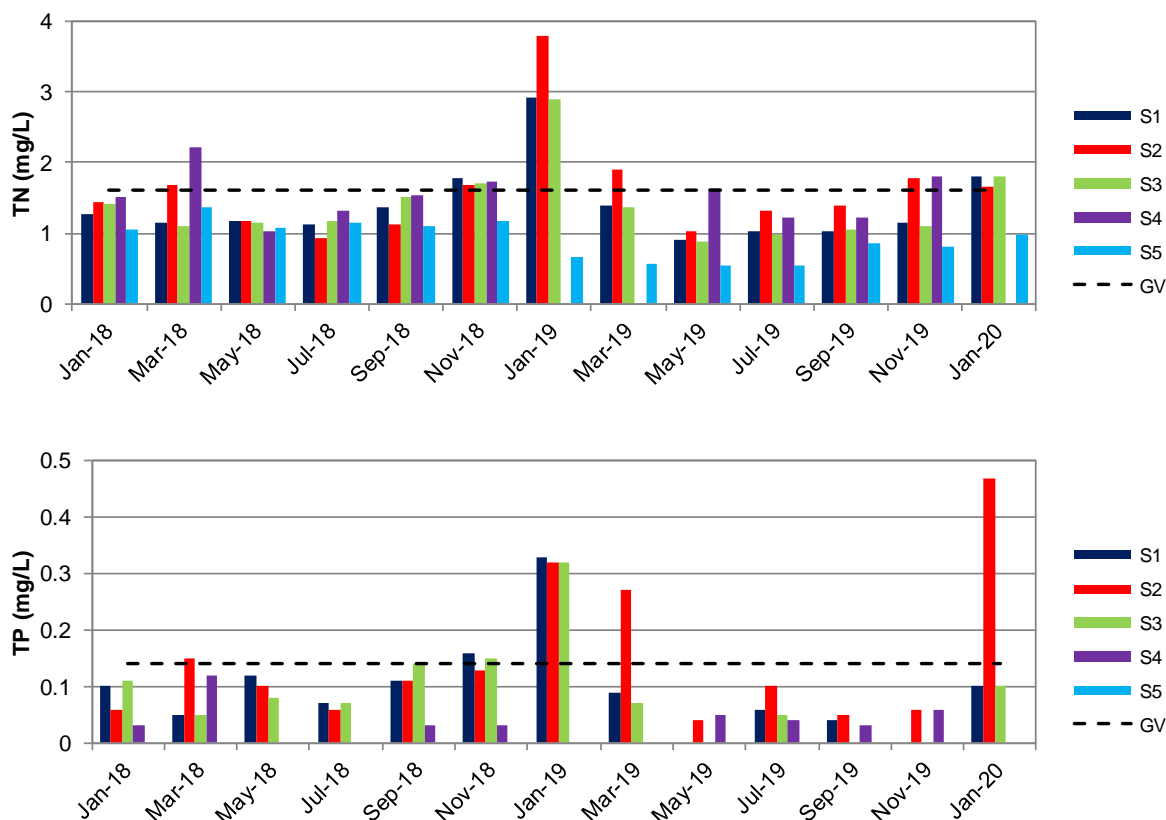
Illustration 4.1 Discrete Measurements of TN and TP at all Sites Since January 2018 Plotted Against the Salty Lagoon Guiding Value

Most of the nutrient concentrations from samples collected on 22 January 2020 complied with guiding values. The exceptions were the TN concentrations from S1, S2 and S3, the nitrate concentration from Salty Creek and the ammonia, TP and orthophosphate concentrations from S2. Nutrient concentrations typically increase in Salty Lagoon in periods where evaporation is much greater than rainfall (**Illustration 4.1**), often in the summer months. Bioavailable nitrogen was not detected in any samples from Salty Lagoon and bioavailable phosphorus was only detected at S2. Chlorophyll-a

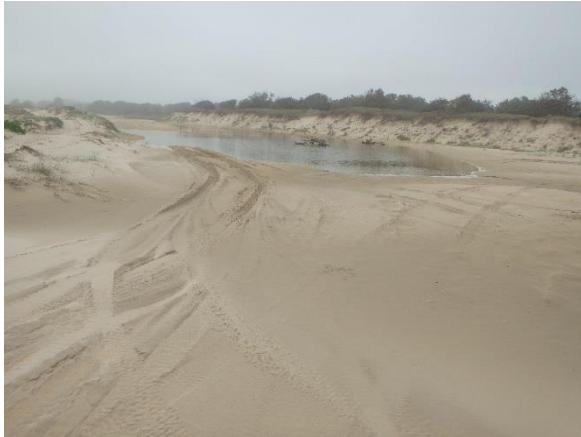
Plate 4.1 The closed entrance to Salty Creek on 22 January 2020

The entrance to Salty Creek was closed on 22 January 2020. A large number and wide variety of birds were observed incidentally during the site inspection including Pacific Black Duck, Chestnut Teal, Pelican, Black Swan, White Ibis, Great Egret, White-faced Heron, Masked Lapwing, Red-capped Plover, Pied Stilt, Sharp-Tailed Sandpiper, Curlew Sandpiper, Sanderling and White-bellied Sea

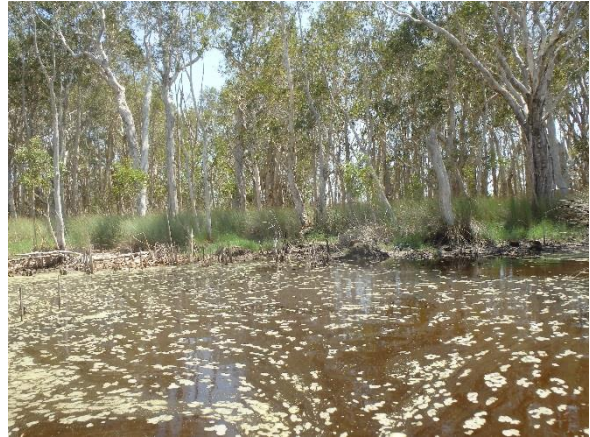
Plate 4.2 Dense macroalgal growth at S2 on 22 January 2020

No significant aquatic weeds were identified during the aquatic weed survey on 22 January 2020. Dense growth of green algae formed mats in some parts of the lagoon.
