Salty Lagoon

Post Closure Monitoring

Project Management and Ecosystem Health Report

April 2020

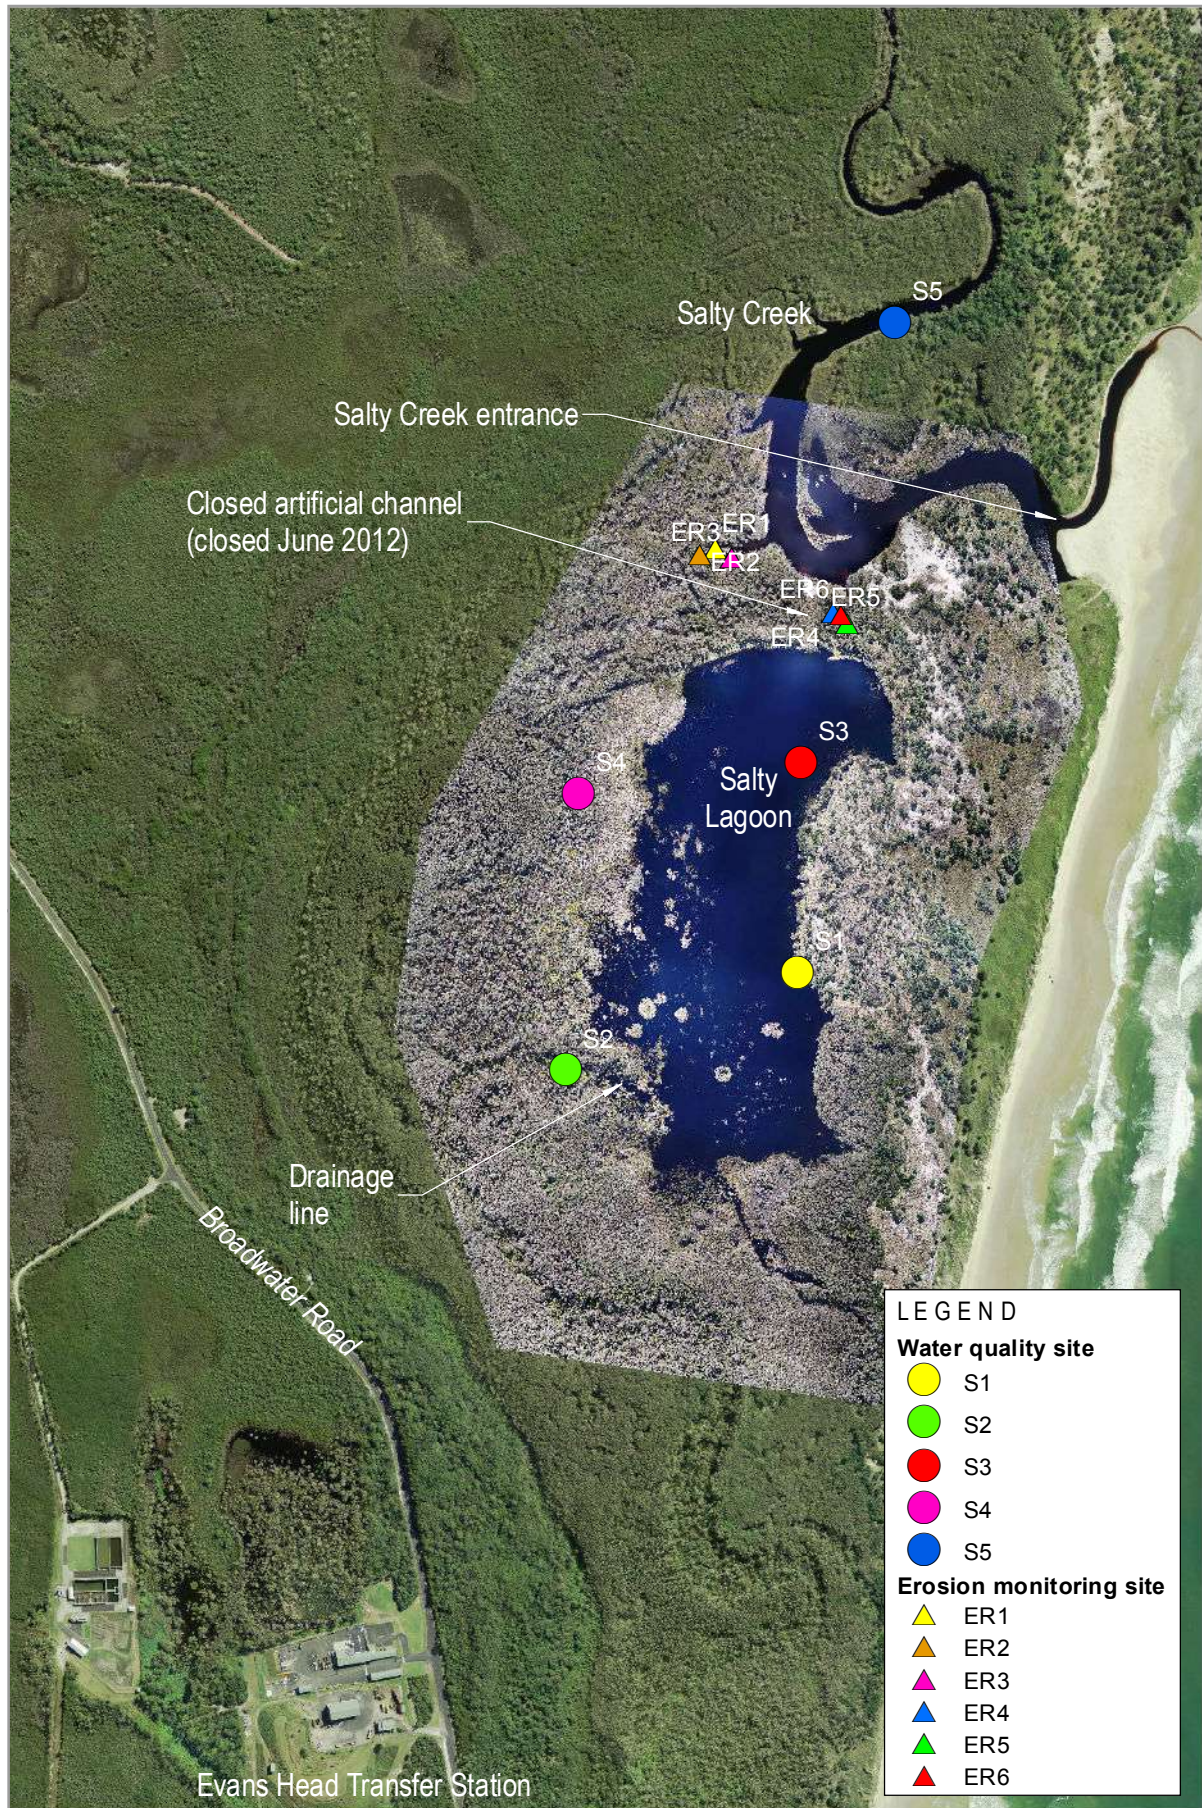
Illustration 2.1

Water Quality and Erosion Monitoring Site Locations

Discrete water quality samples were taken from surface water (approximately 0.2 metre depth) at three sites in Salty Lagoon and a single site (S5) in Salty Creek. An additional quality assurance (QA) replicate sample was collected at S4. The specific locations of all sites sampled are presented in **Table 2.1** and **Illustration 2.1**. They are the same sites previously used for the MPPC (GeoLINK 2017).

A series of stations have been set up around the active head cut to the east of the infilled channel and some nearby control sites to assess the progression of erosion between Salty Lagoon and Salty Creek. The specific locations of all sites sampled are presented in **Table 2.2** and **Illustration 2.1**.

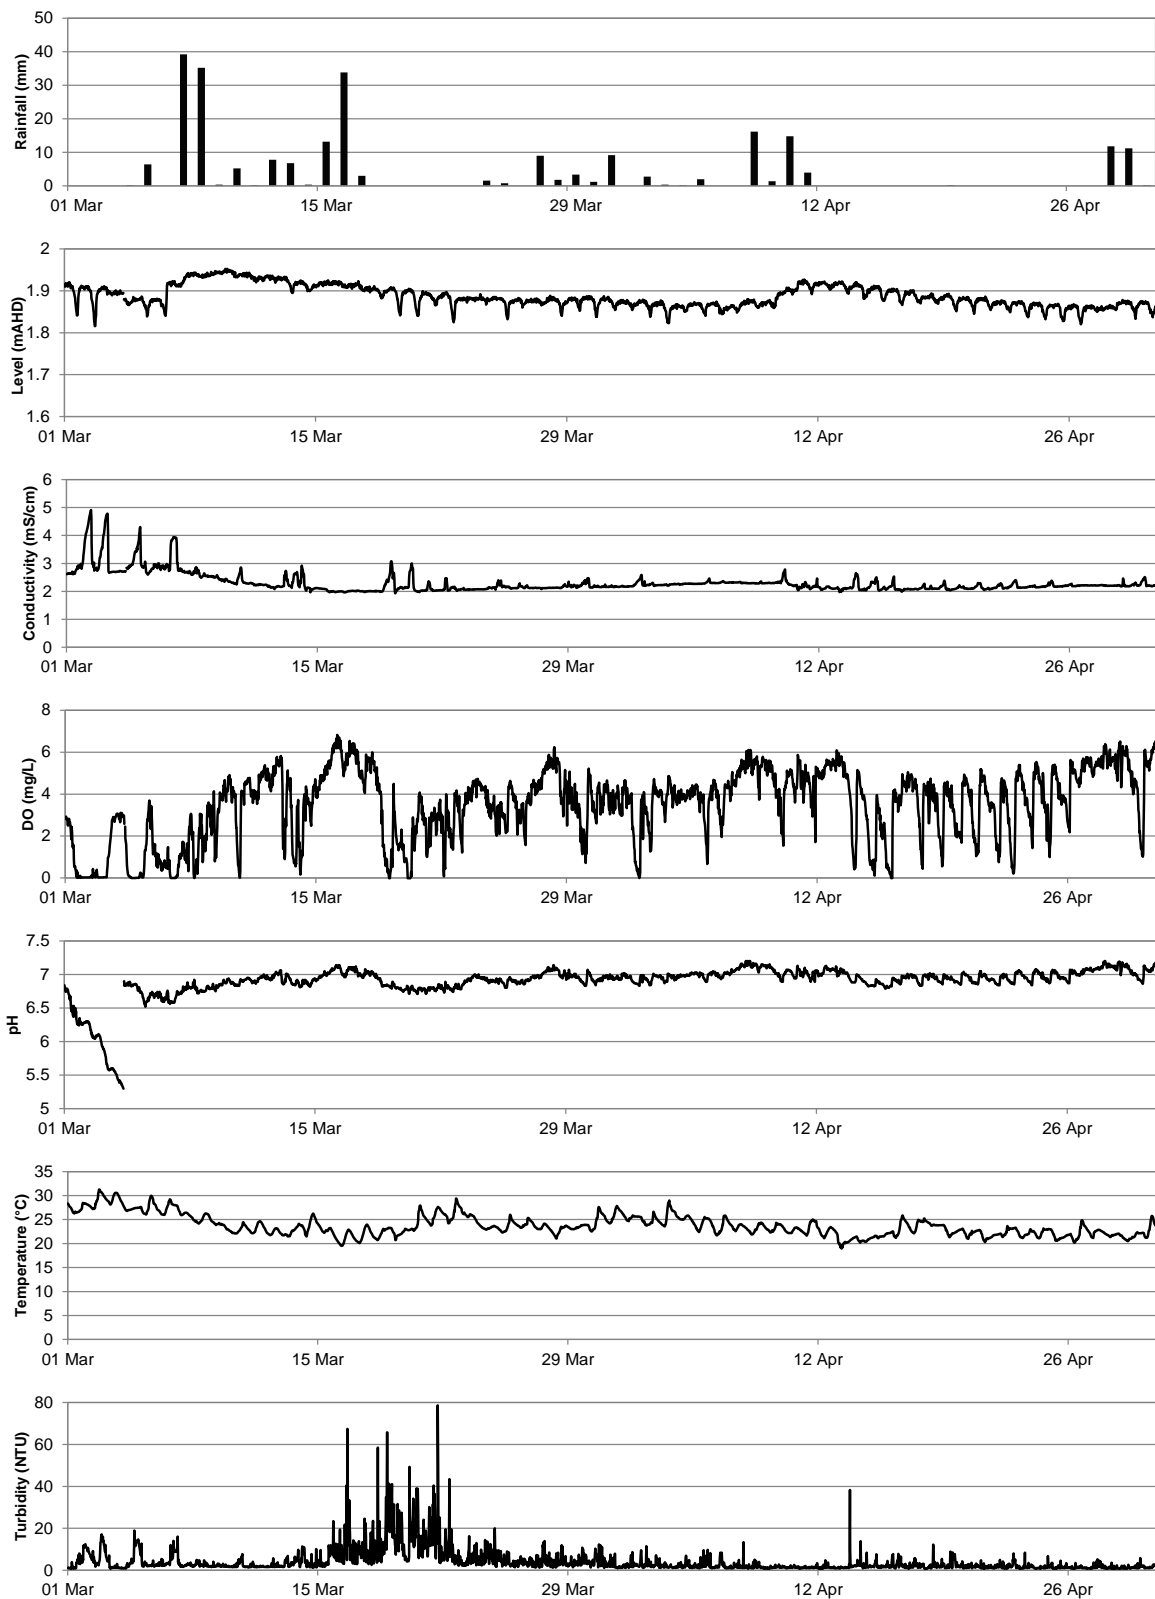
Illustration 3.1 Salty Lagoon Rainfall and Water Quality Monitoring Station Data 1 March 2020 to 30 April 2020

The data collected at the PWQMS, and rainfall data correlating to the reporting period are presented in **Illustration 3.1** and **Illustration 3.2**.

Total rainfall for this reporting period was below average. However, rain fell throughout the reporting period in a variety of small and medium sized events. The conductivity and level data from the Salty Creek PWQMS indicate that the entrance to Salty Creek was open and tidal for the first two weeks of the reporting period but that it was substantially constricted from then onwards, with the exception of a short period following seawater ingress on 9 April 2020. The water level in Salty Creek increased over the course of the reporting period, having started at very low levels. At the time of the site inspection on 4 May 2020, the status of the entrance to Salty Creek was unknown, due to restricted access to Airforce Beach. The water level in Salty Lagoon remained relatively high throughout this monitoring period. The key factors causing variation in the water levels of Salty Lagoon during this reporting period appear to have been rainfall, runoff to Salty Creek and daily temperature fluctuations. Aside from the response to rainfall, daily water level fluctuations of more than 5 cm were measured in Salty Lagoon and Salty Creek on the hottest days when water temperatures were fluctuating by as much as 10 °C. It is likely that the dark tannin staining and large surface area to depth ratio of the water contributes to these fluctuations through expansion and contraction but also that they may reflect groundwater fluctuations in response to evapotranspiration.

The conductivities measured at the Salty Lagoon and Salty Creek PWQMS both decreased over the course of the monitoring period, indicating that dilution by rainfall runoff was a major factor driving water quality. However, the conductivity measurements at the Salty Creek PWQMS did reach very high levels during times when tidal movements were registered and during two seawater ingress events. At the time of the site inspection on 4 May 2020 the water in Salty Lagoon and Salty Creek was brackish. The conductivity measurements collected on 4 May 2020 complied with guiding values at all sites.

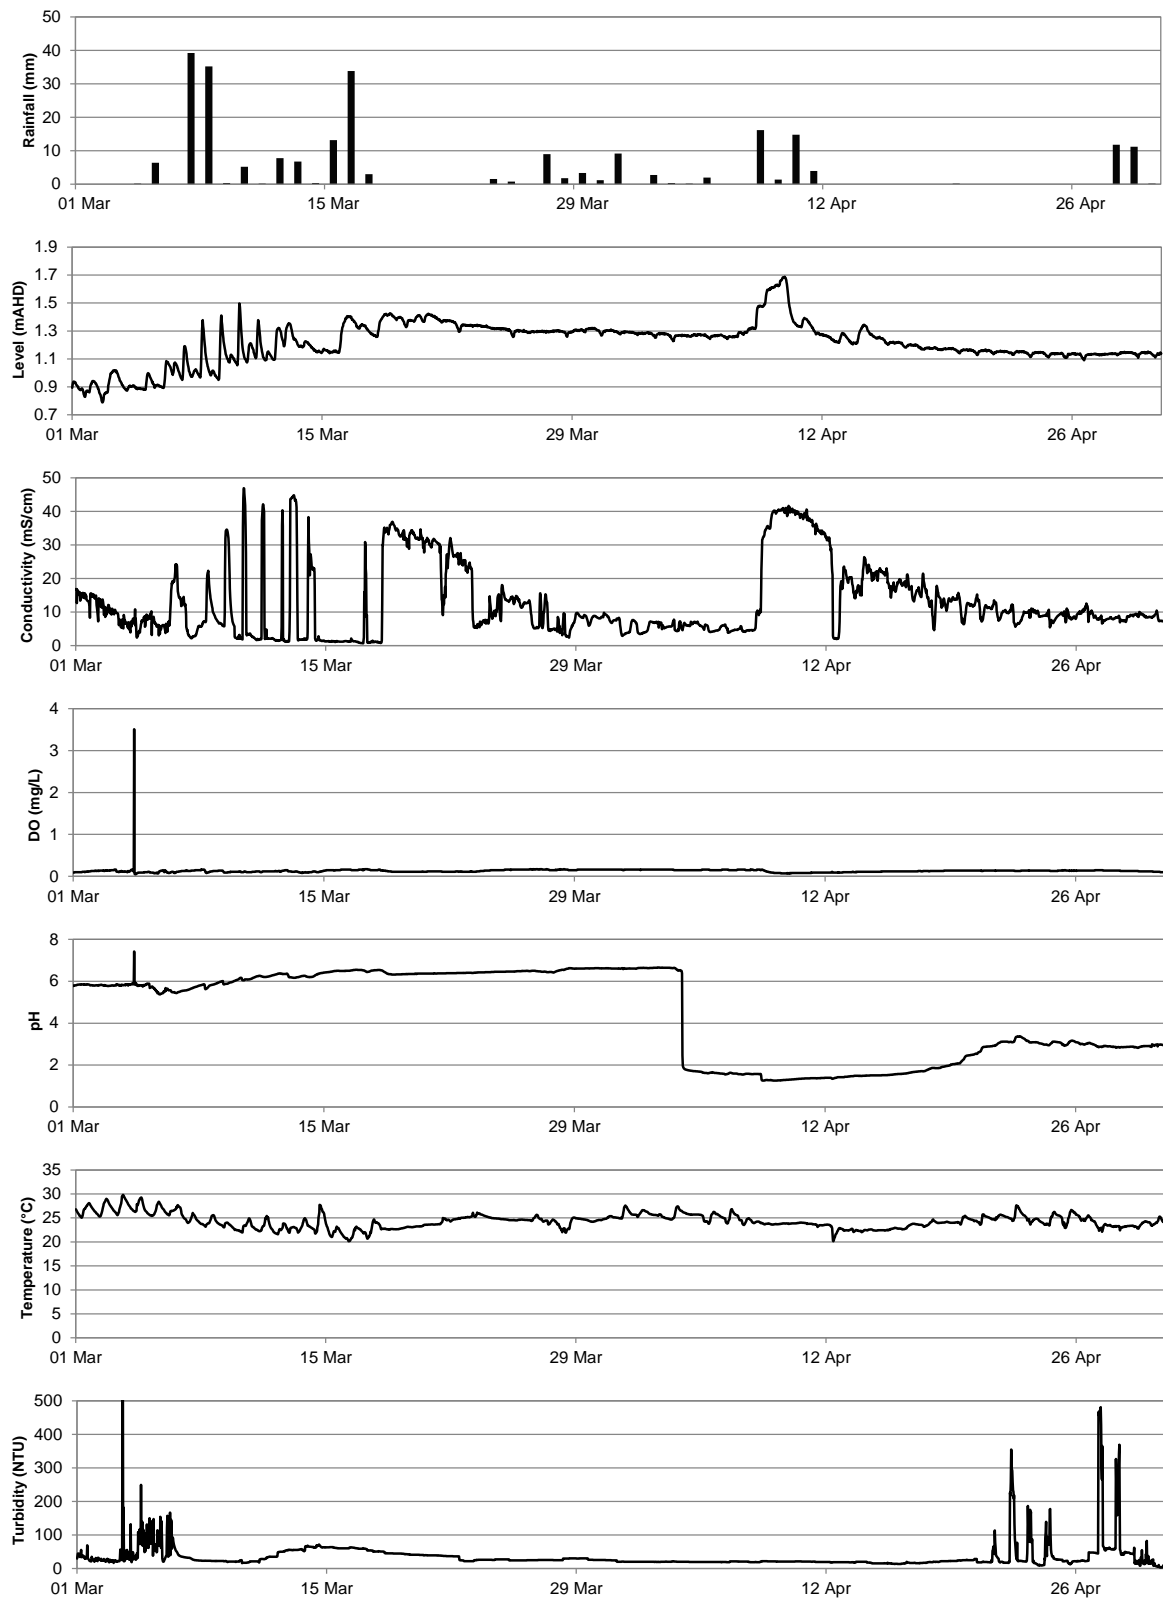
Illustration 3.2 Salty Creek Rainfall and Water Quality Monitoring Station Data 1 March 2020 to 30 April 2020

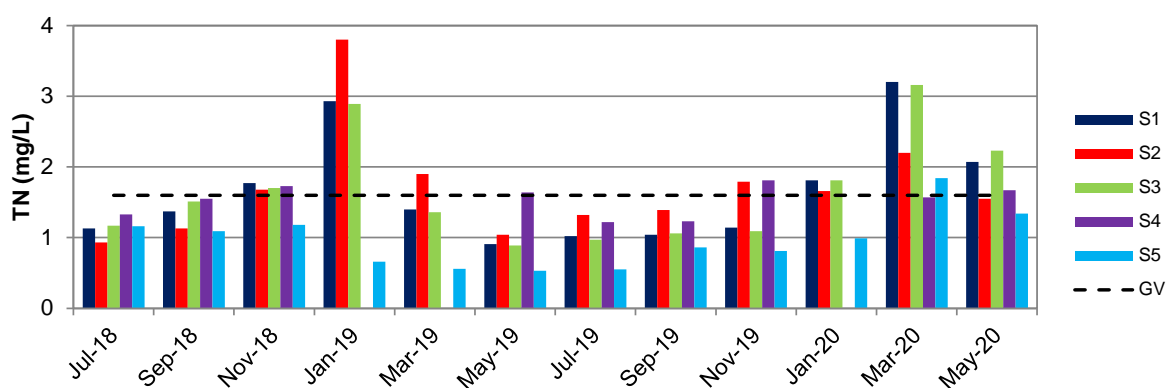
Illustration 4.1 TN concentration at all sites since July 2018, plotted against the Salty Lagoon guiding value

Most of the nutrient concentrations in samples collected on 4 May 2020 complied with guiding values. The exceptions were the TN, TP, nitrate and orthophosphate concentrations from S1 and S3, ammonia concentrations from S2 and S4 and TN concentration from S4. The TN and TP concentrations from most sites were reduced from the previous samples collected on 4 March 2020

(Illustrations 4.1 and 4.2). It is likely that dilution from rainfall resulted in lower nutrient concentrations, in the same way it resulted in lower conductivity measurements. Chlorophyll-a concentrations did not comply with guiding values at S1, S3, S4 or S5. At S1, S3 and S5 they indicated an algal bloom of moderate proportions and at S4 an algal bloom of small proportions. There were no blue-green algae detected in any samples.

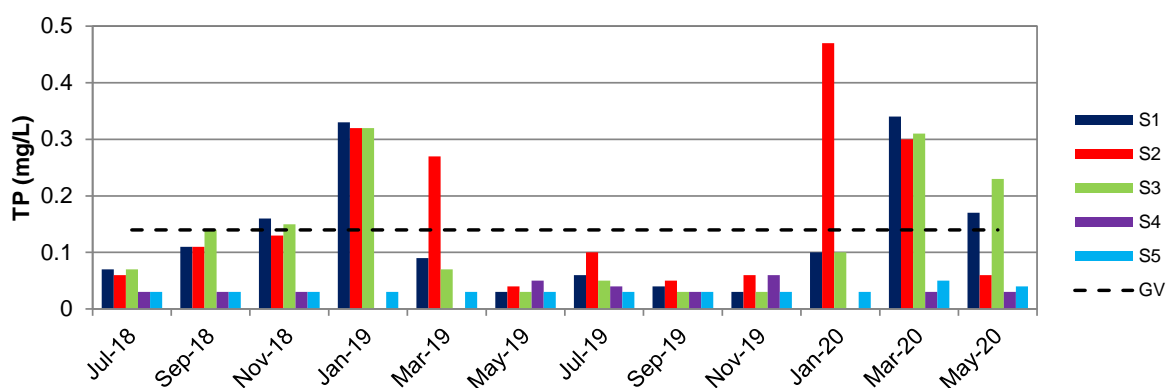
Illustration 4.2 TP concentration at all sites since July 2018, plotted against the Salty Lagoon guiding value

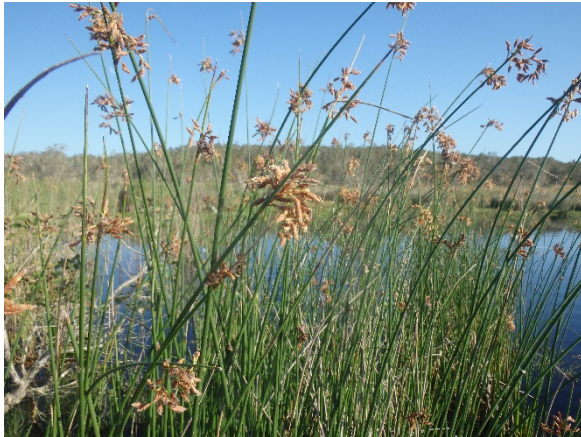
Plate 4.1 River Club Rush (*Schoenoplectus validus*) survived the very saline conditions of the previous four months. Other emergent rushes, such as Cumbungi (*Typha sp.*) did not.

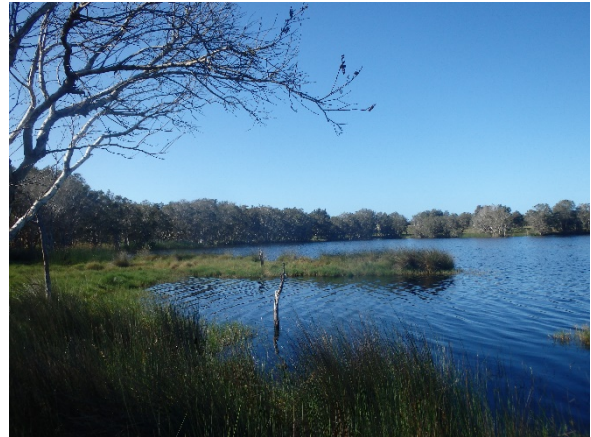
Plate 4.2 Water levels in Salty Lagoon remained high throughout the current monitoring period.

1. Water levels remained high in Salty Lagoon throughout the current monitoring period. Water levels in Salty Creek were variable in response to rainfall conditions, entrance status and seawater ingress.
