Salty Lagoon

Post Closure Monitoring

Project Management and Ecosystem Health Report

August 2020

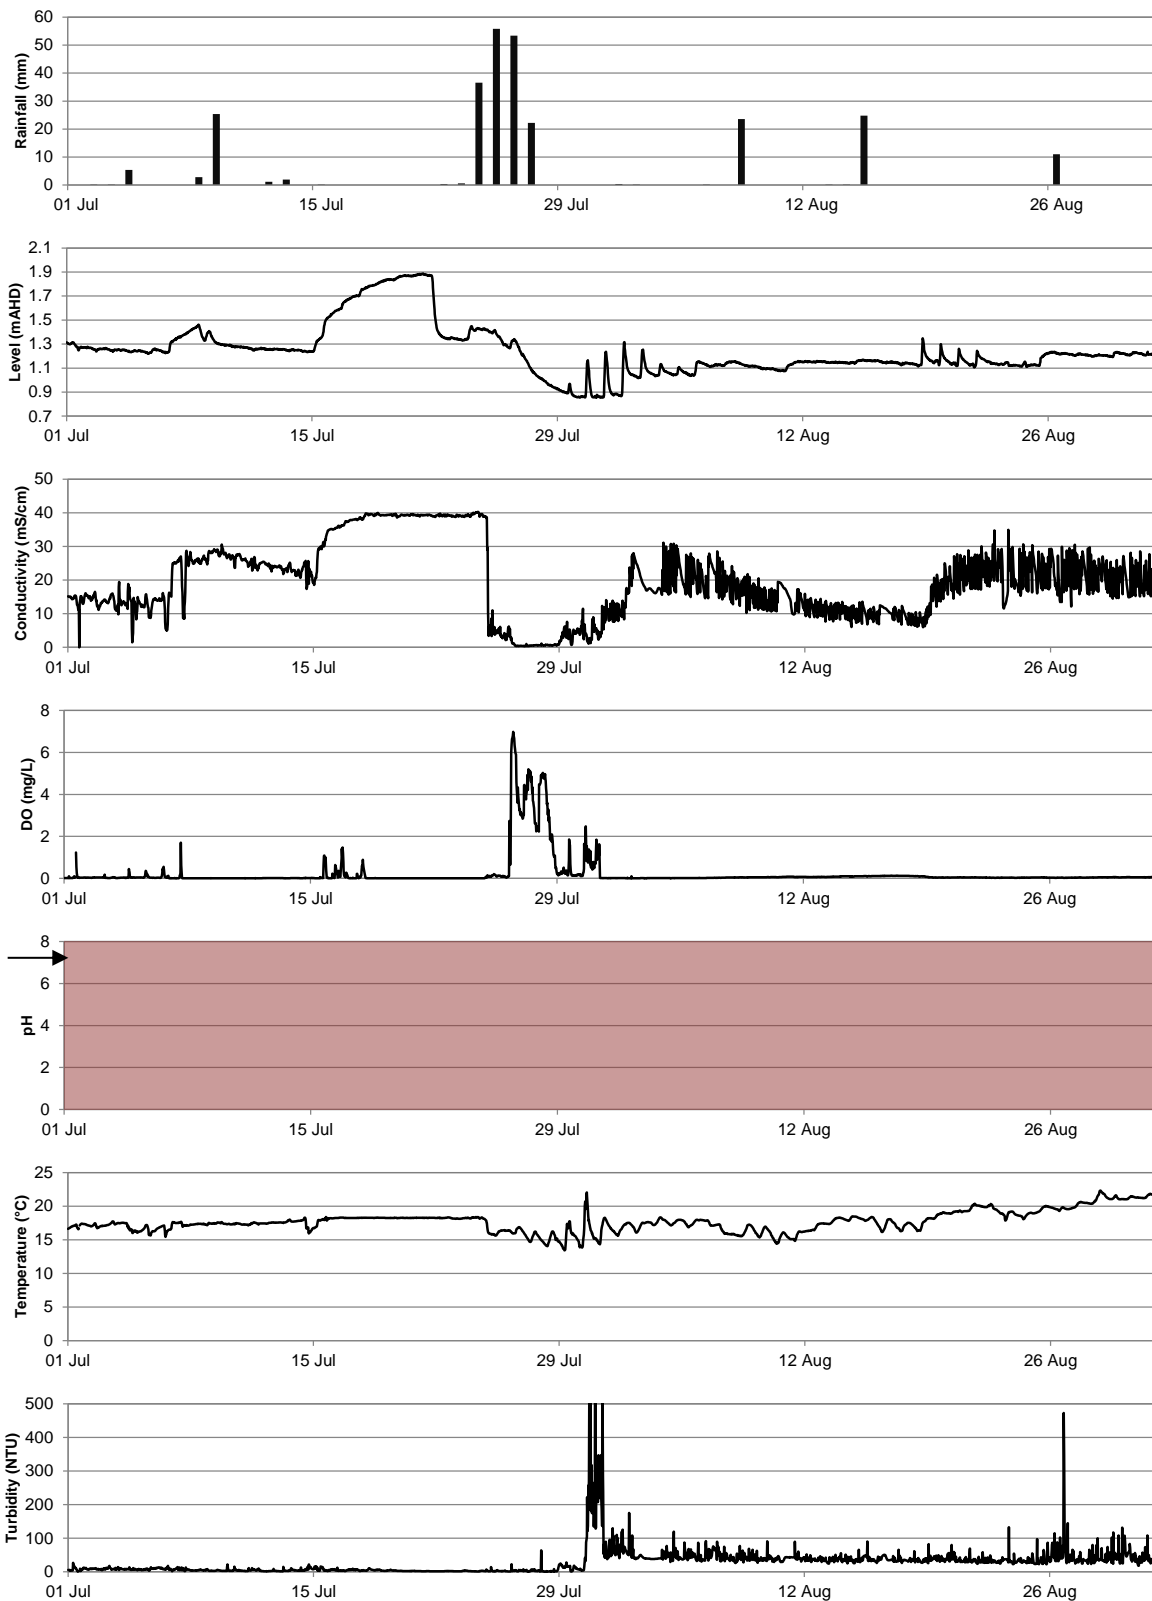
Illustration 3.2 Salty Creek Rainfall and Water Quality Monitoring Station Data 1 July 2020 to 31 August 2020

The logged water quality data for this reporting period was slightly impacted by technical problems. The pH probe on the Salty Creek logger was malfunctioning for the entire monitoring period, probably due to an early demise of the pH cap for an unknown reason. At the time of writing the pH cap had been replaced.

Total rainfall for this reporting period comprised of several evenly spaced small to moderate events and one large event between 24 and 27 July 2020. The conductivity and level data from the Salty Creek PWQMS indicate that the entrance to Salty Creek was constricted from the beginning of the monitoring period and seawater ingress resulted in very high water levels until the entrance opened on 21 July 2020 and water drained quickly. Heavy rainfall in the week afterwards resulted in a further opening, very low water levels and fresh water conditions. Two short periods of tidal movements led to a return of saline water conditions. At the time of the site inspection on 1 September 2020, the entrance to Salty Creek was narrowly open, shallow and flowing slowing outwards. The water level in Salty Lagoon remained relatively high throughout this monitoring period, increasing significantly in response to the large rainfall event and decreasing slowly at other times, probably as water flowed out into Salty Creek (as observed during an adaptive management site inspection on 27 July 2020). Daily water level fluctuations in Salty Lagoon were low again during this reporting period due to lower temperatures and smaller temperature fluctuations.

The data collected at the PWQMS, and rainfall data correlating to the reporting period are presented in **Illustration 3.1** and **Illustration 3.2**.

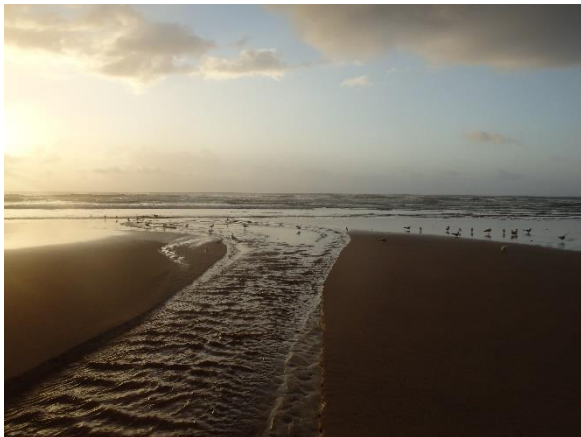
The entrance to Salty Creek was narrowly open on 1 September 2020. A variety of birds were observed incidentally during the site inspection including Pacific Black Duck, Pelican, Black Swan, Pied Cormorant and Little Black Cormorant.

Plate 4.1 The open entrance to Salty Creek on 1 September 2020

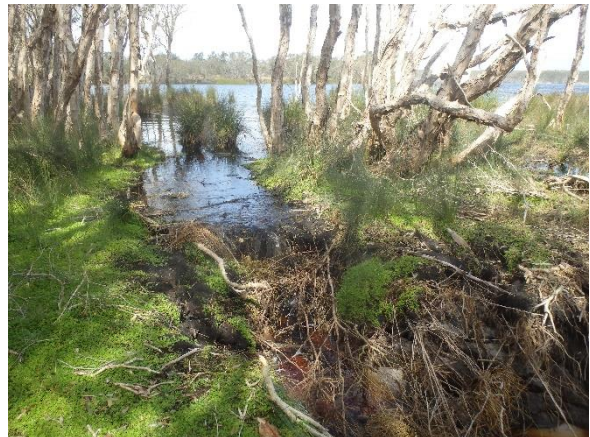
Plate 4.2 The erosive headcut is now within approximately 14 m of Salty Lagoon

4. The erosive headcut to the east of the old channel between Salty Lagoon and Salty Creek advanced slightly south towards Salty Lagoon and west during this reporting period. There is a continued risk that the eroding channel will break into Salty Lagoon during the next heavy rainfall, or if moderate rainfall conditions persist for an extended period.

5. The risk rating for the Salty Lagoon Response Protocol is 'uncertain', due to the potential for the erosive channel to break into Salty Lagoon. Heavy rainfall may lead to a 'high' risk rating and require a site inspection in the coming months. An adaptive management site inspection was undertaken in response to heavy rainfall on 27 July 2020. No environmental incident was recorded but the headcut was noted to have advanced towards Salty Lagoon.
