Salty Lagoon

Post Closure Monitoring

Project Management and Ecosystem Health Report

October 2020

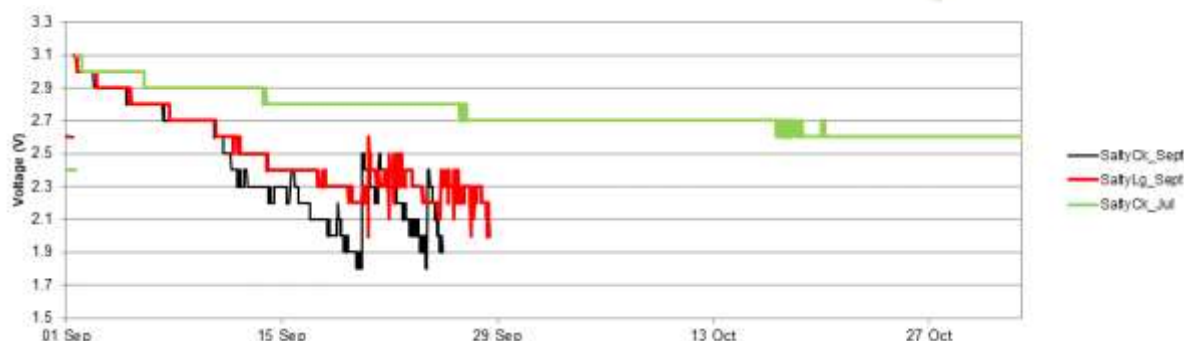
At the time of the site visit on 2 November 2020 the batteries on both sondes were completely discharged, despite new batteries having been installed on 1 September 2020 as per protocol. The only explanation for this is a change of battery brand. A routine battery life of 4 months was normal with the previous brand but the batteries installed on 1 September 2020 only lasted 25 to 28 days (**Illustration 2.1**). A third alternative brand of battery was installed on 2 November 2020 and all future batteries will be the initial brand used.

Illustration 2.1 Battery life in the EXO Sondes during this reporting period plotted against battery life from the Salty Creek PWQMD from July 2020 to August 2020

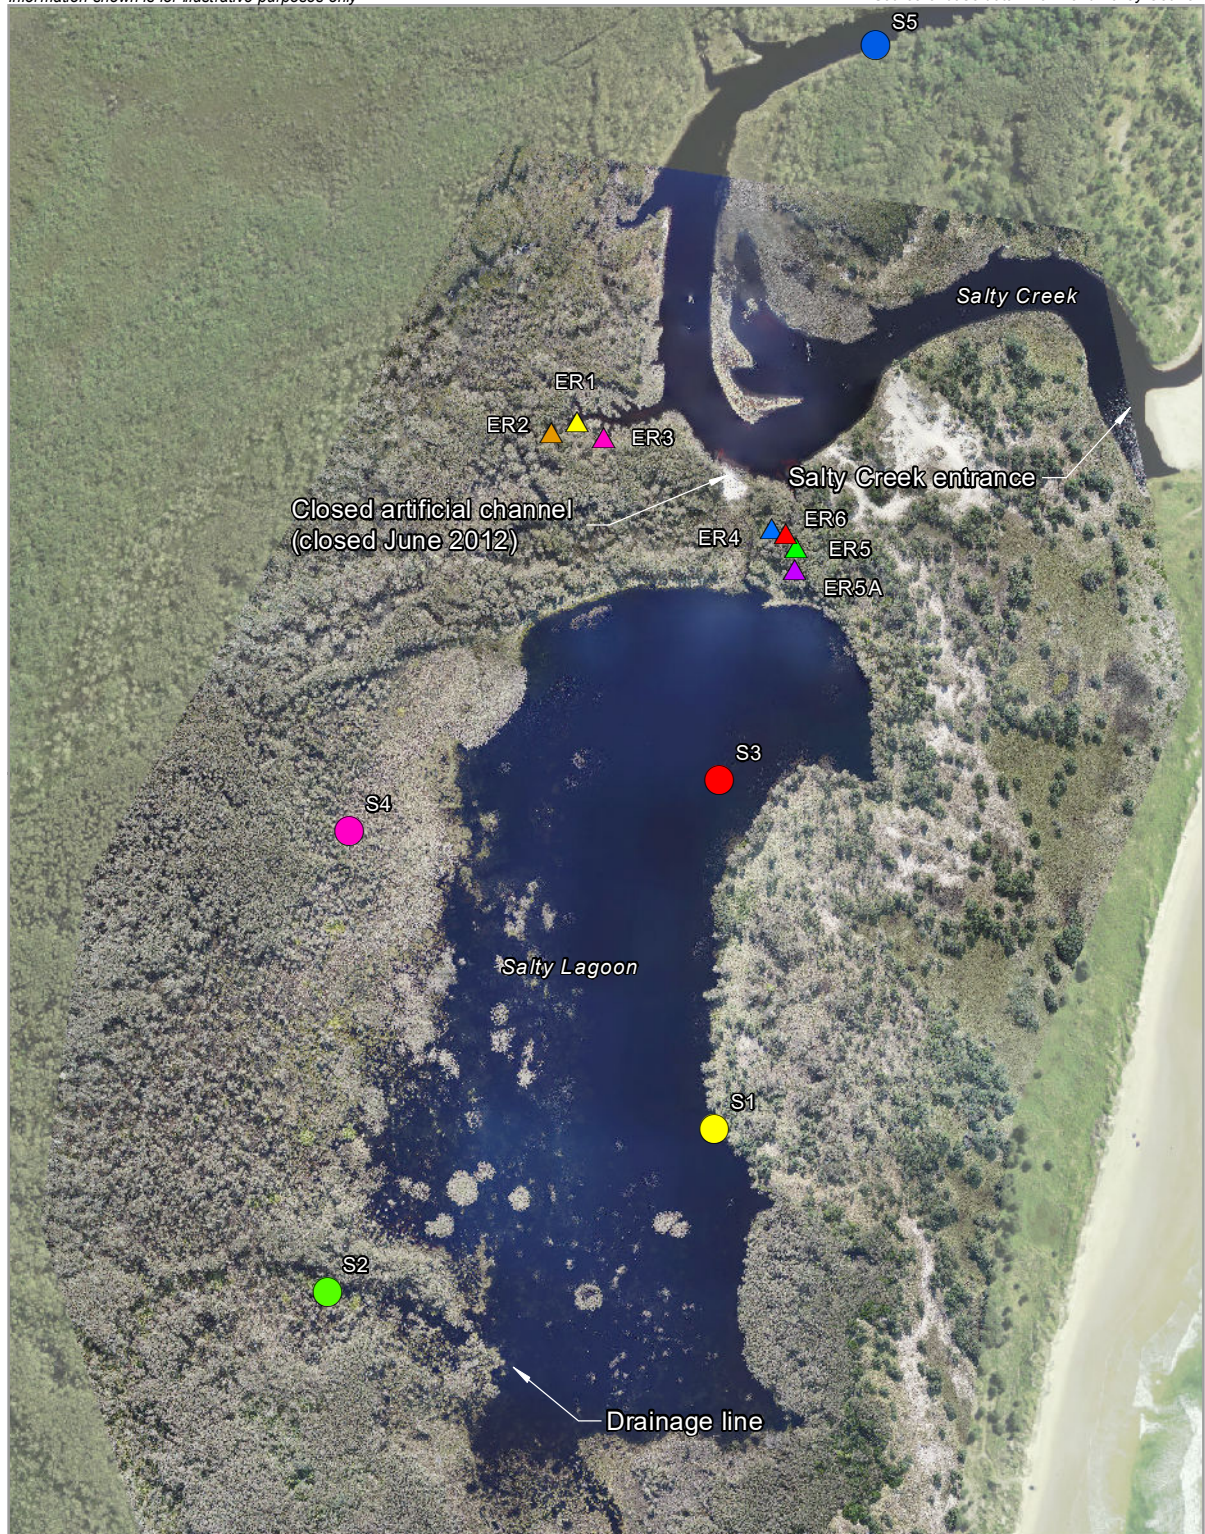
Location of Water Quality and Erosion Monitoring Sites

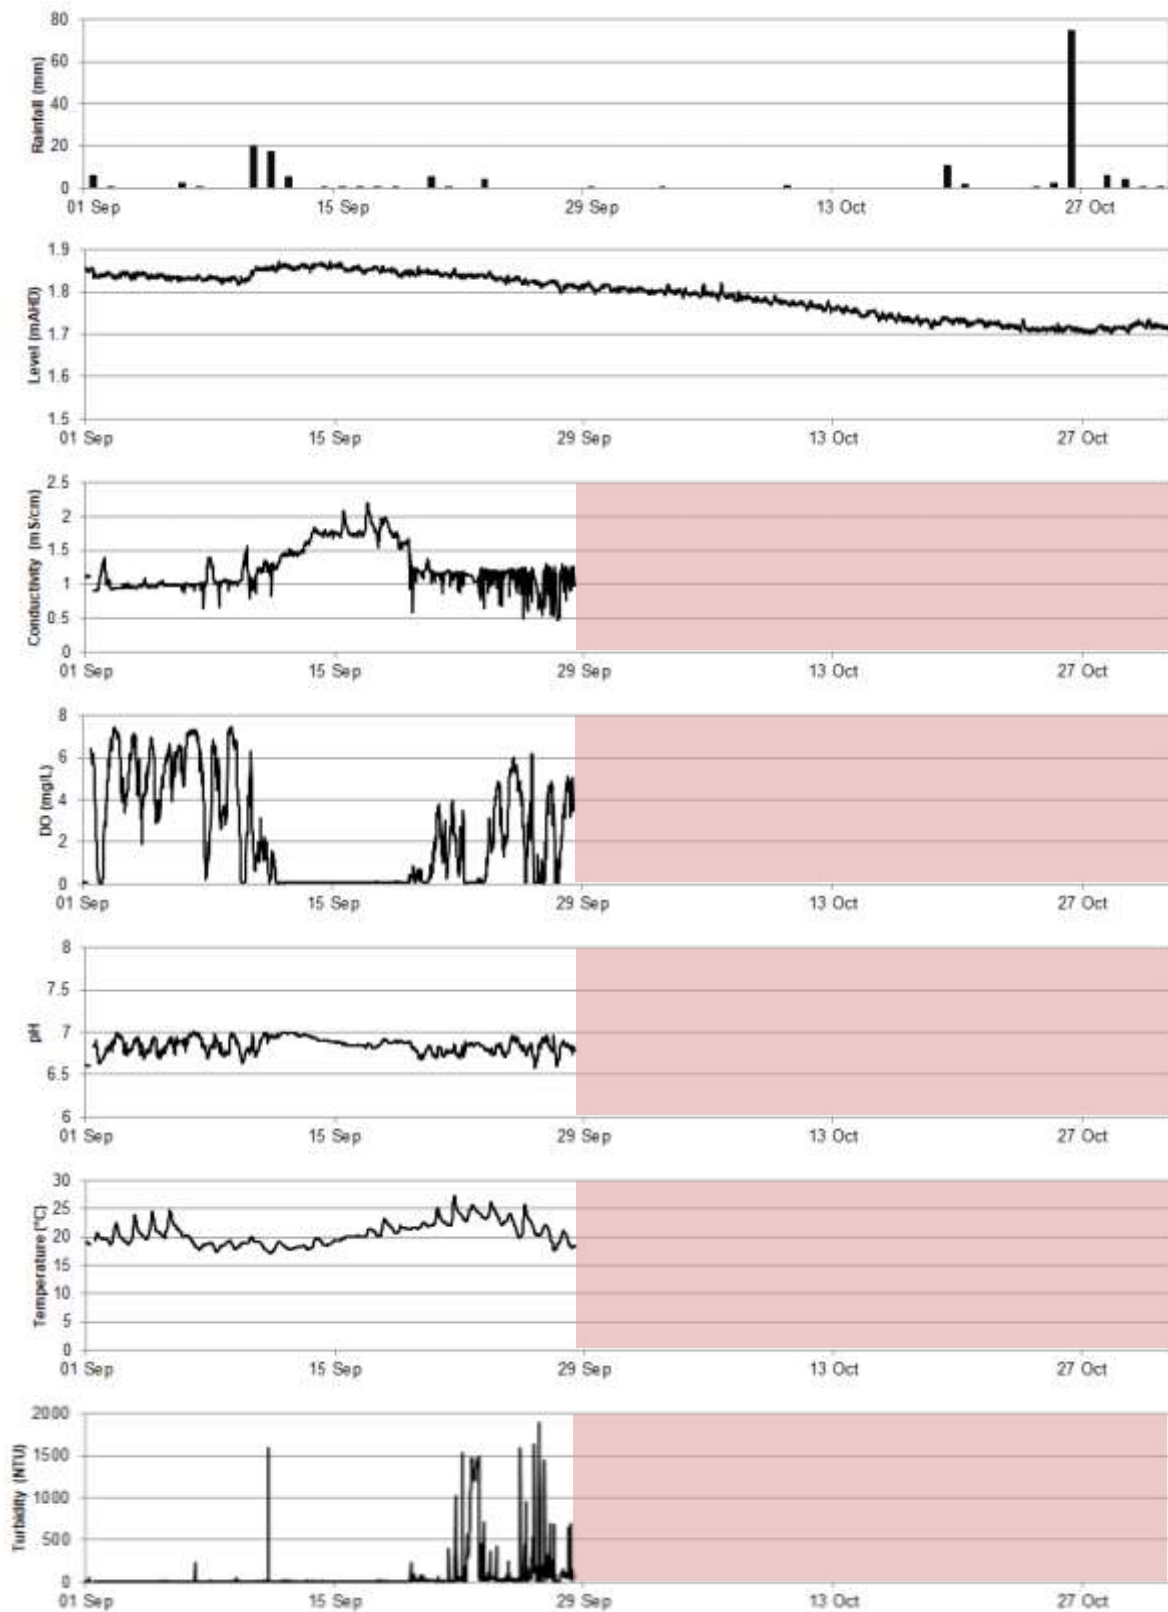
Illustration 3.1 Salty Lagoon Rainfall and Water Quality Monitoring Station Data 1
September 2020 to 31 October 2020

The conductivity and level data from the Salty Creek PWQMS indicate that the entrance to Salty Creek was constricted from the beginning of the monitoring period and that catchment inflow was the key influence on water levels although there were minor seawater ingress events on 1 and 16 September. At the time of the site inspection on 2 November 2020, the entrance to Salty Creek was closed (**Plate 4.1**). The water level in Salty Lagoon reduced throughout this monitoring period, initially as water flowed out into Salty Creek and later as a result of evaporation. Heavy rainfall on 26 October 2020 had little influence on the water level in Salty Lagoon.

The conductivity measured at the Salty Lagoon PWQMS remained relatively constant during this reporting period, remaining within the range of typical fresh to brackish conditions. There was a small increase in conductivity, which together with other parameters indicates that the water column in Salty Lagoon was stratified for a period of approximately 8 days following moderate rainfall between 9 and 11 September 2020. The conductivity measurements at the Salty Creek PWQMS fluctuated in response to seawater ingress and rainfall events. At the time of the site inspection on 2 November 2020 the water in Salty Lagoon was well mixed and brackish, indicating that further evaporation had occurred. The water in Salty Creek was also well mixed and the conductivity measurements were approximately 50% those of seawater. The conductivity measurements collected on 2 November 2020 complied with guiding values at all sites except S5, where they slightly exceeded them.

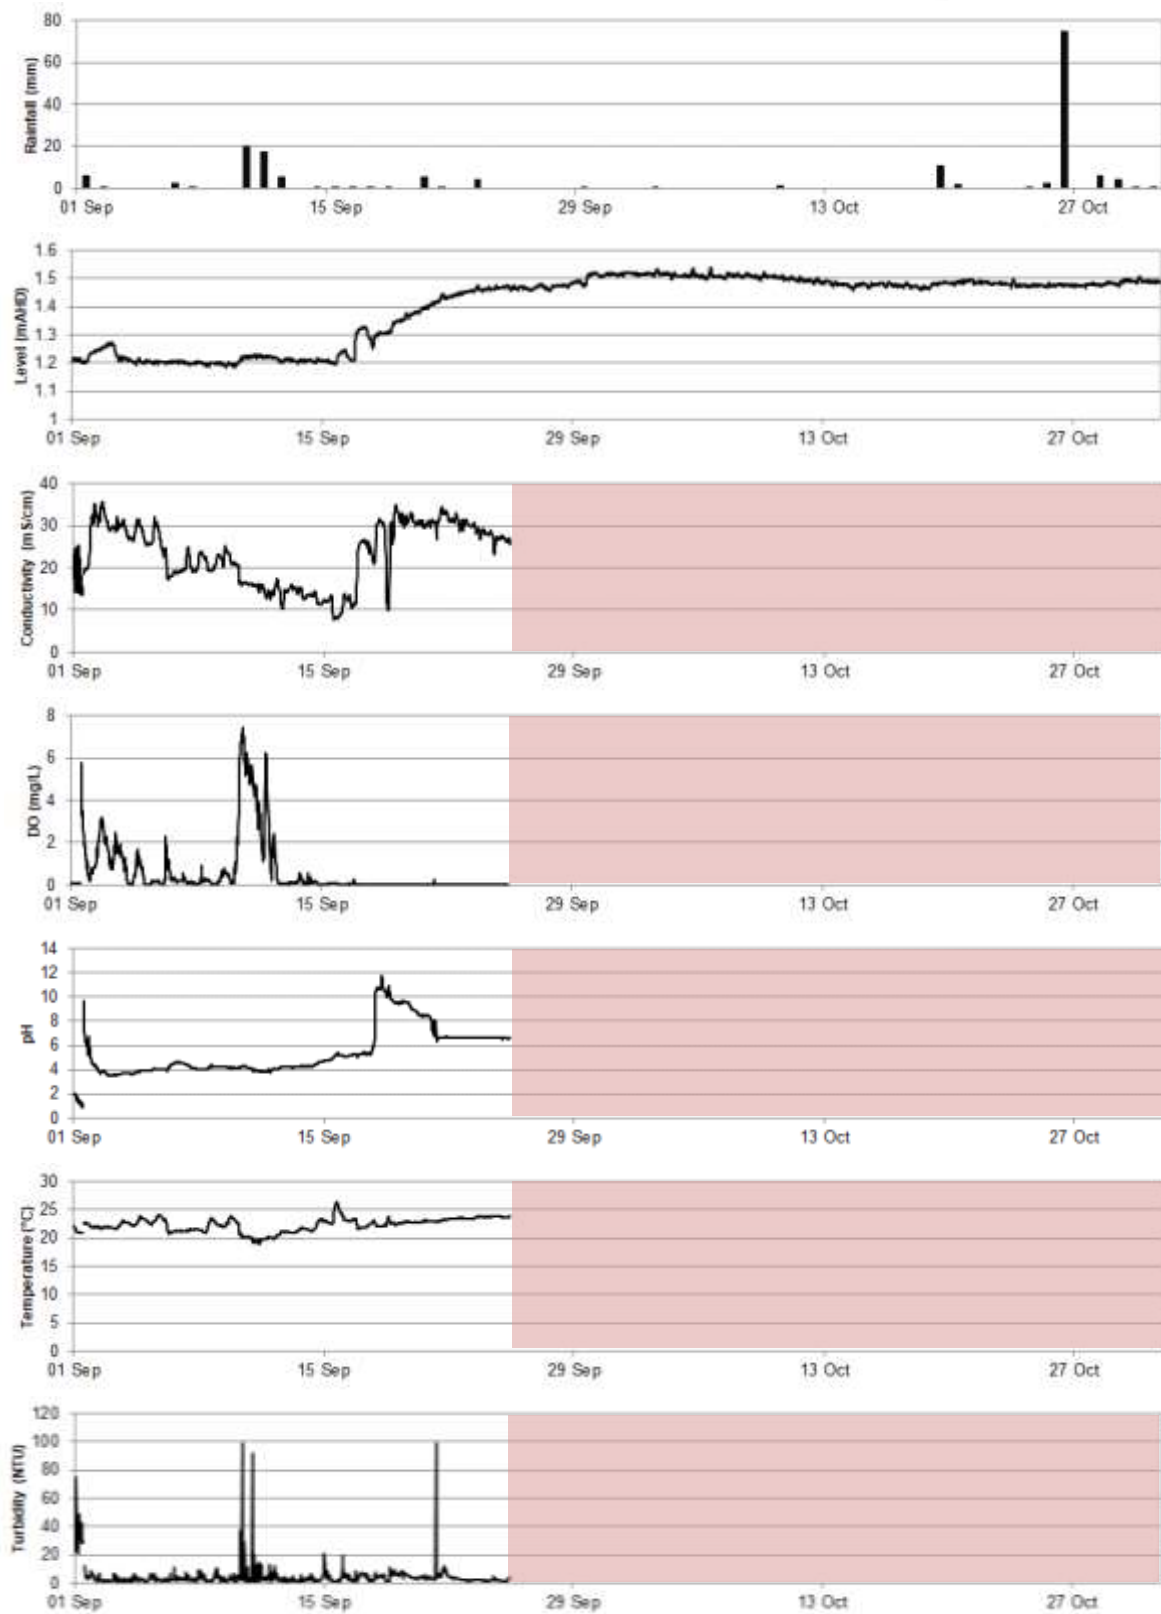
Illustration 3.2 Salty Creek Rainfall and Water Quality Monitoring Station Data 1
September 2020 to 31 October 2020

The logged water quality data for this reporting period was impacted by technical problems. The pH probe on the Salty Creek logger was replaced on 21 September 2020 after anomalous results were noted during the previous site inspection. The batteries in both probes failed on 25 and 28 September 2020 although new batteries (of a reputable brand) had been installed on 1 September 2020.

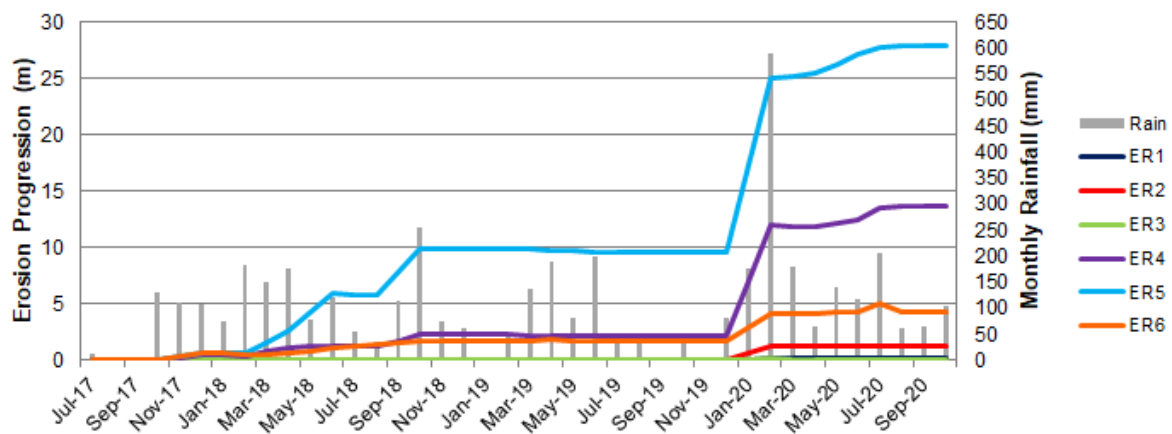
The data collected at the erosion monitoring stations is presented in **Table 3.2** and **Illustration 3.3**. There was no advance of the head cuts at any of the three impact stations in relation to the previous measurements on 1 September 2020. The head cut has advanced at least 27 m towards Salty Lagoon since the monitoring began in July 2017.

Illustration 3.3 Erosion Progression Plotted against Monthly Rainfall since July 2017

Erosion monitoring indicated that the head cut did not advance during this reporting period. The level information indicates that runoff from Salty Lagoon into Salty Creek was low and did not persist for the entire monitoring period. There was no advance of the head cuts at the control sites. The head cut is approximately 14 m from the current banks of Salty Lagoon. If it reaches Salty Lagoon, the channel formed is highly likely to increase in size when tidal movements occur and some of the conditions that previously led to fish kills will be restored. Such a scenario could have an impact on future planning for the disposal of treated wastewater.

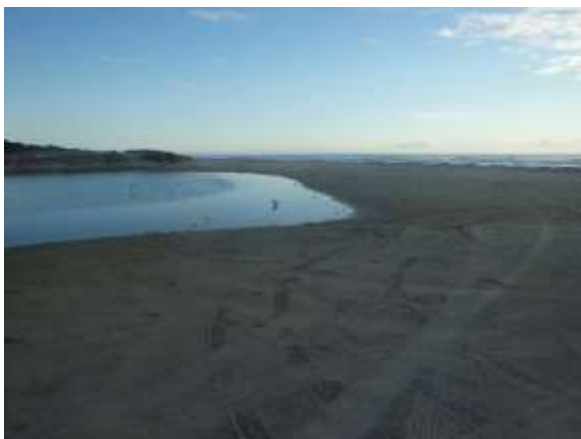
The entrance to Salty Creek was closed on 2 November 2020. A variety of birds were observed incidentally during the site inspection including Pacific Black Duck, Pelican, Pied Cormorant, Little Black Cormorant, Great Egret, Whimbrel, Masked Lapwing, Little Tern, White bellied Sea Eagle, Brahminy Kite and Swamp Harrier.

Plate 4.1 The closed entrance to Salty Creek on 2 November 2020

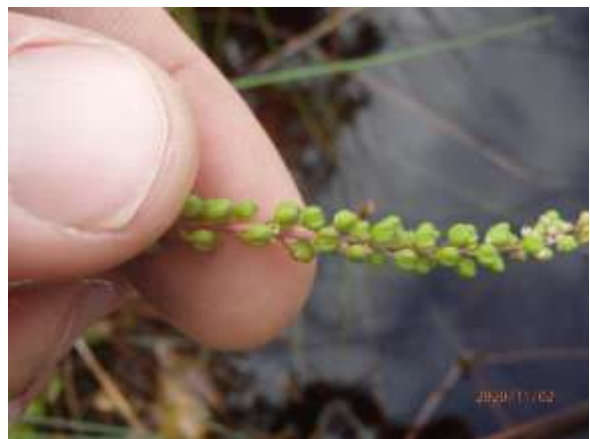
Plate 4.2 Streaked Arrowgrass, commonly associated with saline environments, was observed for the first time in Salty Lagoon
