Salty Lagoon

Post Closure Monitoring

Project Management and Ecosystem Health Report

December 2020

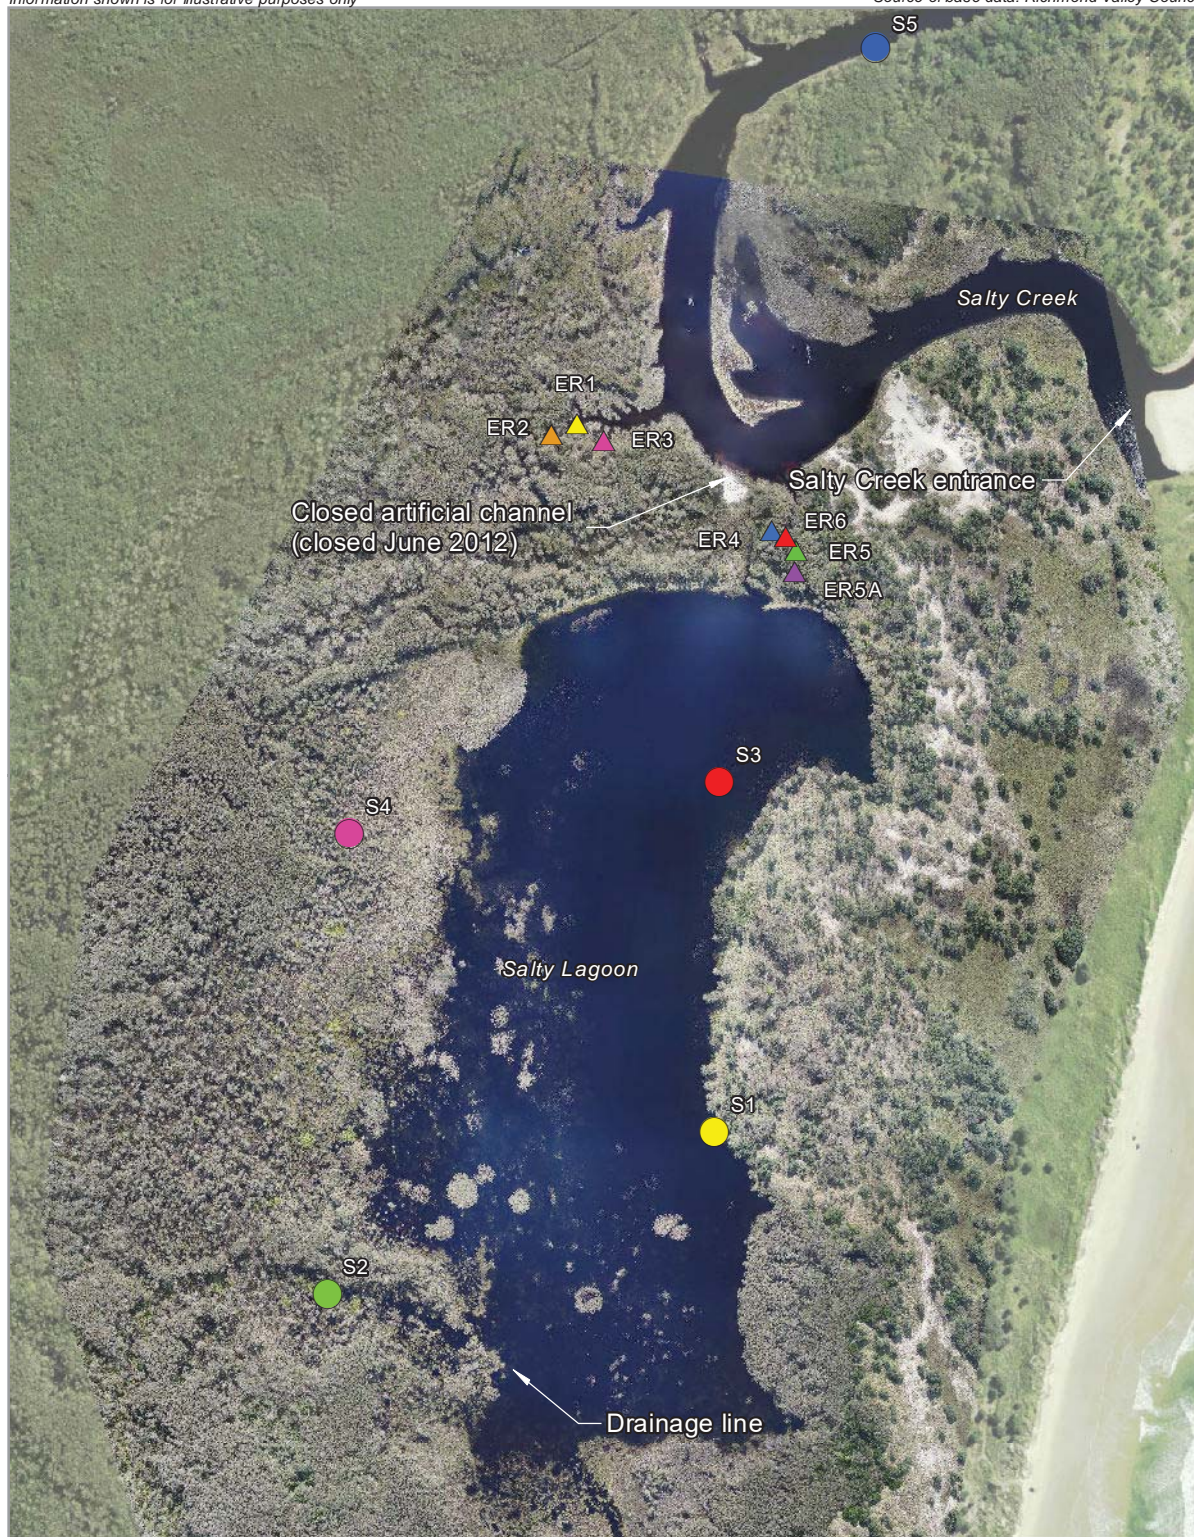
Location of Water Quality and Erosion Monitoring Sites

Discrete water quality samples were taken from surface water (approximately 0.2 metre depth) at four sites in Salty Lagoon and a single site (S5) in Salty Creek. An additional quality assurance (QA) replicate sample was collected at S3. The specific locations of all sites sampled are presented in **Table 2.1** and **Illustration 2.1**. They are the same sites previously used for the MPPC (GeoLINK 2017).

A series of stations have been set up around the head cut to the east of the infilled channel and some nearby control sites to assess the progression of erosion between Salty Lagoon and Salty Creek. The specific locations of all sites sampled are presented in **Table 2.2** and **Illustration 2.1**. Remediation of the headcut was undertaken by NSW National Parks and Wildlife Service (NPWS) in late 2020 through creation of a rock, geofabric and sand spillway at the outlet. Erosion monitoring is continuing to confirm if the headcut has stabilised (especially as the headcut scour was not infilled).

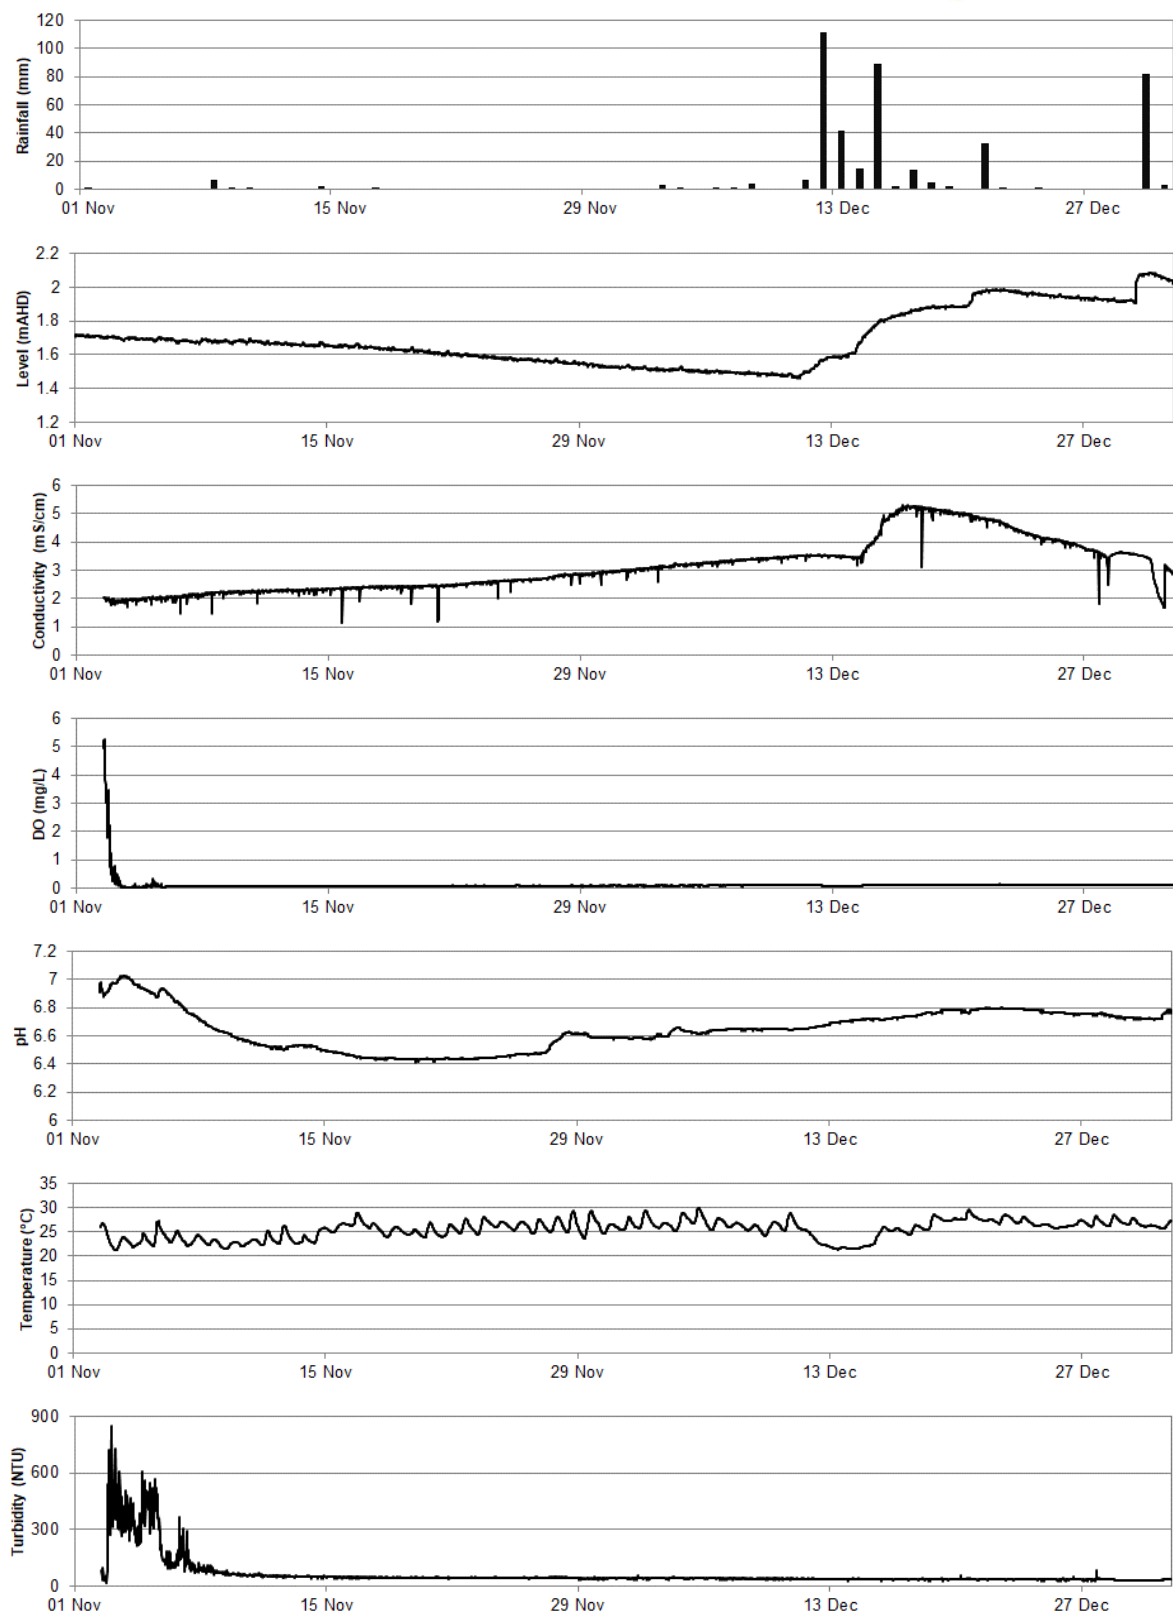
Illustration 3.1 Salty Lagoon Rainfall and Water Quality Monitoring Station Data 1
November 2020 to 31 December 2020

The data collected at the PWQMS, and rainfall data correlating to the reporting period are presented in **Illustration 3.1** and **Illustration 3.2**.

The conductivity measured at the Salty Lagoon PWQMS was relatively dynamic during this reporting period in response to evaporation, saline water inflow from Salty Creek and dilution from rainfall runoff. Overall, the conductivity measurements increased slightly but remained brackish. The available conductivity measurements from the Salty Creek PWQMS show that Salty Creek was saline at the beginning of the reporting period. At the time of the site inspection on 4 January 2021 the water in Salty Lagoon was well mixed and fresh, indicating that further dilution with rainfall runoff had occurred. The water in Salty Creek was also well mixed and fresh. The conductivity measurements collected on 4 January 2021 complied with guiding values at all sites.

the Salty Lagoon PWQMS indicates that the DO concentrations at the bottom of the water column in Salty Lagoon remained at very low levels for most of the reporting period. The available data from the Salty Creek PWQMS indicate that DO concentrations were fluctuating according to normal diurnal cycles.

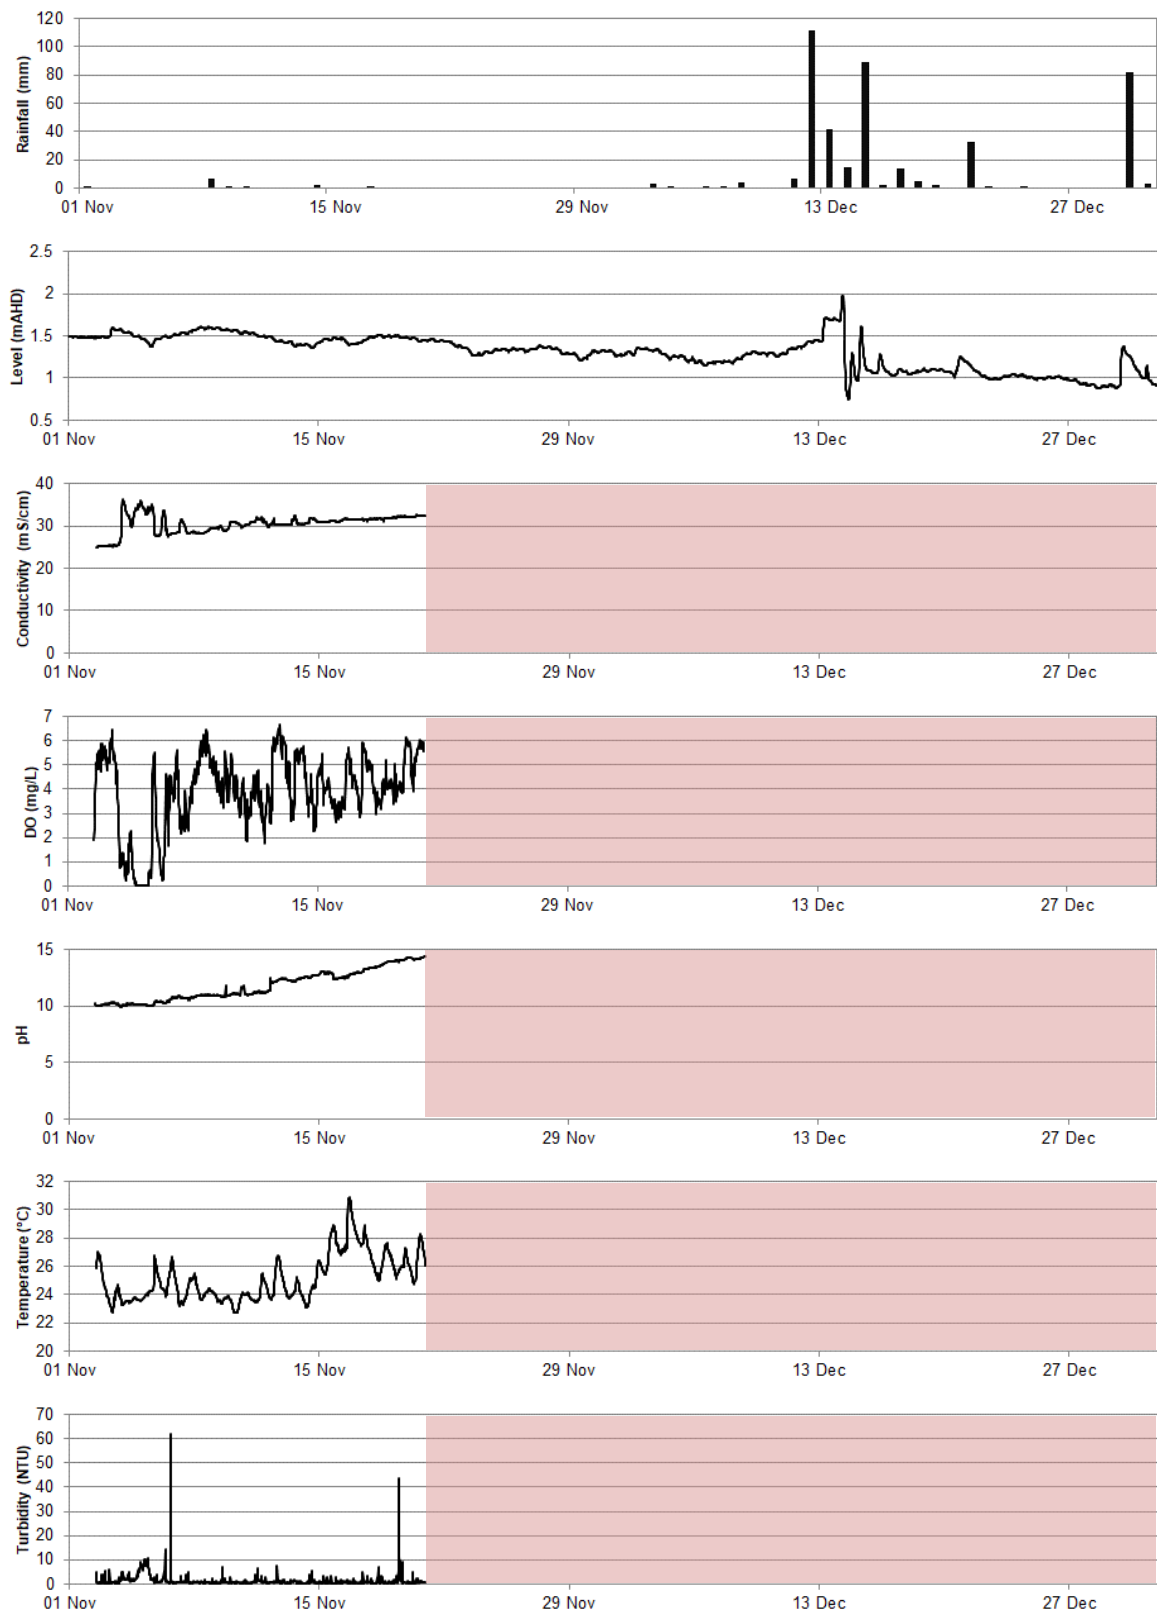
**Illustration 3.2 Salty Creek Rainfall and Water Quality Monitoring Station Data
1 November 2020 to 31 December 2020**

The logged water quality data for this reporting period was impacted by technical problems. The batteries in the Salty Creek sonde failed on 20 November 2020 although new batteries (of a reputable brand) had been installed on 1 November 2020 and the same batteries (from the same retailer) had been installed in the Salty Lagoon sonde without failure. The batteries in the Salty Lagoon sonde were checked and found to be operational on 8 December 2020. As a result, the Salty Creek sonde was not checked. Prior to battery failure the pH measurements collected at the Salty Creek PWQMS were faulty. A replacement pH cap has been ordered.

The level data from the Salty Creek PWQMS indicates that the entrance to Salty Creek was closed from the beginning of the monitoring period until heavy rainfall from 12 December led to very high water levels and subsequent opening of the entrance on 14 December. After opening, the entrance remained tidal for only 3 days, before closing again. At the time of the site inspection on 4 January 2021, the entrance to Salty Creek was open and flowing out (**Plate 4.1**), after opening in response to heavy rainfall on 30 December 2020. The water level in Salty Lagoon was dynamic during this monitoring period. The effects of evaporation led to significant decreases in the water level during the first 6 weeks of this monitoring period, before heavy rain led to a relatively rapid increase. The conductivity and level data indicate that Salty Lagoon received saline water inflow from Salty Creek on 14 December 2020 when water levels in Salty Creek were at a level of almost 2 mAHd.

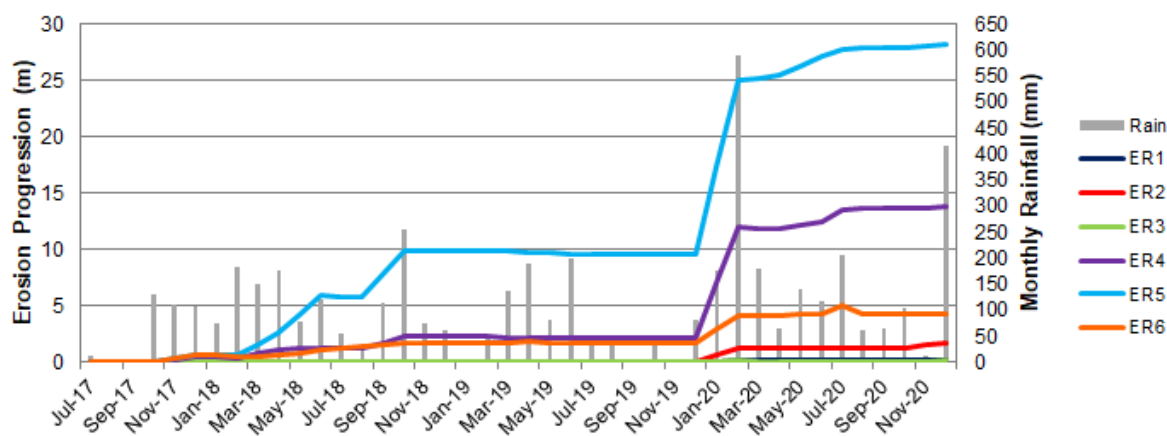
Illustration 3.3 Erosion Progression Plotted against Monthly Rainfall since July 2017

The data collected at the erosion monitoring stations is presented in **Table 3.2** and **Illustration 3.3**. There was only a minor advance of the head cuts at the three impact stations in relation to the previous measurements on 2 November 2020. The head cut has advanced at least 28 m towards Salty Lagoon since the monitoring began in July 2017.

Erosion monitoring indicated that the head cut did not advance significantly during this reporting period. The level information indicates that runoff from Salty Lagoon into Salty Creek only occurred between 20 December 2020 and the end of the reporting period. At the control sites there was only a small advance of the head cut at one site. The head cut remains approximately 14 m from the current banks of Salty Lagoon. It appears that the works undertaken to reduce erosive pressure on the head cut are currently working.

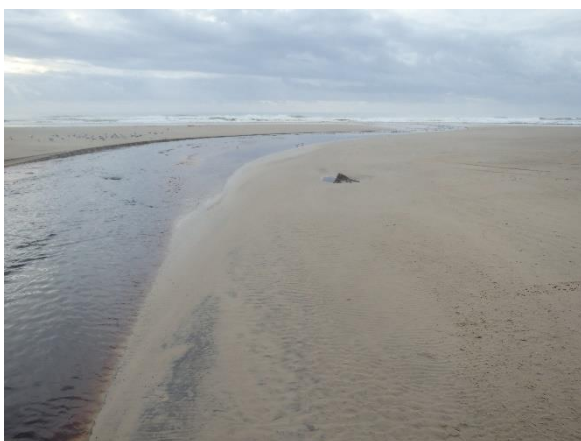
The entrance to Salty Creek was open on 4 January 2021. A variety of birds were observed incidentally during the site inspection including Pacific Black Duck, Black Swan, Pelican, Little Pied Cormorant, Little Black Cormorant, Pied Cormorant and Great Cormorant. Blue-green Algae were noted at S1. An individual Striped Rocket Frog (*Litoria nasuta*) was observed at S1.

Plate 4.1 The open entrance to Salty Creek on 4 January 2021

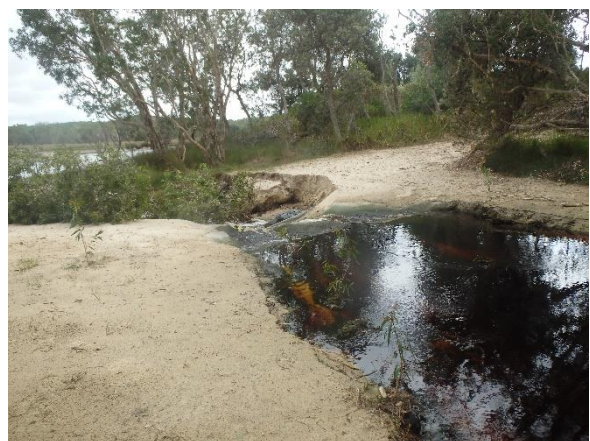
Plate 4.2 Scour spillway installed to reduce the erosive pressure on the head cut.

6. The erosive headcut to the east of the old channel between Salty Lagoon and Salty Creek did not advance significantly during this reporting period despite heavy rainfall. It appears that the installation of a spillway has successfully reduced erosive pressure on the headcut.
