# **Salty Lagoon**

## **Post Closure Monitoring**

### **Project Management and Ecosystem Health Report**

**February 2021**

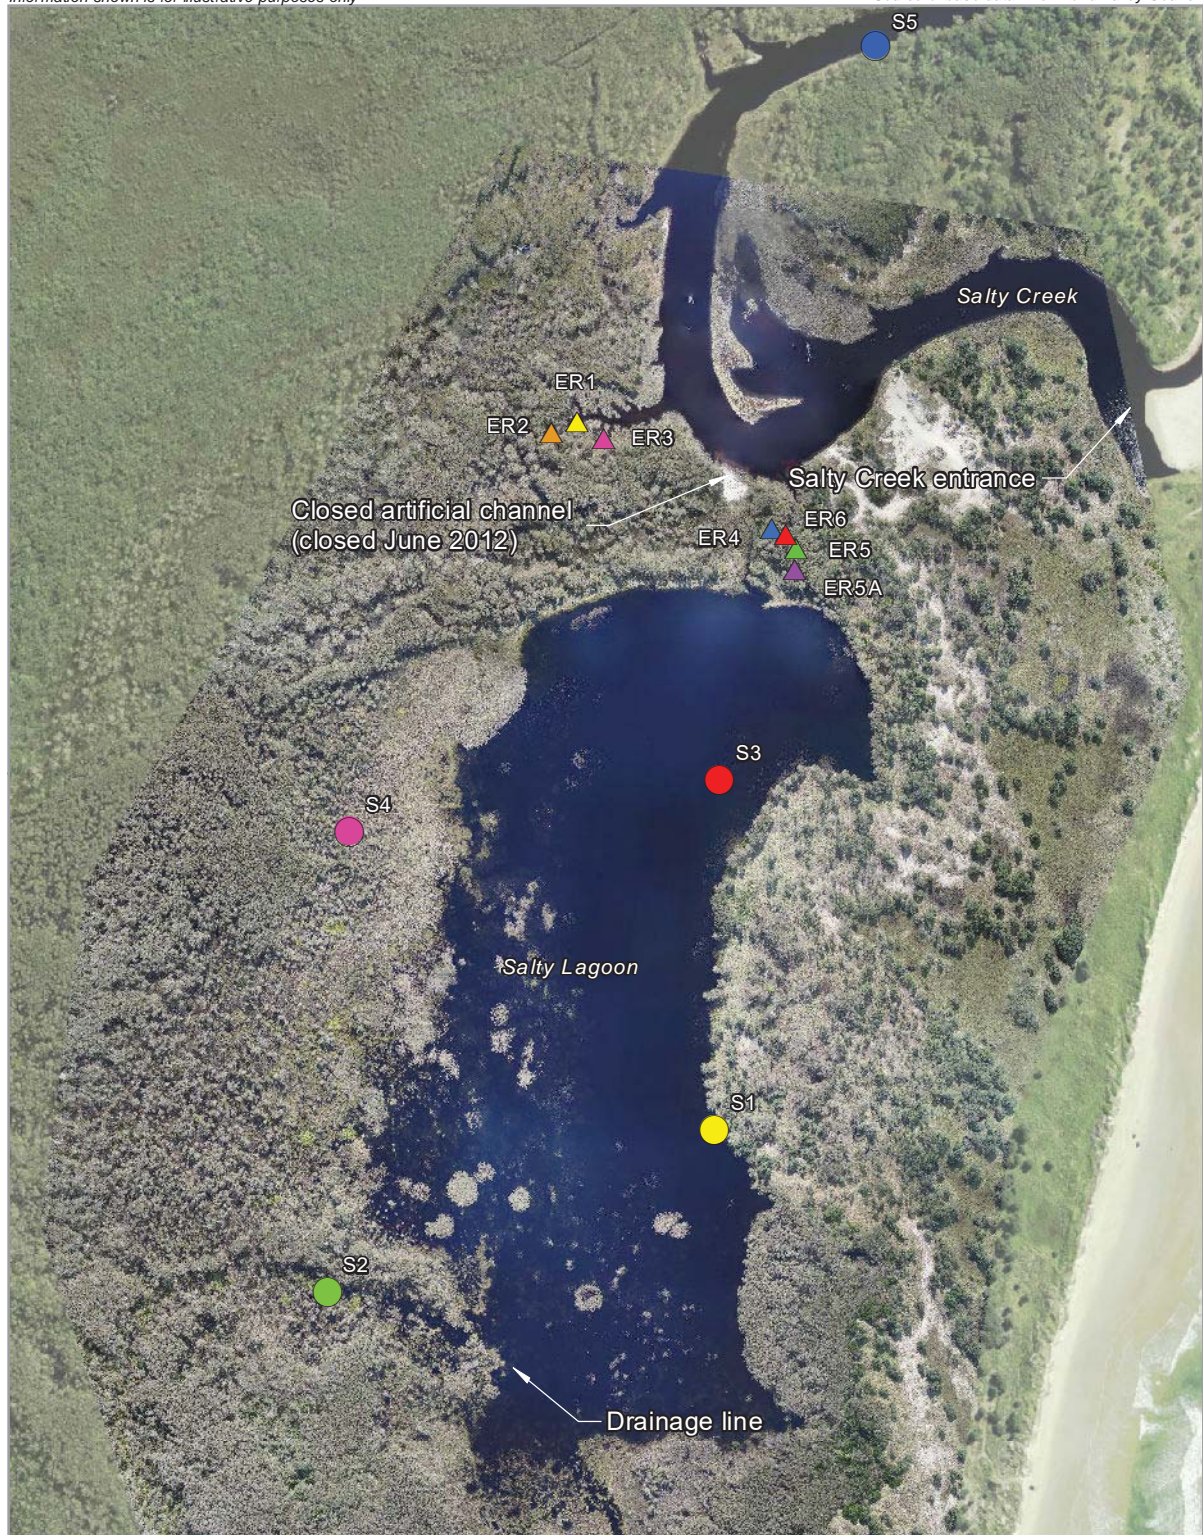
## Location of Water Quality and Erosion Monitoring Sites

Discrete water quality samples were taken from surface water (approximately 0.2 metre depth) at four sites in Salty Lagoon and a single site (S5) in Salty Creek. An additional quality assurance (QA) replicate sample was collected at S3. The specific locations of all sites sampled are presented in **Table 2.1** and **Illustration 2.1**. They are the same sites previously used for the MPPC (GeoLINK 2017).

A series of stations have been set up around the head cut to the east of the infilled channel and some nearby control sites to assess the progression of erosion between Salty Lagoon and Salty Creek. The specific locations of all sites sampled are presented in **Table 2.2** and **Illustration 2.1**. Remediation of the headcut was undertaken by NSW National Parks and Wildlife Service (NPWS) in late 2020 through creation of a rock, geofabric and sand spillway at the outlet. Erosion monitoring is continuing to confirm if the headcut has stabilised (especially as the headcut scour was not infilled).

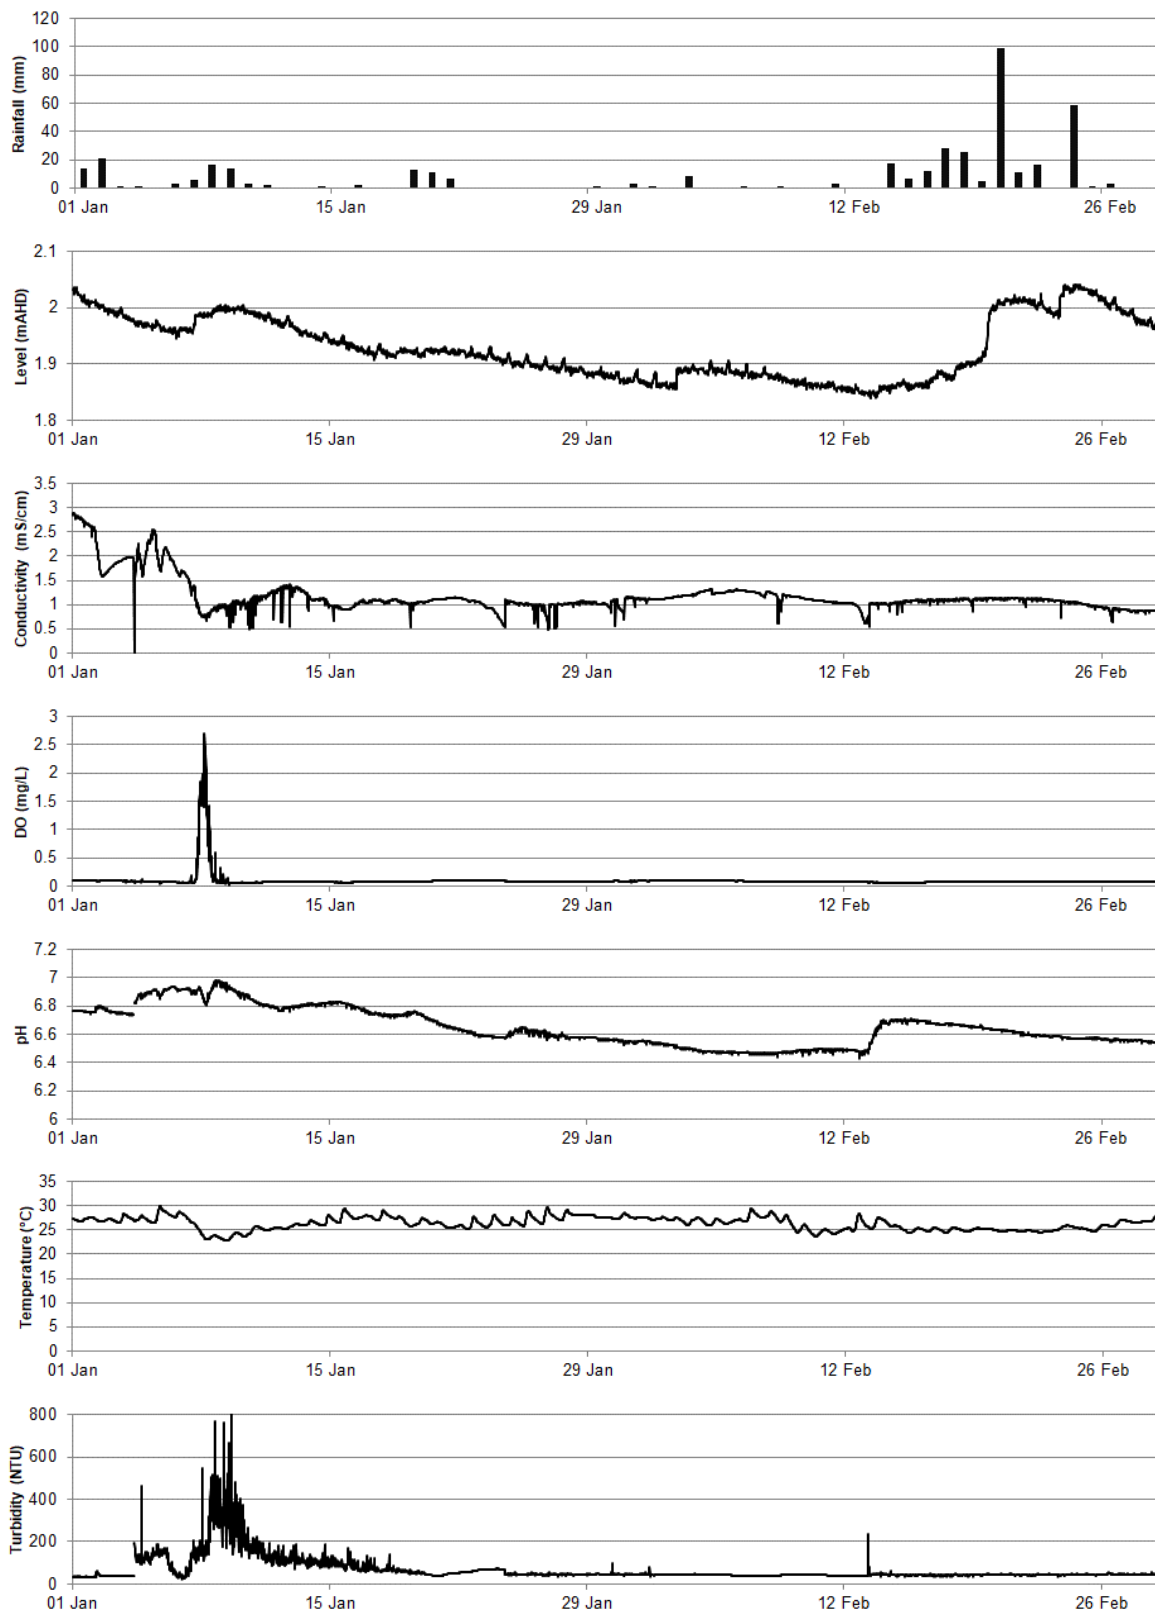
**Illustration 3.1** Salty Lagoon Rainfall and Water Quality Monitoring Station Data  
1 January 2021 to 28 February 2021

The data collected at the PWQMS, and rainfall data correlating to the reporting period are presented in **Illustration 3.1** and **Illustration 3.2**.

The conductivity measured at the Salty Lagoon PWQMS was relatively stable during this reporting period, remaining low in response to continued rainfall runoff. Overall, the conductivity measurements decreased slightly from slightly brackish to freshwater. The conductivity measurements from the Salty Creek PWQMS show that Salty Creek remained fresh for the first 3 weeks of the reporting period, became saline for an extended period and was fresh again for the final week of the monitoring period after a very heavy rainfall event on 19 February 2021. At the time of the site inspection on 2 March 2021 the water in Salty Lagoon was well mixed and fresh, and the water in Salty Creek was fluctuating between brackish and saline in response to tidal movements. The conductivity measurements collected on 2 March 2021 complied with guiding values at all sites.

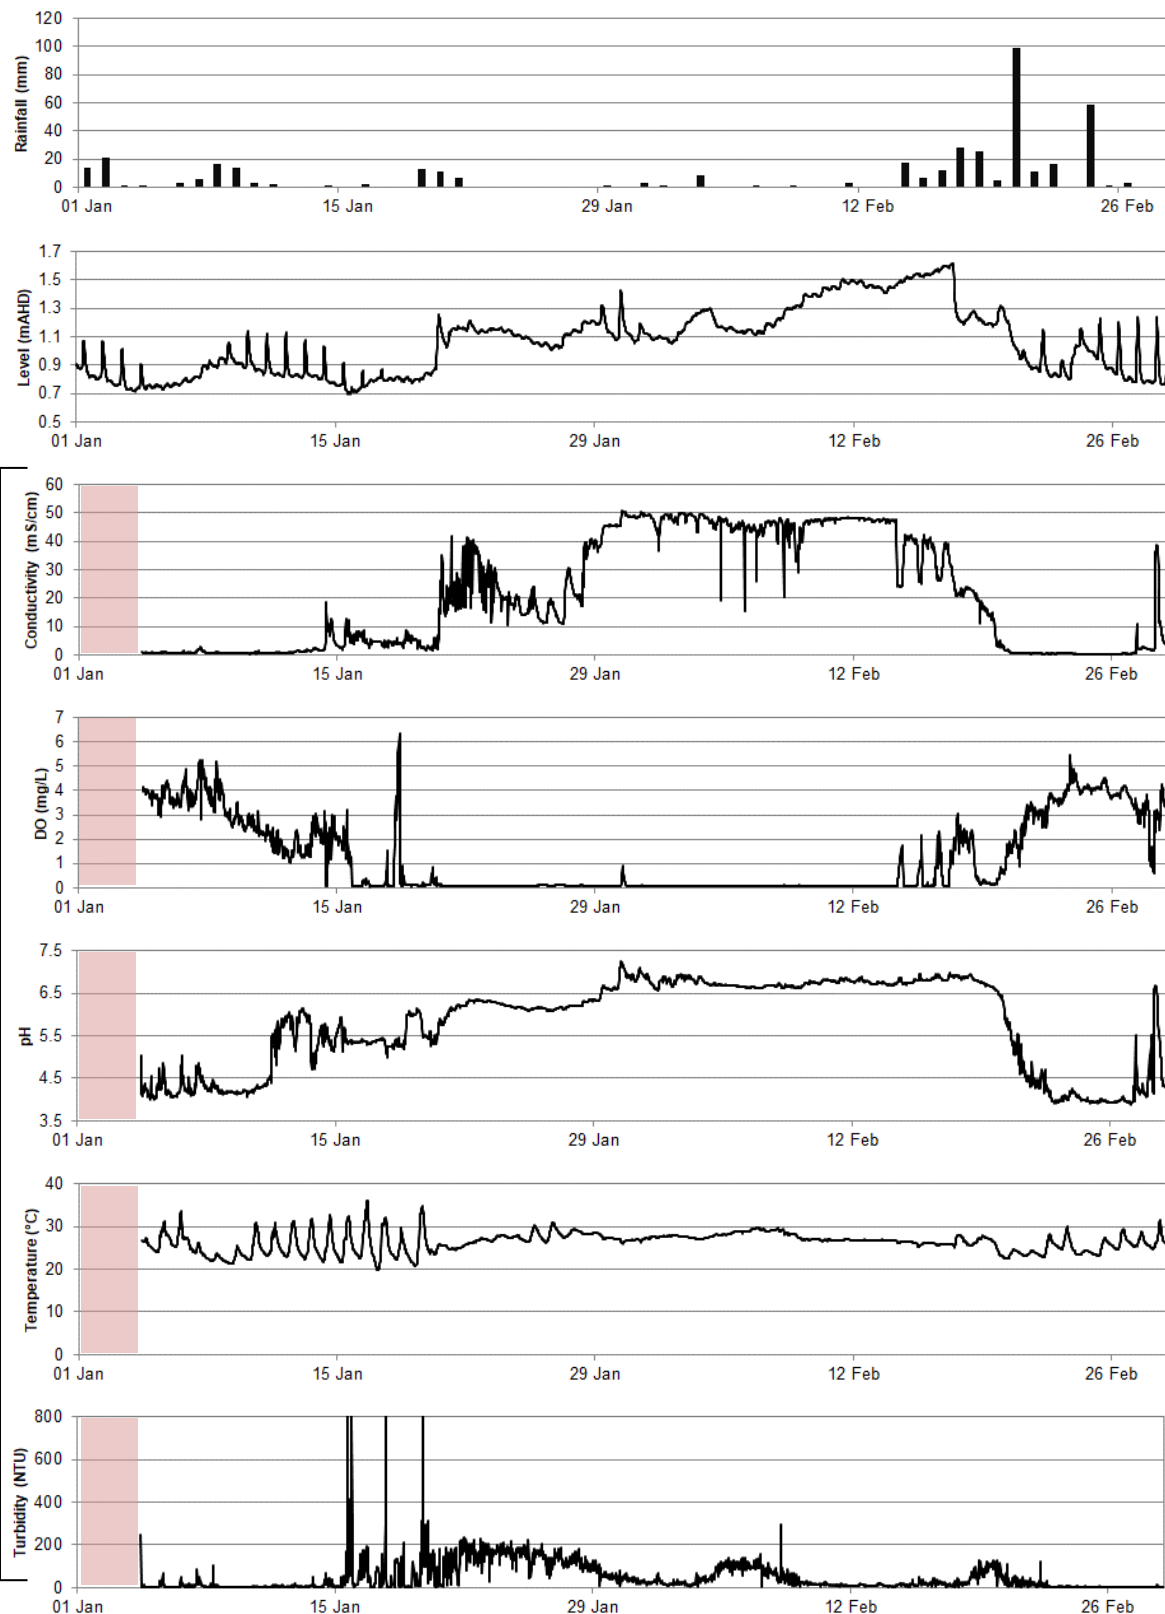
**Illustration 3.2** Salty Creek Rainfall and Water Quality Monitoring Station Data  
1 January 2021 to 28 February 2021

The water level data from the Salty Creek PWQMS indicates that the entrance to Salty Creek was open and tidal movements were evident from the beginning of the monitoring period until 20 January 2021, when it became constricted and Salty Creek slowly filled with saline water. After heavy rainfall, it opened again on 17 February 2021, draining Salty Creek to very low levels and operating tidally until the end of the monitoring period. At the time of the site inspection on 2 March 2021, the entrance to Salty Creek was open and flowing out (**Plate 4.1**), with clear evidence of tidal movements. The water level in Salty Lagoon remained high throughout this monitoring period with very high levels recorded at the beginning and end of the monitoring period in response to heavy rainfall. The water levels from the Salty Lagoon PWQMS indicate that water from Salty Lagoon would have flowed into Salty Creek for the duration of the monitoring period.

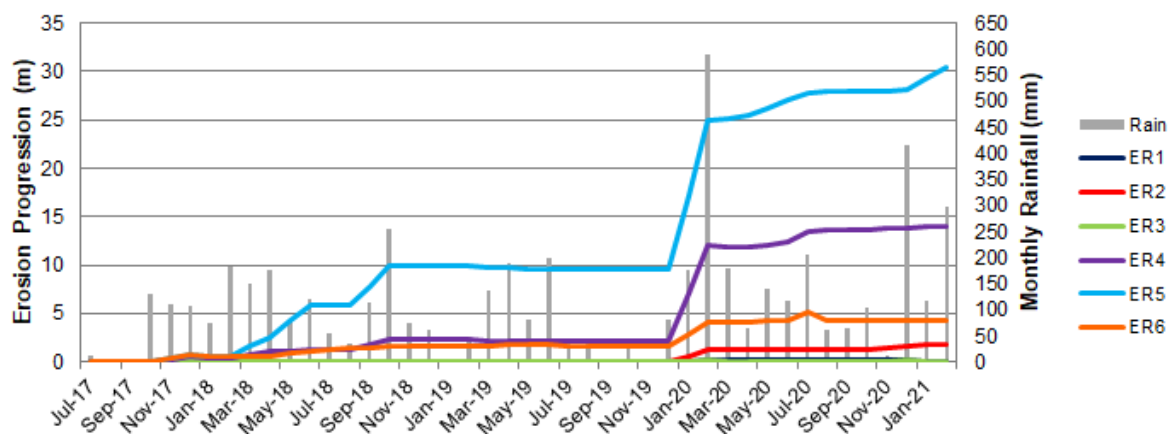
**Illustration 3.3 Erosion Progression Plotted against Monthly Rainfall since July 2017**

The data collected at the erosion monitoring stations is presented in **Table 3.2** and **Illustration 3.3**. There was local advancement of the head cut at ER5, progressing approximately 2.3m towards Salty Lagoon since the previous measurement on 4 January 2021 (post completion of the remediation works). The head cut has advanced at least 30 m towards Salty Lagoon since the monitoring began in July 2017.

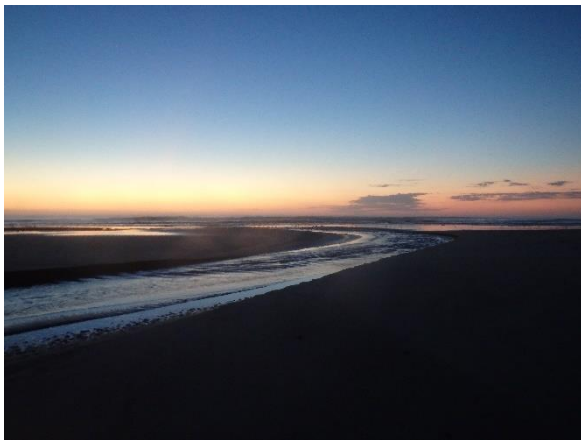
The entrance to Salty Creek was open and tidal on 2 March 2021. A variety of birds were observed incidentally during the site inspection including Pacific Black Duck, Little Pied Cormorant, Little Black Cormorant, Pied Cormorant and White-Bellied Sea Eagle. Blue-green Algae were noted at S1. Lots of jumping Sea Mullet (*Mugil cephalus*) were observed at S1.

**Plate 4.1** The open entrance to Salty Creek on 2 March 2021

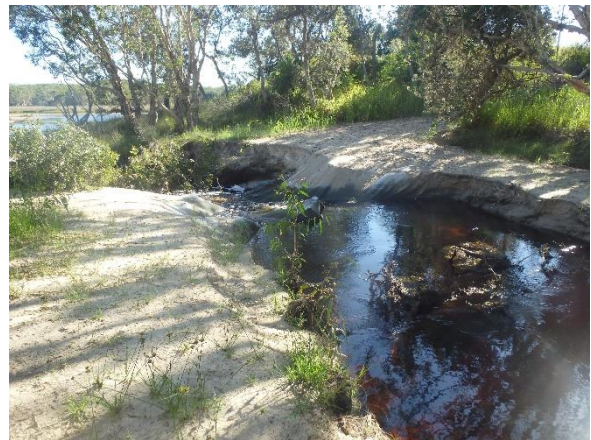
Erosion monitoring indicated that the head cut did advanced slightly during this reporting period. The level information indicates that runoff from Salty Lagoon into Salty Creek occurred for the majority of the reporting period. At the control sites there was only a small advance of the head cut at one site. The head cut remains approximately 12 m from the current banks of Salty Lagoon. It appears that the works undertaken to reduce erosive pressure on the head cut are currently working, but that erosion is still occurring, just to a lesser extent.

**Plate 4.2** Evidence of a slight reduction in the level of the scour spillway installed to reduce the erosive pressure on the head cut.

Due to the recent progression of the head cut between Salty Lagoon and Salty Creek post remediation (spillway) works, the risk of a channel forming between the two water bodies has heightened. Should the headcut continue and form a channel, the system would become a more dynamic ecosystem, although less than pre-channel closure conditions provided the head cut remediation (spillway) works in late 2020 is maintained.

In accordance with the project *Environmental Response Protocol* (GeoLINK 2017b), the risk rating for the Salty Lagoon Response Protocol is uncertain. Adaptive management site visits are recommended for periods of potential head cut progression, with the following triggers:

- >50 mm of rainfall with 24 hrs.
- >200 mm of rainfall within a week.
- Other high risk events, for example >100 mm of rainfall within 72 hours, significant storm surge, atypically large tides, etc. Due consideration would be given to rainfall intensity and volume, and the Salty Creek entrance status when known as appropriate.
