# **Salty Lagoon**

## **Post Closure Monitoring**

### **Project Management and Ecosystem Health Report**

**April 2021**

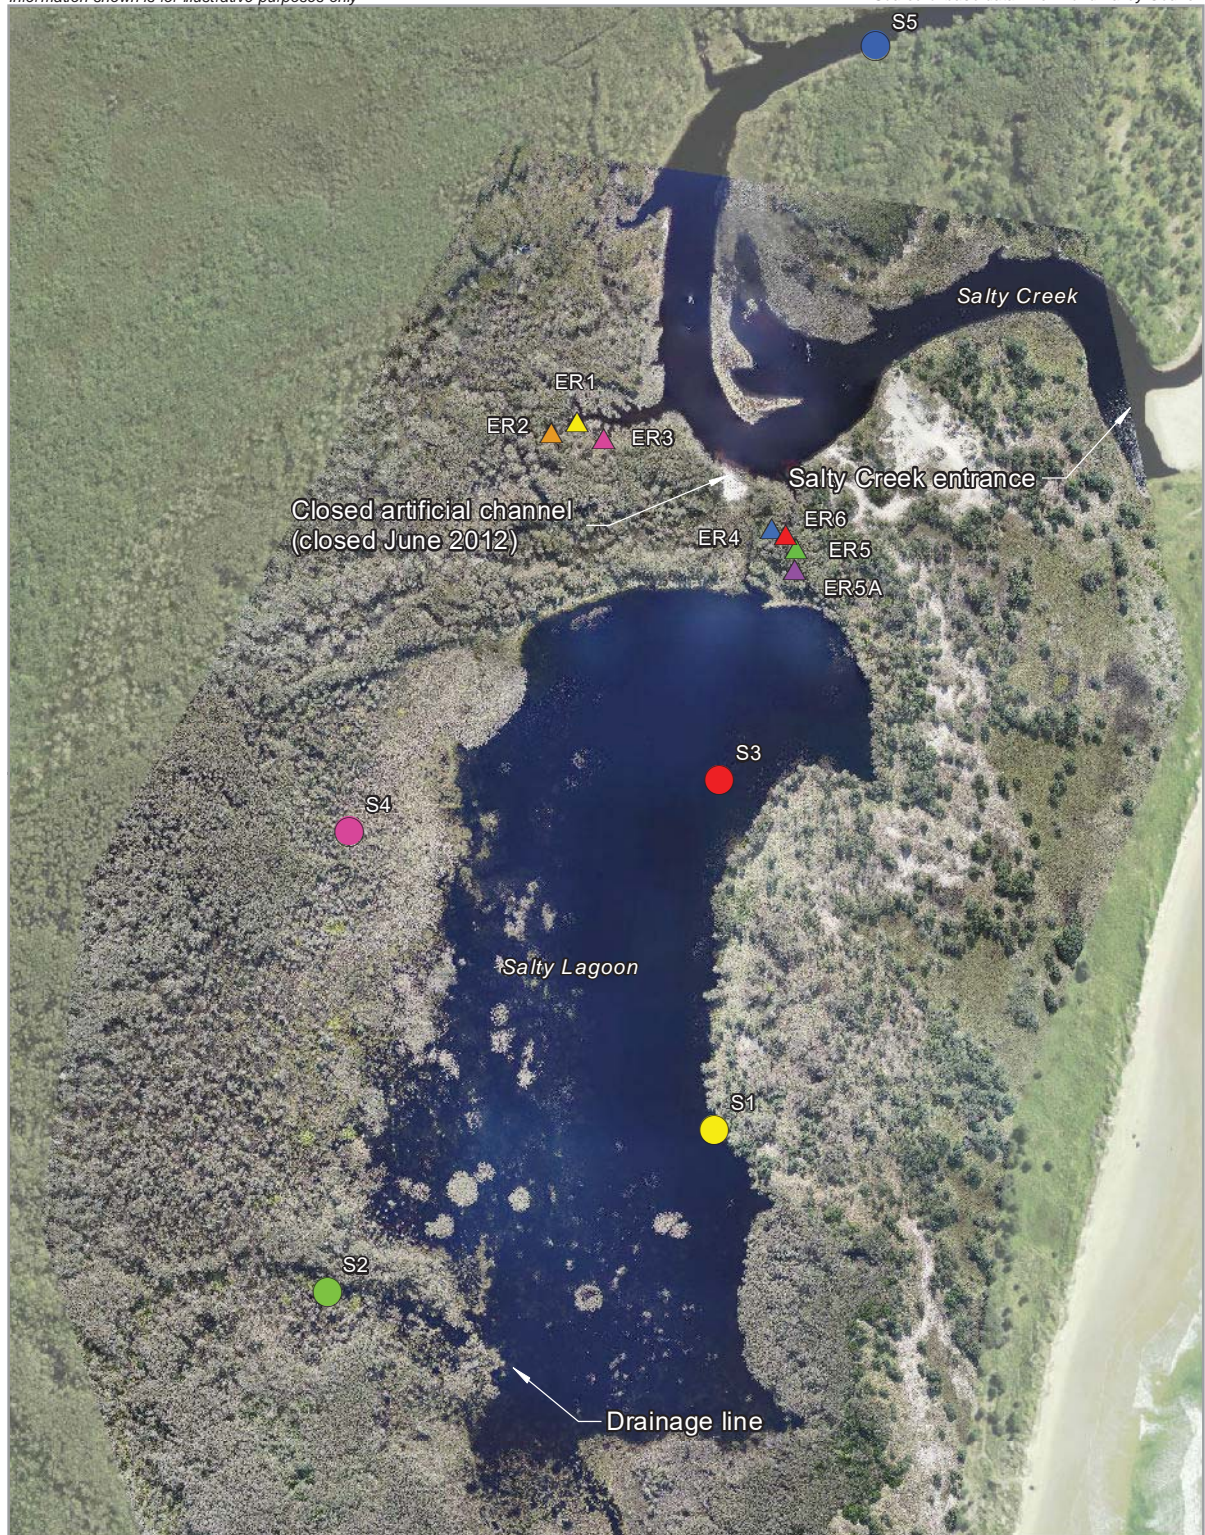
## Location of Water Quality and Erosion Monitoring Sites

Discrete water quality samples were taken from surface water (approximately 0.2 metre depth) at four sites in Salty Lagoon and a single site (S5) in Salty Creek. An additional quality assurance (QA) replicate sample was collected at S2. The specific locations of all sites sampled are presented in **Table 2.1** and **Illustration 2.1**. They are the same sites previously used for the MPPC (GeoLINK 2017).

A series of stations have been set up around the head cut to the east of the infilled channel and some nearby control sites to assess the progression of erosion between Salty Lagoon and Salty Creek. The specific locations of all sites sampled are presented in **Table 2.2** and **Illustration 2.1**. Remediation of the headcut was undertaken by NSW National Parks and Wildlife Service (NPWS) in late 2020 through creation of a rock, geofabric and sand spillway at the outlet. Erosion monitoring is continuing to confirm if the headcut has stabilised.

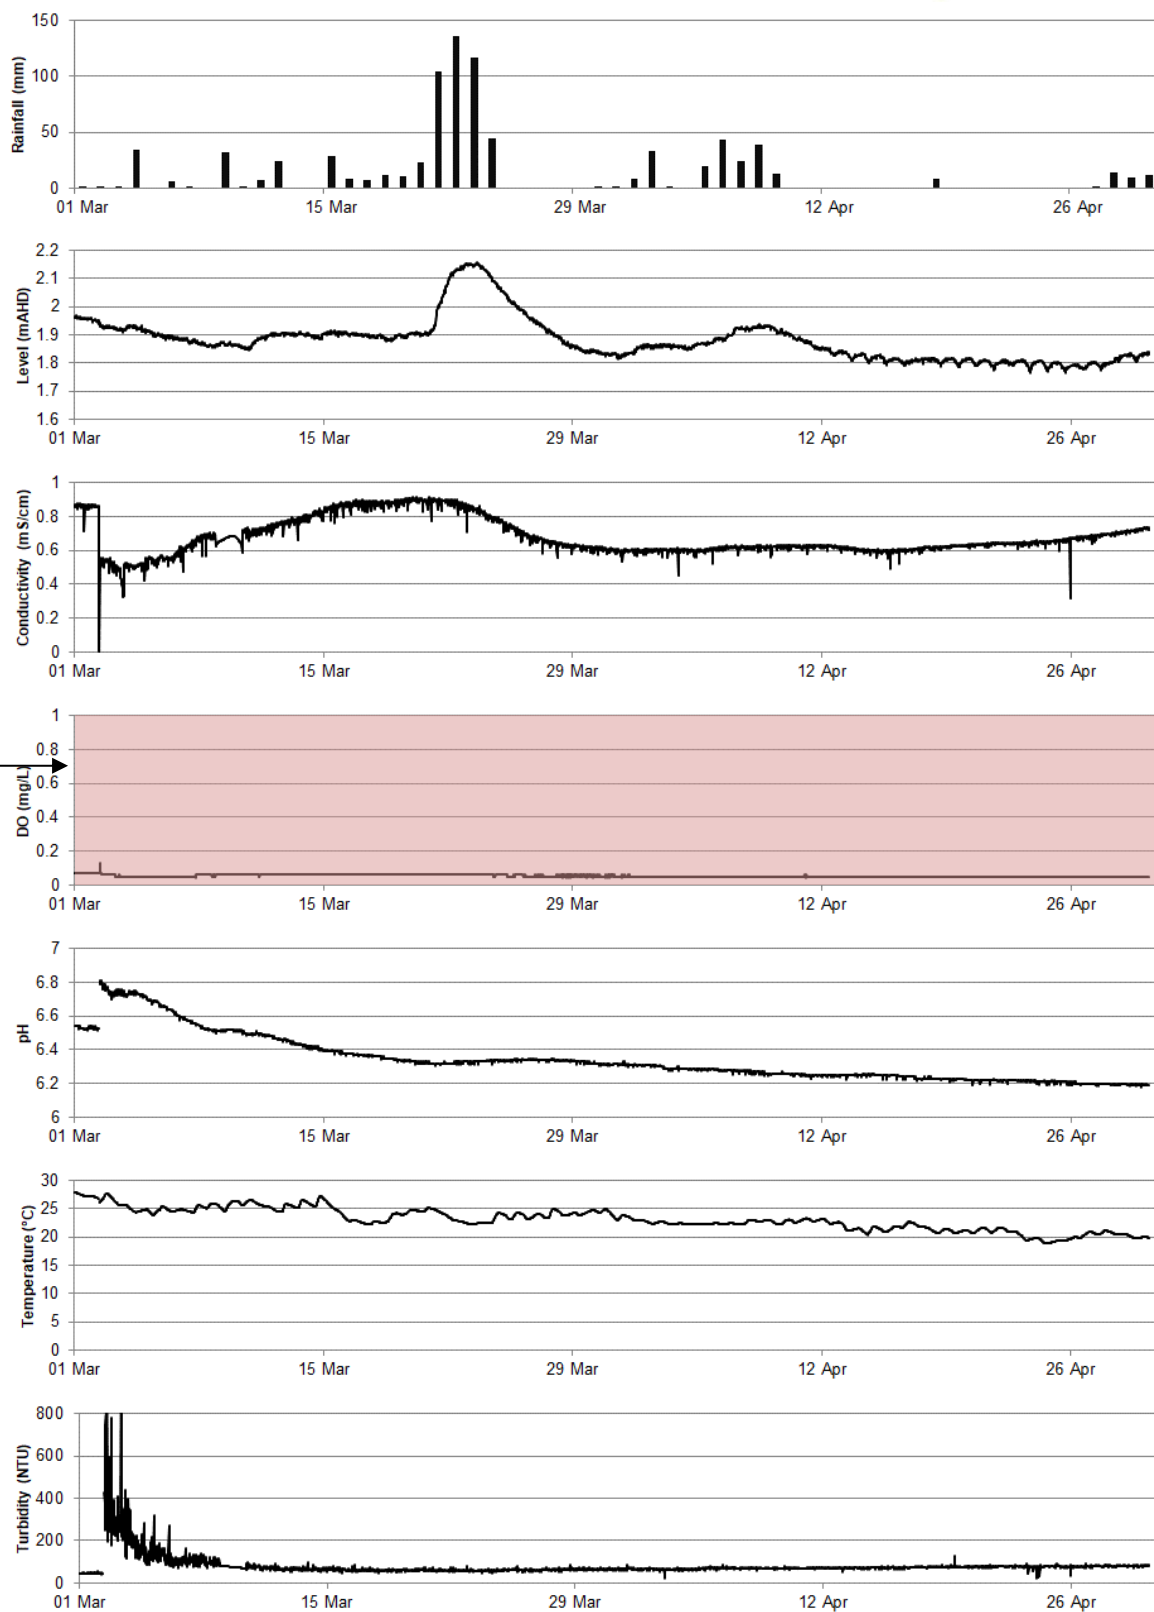
**Illustration 3.1 Salty Lagoon Rainfall and Water Quality Monitoring Station Data 1**  
**March 2021 to 30 April 2021**

The data collected at the PWQMS, and rainfall data correlating to the reporting period are presented in **Illustration 3.1** and **Illustration 3.2**.

The conductivity measured at the Salty Lagoon PWQMS was stable during this reporting period, remaining low in response to continued rainfall runoff. The conductivity measurements from the Salty Creek PWQMS show that the water quality in Salty Creek fluctuated dynamically in response to rainfall runoff and tidal movements and that the two partial closures of the entrance to Salty Creek were accompanied by seawater ingress. At the time of the site inspection on 30 April 2021 the water in Salty Lagoon was well mixed and fresh and the water in Salty Creek was stratified into a slightly brackish surface layer and a strongly saline, heavier bottom layer. The conductivity measurements collected on 30 April 2021 complied with guiding values at all sites.

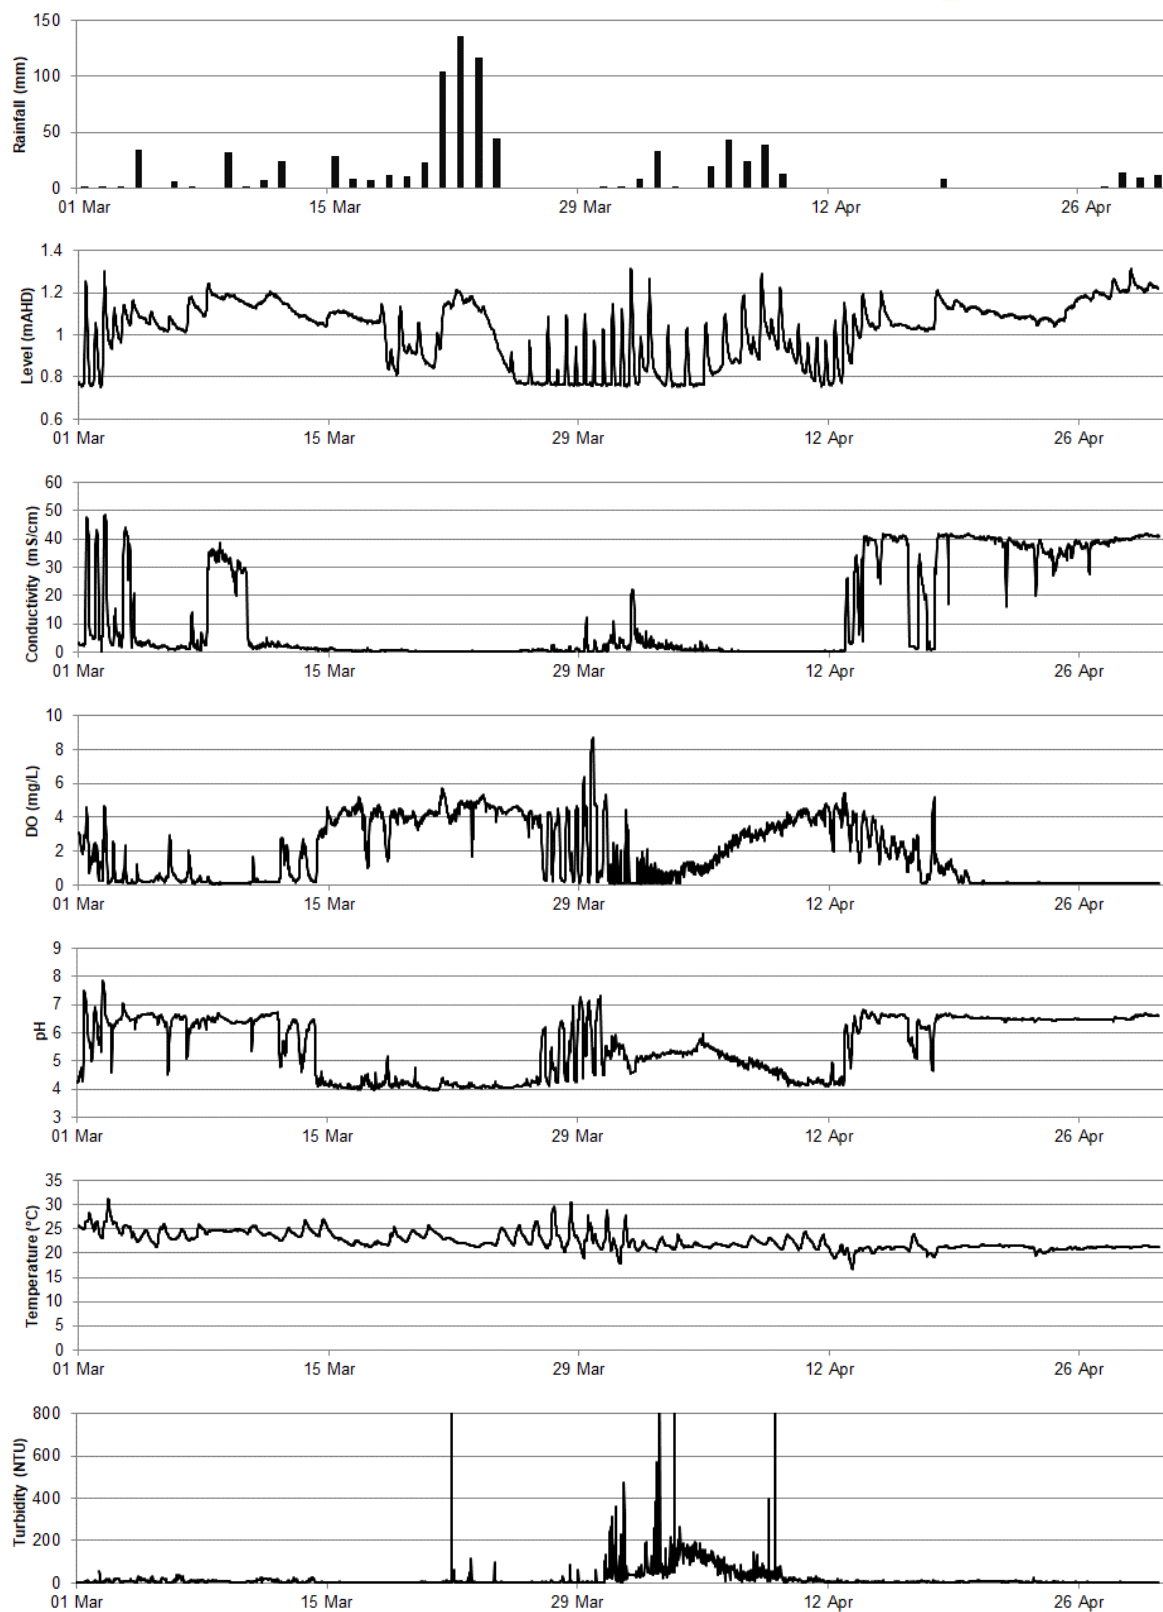
**Illustration 3.2 Salty Creek Rainfall and Water Quality Monitoring Station Data 1 March 2021 to 30 April 2021**

The water level data from the Salty Creek PWQMS indicates that the entrance to Salty Creek was particularly dynamic during this reporting period. The entrance was tidal at the beginning of the reporting period before partially closing in early March. After ten days of rain starting on 15 March 2021 the entrance to Salty Creek opened again and remained tidal for an unusually long period of approximately 3 weeks before closing partially on 15 April 2021. At the time of the site inspection on 30 April 2021, the entrance to Salty Creek was slightly open and flowing out (**Plate 4.1**), with evidence of small tidal movements. The water level in Salty Lagoon remained high throughout this monitoring period with very high levels recorded on 23 March in response to heavy rainfall. The water levels from the Salty Lagoon PWQMS indicate that water from Salty Lagoon would have flowed into Salty Creek for the duration of the monitoring period.

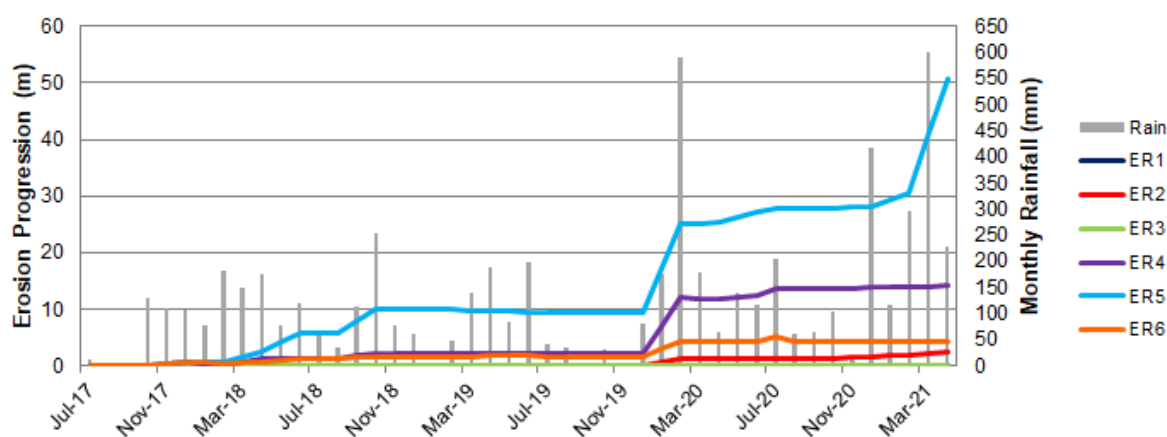
**Illustration 3.3 Erosion Progression Plotted against Monthly Rainfall since July 2017**

The data collected at the erosion monitoring stations is presented in **Table 3.2** and **Illustration 3.3**. There was only a very large advance of the head cut at impact station ER5 in relation to the previous measurements on 2 March 2021. The head cut has advanced at least 50 m towards Salty Lagoon since the monitoring began in July 2017.

Erosion monitoring indicated that the head cut advanced significantly during this reporting period. The level information indicates that runoff from Salty Lagoon into Salty Creek occurred for the majority of the reporting period and that flow would have been particularly strong for the week starting on 23 March 2021. At the control sites there was only a small advance of the head cut at one site. The head cut remains approximately 6 m from the current banks of Salty Lagoon. The recent works undertaken to reduce erosive pressure on the head cut slumped during this monitoring period, increasing the erosive potential of the water stored in Salty Lagoon.

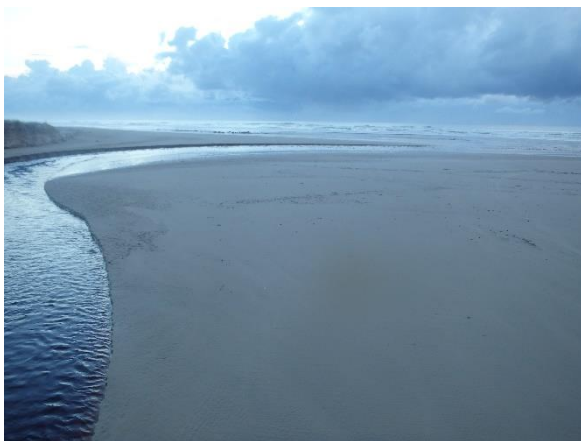
The entrance to Salty Creek was open and tidal on 30 April 2021. A variety of birds were observed incidentally during the site inspection including Pacific Black Duck, Black Swan, Pelican, Little Pied Cormorant, Great Cormorant and Pied Cormorant.

**Plate 4.1** The open entrance to Salty Creek on 30 April 2021

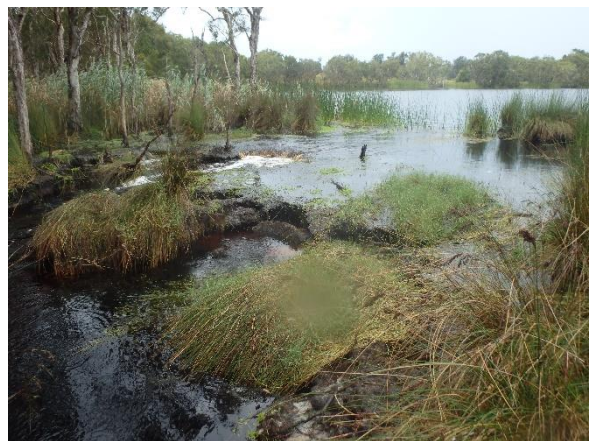
**Plate 4.2** The head cut continues to move towards Salty Lagoon.

6. The risk rating for the Salty Lagoon Response Protocol is unknown due to the advance of the headcut. NPWS are currently investigating remediation options and the timing of this work will affect the risk rating.

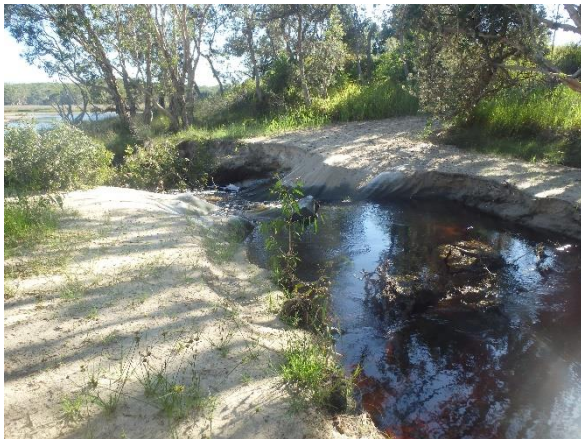
**Plate 5.1** The scour spillway on 2 March 2021

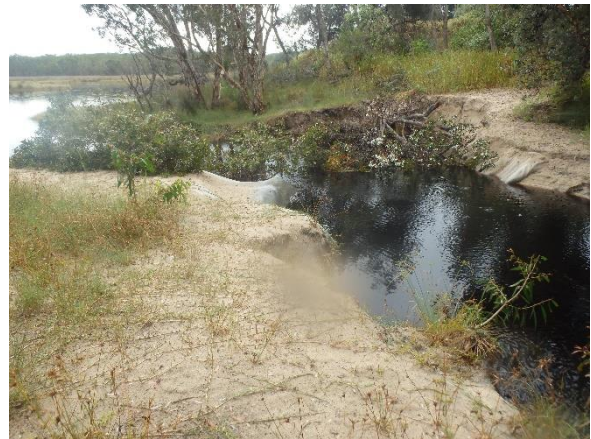
4. Blue-green algae were detected for the fourth consecutive month but at reduced concentrations and a lower number of sites.
5. The erosive headcut to the east of the old channel between Salty Lagoon and Salty Creek advanced significantly during this reporting period in response to heavy rainfall. The scour spillway installed appears to have slumped somewhat during this reporting period (**Plates 5.1** and **5.2**).

**Plate 5.2** Evidence of a reduction in the level of the scour spillway on 30 April 2021.
