Salty Lagoon

Post Closure Monitoring

Project Management and Ecosystem Health Report

August 2021

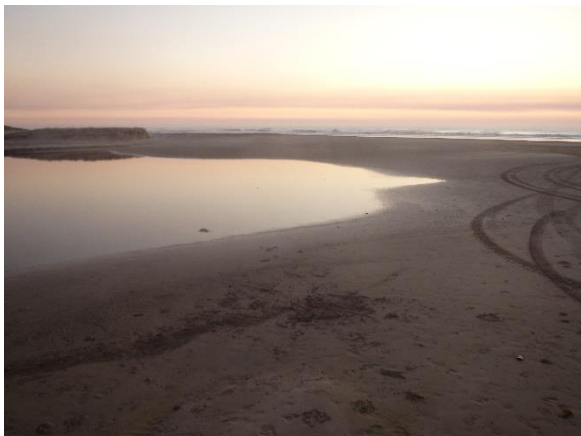
The entrance to Salty Creek was closed on 12 September 2021. A variety of birds were observed incidentally during the site inspection including Pacific Black Duck, Australasian Grebe, Great Cormorant and Buff-banded Rail.

Plate 4.1 The closed entrance to Salty Creek on 12 September 2021
