Salty Lagoon Post Closure Monitoring

Project Management and Ecosystem Health Report October 2021

Prepared for: Richmond Valley Council
© GeoLINK, 2021

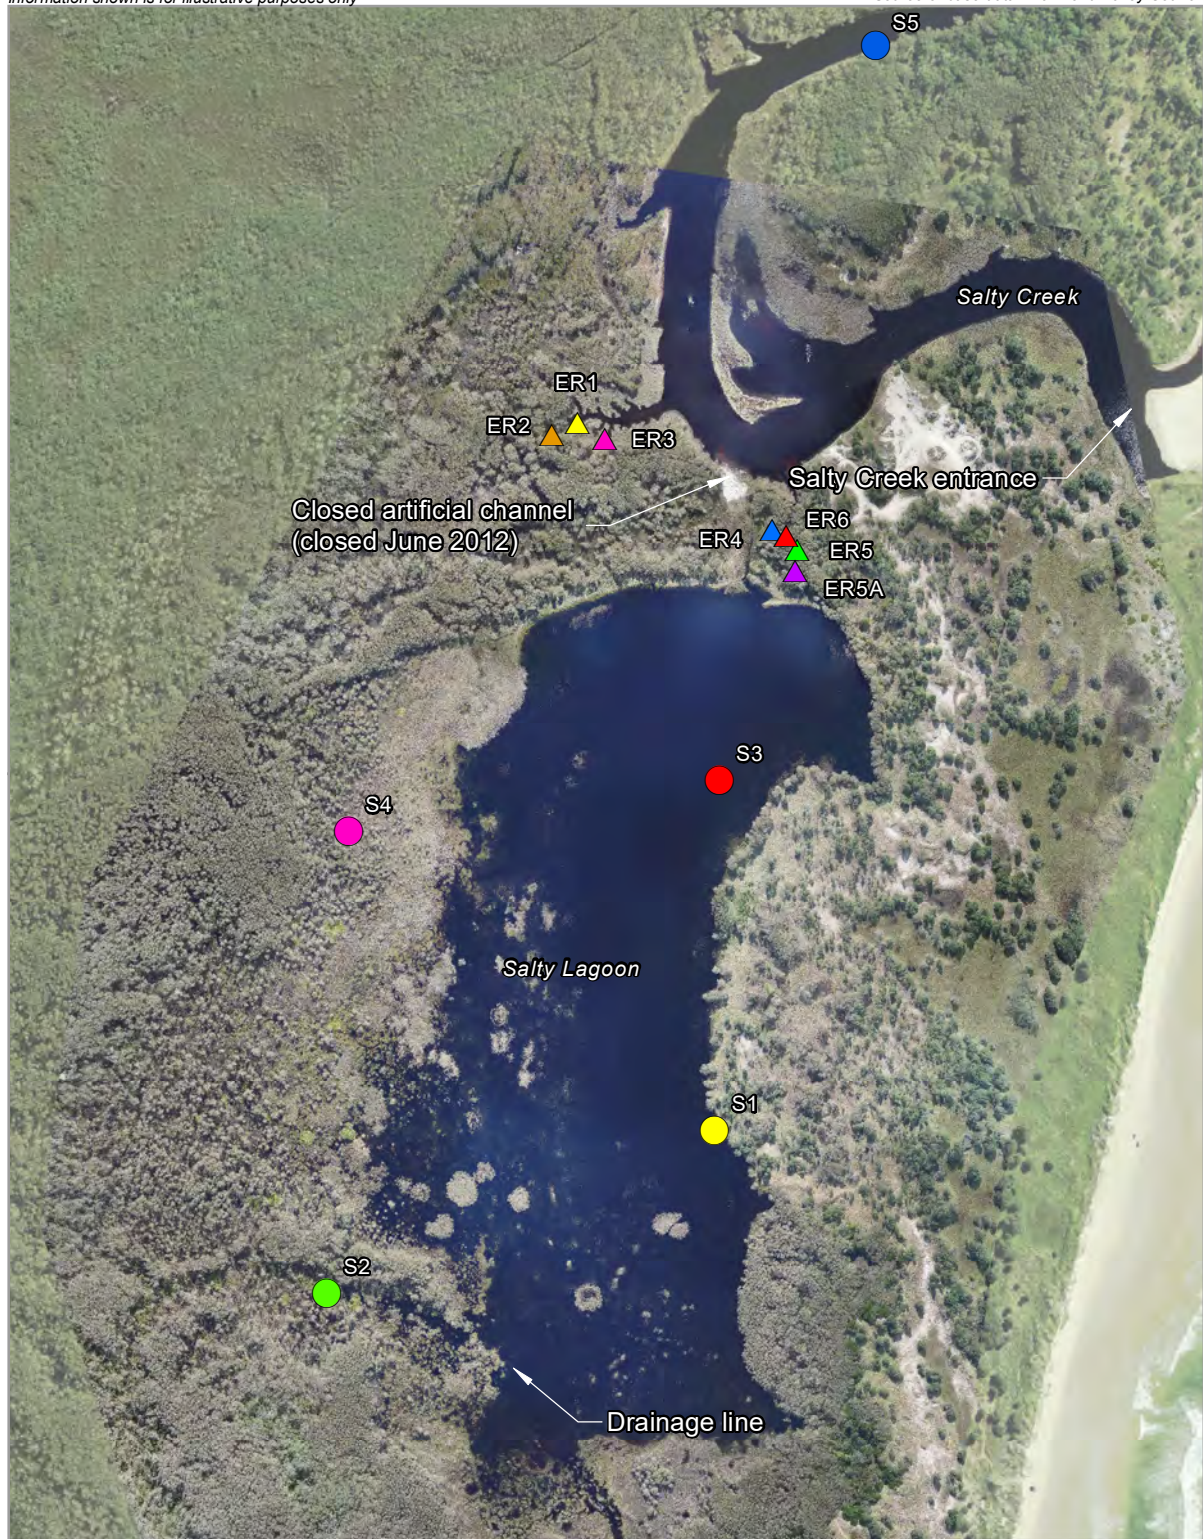
Location of Water Quality and Erosion Monitoring Sites

Discrete water quality samples were taken from surface water (approximately 0.2 metre depth) at four sites in Salty Lagoon and a single site (S5) in Salty Creek. An additional quality assurance (QA) replicate sample was collected at S3. The specific locations of all sites sampled are presented in **Table 2.1** and **Illustration 2-1**. They are the same sites previously used for the MPPC (GeoLINK 2017).

A series of reference stations have been set up around the head-cut to the east of the infilled channel and some nearby control sites to assess the progression of erosion between Salty Lagoon and Salty Creek. The specific locations of all sites sampled are presented in **Table 2.2** and **Illustration 2-1**. Repairs to the control structure installed by NSW National Parks and Wildlife Service (NPWS) in late 2020 were undertaken in June and July 2021. Erosion monitoring is continuing to confirm if the head-cut has stabilised.

The stations were set up in July 2017 at the head-cut (Stations 4, 5 and 6), with control sites at points where lateral tributaries from Salty Creek lead towards Salty Lagoon (Stations 1, 2 and 3). At each site the monitoring involves a fixed-point photo and a measurement from a fixed peg to the nearest point of the head-cut. In March 2020 site ER5 had to be extended because the fixed peg was overtaken by the erosion. A new site, ER5A was created but allows erosion progression to be measured from the same initial reference point as ER5.

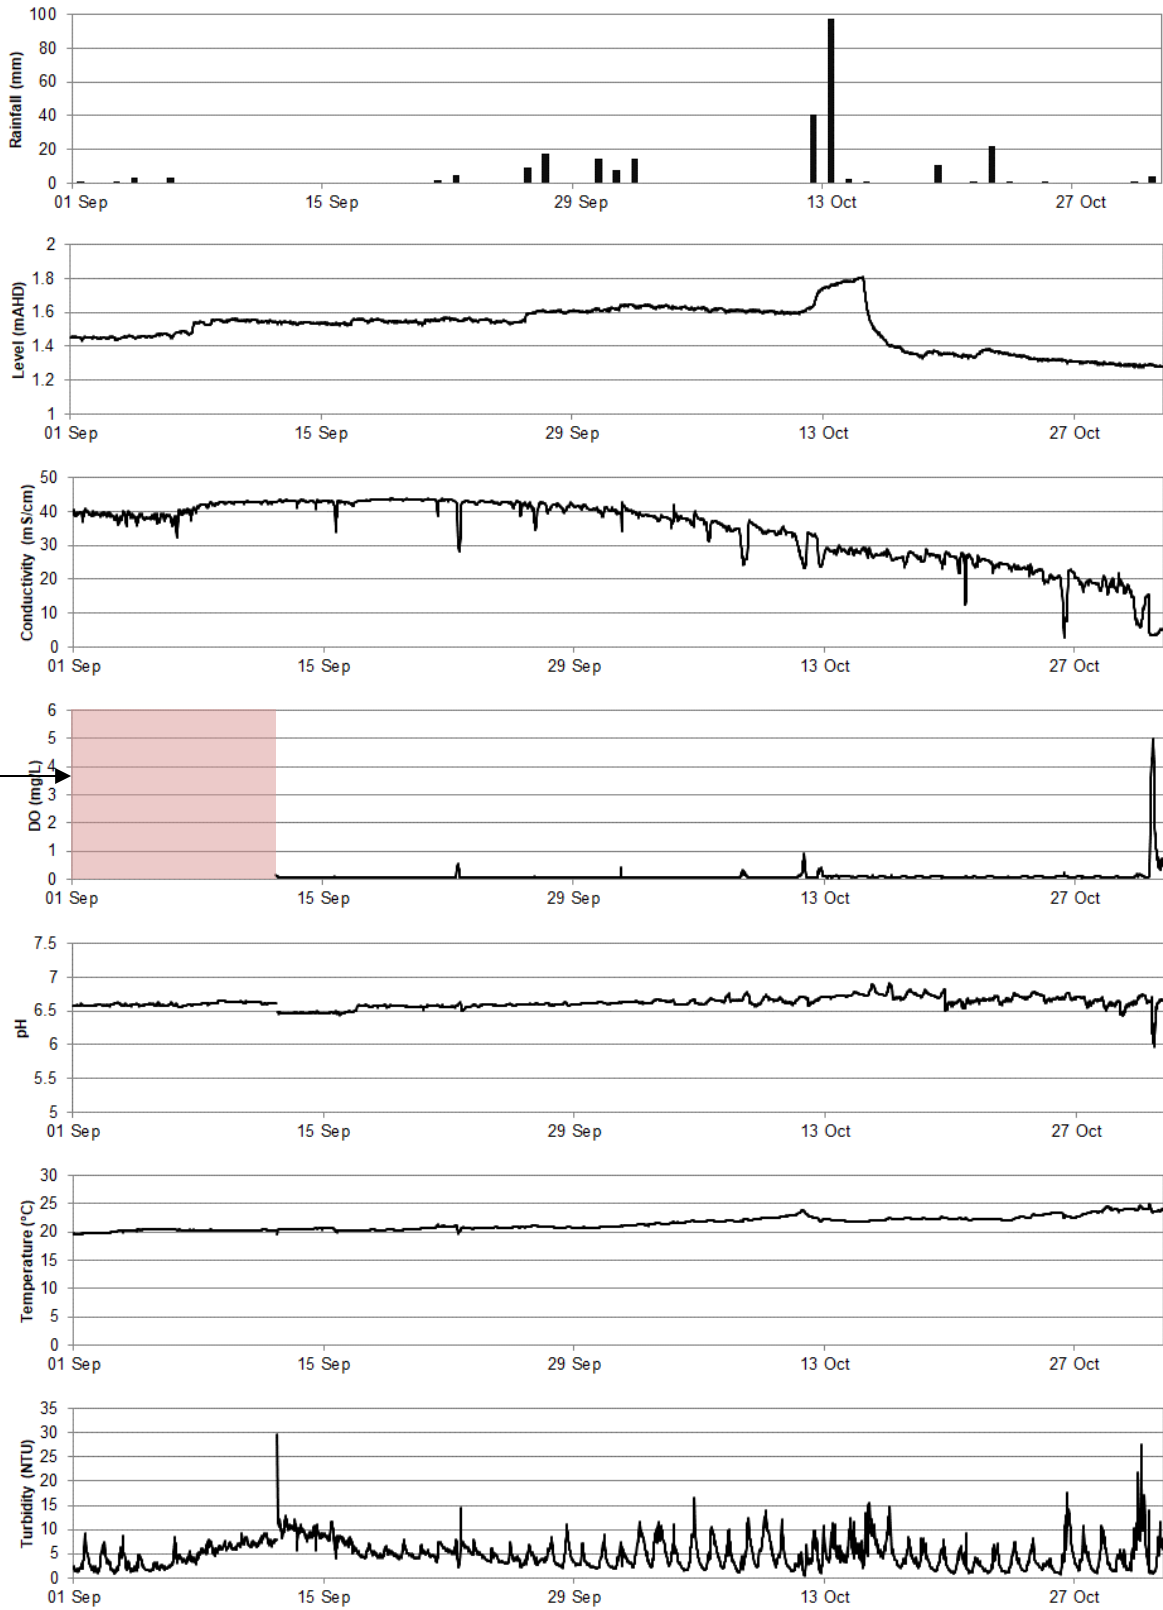
Illustration 3-2 Salty Creek Rainfall and Water Quality Monitoring Station Data 1 September 2021 to 31 October 2021

The data collected at the PWQMS, and rainfall data correlating to the reporting period are presented in **Illustration 3-1** and **Illustration 3-2**.

The water level data from the Salty Creek PWQMS indicates that the entrance to Salty Creek was closed at the beginning of the reporting period and remained closed until 15 October 2021 when it opened in response to a large rainfall event and water levels in Salty Creek became very low. The entrance to Salty Creek appeared to have remained slightly open until the end of the reporting period but was closed again by the time of the site inspection on 15 November 2021 (**Plate**). The water levels in Salty Lagoon remained relatively constant at approximately 1.7 mAHD before increasing in response to heavy rainfall and draining to approximately 1.7 mAHD again by the end of the reporting period.

The DO concentrations in discrete samples collected on 15 November 2021 were below the guiding values at the two western sites in Salty Lagoon (sites S2 and S4) and in deeper water at S5. Low DO concentrations are naturally prevalent at the sites to the west of Salty Lagoon. The low DO concentration in deeper water at S5 is further indication of stratification resulting from low mixing of seawater and freshwater runoff. Logged data from the Salty Lagoon PWQMS indicates that the DO concentrations at the bottom of the water column in Salty Lagoon only increased in response to strong mixing and remained low at other times. Logged data from the Salty Creek PWQMS indicates that the DO concentration at the bottom of the water column in Salty Creek remained low for the entire reporting period.

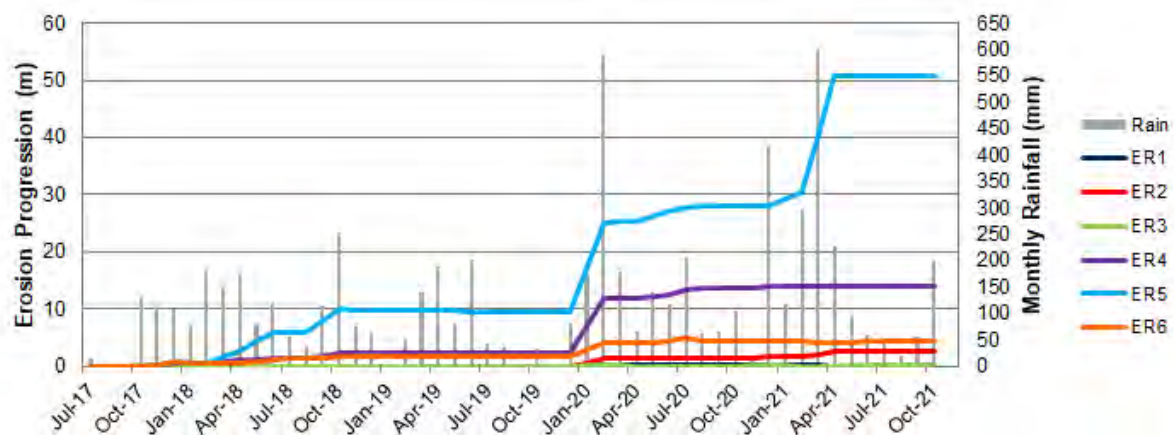
Illustration 3-3 Erosion Progression Plotted against Monthly Rainfall since July 2017

The data collected at the erosion monitoring stations is presented in **Table 3.2** and **Illustration 3-3**. There was no significant advance of the head-cut at ER5 in relation to the previous measurements on 12 September 2021. The results reported in the previous bi-monthly report from ER5 were erroneous, and appear to have been based on an observational error. The head-cut has advanced more than 50 m towards Salty Lagoon since the monitoring began in July 2017.

Erosion monitoring showed no further movement of the primary head-cut towards Salty Lagoon since the previous measurements taken on 12 September 2021. The results also indicate that the previous measurement was erroneous. The erosion progression chart displayed in **Illustration 3-3** contains rectified data.

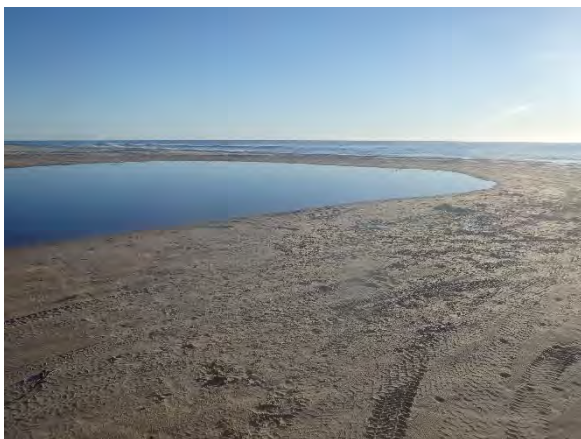
The entrance to Salty Creek was closed on 15 November 2021 (**Plate 4-1**). A variety of birds were observed incidentally during the site inspection including Pacific Black Duck, Chestnut Teal, Black Swan, Little Pied Cormorant, Little Black Cormorant, Pied Cormorant, Great Cormorant and Royal Spoonbill. There was a bloom of *Azolla fimbriatilis* at S2 that covered the entire pool (**Plate 4-2**). Such blooms have occurred irregularly between October and December throughout the years of monitoring at Salty Lagoon.

Plate 4-1 The closed entrance to Salty Creek on 15 November 2021

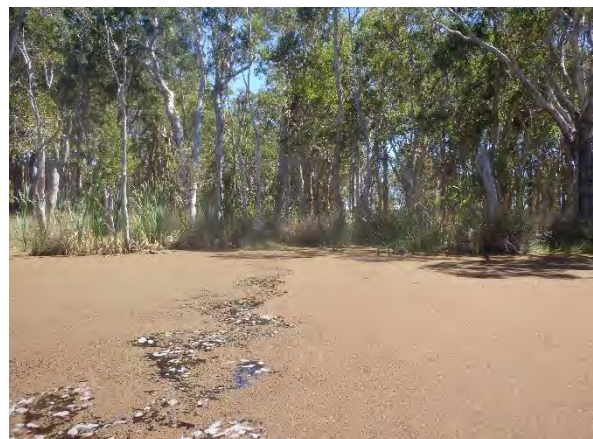
Plate 4-2 The pool at S2 was completely covered in Azolla on 15 November 2021
