Salty Lagoon

Post Closure Monitoring

Project Management and Ecosystem Health Report

December 2021

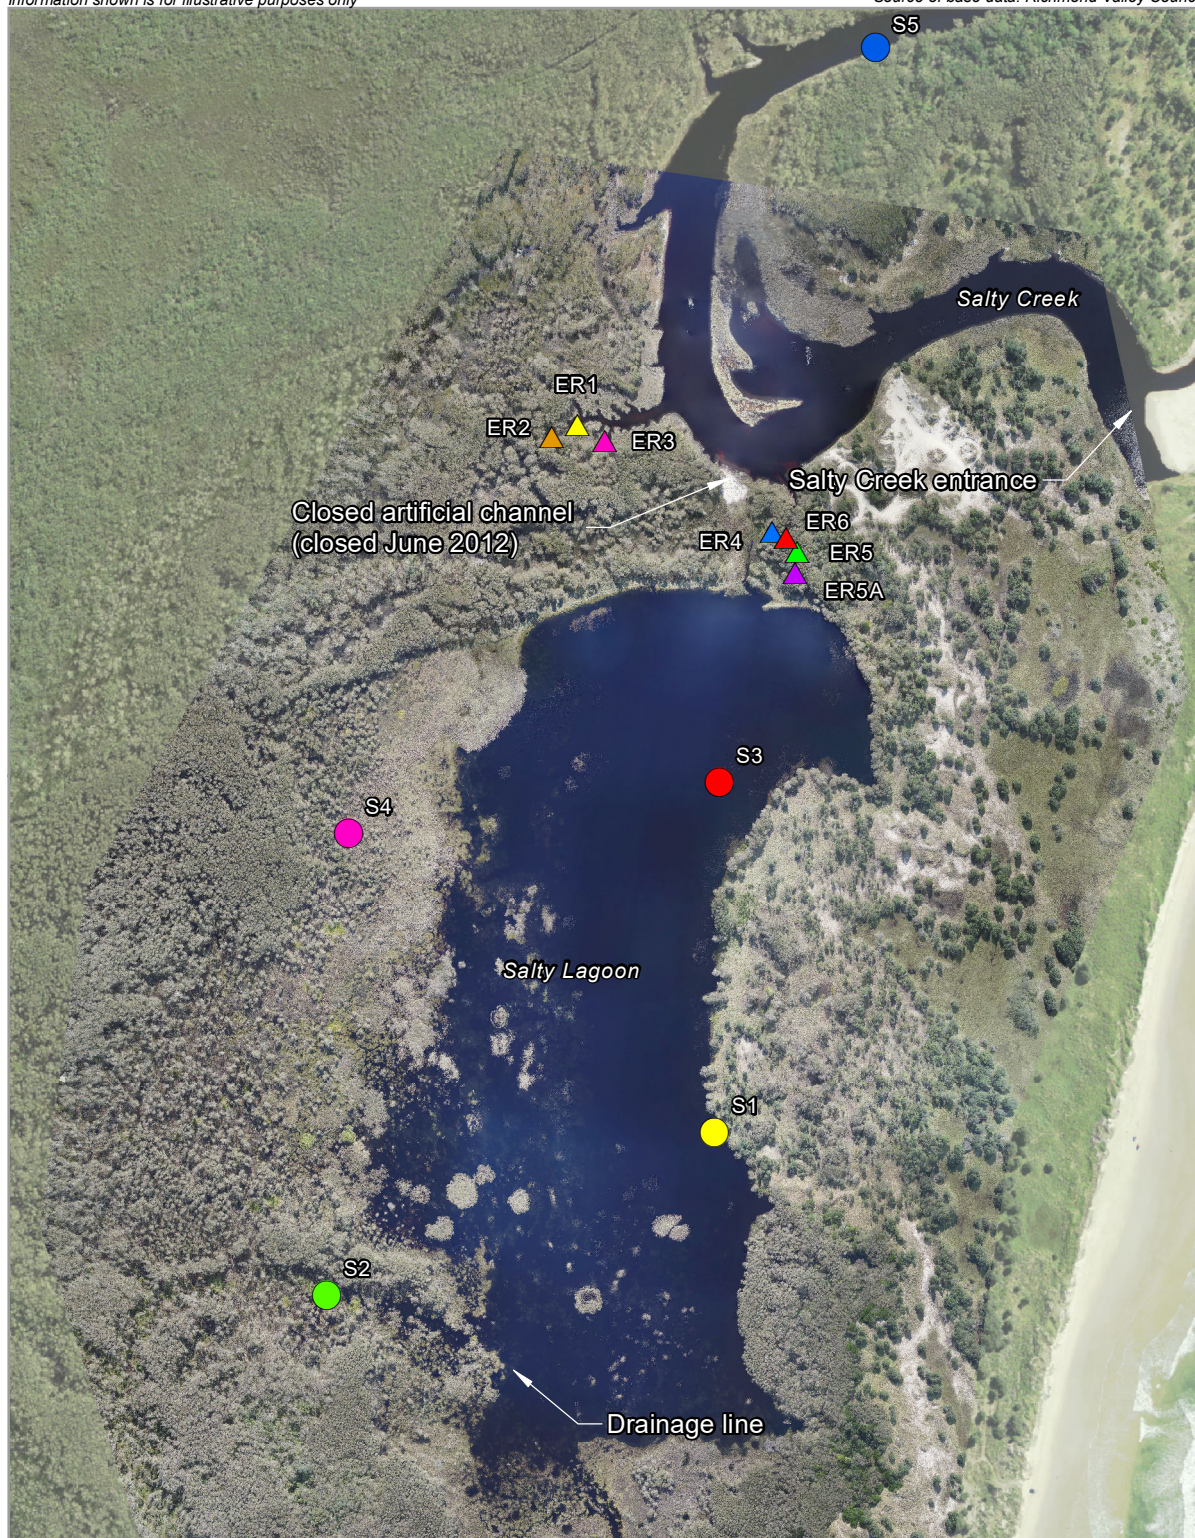
Location of Water Quality and Erosion Monitoring Sites

Discrete water quality samples were taken from surface water (approximately 0.2 metre depth) at four sites in Salty Lagoon and a single site (S5) in Salty Creek. An additional quality assurance (QA) replicate sample was collected at S3. The specific locations of all sites sampled are presented in **Table 2.1** and **Illustration 2.1**. They are the same sites previously used for the MPPC (GeoLINK 2017).

A series of reference stations have been set up around the head cut to the east of the infilled channel and some nearby control sites to assess the progression of erosion between Salty Lagoon and Salty Creek. The specific locations of all sites sampled are presented in **Table 2.2** and **Illustration 2.1**. Repairs to the control structure installed by NSW National Parks and Wildlife Service (NPWS) in late 2020 were undertaken in June and July 2021. Erosion monitoring is continuing to confirm if the headcut has stabilised.

The stations were set up in July 2017 at the head cut (Stations 4, 5 and 6), with control sites at points where lateral tributaries from Salty Creek lead towards Salty Lagoon (Stations 1, 2 and 3). At each site the monitoring involves a fixed-point photo and a measurement from a fixed peg to the nearest point of the head cut. In March 2020 site ER5 had to be extended because the fixed peg was overtaken by the erosion. A new site, ER5A was created but allows erosion progression to be measured from the same initial reference point as ER5.

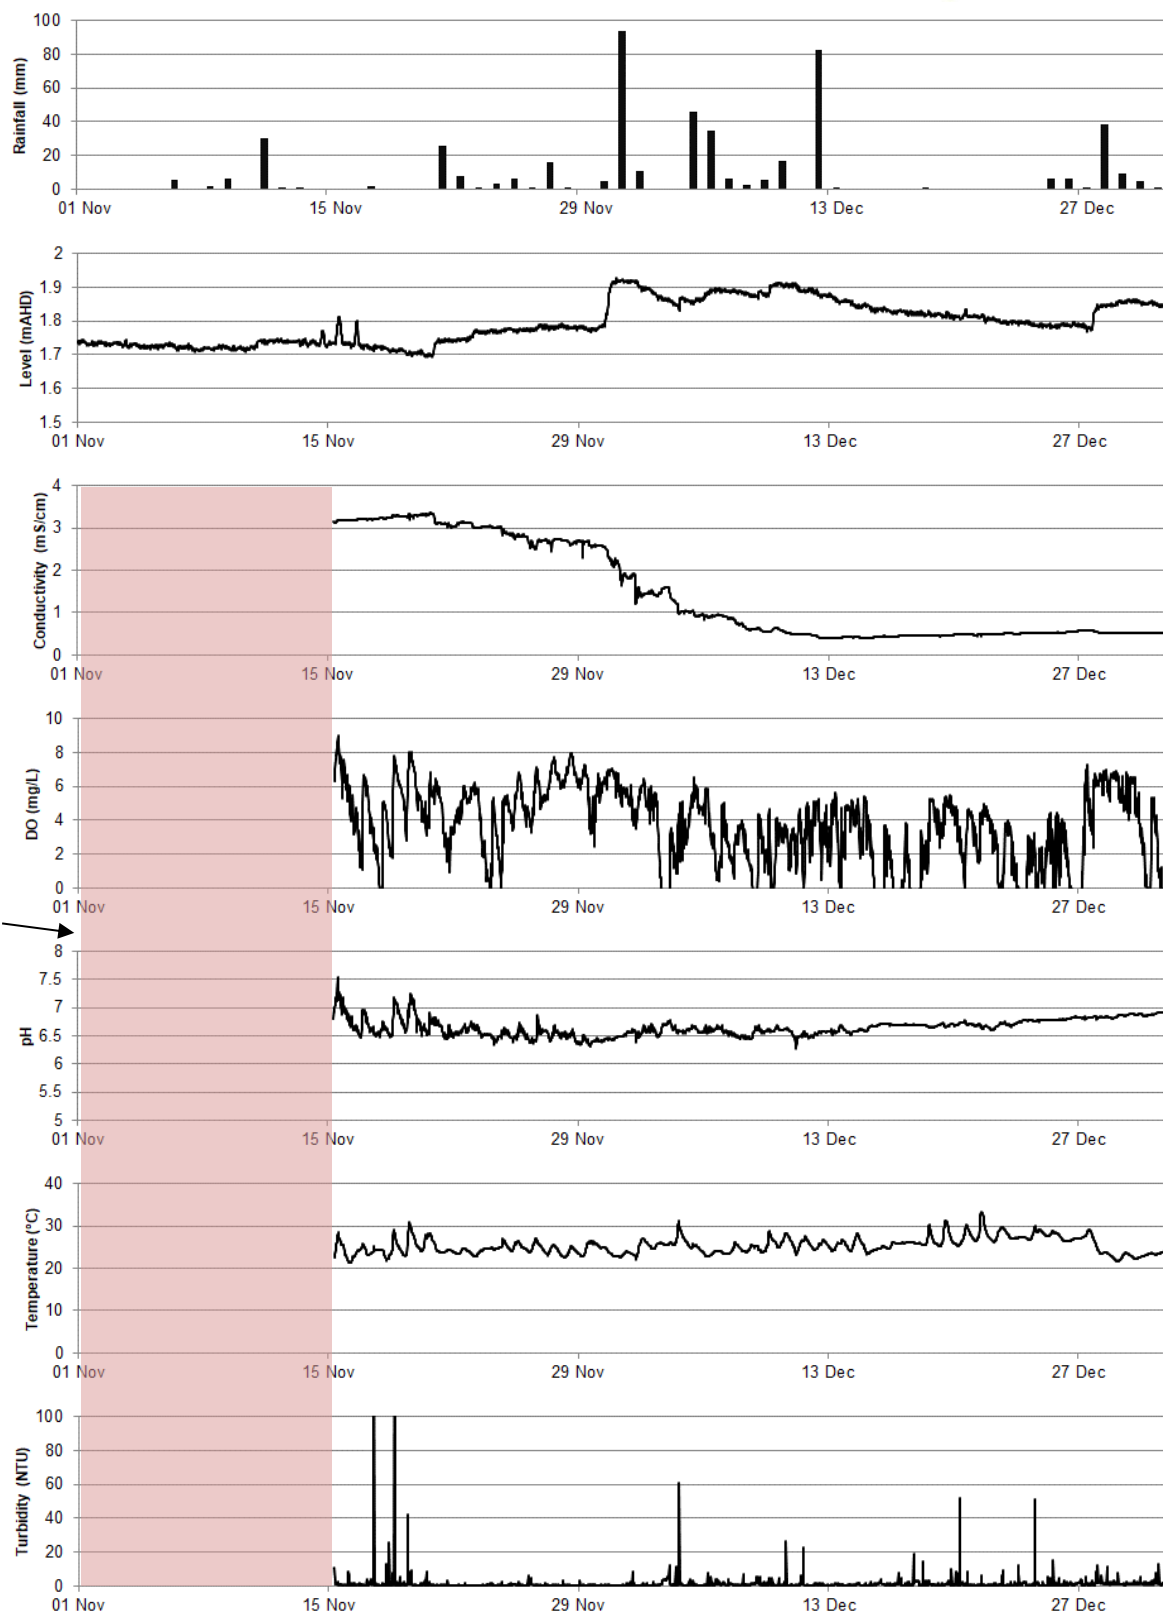
Illustration 3.1 Salty Lagoon Rainfall and Water Quality Monitoring Station Data 1
November 2021 to 31 December 2021

The data collected at the PWQMS, and rainfall data correlating to the reporting period are presented in **Illustration 3.1** and **Illustration 3.2**.

The conductivity measured at the Salty Lagoon PWQMS decreased overall during this reporting period in response to consistent rainfall runoff. The conductivity measurements from the Salty Creek PWQMS clearly indicate the influence of seawater ingress initially and then consistent rainfall runoff flowing through the open entrance. At the time of the site inspection on 12 January 2022 the water in Salty Lagoon was well mixed and brackish, and the water in Salty Creek was stratified into a slightly brackish surface layer and a more saline, heavier bottom layer, indicating that further seawater ingress may have occurred after 31 December 2021. The conductivity measurements collected on 12 January 2022 complied with guiding values at all sites except S5, where the sample collected from deeper water indicated the conductivity had increased in response to seawater ingress.

the west of Salty Lagoon but unusual in the open water sites. Low DO concentrations in the open water sites are often associated with saline water ingress, which is likely to have occurred between 31 December 2021 and the site inspection. Logged data from the Salty Lagoon PWQMS indicates that the DO concentrations at the bottom of the water column in Salty Lagoon were highly variable during this reporting period in response to light availability and other factors. Logged data from the Salty Creek PWQMS indicates that the DO concentration at the bottom of the water column in Salty Creek improved when freshwater conditions prevailed but was still variable in response to light availability.

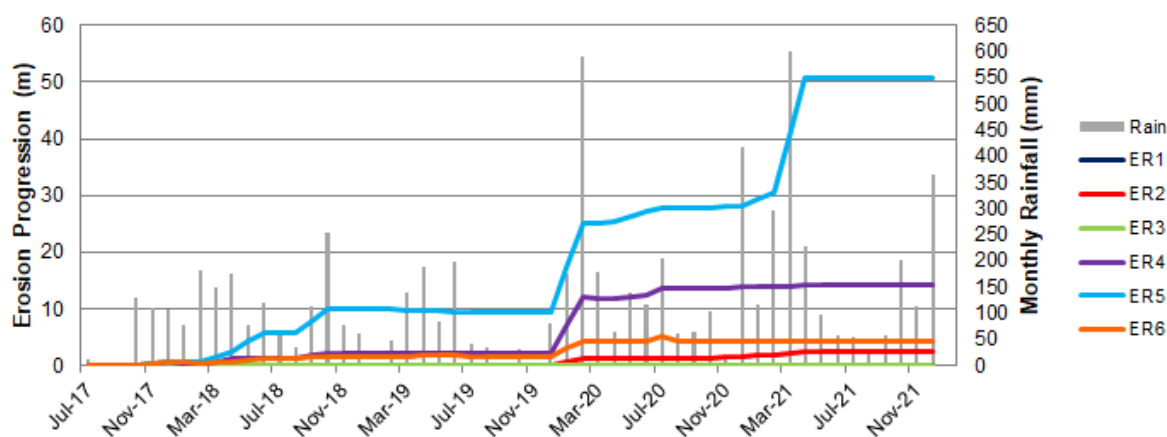
Illustration 3.3 Erosion Progression Plotted against Monthly Rainfall since July 2017

The data collected at the erosion monitoring stations is presented in **Table 3.2** and **Illustration 3.3**. There was no significant advance of the head cut at ER5 in relation to the previous measurements on 15 November 2021. The head cut has advanced more than 50 m towards Salty Lagoon since the monitoring began in July 2017.

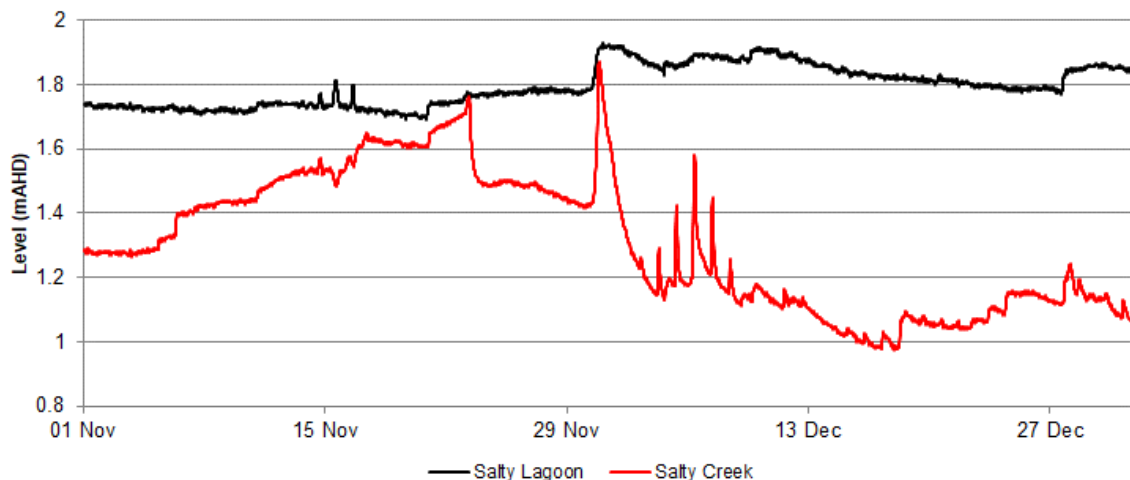
Illustration 4.1 Water levels in Salty Lagoon and Salty Creek during this reporting period

The water level at the Salty Creek PWQMS was particularly dynamic during this reporting period, in response to rainfall runoff, seawater ingress, the entrance opening on two separate occasions and tidal movements. Although water levels became very high on 30 November 2021 in response to very heavy rainfall, they were low at the beginning of the reporting period and very low at the end. The data indicates that the entrance to Salty Creek was open and flowing out for the final 20 days of the reporting period. Water levels in Salty Lagoon remained relatively high for the majority of the reporting period, increasing to very high levels in response to some of the heavier rainfall events. Water would have flowed from Salty Lagoon into Salty Creek for the majority of the reporting period, with the exception of two short periods prior to entrance opening events where the waterways were hydrologically connected (**Illustration 4.1**).

Erosion monitoring showed no further movement of the primary head cut towards Salty Lagoon since the previous measurements taken on 15 November 2021, despite consistent flow from Salty Lagoon into Salty Creek and a hydraulic head of up to approximately 0.8 m (**Illustration 4.1**). This is an indication that the repairs to the erosion control structure in the eroding channel have functioned well during this reporting period.

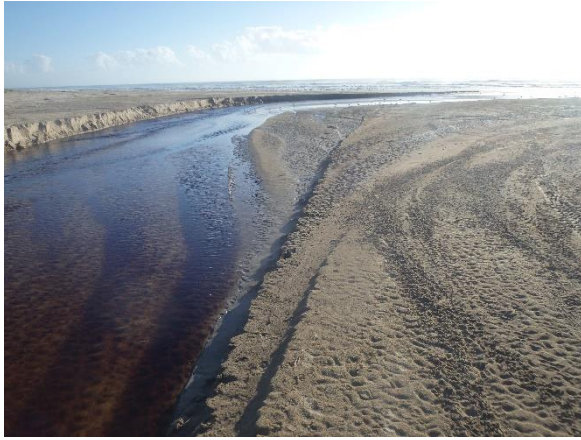
The entrance to Salty Creek was open on 12 January 2022 (**Plate 4.1**). A variety of birds were observed incidentally during the site inspection including Pacific Black Duck, Little Pied Cormorant, Little Black Cormorant, Pied Cormorant, and Pelican. There was a bloom of *Azolla fimbristylis* at S2 that covered most of the pool. This is the second consecutive observation of such a bloom. They have occurred irregularly between October and December throughout the years of monitoring at Salty Lagoon.

Plate 4.1 The open entrance to Salty Creek on 12 January 2022

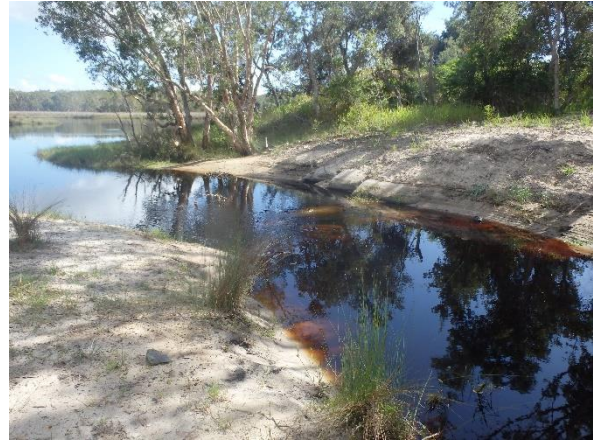
Plate 4.2 Higher water levels on 12 January 2022 showing a hydraulic connection between Salty Lagoon and Salty Creek over the erosion control structure.
