Salty Lagoon

Post Closure Monitoring

Project Management and Ecosystem Health Report

April 2022

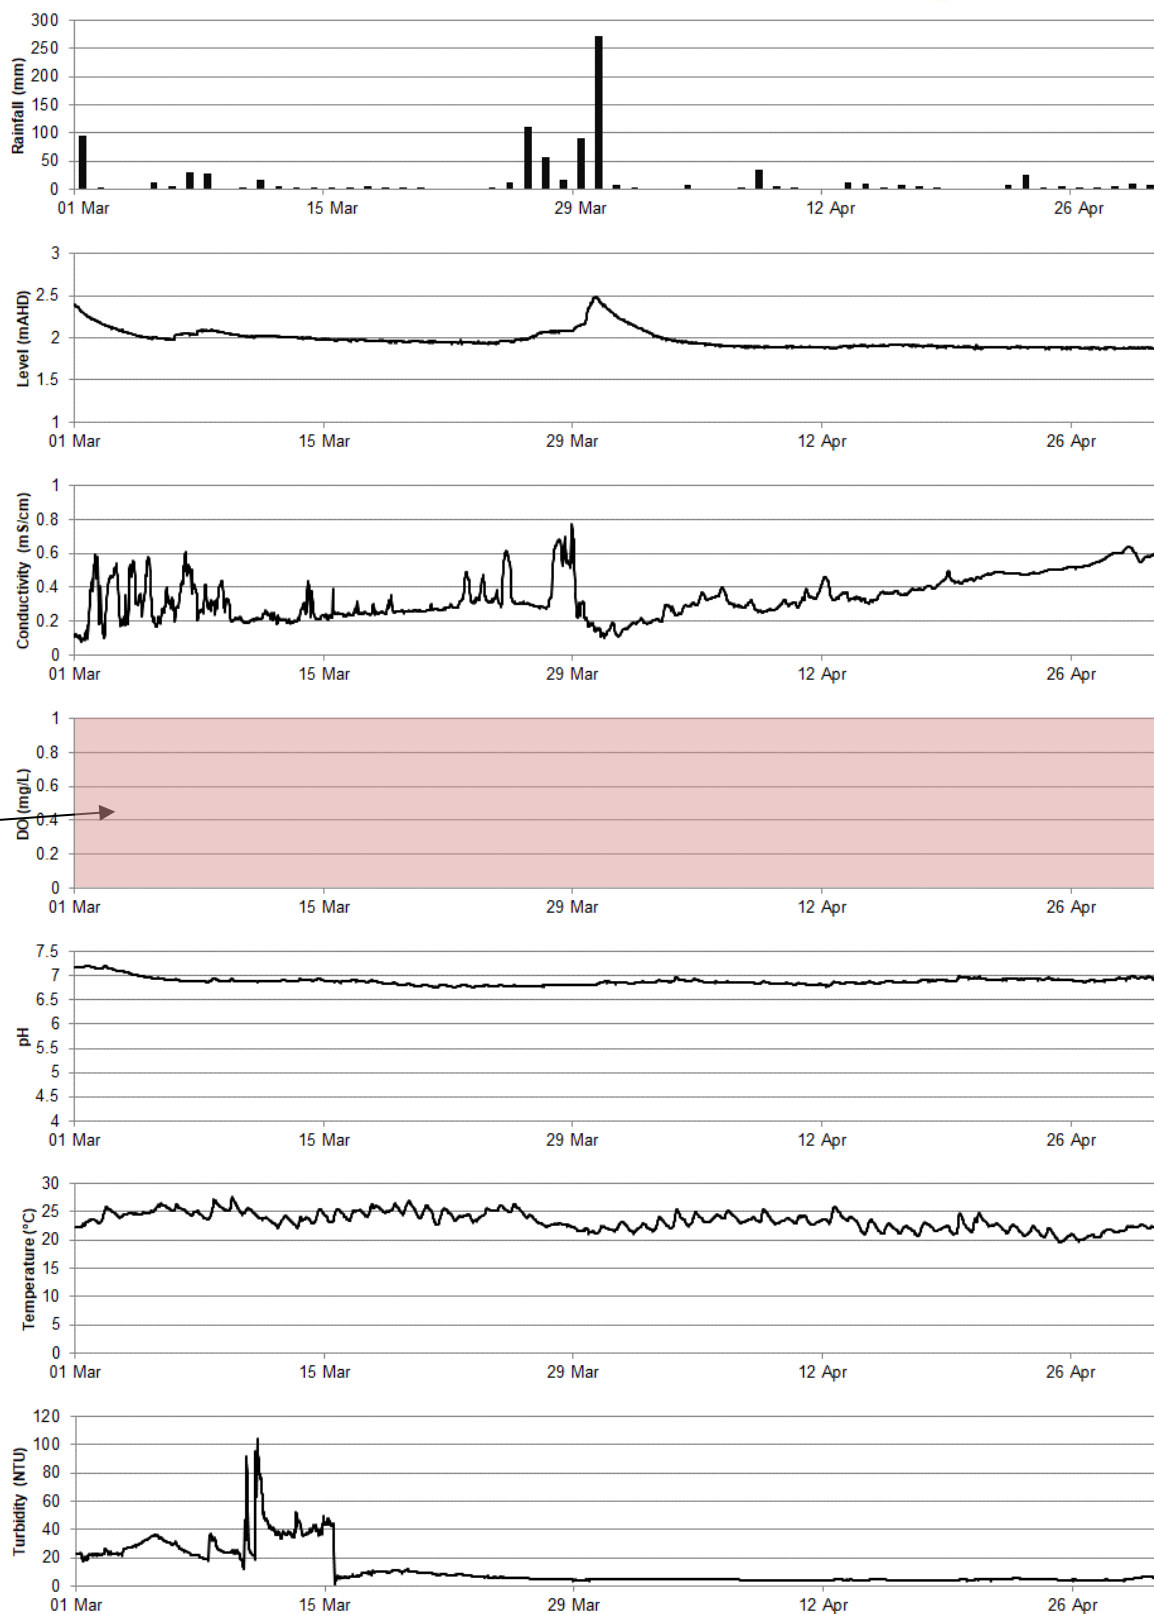
Illustration 3.1 Salty Lagoon Rainfall and Water Quality Monitoring Station Data 1
March 2022 to 30 April 2022

The data collected at the PWQMS, and rainfall data correlating to the reporting period are presented in **Illustration 3.1** and **Illustration 3.2**.

The conductivity measured at the Salty Lagoon PWQMS remained very low during this reporting period in response to consistent rainfall runoff. Small fluctuations detected at the Salty Lagoon PWQMS probably indicate variability of wind and flow driven mixing conditions. The conductivity measurements from the Salty Creek PWQMS remained low for the majority of the reporting period in response to heavy rainfall runoff, although tidal movements caused a short spike before flooding saw a return to freshwater dominance. At the end of the reporting period (and at the time of the site inspection on 9 May 2022) the water in Salty Lagoon and Salty Creek was fresh. The conductivity measurements collected on 9 May 2022 complied with guiding values at all sites except S5, where the results were below the lower guideline limit as a result of the very strong influence from rainfall runoff.

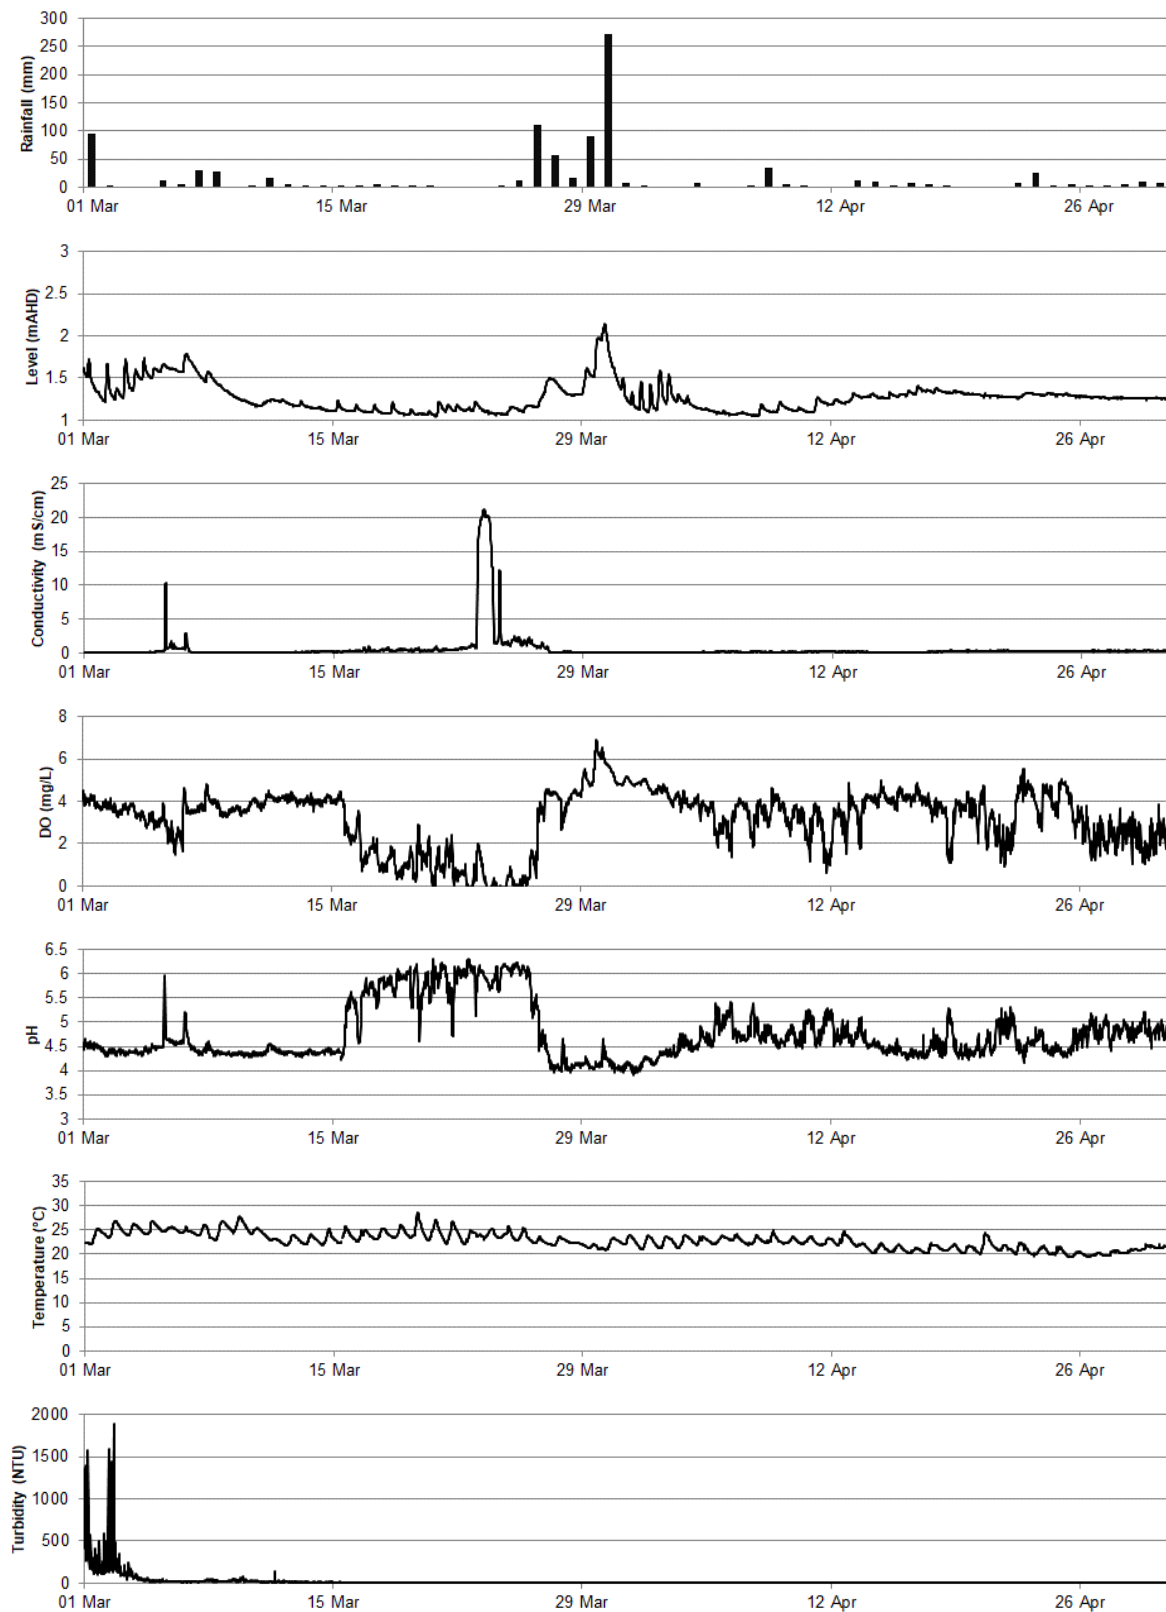
Illustration 3.2 Salty Creek Rainfall and Water Quality Monitoring Station Data 1 March 2022 to 30 April 2022

The water level at the Salty Creek PWQMS was particularly dynamic again during this reporting period, in response to rainfall runoff, seawater ingress, the entrance opening on at least one occasion and tidal movements. Although water levels became very high on one occasion, they were moderately low for the majority of the reporting period. The data indicates that the entrance to Salty Creek was open for most of the reporting period, and operating tidally for approximately half of it. Water levels in Salty Lagoon remained high for the majority of the reporting period, increasing to very high levels in response to a flood event in the middle of the reporting period. Water would have flowed from Salty Lagoon into Salty Creek for the entire reporting period. This flow led to an advance of the eroding head cut (refer to **Illustration 3.3**) and also caused the erosion control structure to fail.

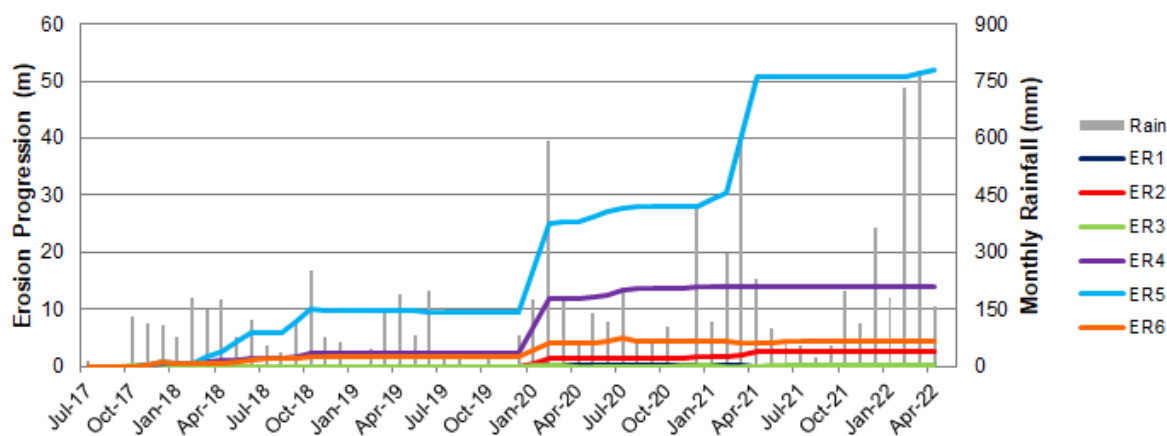
Illustration 3.3 Erosion Progression Plotted against Monthly Rainfall since July 2017

The data collected at the erosion monitoring stations is presented in **Table 3.2** and **Illustration 3.3**. There was a moderate advance of the head cut at ER5 in relation to the previous measurements on 15 March 2022. The head cut has advanced more than 50 m towards Salty Lagoon since the monitoring began in July 2017.

Erosion monitoring showed a moderate movement of the primary head cut towards Salty Lagoon since the previous measurements taken on 15 March 2022. Although the advance towards Salty

Lagoon was approximately 1.3 m during this reporting period, the eroding channel extended approximately 3-4 m.

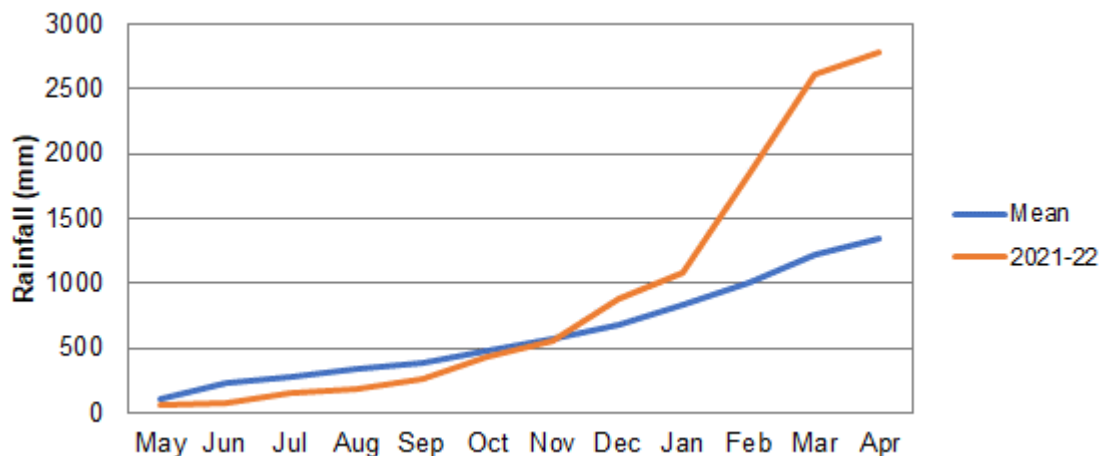
Illustration 4.1 Cumulative rainfall since May 2021 plotted against cumulative average rainfall

There was consistent rainfall during this reporting period including a flood event, several large events and a number of small events. Rainfall was recorded on approximately 3/4 of the days of the reporting period. The total rainfall for this reporting period was approximately 280 percent of the average amount. This is the fourth consecutive bi-monthly reporting period where rainfall exceeded the average amount (**Illustration 4.1**) and for the previous 12 months rainfall in the area was more than twice the average amount.

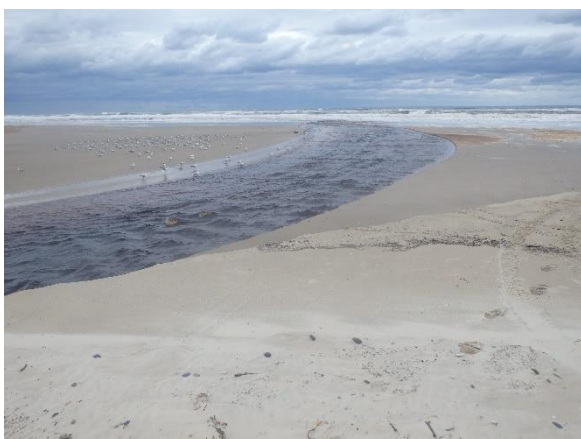
The entrance to Salty Creek was open and flowing on 9 May 2022 (refer to **Plate 4.1**). Few birds were observed incidentally during the site inspection. The species observed were Pacific Black Duck, White-eyed Duck, Little Pied Cormorant, Little Black Cormorant, Australasian Grebe, Black Swan and Great Egret. A native aquatic plant, hornwort (*Ceratophyllum demersum*), was observed throughout Salty Lagoon in unusually high densities.

Plate 4.1 The open entrance to Salty Creek on 9 May 2022

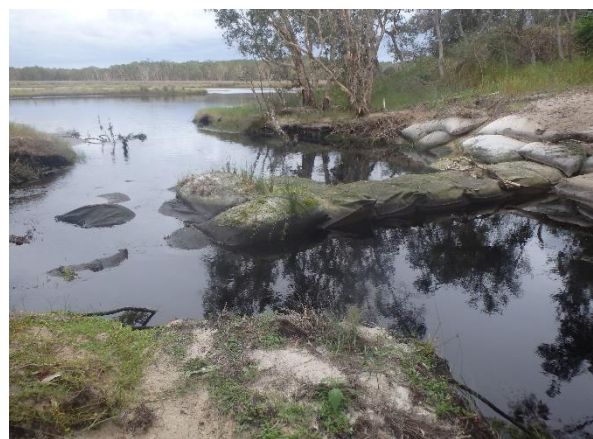
Plate 4.2 The damaged erosion control structure.

5. Following 6 months of rainfall that greatly exceeded average conditions the erosive headcut has advanced since the measurements on 15 March 2022. The erosion control structure has been damaged and is no longer functional.

6. *In accordance with the project Environmental Response Protocol (GeoLINK 2017b), the risk rating for the Salty Lagoon Response Protocol is uncertain. Adaptive management site visits are recommended for periods of potential head cut progression, with the following triggers:*

- >50 mm of rainfall with 24 hrs.
 - >200 mm of rainfall within a week.
 - Other high risk events, for example >100 mm of rainfall within 72 hours, significant storm surge, atypically large tides, etc. Due consideration would be given to rainfall intensity and volume, and the Salty Creek entrance status when known as appropriate.

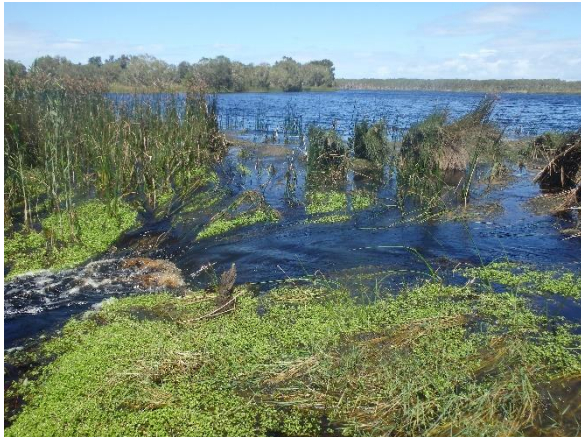
Plate 4.3 The position of the headcut on 15 March 2022

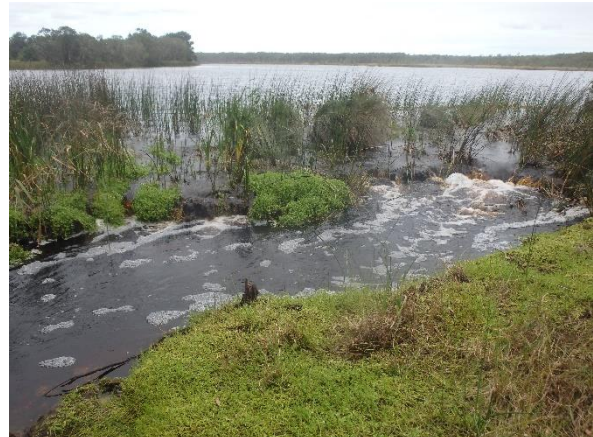
Plate 4.4 The position of the headcut on 9 May 2022 showing a westwards and southwards advance
