CASINO CBD HERITAGE CONSERVATION AREA MAIN STREET AUDIT

Prepared by
CLARENCE HERITAGE
FOR RICHMOND VALLEY COUNCIL
AUGUST 2020

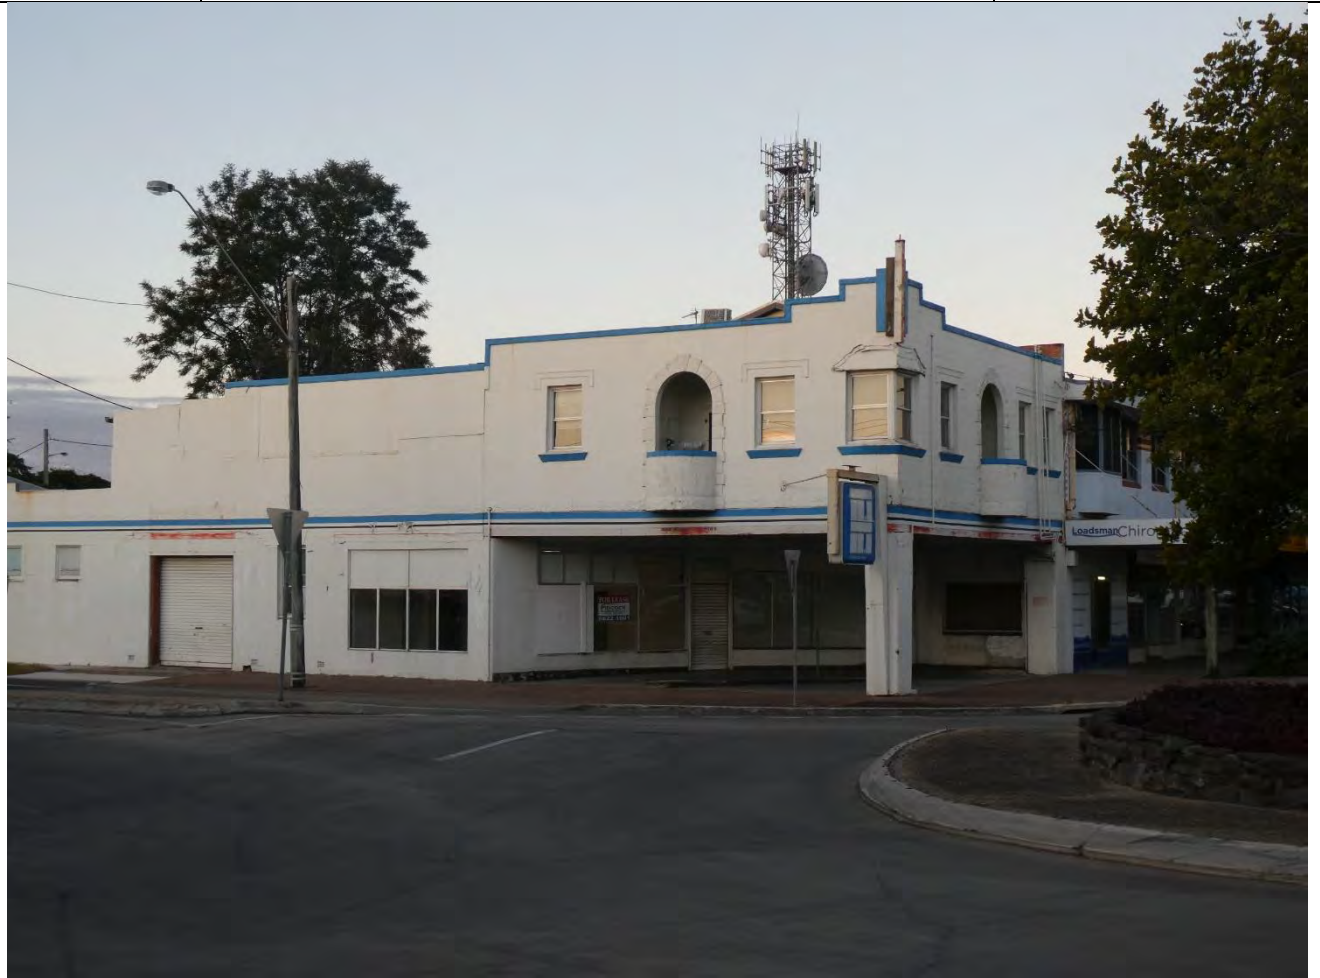
Building Elements	Observations	Recommendations
Roof	Not visible as behind parapet. Appears to be Galvanised on aerial photo.	Replace as required to original details.
Gutter	Not visible	Ensure guttering is well maintained.
Walls	<p>Rendered masonry scored out with horizontal courses. Decorative parapet and mouldings. Art deco pillar finial to corner of parapet. Awning removed leaving flashing edge.</p>  	<p>Maintain all detailing to façade to original design. Utilise an authentic heritage colour scheme for any future repainting.</p>
Windows	<p>Aluminium framed within the original window openings of vertical proportions. Double window to corner. Awning has been removed – refer to images above and below.</p>  	<p>Consider reinstatement of timber framed first floor windows in future works. Reinststate hood over corner window.</p>

Carefully conserve to original details.
Doors	Aluminium framed and roller doors. No original doors or joinery remain on ground floor streetfacade.	Research original detailing and consider reinstatement in future restoration or new proposals.
Awning	Awning over former service station forecourt. Lining- fibre cement sheets with expressed batten trims.	Conserve existing fabric or replace to match.
Interior	Not inspected

Summary of Recommendations

- The top priority is to ensure the building is water tight and that stormwater is being dispersed away from the edge of the building.
- Replace any rusted roofing or guttering to match original.

- Check downpipes and ensure all stormwater is discharged away from the edges of building to ensure no pooling on foundations.
- Carefully conserve and retain all original external fabric to original details.

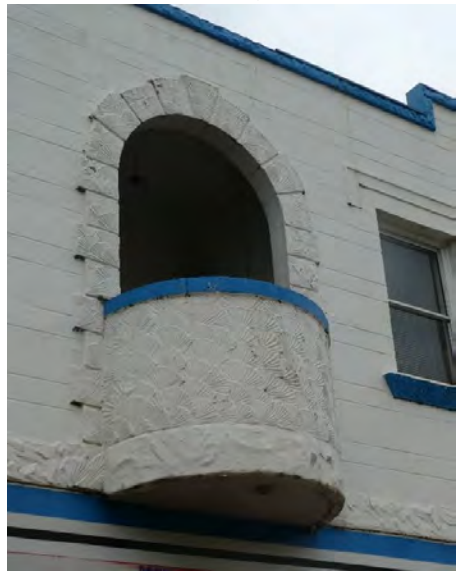
Balconies	Original Juliet balconies with shell patterned render and stone like arched mouldings.

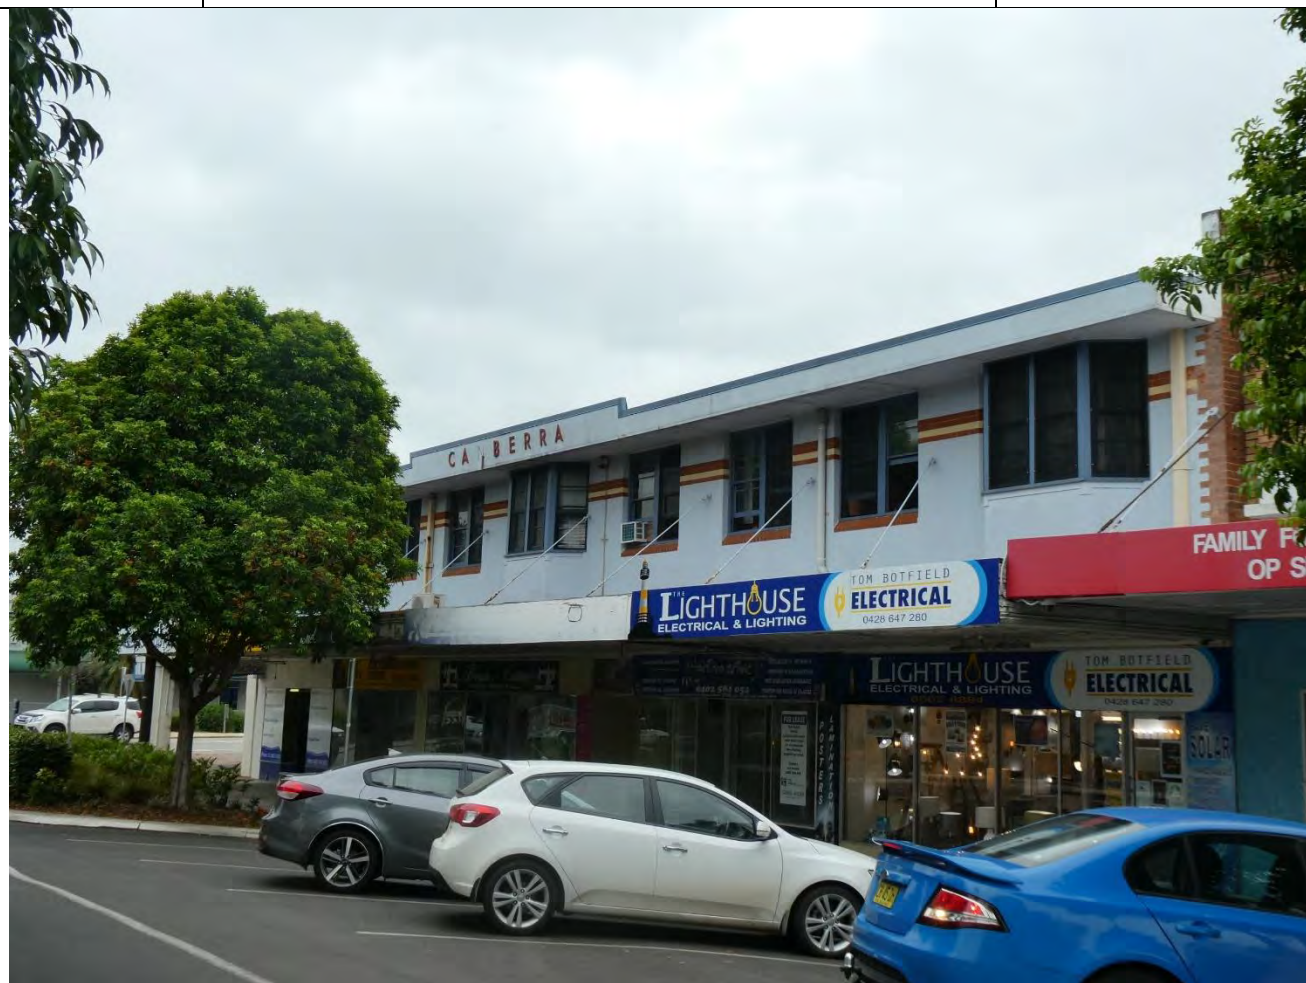
Building Elements	Observations	Recommendations
Roof	Gabled roof behind parapet.	Replace as required to original details.
Gutter	Not visible	Ensure guttering is well maintained.
Walls	<p>Rendered masonry with decorative horizontal brick courses and brick quoins to corners.</p>

<p>Maintain all detailing to façade to original design.</p> <p>The original raised lettering should be checked for fixture and maintained. Reinstate the missing letter N.</p>
Windows	<p>Windows to upper floor are timber framed, double hung with horizontally proportioned glazing bars typical of the 1940s era. Bay oriel windows mark each end of the façade.</p>

<p>Carefully repair and maintain original timber joinery.</p>

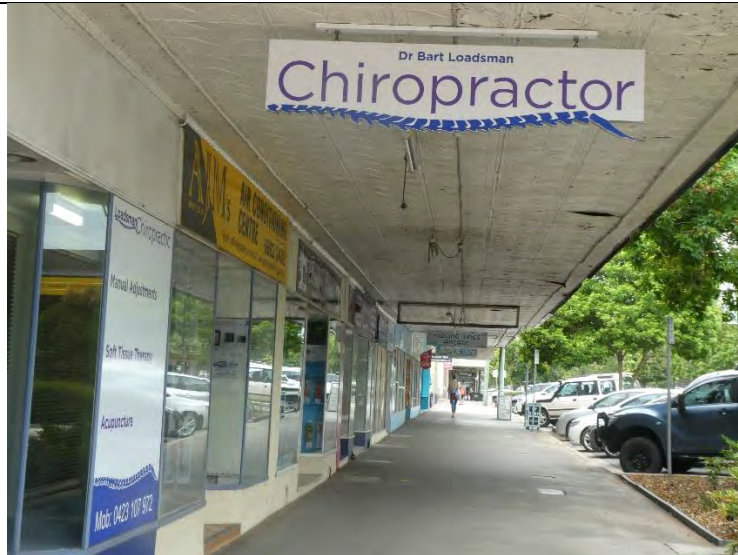
At street level, 4 of 5 shopfronts retain original fabric including stall risers and slender chrome frames, recessed entries and terrazzo polished granite thresholds and some timber entry doors.

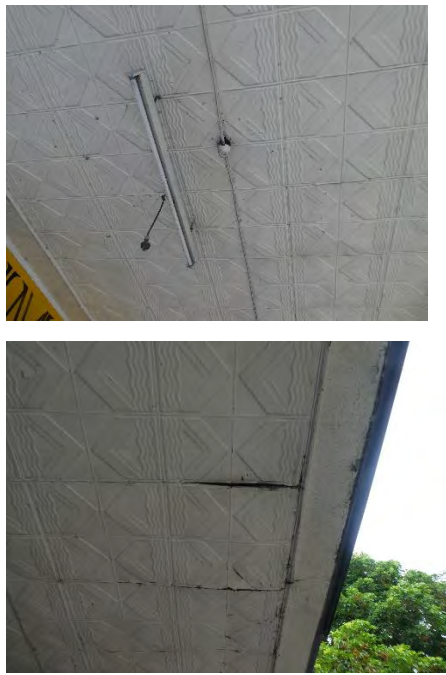
<p>Awning</p>	<p>The awning is a significant feature lined with pressed metal This is a highly contributory element of the building.</p>

<p>There is evidence of water ingress which if unaddressed, will substantially damage and cause loss of this feature. Urgent action is required to remediate this.</p>
<p>Fascia</p>	<p>2005 The street facing edge of the awning has a moulded zigzag design pressed into it, however this is now concealed by modern fascia signage.</p>

<p>Consider more co-ordinated set of fascia signage which complements the heritage character of the building.</p>
<p>Summary of Recommendations</p> <ul style="list-style-type: none"> • The top priority is to ensure the building is water tight and that stormwater is being dispersed away from the edge of the building. Replace any rusted roofing or guttering to match original. • Urgently address leaks to awning and repair pressed metal lining. • Reinstate missing letter N to name on building parapet. • Carefully conserve and retain all original external fabric to original details. • Retain contrasting face brick horizontal string courses or quoins unpainted. • Maintain a colour scheme for the whole building in an authentic heritage colour scheme. • Shopfronts containing original window framing, recessed entries and original terrazzo thresholds should be carefully retained to original details. Encourage re-instatement of missing details. • Maintain a colour scheme for the whole building in an authentic heritage colour scheme. • Use a single background colour on the fascia and consider a co-ordinated set of fascia signage of more slender proportions which complements the heritage character of the building or hanging signs beneath a revealed art deco fascia. • A heritage grant can be sought for maintenance and conservation works • A conservation management plan for the entire building is also recommended.

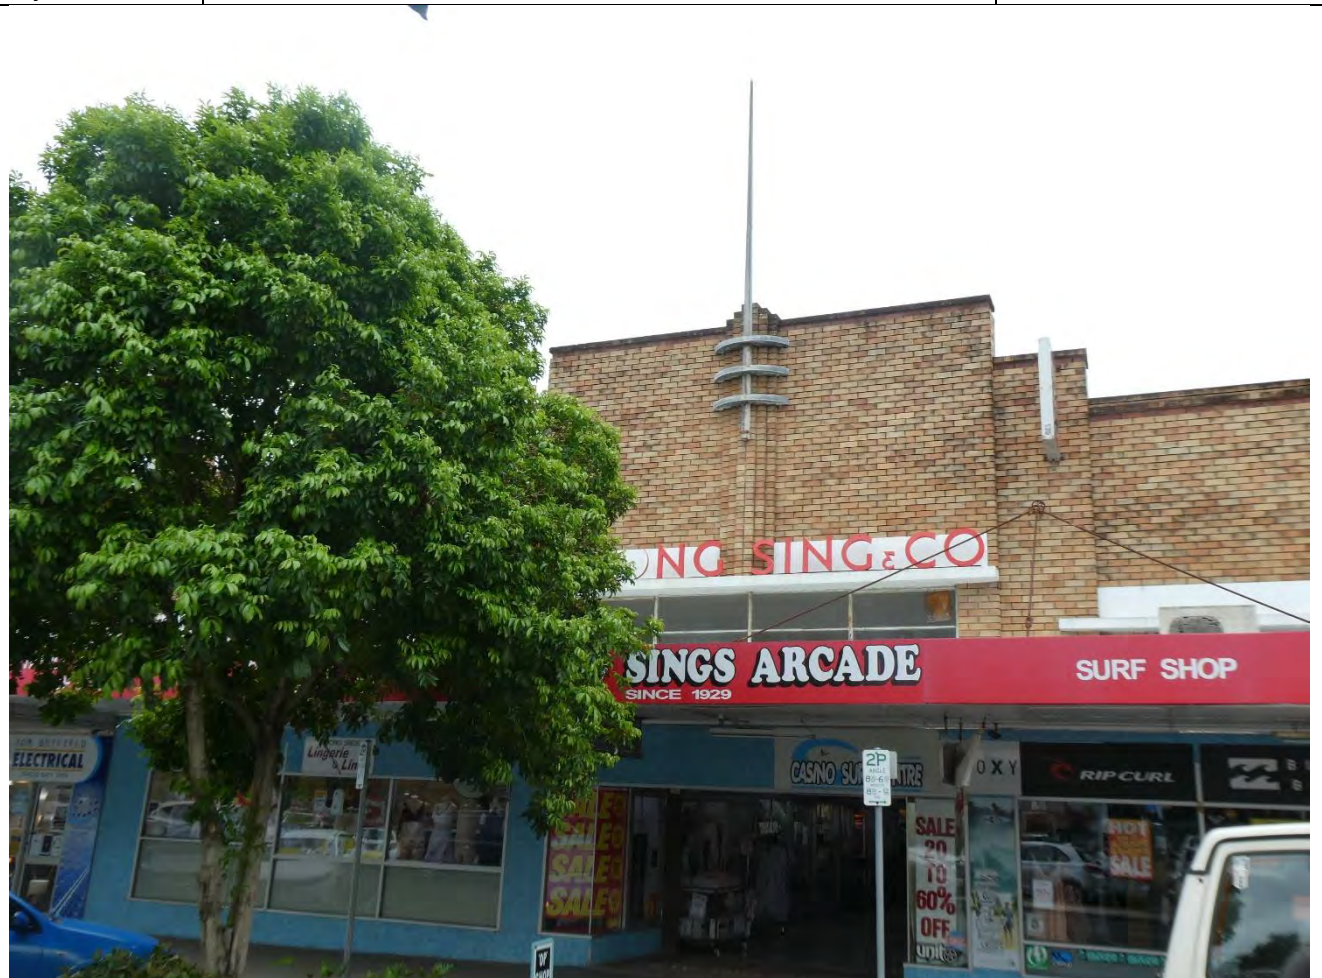
Building Elements	Observations	Recommendations
Roof	Gabled roof behind parapet.	Maintain.
Gutter	Not visible	Maintain.
Walls	<p>Face brickwork with central vertical brick corbelling and stylised steel finial.</p>

Summary of Recommendations

- Ensure the building is water tight and that stormwater is being dispersed away from the edge of the building. Replace any rusted roofing or guttering to match original.
- Maintain façade and stepped parapet and central finial to original design, with the Kwong Sing individual lettering above transom glass.
- Maintain brickwork unpainted.
- Consider repainting of Hardware shop in a more sympathetic main wall colour above the awning.
- Maintain unity of one fascia colour to the building fascia.
- A heritage grant can be sought for maintenance and conservation works

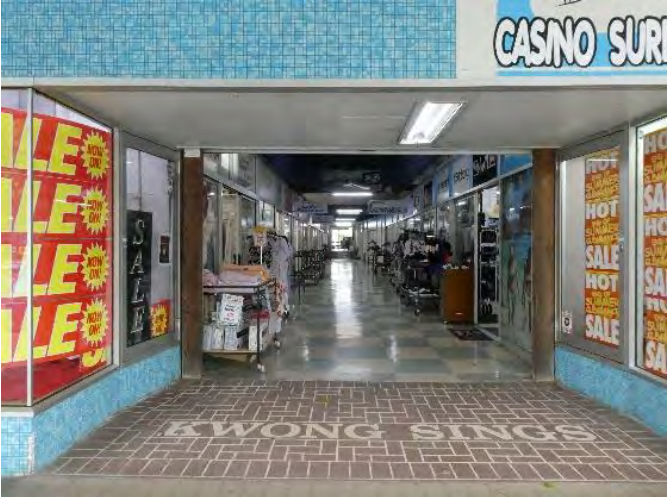
Maintain
Shopfronts	<p>Aluminium shopfronts with traditional stall riser, and mosaic tiling. Central arcade entry. Fibre cement lining batten trim.</p>

Maintain.

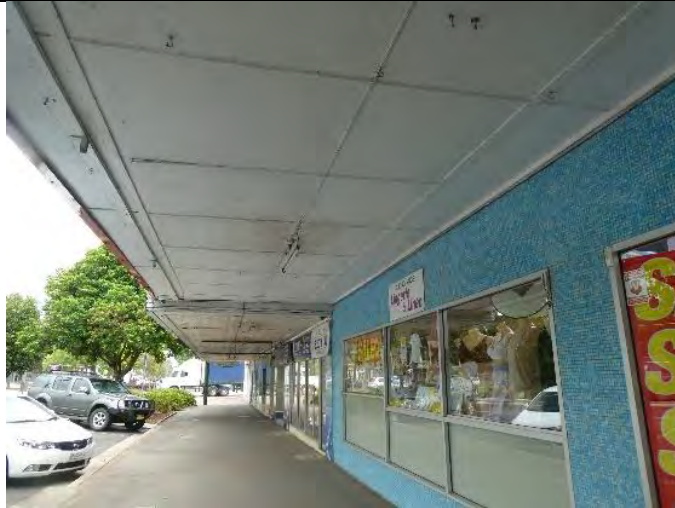
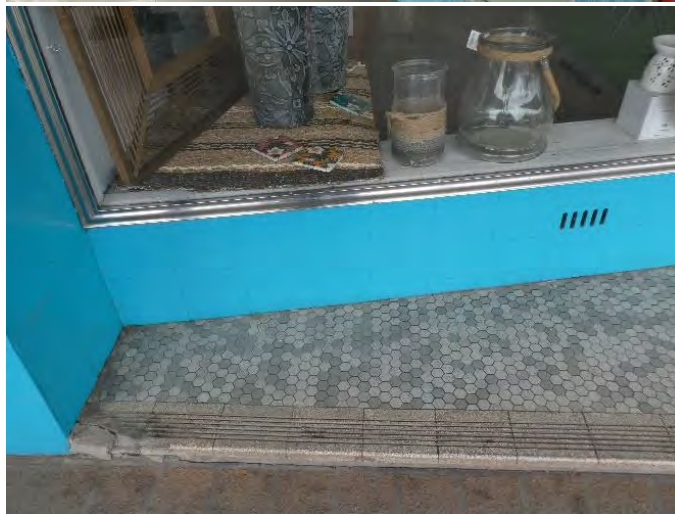
The adjoining hardware shop has a splayed window design and moulded chrome shop window frame. Maintain and conserve.

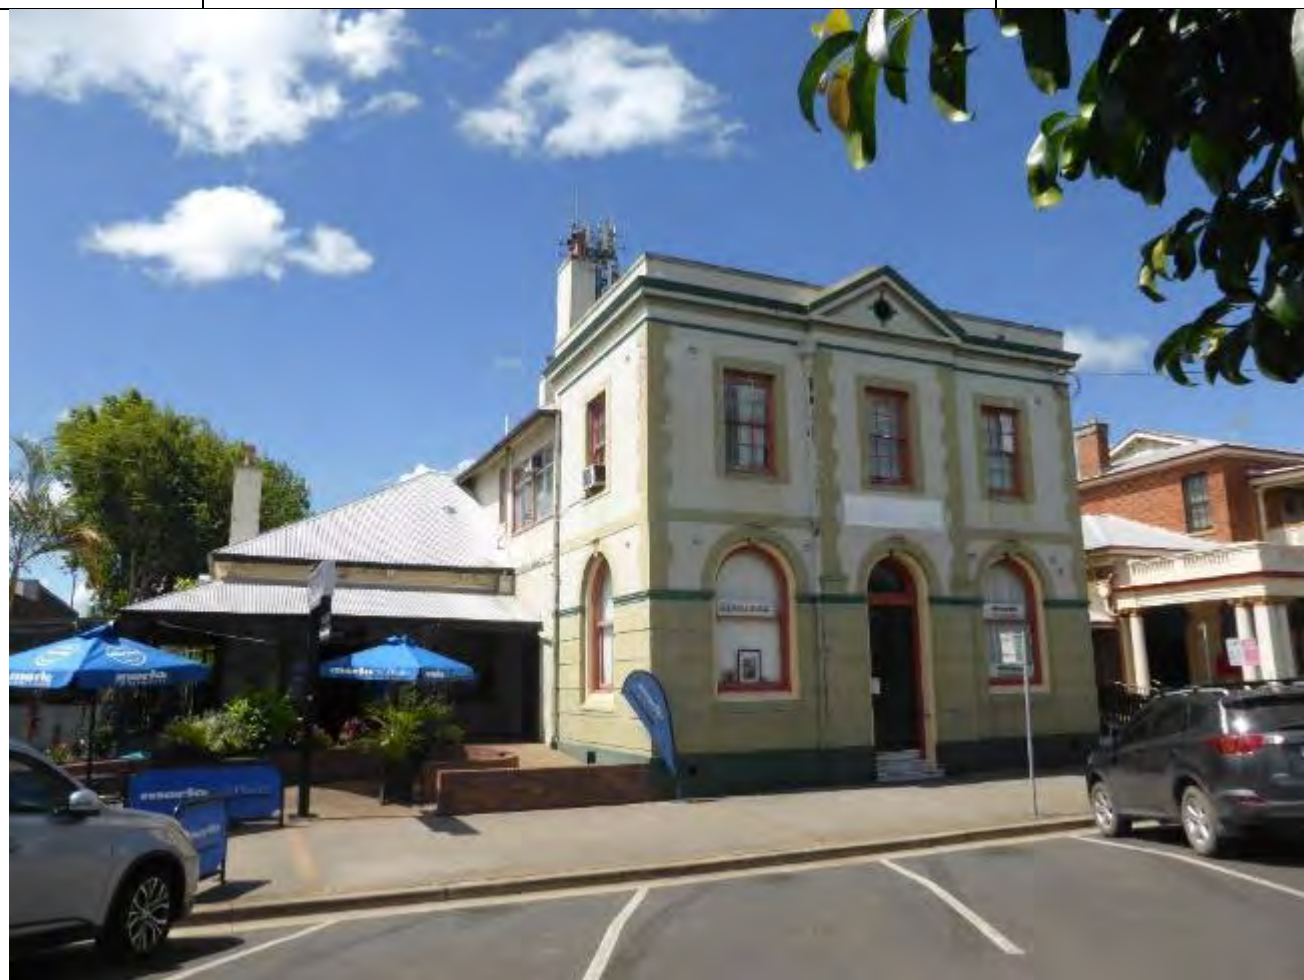
Building Elements	Observations	Recommendations
Roof	Hipped and gabled galvanised iron/steel.	Any roof replacement should be in Galvanised Steel Z600.
Gutter	<p>Low front quad, non-perforated. Rain water heads should be repaired or replaced to match original.</p>  	<p>Gutters are defective in places and downpipes are dislodged causing water to pour on foundations. Guttering should be checked over whole building. Replace as required to original details of ogee or low front quad profile. Replace downpipes ideally in round metal. Ensure all water is dispersing away from the base of the building. This work should be attended to without delay as wet foundations/sub floors are conducive to rot and termite attack.</p>
Walls	<p>Painted brickwork.</p>  	<p>Maintain an authentic heritage colour scheme for any future repainting and highlight architectural detailing.</p>

Repairs of broken glass and painting are urgently required to timber sash windows to protect the original timber joinery.

<p>Doors</p>	<p>Original doors include panelled timber doors with transom lights. Wire mesh has been screwed to rear face of French doors.</p>  	<p>Carefully conserve to original details. Removal of wire mesh is suggested.</p>
<p>Awning</p>	<p>The original verandah is retained to the street frontage with cast iron columns. An awning has been attached to the side and a shade sails have been added to front of courtyard area.</p>  	<p>Carefully conserve existing fabric. Consider use of removable umbrellas to replace shade sail.</p> <p>Utilise an authentic heritage colour scheme.</p>

Summary of Recommendations

- The top priority is to ensure the building is water tight and that stormwater is being dispersed away from the edge of the building.
- Replace rusted guttering with matching low front or ogee profile.

- Repair or replace downpipes and rainwater heads to match original details, and ensure all stormwater is discharged away from the edges of building to ensure no pooling on foundations. (urgent)

- Carefully conserve and retain all original external fabric.
- Timber window joinery is deteriorating and requires repairs and repainting to conserve original fabric.

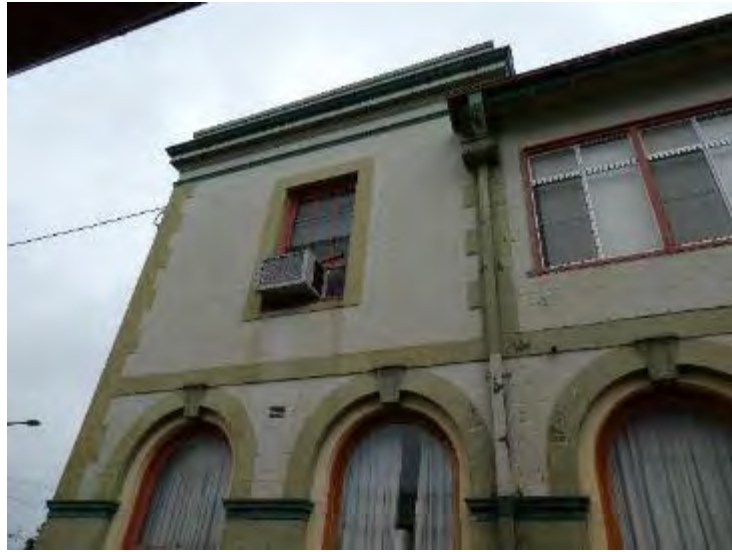
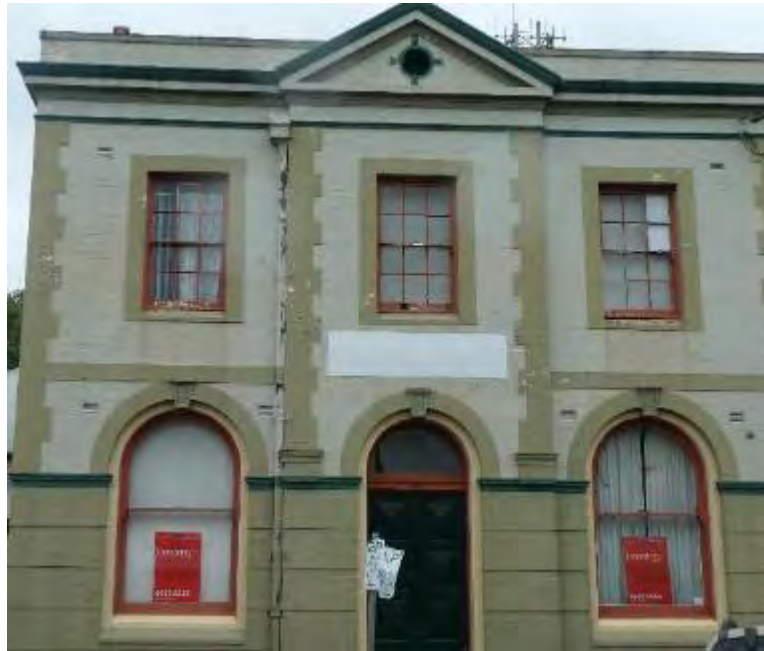
Windows

Original timber framed double hung and arched windows.

Carefully conserve all original doors and windows to original details. Remove air conditioning units from window openings.

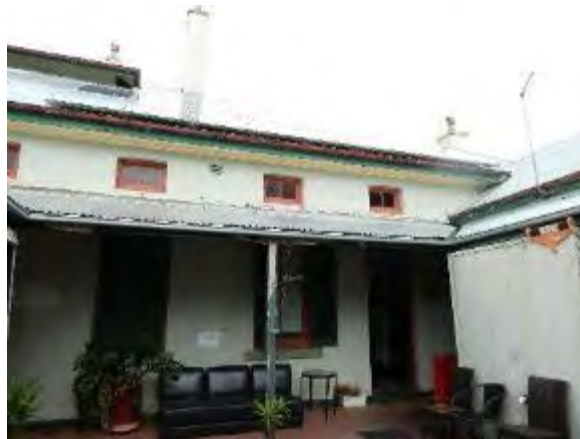
High level transom windows at rear.

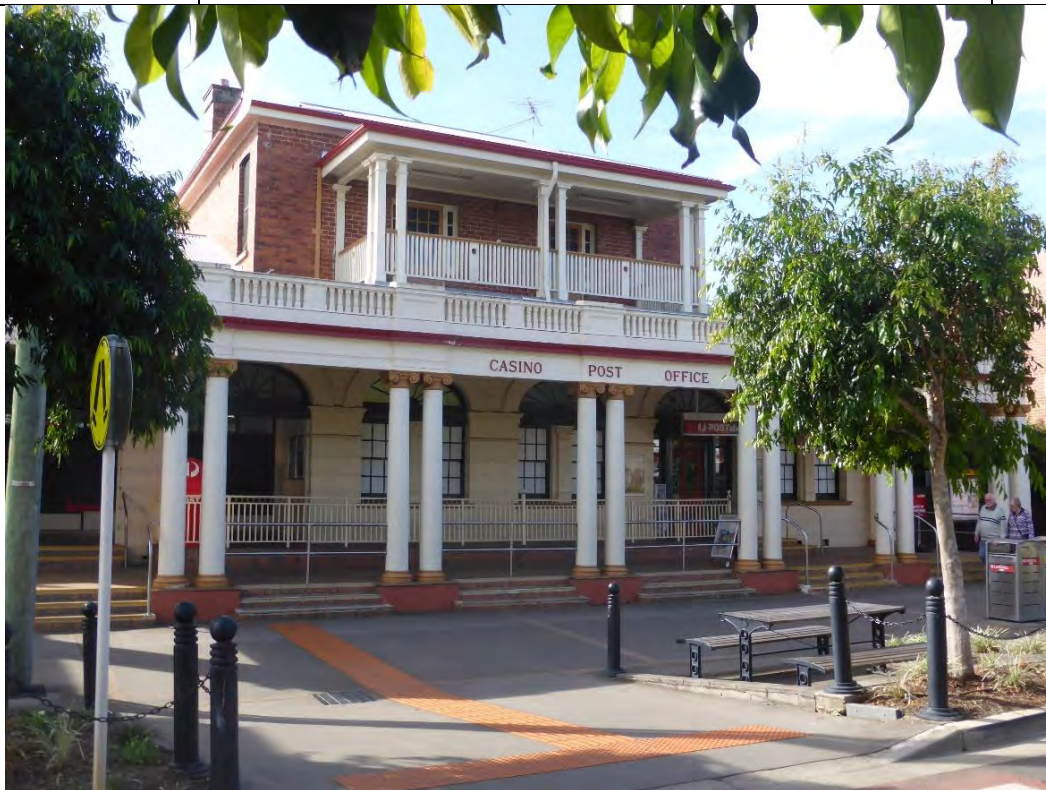
Building Elements	Observations	Recommendations
Roof	Hipped and gabled Galvanised iron/steel.	Maintain to original details
Gutter	Non-perforated, ogee profile is appropriate.	Maintain to original details.
Walls	Ground-floor front facade is rendered as ashlar blockwork, eastern wall is painted brick, Upper floor face sandstock brickwork.	Maintain to original details. Retain an authentic heritage colour scheme in any future repainting of painted surfaces and highlight architectural detailing.
Windows	Original timber framed double hung multi-paned windows with elliptical fanlights to ground floor front façade Windows to the east and west facades appear largely original to the ground and upper floors, being predominantly six pane upper and lower timber sash windows with mainly clear glazing.	Carefully conserve all original fenestration.
Doors	The ground-floor retail entry door is a later addition, as are some later doors and windows to the later rear ground-floor additions and alterations. French doors and windows to upper floor.	Carefully conserve all original fabric.

Interior	As fully described in inventory. The ground floor has been modified by Post Office fit outs. The upper floor retains many original features of skirtings, picture rails, architraves, wall vents and face-brick fireplaces.	Carefully conserve all existing fabric.
Access Ramp	An approval was issued in 2019 for replacement of the existing access ramps and railings with one which addresses current BCA requirements. This has not yet been installed.	
<p>Summary of Recommendations</p> <ul style="list-style-type: none"> This is a well maintained, substantially intact Commonwealth building of high heritage significance. The preparation of a Conservation Management Plan and Maintenance Plan is strongly recommended to guide the future conservation of this building.

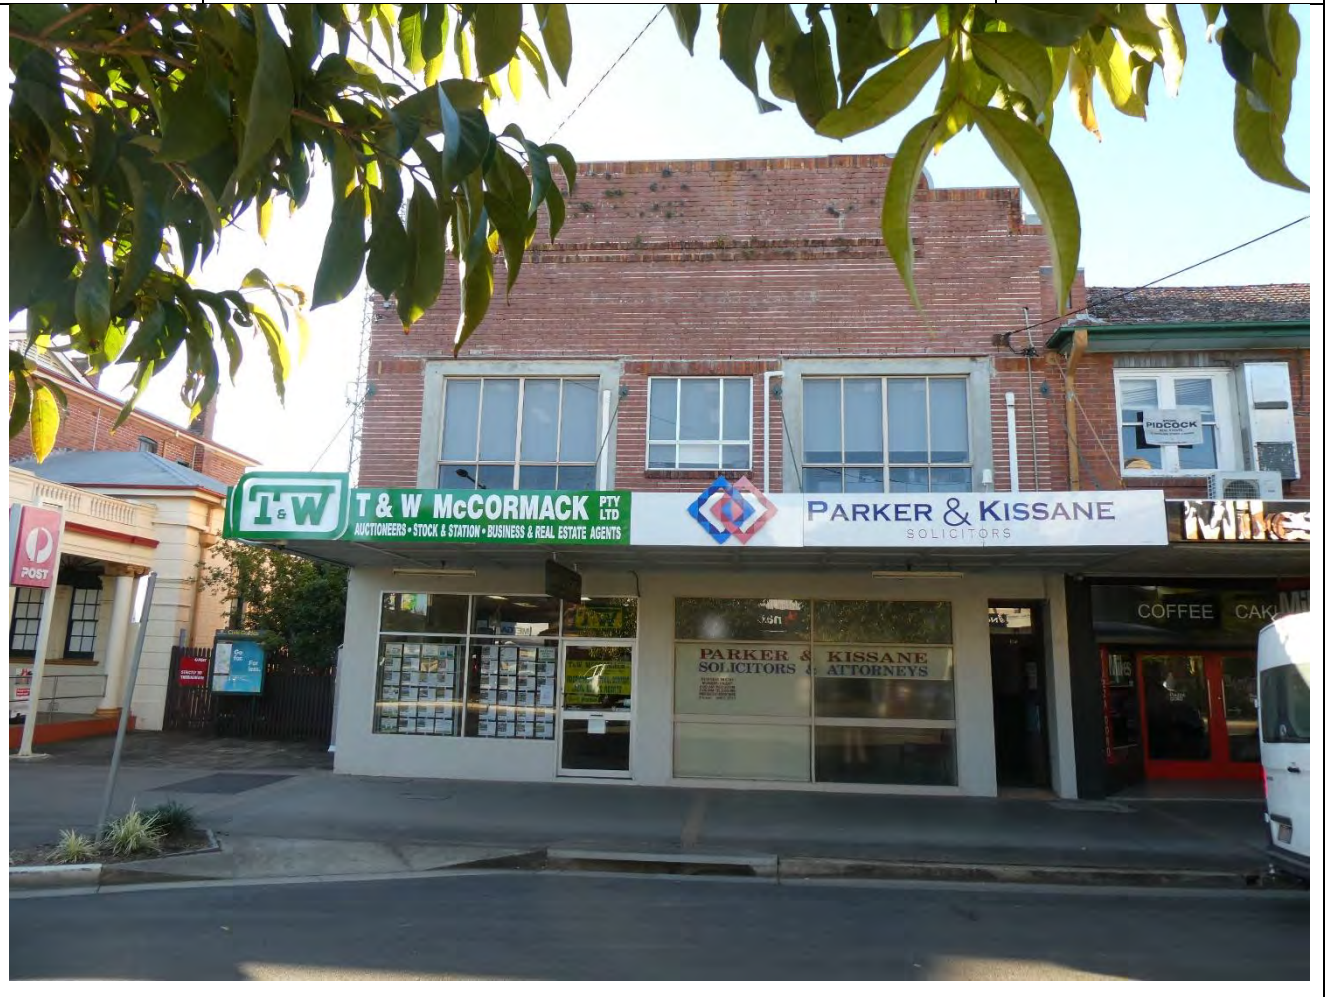
Building Elements	Observations	Recommendations
Roof	Gabled and hipped roof behind parapet.	Keep watertight. Replace as required to original details.
Gutter	Not visible	Ensure guttering is well maintained.
Walls	<p>Face brickwork to upper façade with horizontal brick courses and soldier courses in multi coloured contrast brick. The ground floor has been modified with rendered walls. Evidence of former signage placement on façade which has been removed.</p>

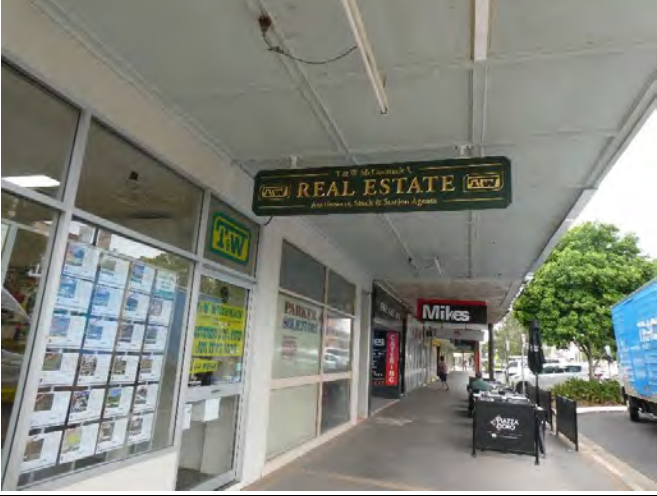
Shopfronts and Awning	<p>Modern aluminium shopfronts. Awning lining is fibre cement with expressed batten trim.</p>

Maintain
Fascia	New fascia signs attached to original fascia.	Install any future signage to fit within the border of the original fascia.

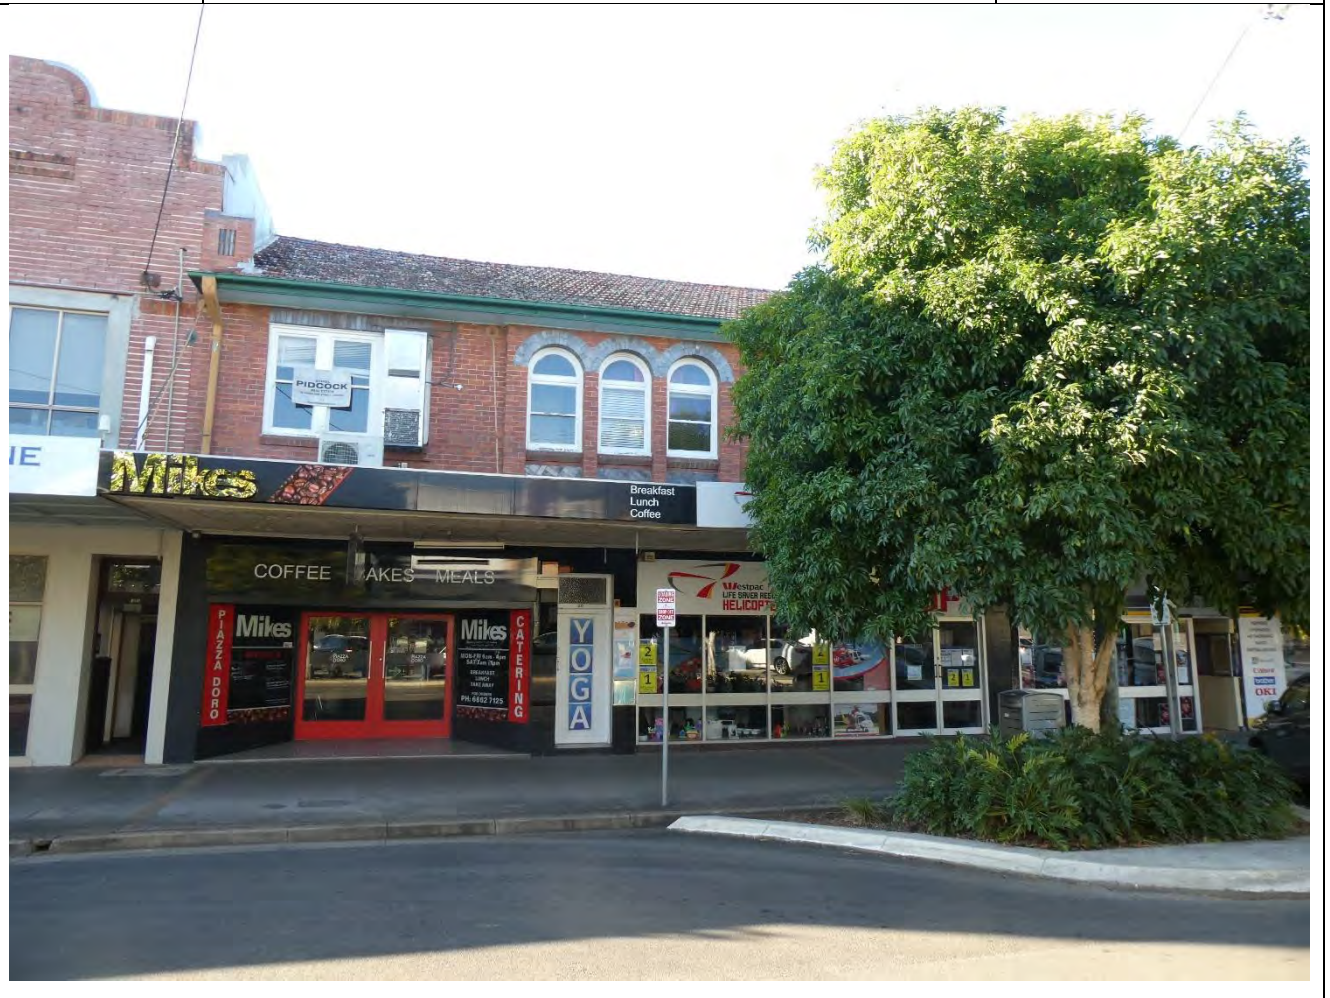
Building Elements	Observations	Recommendations
Roof	Terracotta tiled roof visible to street.	Maintain to original details.
Gutter	Low front quad profile, non-perforated.	Ensure guttering is well maintained and replace with same profile when required.
Walls	<p>Red brick with heads over the windows built in contrasting grey brick. Panels under the centre window are also laid in contrasting brick in zig zag pattern.</p>

Retain all face brickwork unpainted. Maintain the detailing to the upper façade to the original design.
Windows	<p>The façade is divided into three bays, the central bay with three semi-circular headed timber framed windows (above) and two sets of 3 double hung timber sashes to each side. The set to the western end is marred by external air conditioning apparatus.</p>

<p>Consider relocation of the air conditioning and ducting units from front windows.</p>
<p>Shopfronts</p>	<p>The café retains original recessed entry and splayed shopfront although it has been modified by new shopfront cladding. Some early tiling remains at the base of the side panels. A central door with transom light provides access to the upper floor. The Op Shop has a non original straight aluminium shopfront, with loss of original shopfront.</p>

Fascia	The fascia signs are mounted flush over the original fascia on the suspended awning.	Consider reducing the depth of the signage to the original size of the fascia panel in keeping with the original proportions and design for the building.
<p>Summary of Recommendations</p> <ul style="list-style-type: none"> • Check regularly to ensure the building is water tight and that stormwater is being dispersed away from the edge of the building. • Retain all face brickwork with decorative contrasts unpainted. • Urgent attention is needed to check drainage , repair and repaint the significant pressed metal lining to the awning. • Carefully conserve and retain all timber framed window to original details. • Consider relocation of the air conditioning units and ducts from front windows on façade. • Consider reducing the depth of the signage on the fascia so that it fits within the original fascia. • Consider reinstating original shopfront details in any future restoration. • A heritage grant can be sought for maintenance and conservation works.

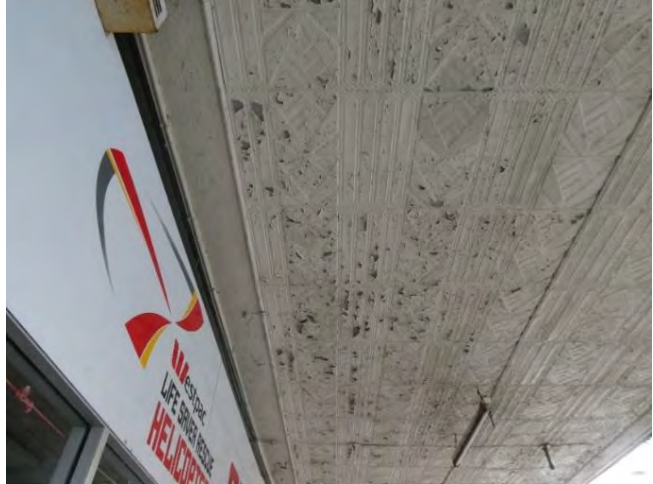
<p>Consider reinstating original shopfront details in any future restoration.</p> <p>Utilise colour schemes in keeping with the inter war era of building to complement red brick façade.</p>
<p>Awning</p>	<p>This is a original pressed metal awning in need of repainting.</p>

<p>Check drainage and ensure watertight. Maintenance is required to conserve this important original element of the building which contributes strongly to the streetscape.</p>

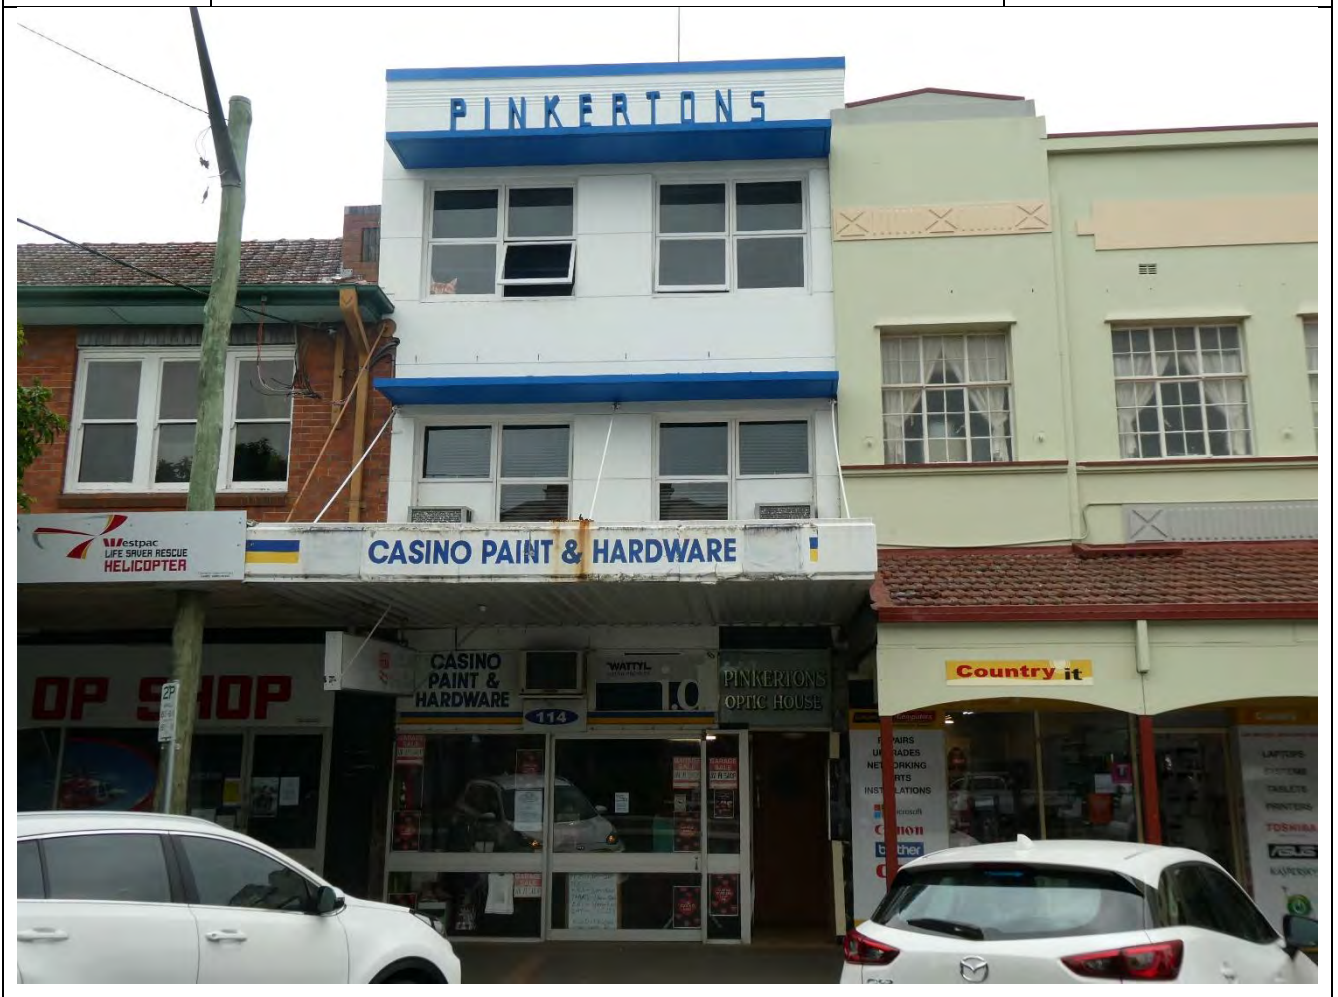
Building Elements	Observations	Recommendations
Roof	Not visible to street.	Maintain to original details.
Gutter	Not visible to street	Ensure guttering is well maintained.
Walls	<p>Rendered and painted masonry with a straight edged parapet, a fluted band under the parapet and scored horizontal courses.</p>  	Utilise a colour scheme appropriate to the era based on earlier evidence. Maintain the detailing to upper façade to original design.
Windows	Symmetrically placed double windows to two upper floors. Timber framed hopper windows. Air conditioning unit on two lower windows which are largely screened by the shop awning.	Maintain timber framed windows.
Shopfronts	<p>Aluminium shopfront appears to extend under the entry of original recessed doorway to access the upper floor.</p>  	Consider reinstating the original shopfront details in any future restoration and relocating the air conditioning unit off the front façade.

Summary of Recommendations

- Conserve and retain timber framed windows.
- Consider reinstating the Op Shop shopfront to original details in any future restoration.
- Relocate air conditioning unit from front of shop.

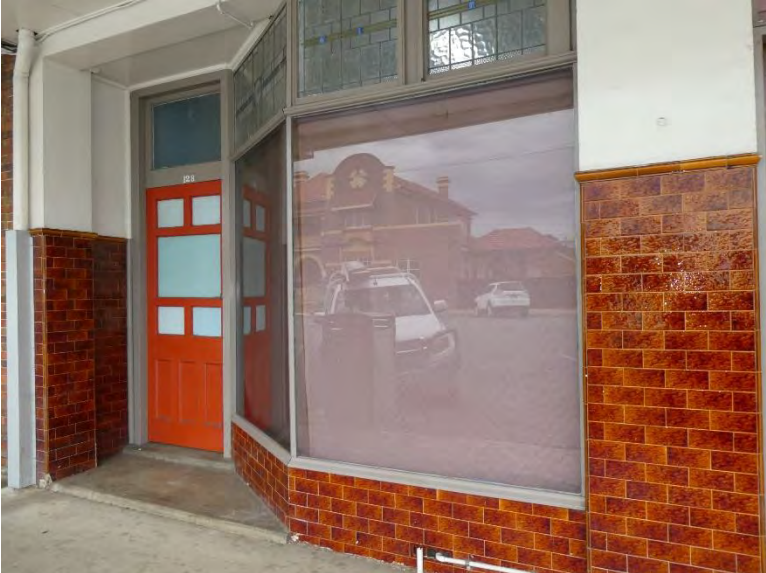
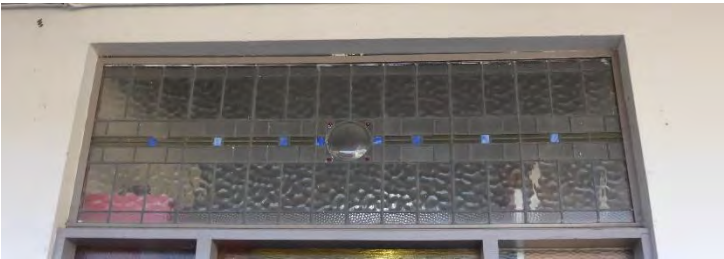
Building Elements	Observations	Recommendations
Roof	Roof not visible to street. Hipped and gabled behind metal clad parapet.	Maintain
Gutter	Not visible	Ensure guttering and stormwater dispersal is well maintained.
Walls	Single storey brick building with rendered masonry and tiles to shopfronts. Upper facade is hidden by metal kliplock parapet.	Consider removal of metal cladding from parapet and restore upper façade to original details. Investigate historical evidence for reconstruction.
Shopfronts	<p>Two separate shopfronts sit either side of a central doorway. Original copper brown subway tiling to stall riser and walls. Original shopfront framing to 128 and 132. Central entry has been modified with later entry door. Leadlight windows to transoms above shop at 128 and over central door but removed from 132.</p>

<p>Carefully conserve all original fabric.</p> <p>Use a colour scheme in keeping with the inter war era of building to complement the copper brown tiling.</p>

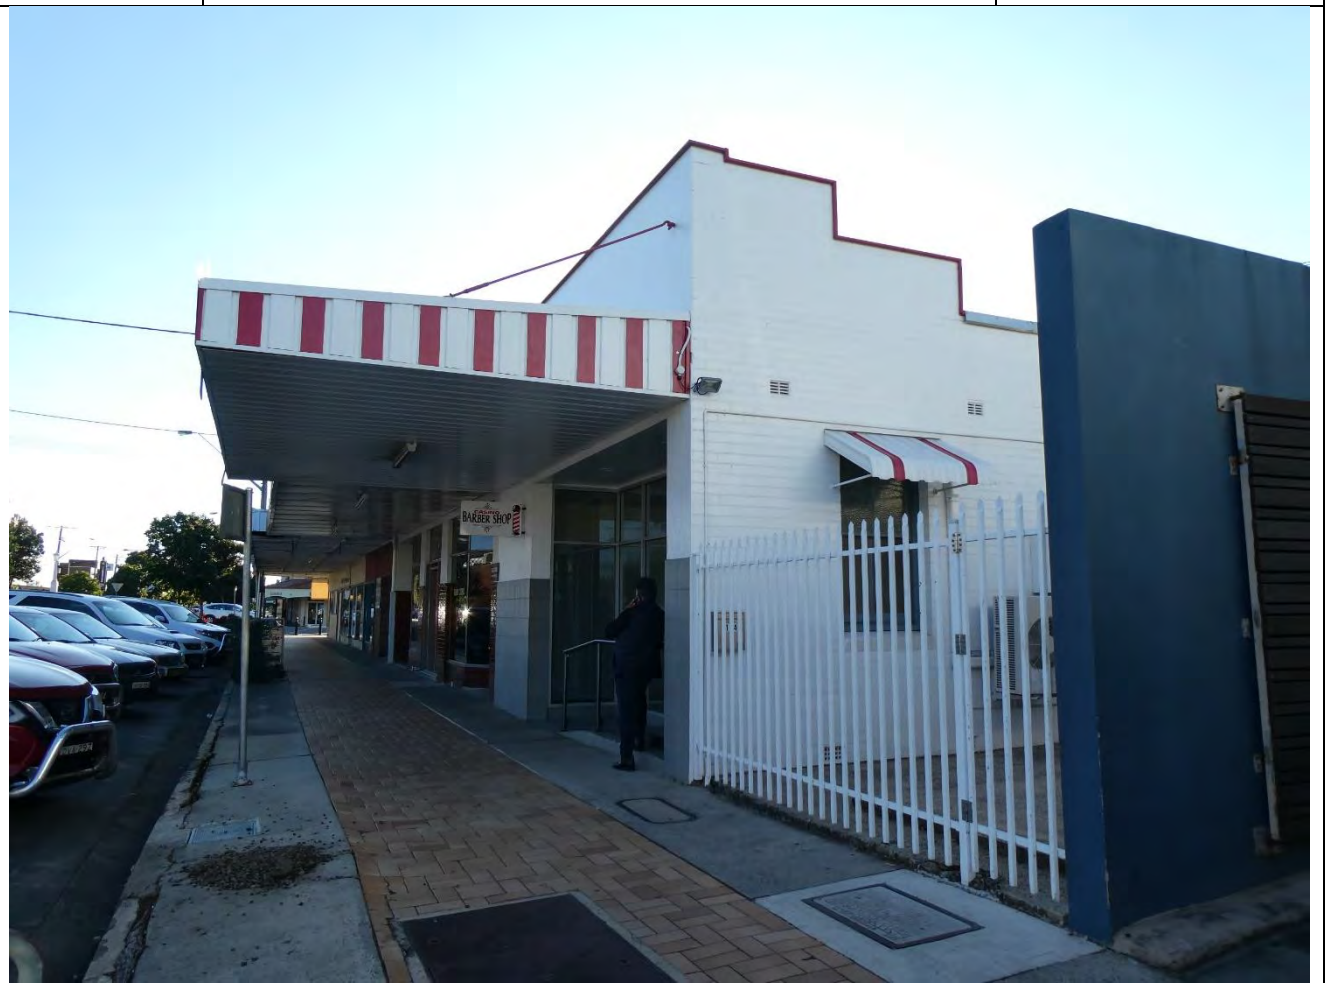
Building Elements	Observations	Recommendations
Roof	Roof not visible to street. Hipped and gabled roof behind parapet	Maintain
Gutter	Not visible	Maintain
Walls	Single storey painted brick building with straight edged parapet and stepped profile to side elevation.	Maintain a sympathetic colour scheme within the Heritage Conservation Area and setting of heritage buildings in the vicinity.
Shopfronts	<p>Aluminium commercial shopfront circa 1960-70s with modern tiled surrounds and rendered masonry and access ramp.</p>

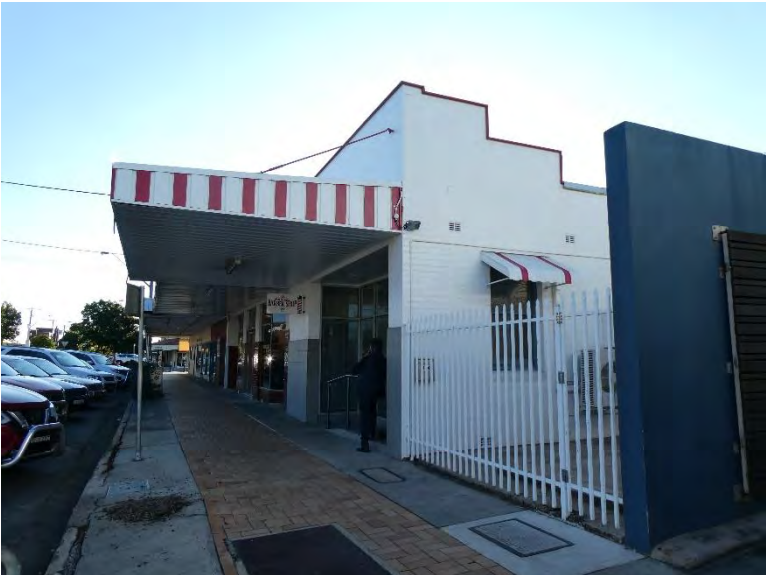
Maintain
Awning	<p>Suspended awning with metal lining. The metal ribbed clad fascia may cover possible earlier detail.</p>

Investigate original fascia. Ensure any signage sits within the original size of the fascia panel in keeping with the original proportions and design for the building.

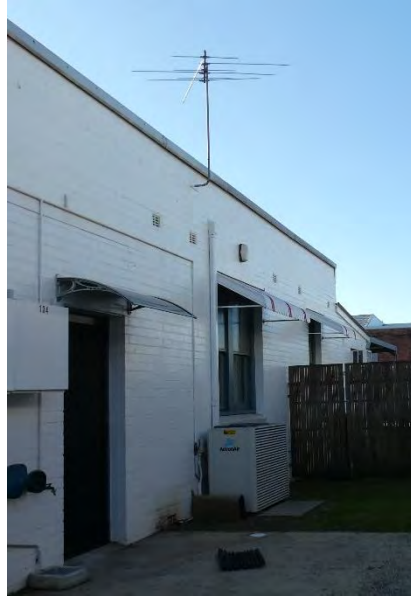
Windows

Double hung timber sash windows to side elevation with obscure glazing.

Conserve to original details.

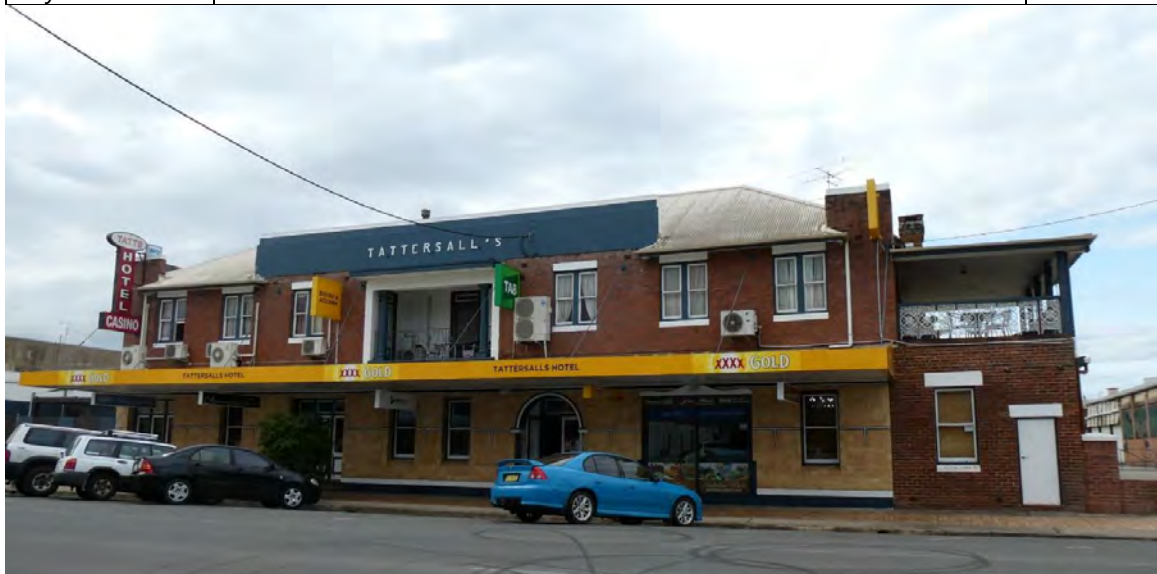
Building Elements	Observations	Recommendations
Roof	<p>Hipped and gabled galvanised roof with prominent chimney.</p>

<p>Maintain as non-perforated low front quad or ogee profile. Ensure all drainage is dispersing away from building and base of walls are kept dry.</p>
Walls	<p>Tiling to front elevation is in excellent condition. Face brick in good condition including interior wall.</p>

<p>Carefully maintain original tile work. Original brickwork to remain unpainted. Any mortar repairs to early brickwork should be in a traditional lime mortar.</p>

Recommendations

- This is a significant historic hotel which should be carefully conserved. Continue to maintain all original fabric and details.
- Any future re-roofing should be Galvanised Steel Z600
- Maintain gutters as non-perforated low front quad profile.
- Ensure all drainage is dispersing away from building and base of walls are kept dry.
- Carefully maintain all original brickwork unpainted. Any mortar repairs should be in a traditional lime mortar.
- Carefully maintain all original joinery.
- Ensure any future signage remains within the fascia and is sympathetic to the heritage values of the hotel.
- Heritage grants are available to assist with conservation work through the annual heritage fund.

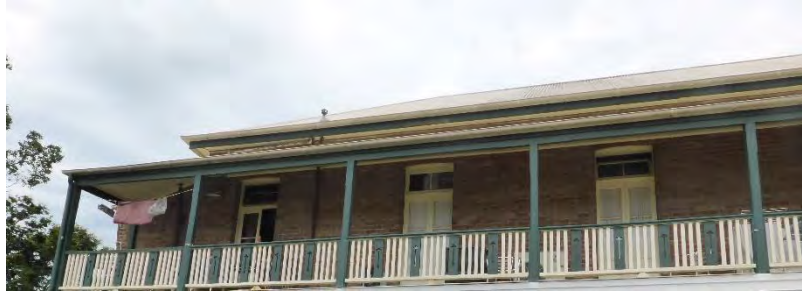
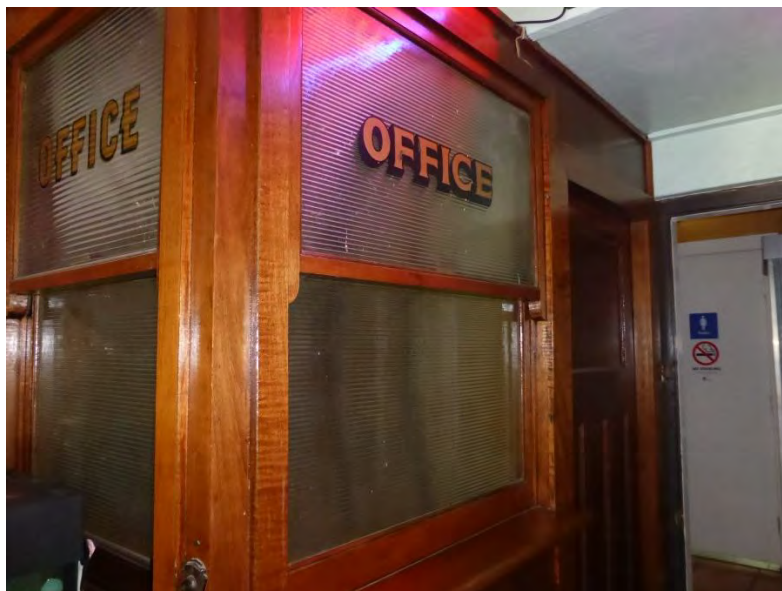
High degree of original fabric. Timber double hung sash windows, 4 panel doors, French doors with fan lights, pairs of double hung sash windows to first floor. Varnished entry doors with etched glass. High waisted door to office area.

Carefully maintain all original joinery, finishes and hand painted signage on glass.
