CASINO CBD HERITAGE CONSERVATION AREA MAIN STREET AUDIT

Prepared by
CLARENCE HERITAGE
FOR RICHMOND VALLEY COUNCIL
AUGUST 2020

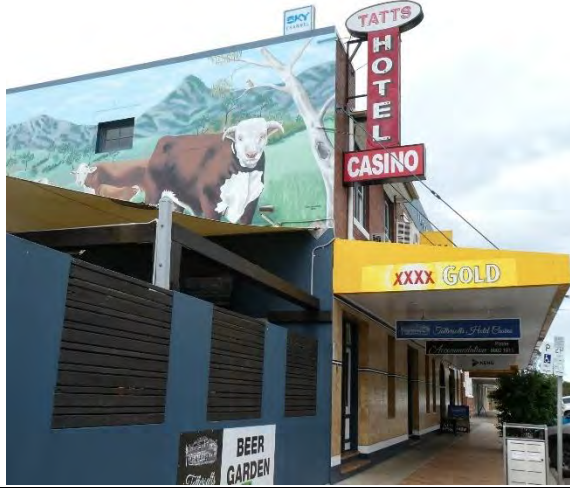
Suspended awning with a narrow fascia. Signage and corporate colour is restricted to this fascia and some projecting signs. An illuminated projecting sign marks the western end of the building with a mural. The hanging signs under the awning do not detract from the main elevation.

Ensure any future signage is contained within the fascia and is sympathetic to the heritage values of the hotel.

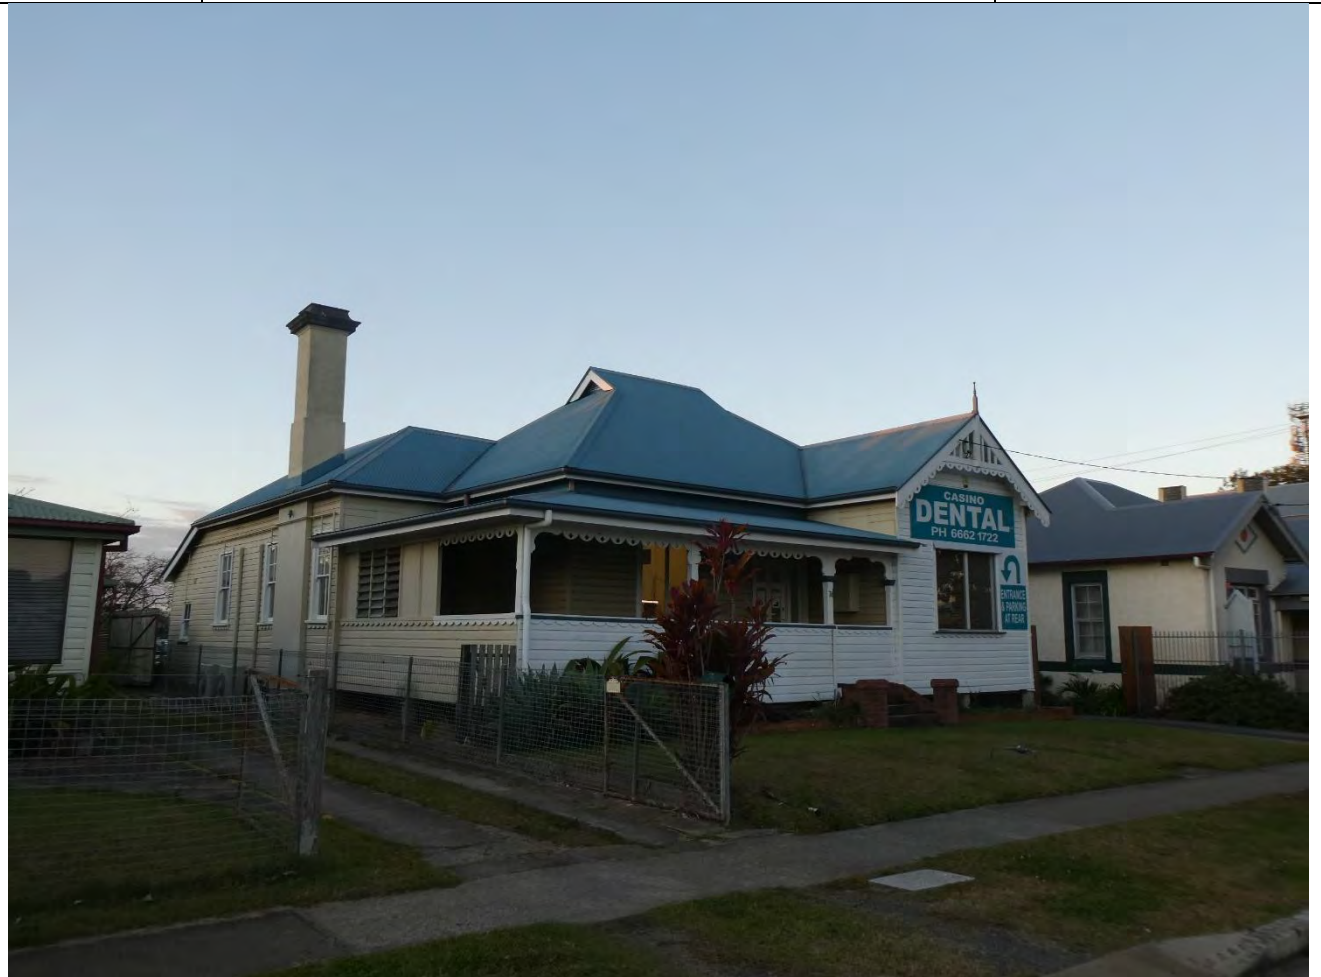
Building Elements	Observations	Recommendations
Roof	Hipped and gabled colorbond roof. Any future replacement ideally should be Galvanised Steel Z600. Barge rolls detail to barge boards on gable ends. Decorative valance trim.	Maintain.
Gutter	Perforated low front quad profile.

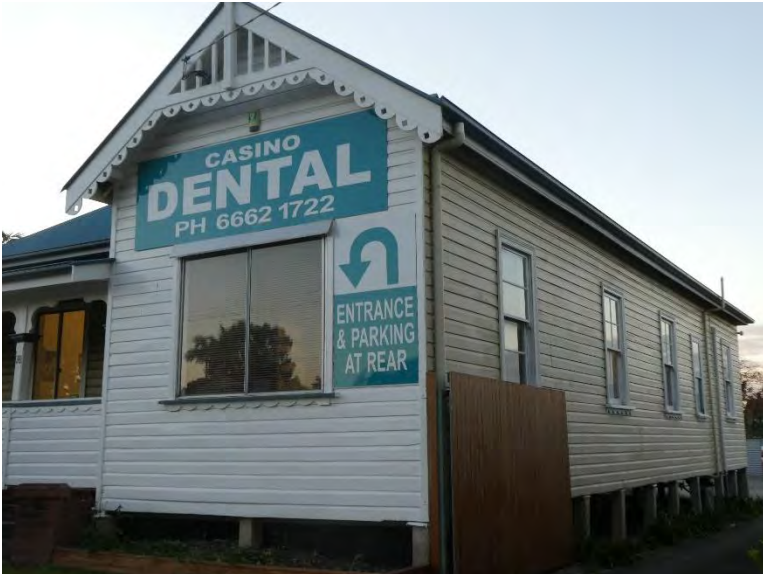
Maintain. Ensure that stormwater is dispersed away from the edge of the building.
Walls	Timber weatherboards. Well maintained.	Maintain use of a heritage colour scheme.
Windows and Doors	Timber framed double hung windows to sides. Original window on front gable and verandah have been altered and widened with an aluminium windows.

Carefully conserve all original timber doors and windows. Consider reinstating aluminium windows back to original details based on early photos or similar examples.
Verandah	Skillion verandah wraps around corner of house with scalloped details and louvres to rear section. Front entry brick steps.	Retain all original features. A period style timber fence would enhance this property.

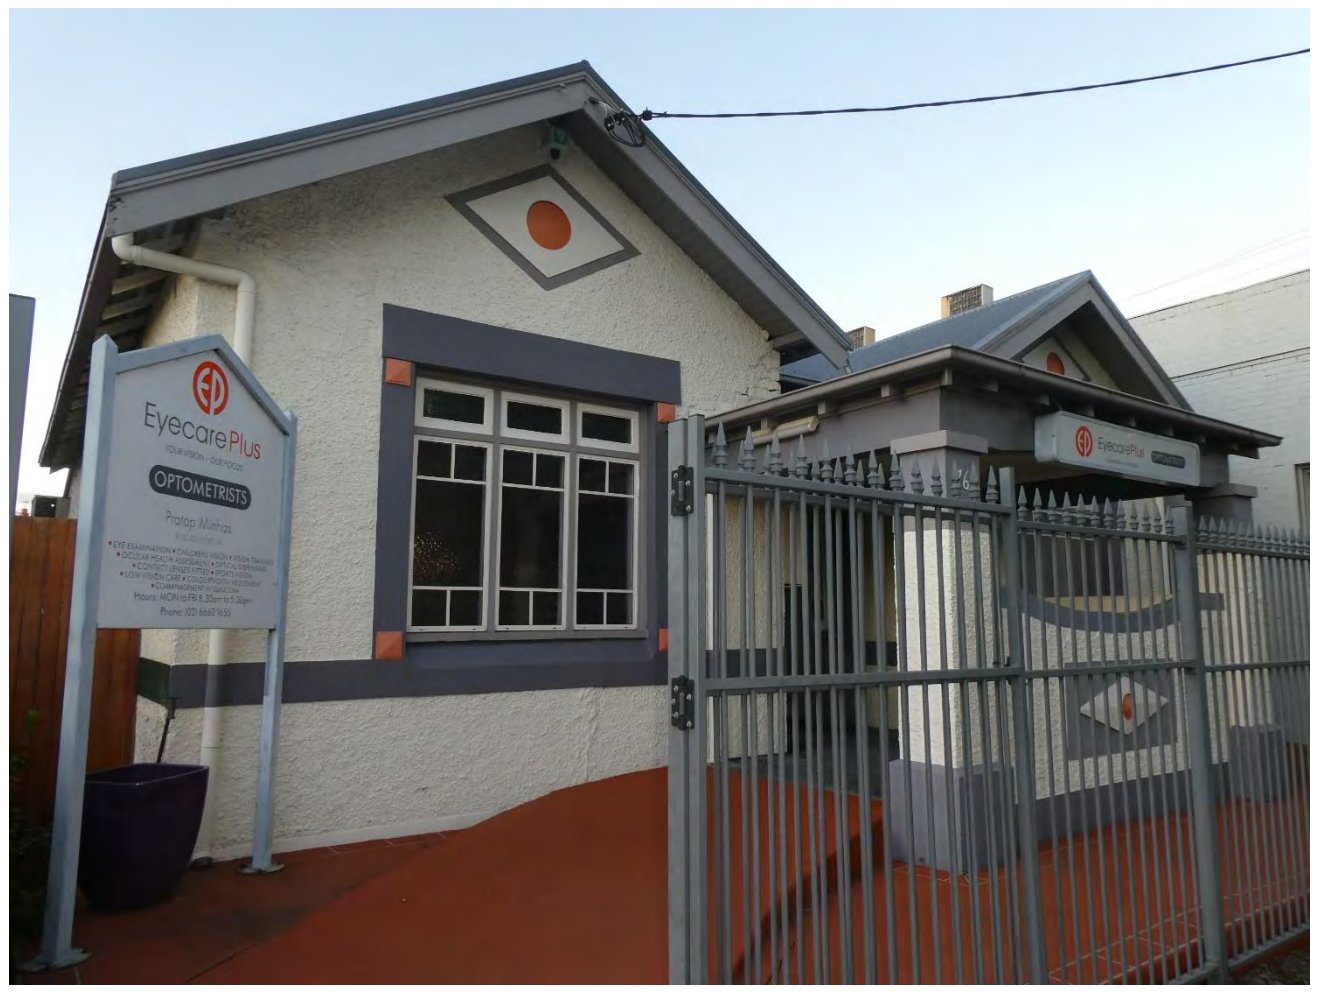
Building Elements	Observations	Recommendations
Roof	<p>Interesting double gable roof to streetscape. Any future replacement ideally should be Galvanised Steel Z600. Barge rolls replaced with barge flush capping.</p>	<p>Maintain. Reinstate barge rolls detail to barge ends.</p>
Gutter	<p>Non-perforated low front quad profile. Exposed rafter tails under eaves.</p>

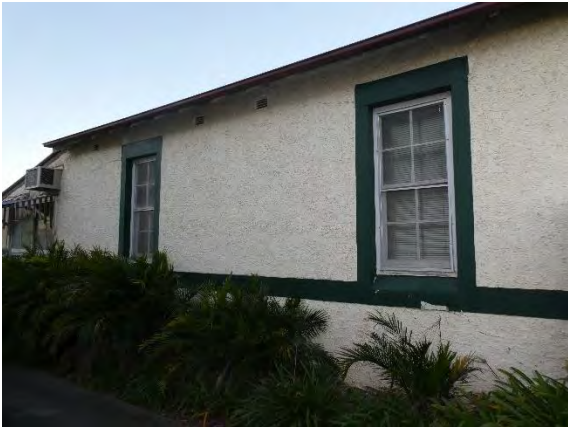
<p>Maintain original profiles and exposed rafter features. Ensure that stormwater is dispersed away from the edge of the building.</p>
Walls	<p>Rough cast rendered walls with contrasting bands of smooth render and architraves around windows.</p>

<p>Maintain an authentic heritage colour scheme of the era.</p>
Windows and Doors	<p>Timber framed double hung windows to sides. Casement aluminium windows to front elevation.</p>	<p>Carefully conserve all original timber doors and windows.</p>
Porch and fencing	<p>Hipped roof over scalloped wall and piers to entry.</p>

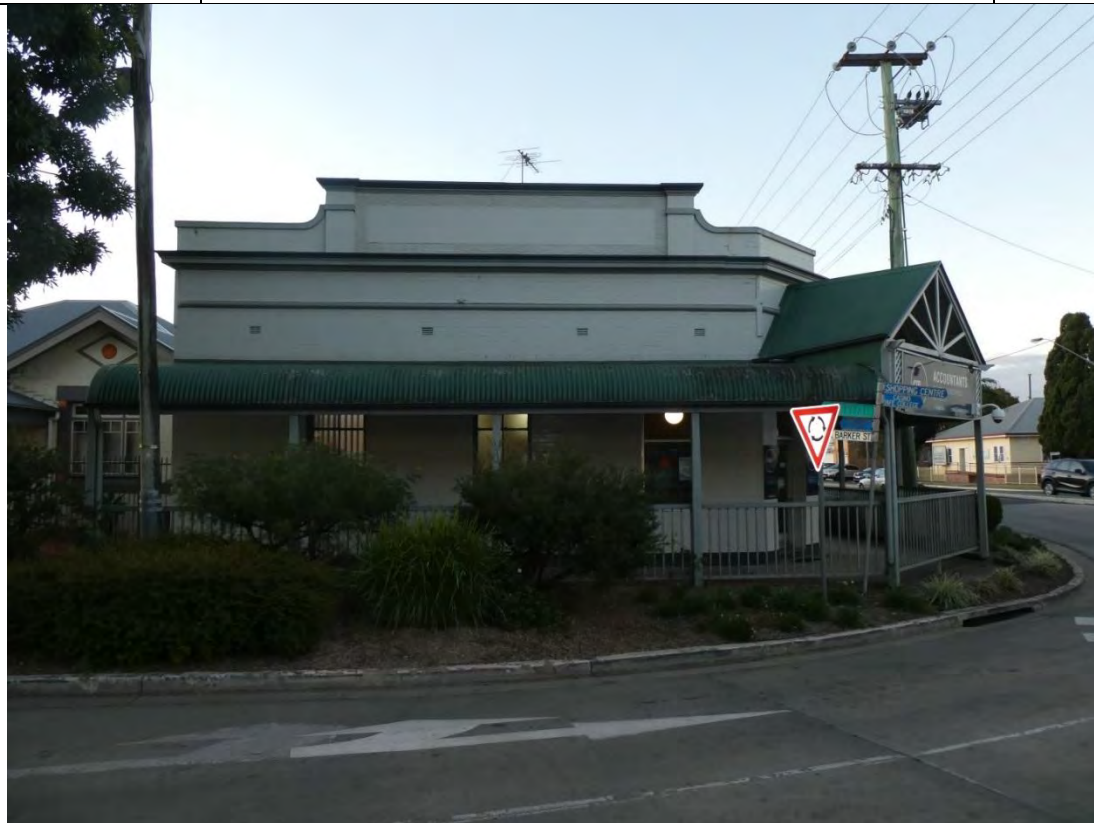
Building Elements	Observations	Recommendations
Roof	Gabled uncoloured steel roof behind parapet.	Maintain
Gutter	Not visible.	Maintain and ensure that stormwater is dispersed away from the edge of the building.
Walls	<p>This single storey building has a high parapet with brick corbel and rough cast rendered details to two panels. The brickwork is now painted a light grey and was white in the 1990s, but originally unpainted as evidenced in a 1930s photo.</p>

Doors	<p>New aluminium framed entry doors with full glazing. Replaced timber panelled doors evidenced in historic photos.</p>

Carefully conserve all original doors and windows to original details. Consider reinstatement of timber windows to match where previously replaced in aluminium.

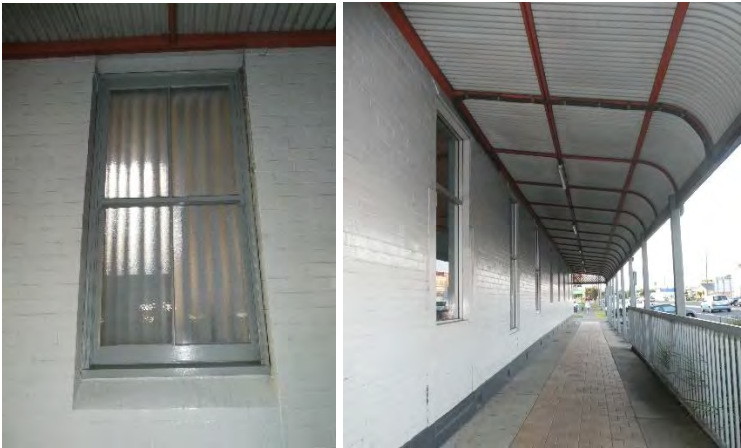
Future repainting is encouraged to utilise an authentic heritage colour scheme of the era.
Windows	<p>Timber framed double hung windows on southern elevation. Aluminium windows to eastern elevation.</p>

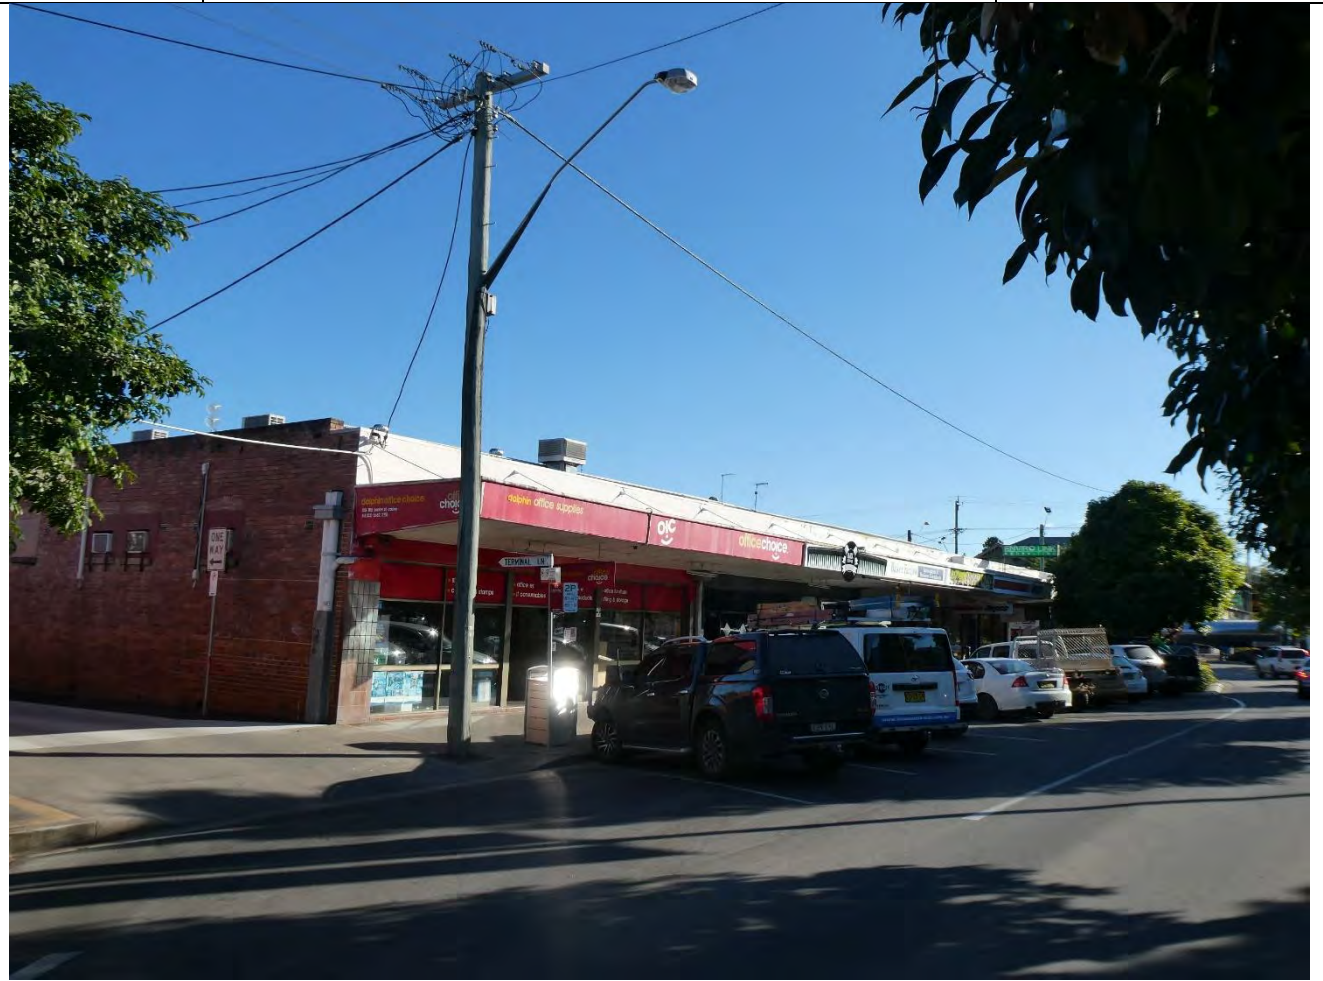
Building Elements	Observations	Recommendations
Roof	Hipped metal roof behind parapet.	Maintain
Gutter	<p>Low front quad to rear. Rear downpipe is missing, water damage evident to brickwork. Ensure any repointing is in lime mortar.</p>

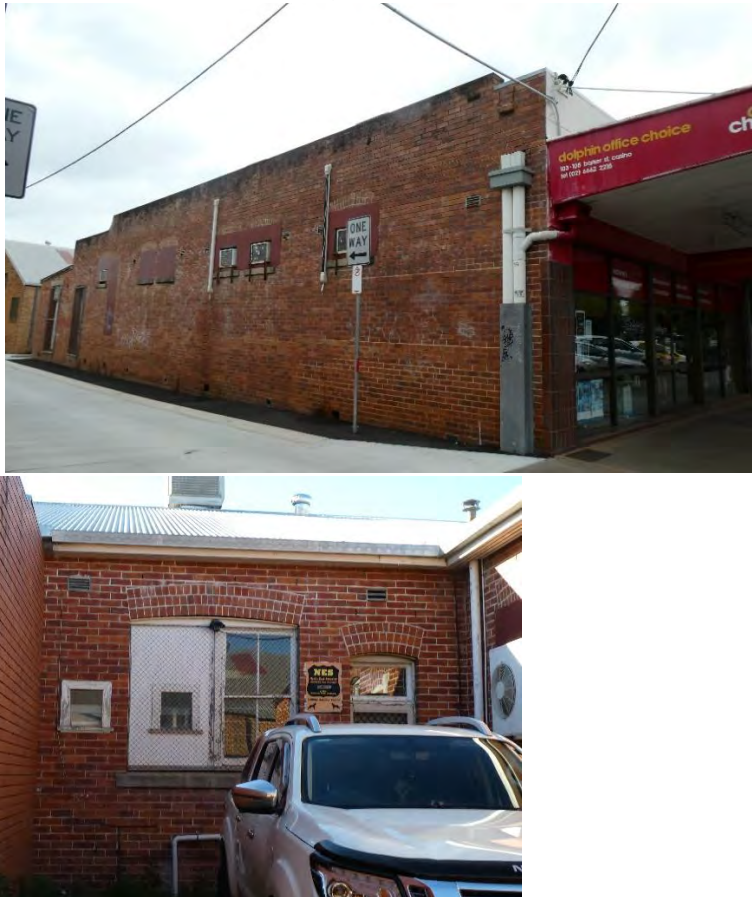
<p>Check all gutters and downpipes. Reinstall downpipe to original details. Ensure all water is dispersing away from the base of the building.</p>
Walls	<p>Face brick with straight edged parapet which steps down to rear. Whilst the facades are modern, the eastern and southern walls are historic and worthy of careful conservation</p>

<p>Carefully maintain historic brickwork. Do not paint over historic brickwork and details.</p>

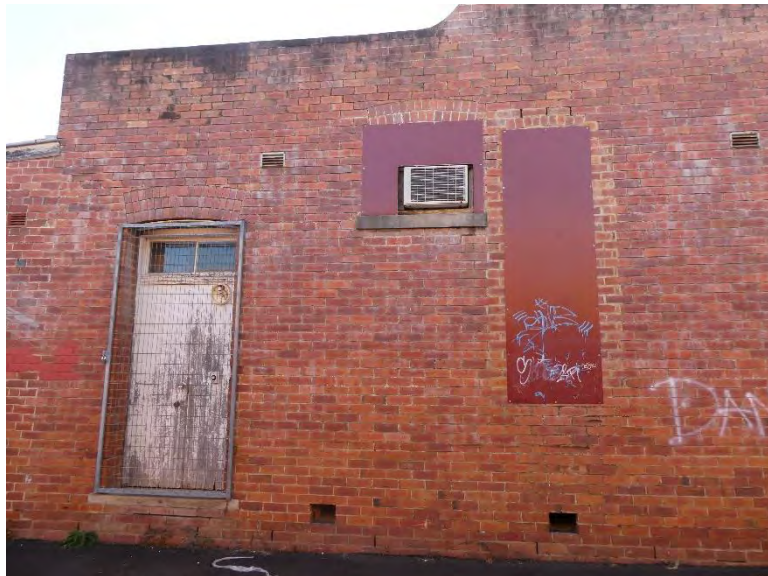
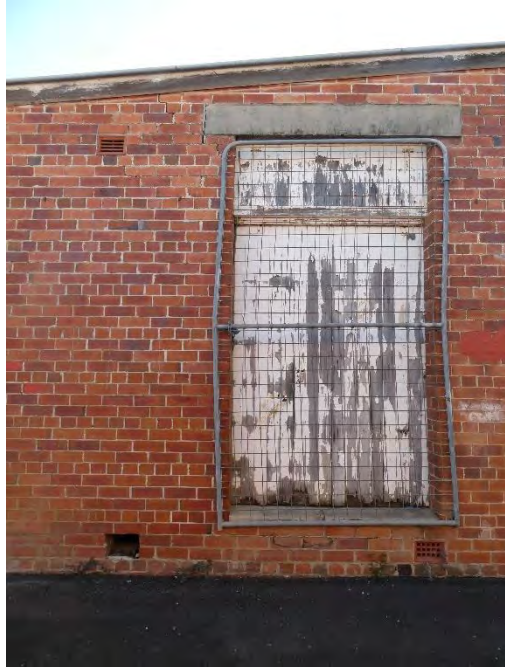
Aluminium shopfront and doors to Barker Street. Original timber vertical jointed doors on eastern wall should be conserved.

Maintain and conserve all original timber joinery.

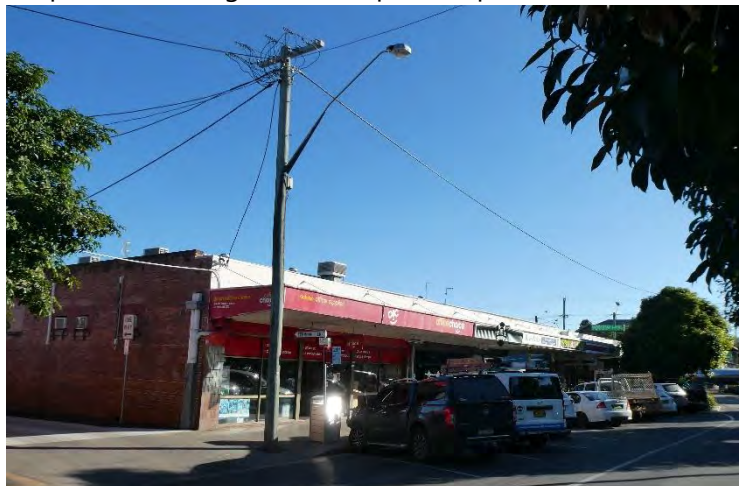
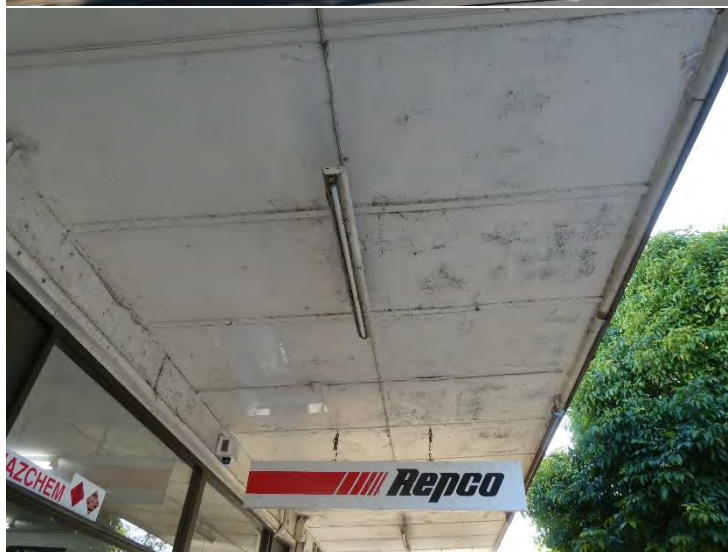
Suspended awning with a deep fascia panel.

Sections in need of painting. A suite of coordinated signage and colours would enhance the building and its relationship within the Heritage Conservation Area.

- Ensure the building is water tight and that stormwater is dispersed away from the edge of the building. Check all guttering and downpipes and reinstate to original details.
- Any repairs to mortar on historic brickwork should be in a traditional lime mortar.
- Carefully conserve historic brickwork on eastern wall of laneway and consider the relocation of air conditioning units from this wall.
- Reinstate cast iron ventilation grilles to laneway wall.
- Ensure any advertising signage is restrained, sits within the fascia and does not detract from the heritage values of the Heritage Conservation Area.
- Signage should not be erected above awning level
- A suite of co-ordinated signage and colours would enhance the building and its relationship within the Heritage Conservation Area.

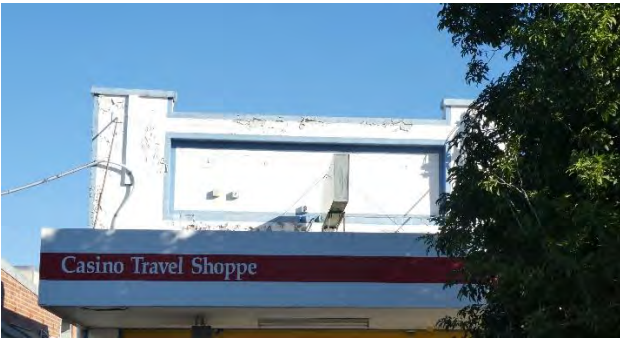
Building Elements	Observations	Recommendations
Roof	Not visible, behind parapet.	Maintain
Gutter	Not visible.	Maintain. Ensure all water is dispersing away from the base of the building.
Walls	<p>Painted brickwork to façade and face brickwork to side walls. Flat topped pier at each side with a recessed panel in the centre. Façade in need of repainting.</p>

Utilise an authentic heritage colour scheme for any future repainting in keeping with the period of the building. Retain brickwork unpainted to side walls.
Windows and Door	<p>Non original aluminium shopfront.</p>

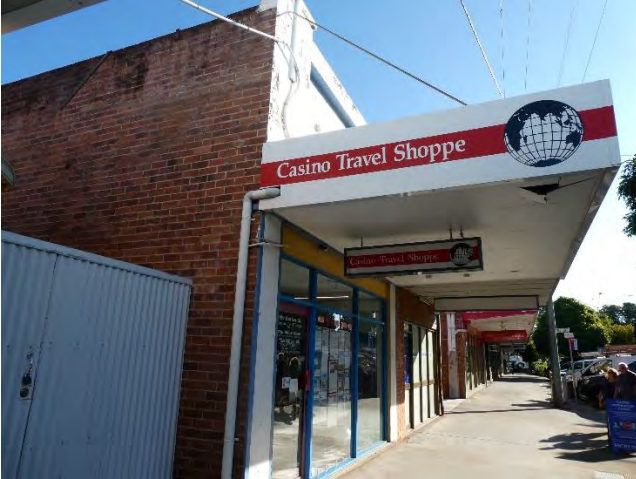
Consider repainting of shopfront framing in a colour to complement future façade repainting.
Awning	<p>Suspended awning with a deep fascia panel.</p>

Repair damage under awning. Reduction of the depth of the signage on the fascia panel would enhance the building. Remove above awning signage.

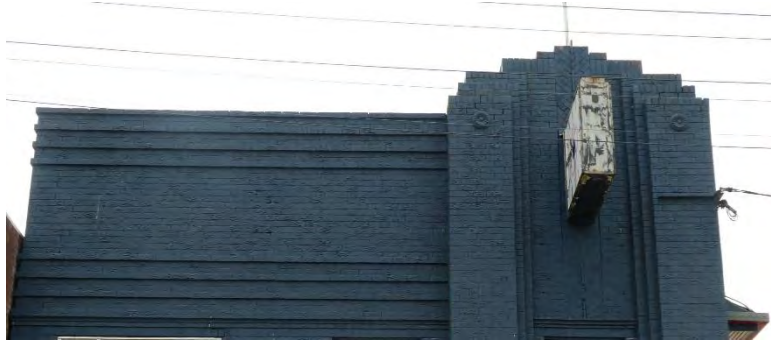
Building Elements	Observations	Recommendations
Roof	Terracotta hipped roof.	Maintain to original details.
Gutter	Non original square perforated profile at rear.	Any future gutter replacement should be non perforated, low front quad
Walls	<p>Two storey red brick (possibly Coombell brick) building with monumental entrance surrounded by rendered cement (synthetic) stone). Vertical piers or fins extend from the footpath on either side of the entrance to the top of the building where they form a stepped silhouette to the skyline. A strong influence on this building has been the US "skyscraper style". Four horizontal tied brick courses decorate the slightly recessed façade. Decorative brickwork is also a feature of the vertical fin or pier. Overall the standard of brickwork on this building shows the skill of the bricklayer.</p> <p>Modification- The brickwork on the front façade was painted in August 2005 (prior to HCA) but remains unpainted at the rear.</p>

Retain unpainted brick to rear. Any future colour scheme for façade should be sympathetic to the era of the building.

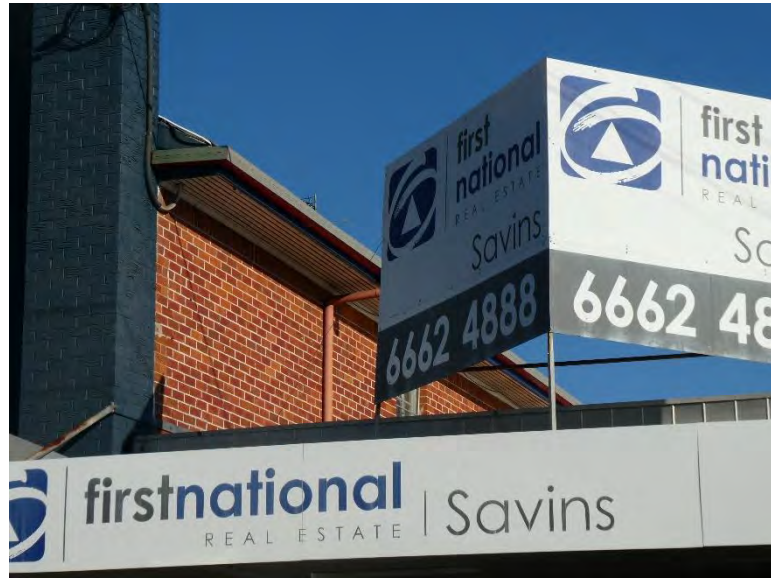
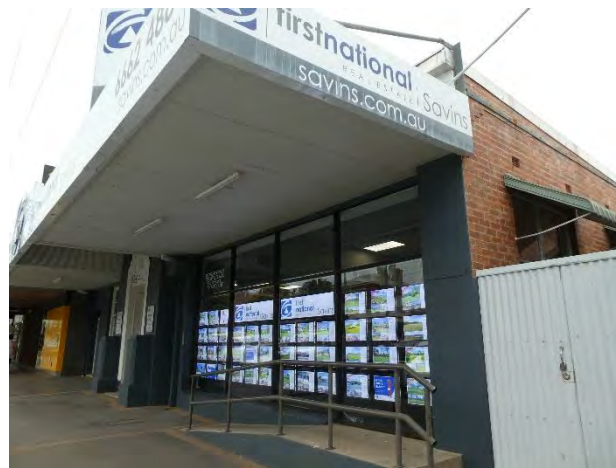
Awning and signage	<p>The awning was added to the building after 1992 and hides the monumental entrance.</p>

The awning extends across to the adjoining single storey building with a large above awning sign.

<p>Removal of the awning is recommended as a long term action to reinstate the façade to its original appearance.</p> <p>A more restrained narrow fascia would improve the appearance of the current awning.</p>

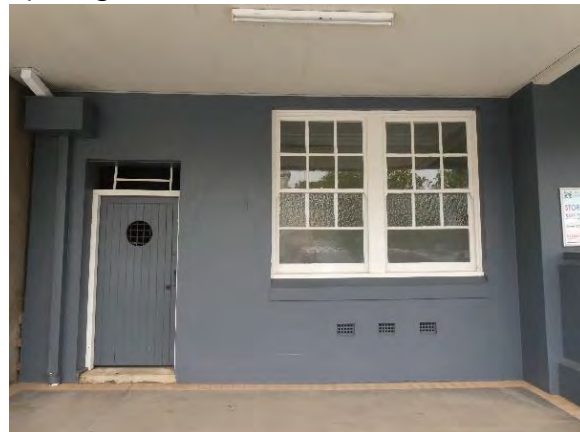
Mostly timber framed, multi paned sash windows to original details to front and rear of building. An aluminium framed window on the first floor encloses a former corner balcony.

Vertical jointed timber secondary entry door with porthole opening on eastern end.

Carefully conserve all original timber windows and doors.

Consider re-opening of the upper balcony or install a pair of double hung sash windows to match the remainder to replace the aluminium window.

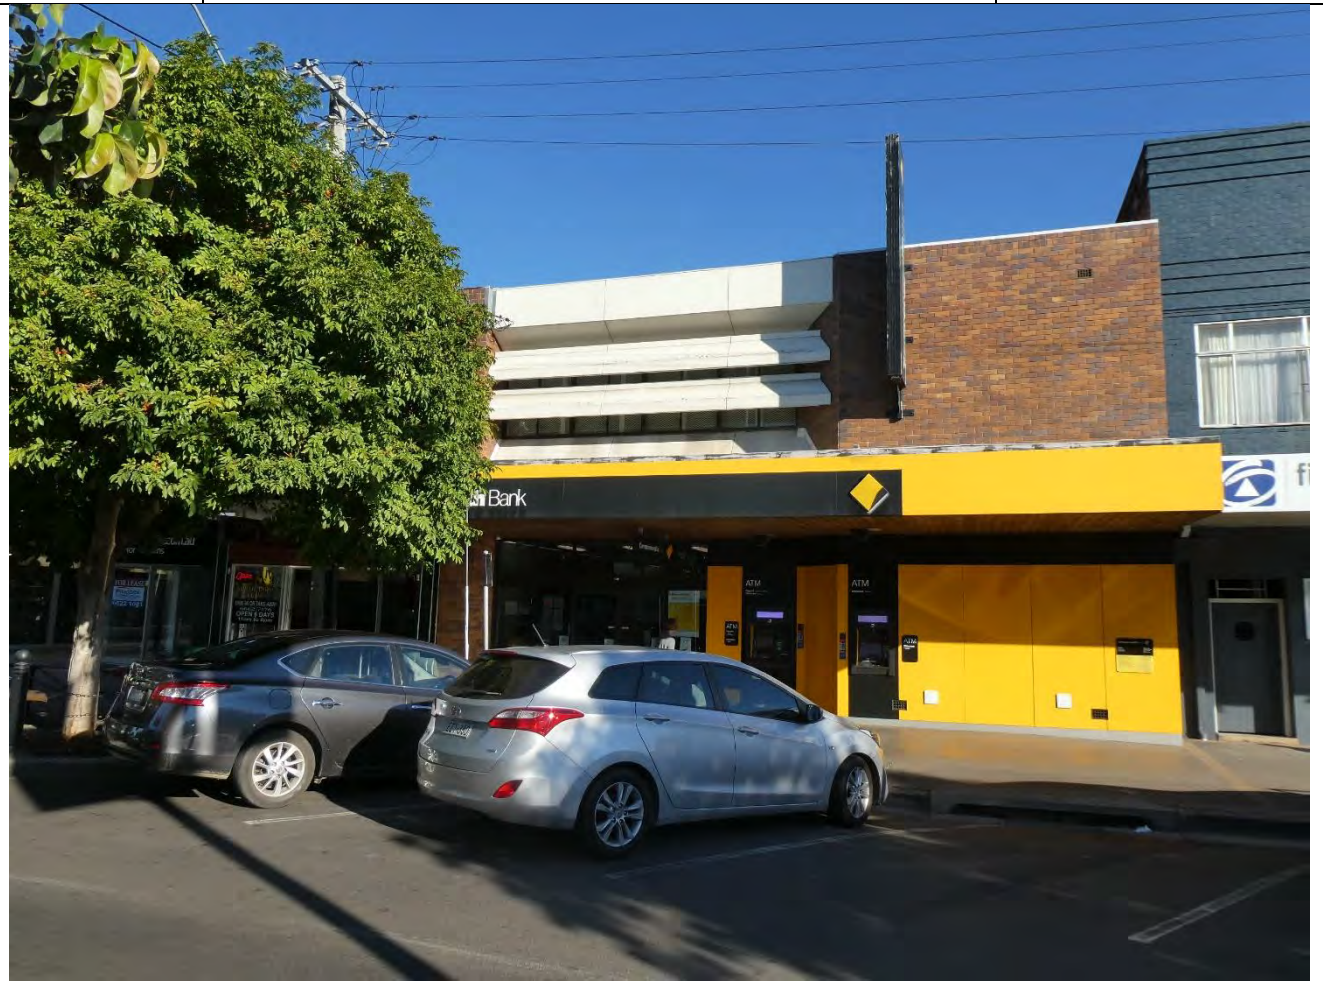
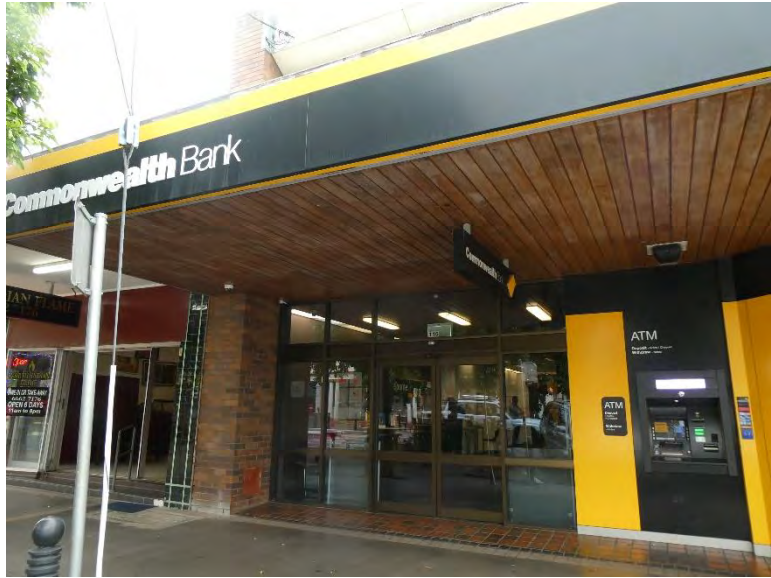
Name	Commonwealth Bank of Australia	
Address	113 Barker Street	
Heritage Item	No	
Contributory Item	No	SHI 2850237
Architectural Style	Modern	1980

Building Elements	Observations	Recommendations
Roof	Not visible, behind parapet.	Maintain
Gutter	Not visible	Maintain.
Walls	Face brick two storey building with a flat edged parapet and cantilevered steel footpath awning. Angled sun awnings extend over windows on eastern side. Yellow cladding to pillars around ATM, and walls at ground level.	Consider reduction of yellow cladding within context of Heritage Conservation Area in a future upgrades.
Shopfront	Neutral aluminium shopfront frames are setback from building line.	Maintain
Awning	<p>Cantilevered awning with corporate fascia signage. Natural Timber varnished lining to soffit.</p>

- This is a more recent modern infill building within the heritage conservation area. The design is a departure from the more vertical emphasis of most historic building stock.
- The face brick is reasonably harmonious with the precinct however amount of bold yellow and black corporate colours applied to building could be reduced to allow it to sit in the heritage conservation area streetscape without dominating the heritage building stock.
- Generally maintain building.

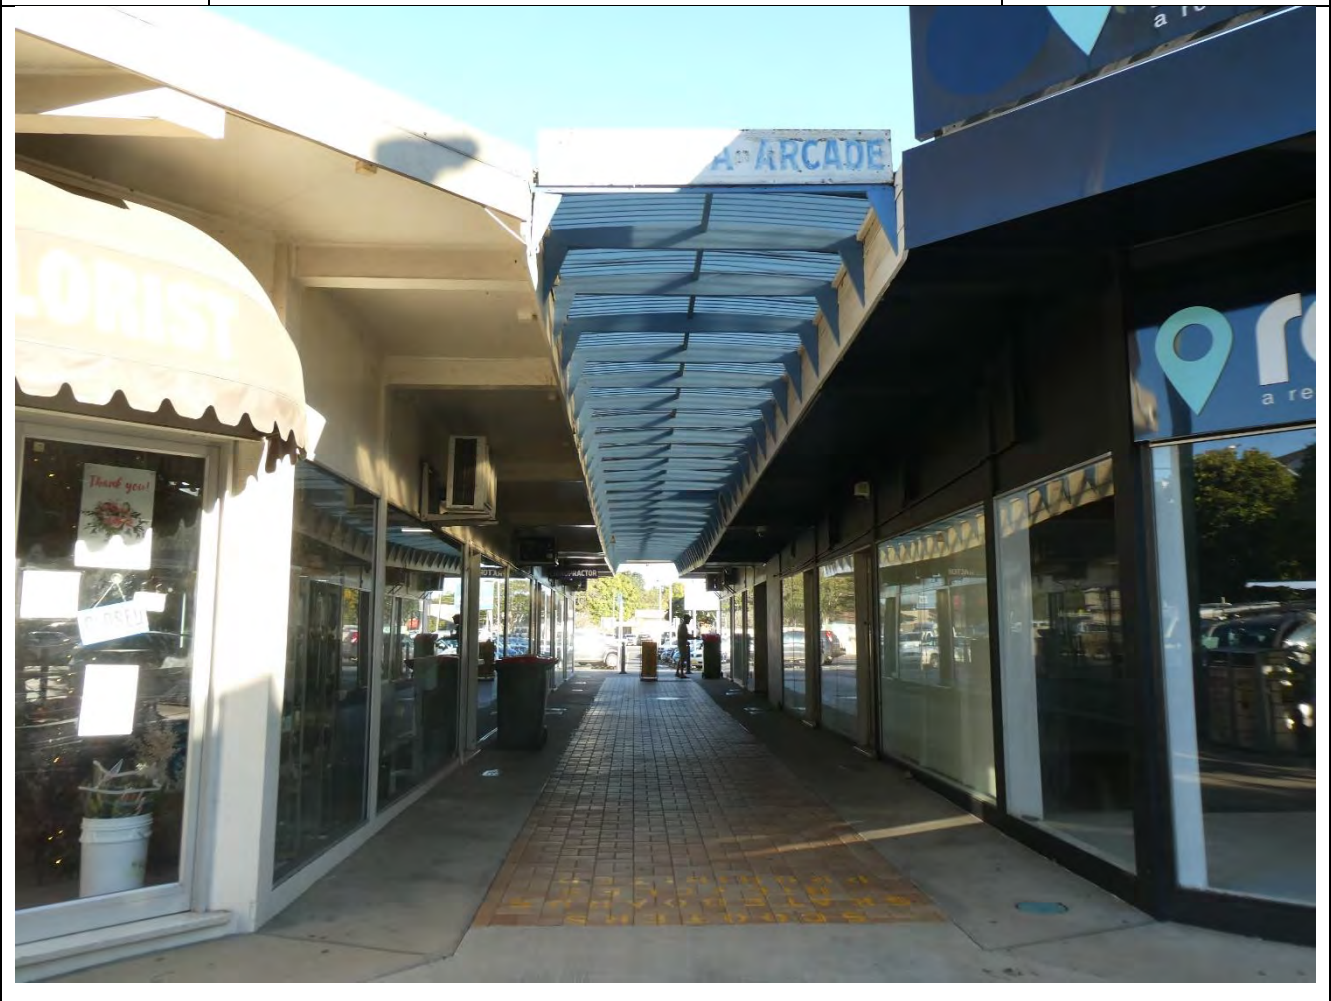
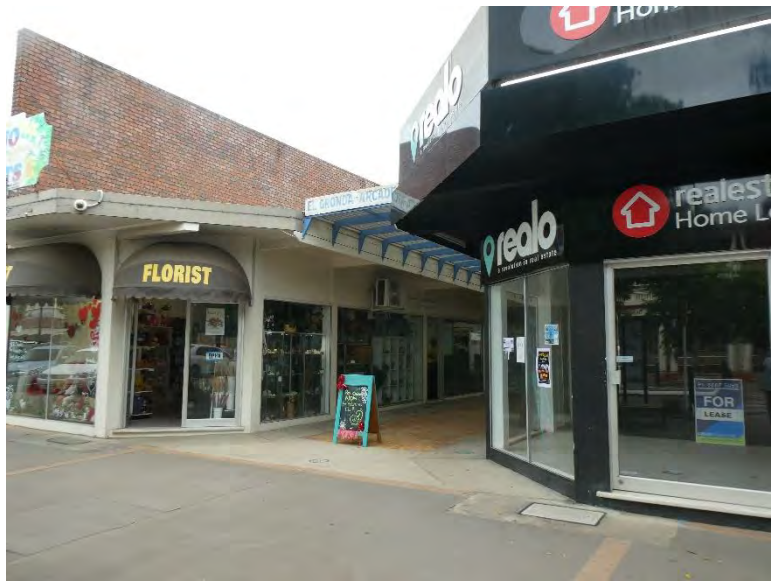
Name	El Gronda Arcade	
Address	117 Barker Street	
Heritage Item	No	
Contributory Item	No	SHI 2850237
Architectural Style	c1960s Modern Infill

Building Elements	Observations	Recommendations
Roof	Not visible, behind parapet.	Maintain
Gutter	Not visible	Maintain.
Walls	<p>Two single storey buildings connected by a covered walkway to car park at rear on site of the former El Gronda Picture Theatre. Painted masonry to Florist building. Timber fascia to top of wall, no substantial parapet. On the western side of the walkway a gloss black façade cladding has been added making this building higher and heavier in form on the opposite side of the walkway.</p>

Consider painting of the black cladding to a more appropriate colour in the context of the Heritage Conservation Area.
Shopfronts	Anodised aluminium frames.

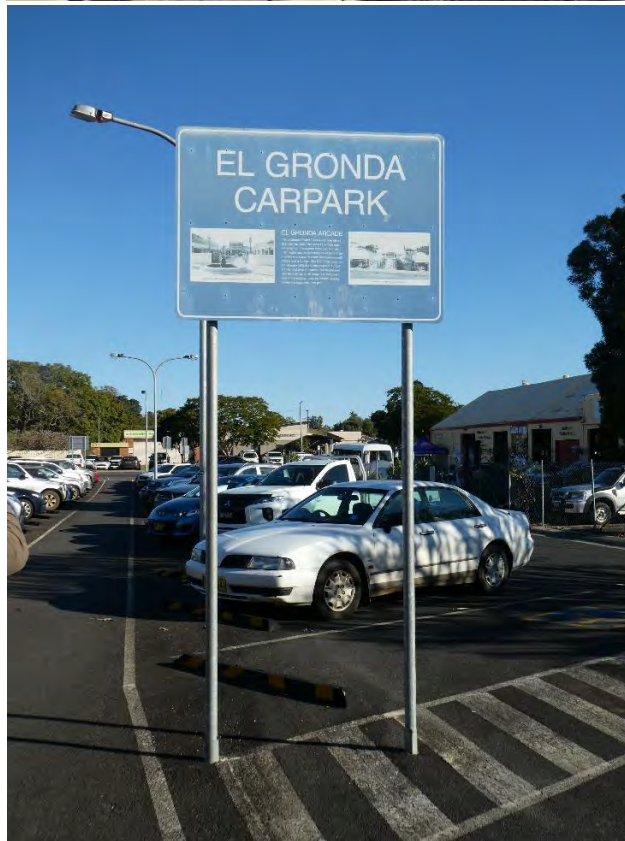
The current sign is high set and not easy to read.

Consider adding more heritage interpretation for the streetside of the former picture theatre site

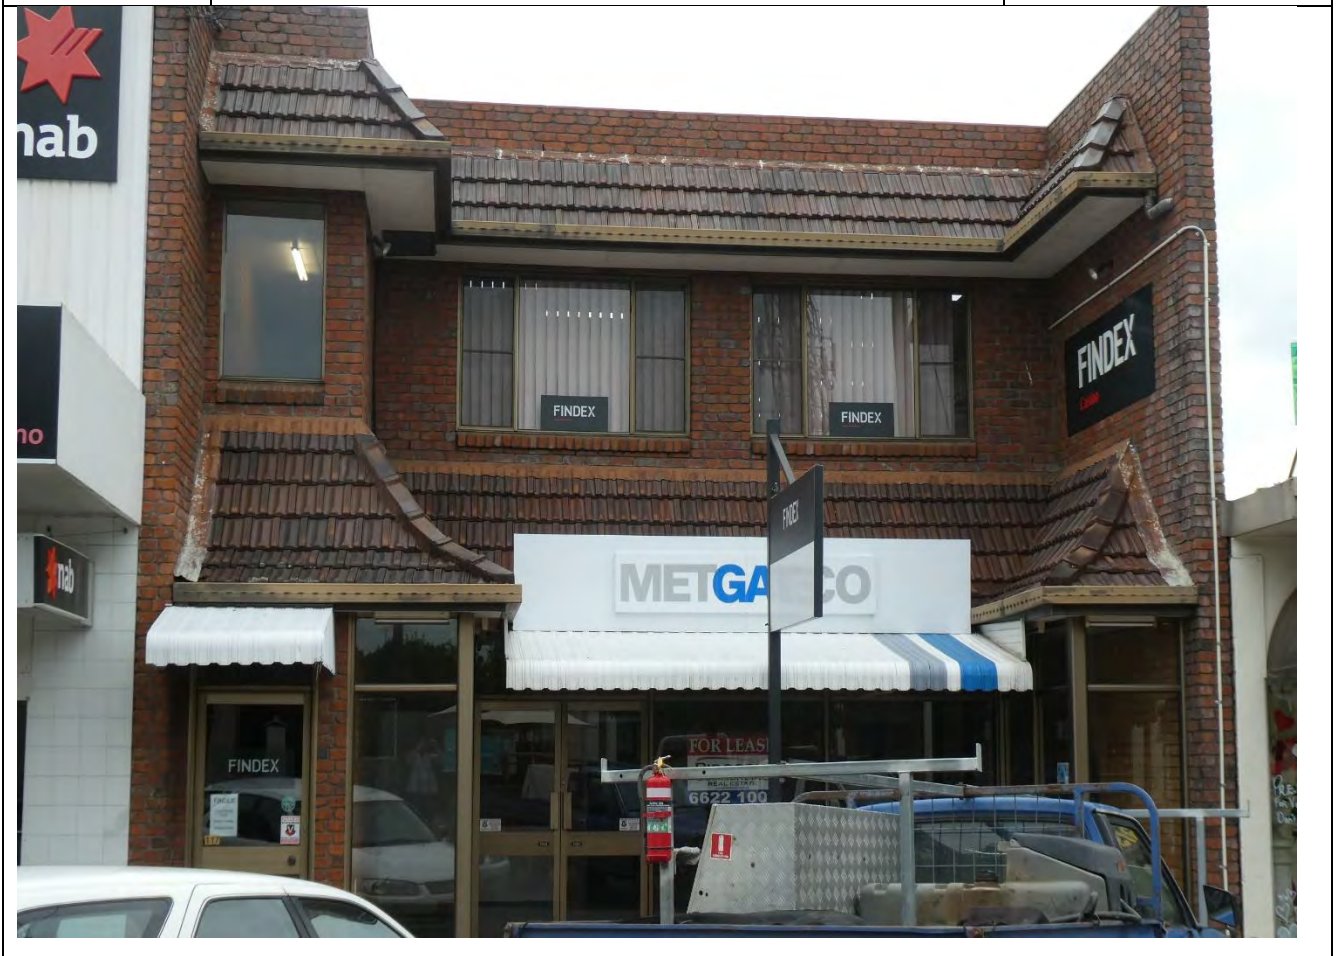
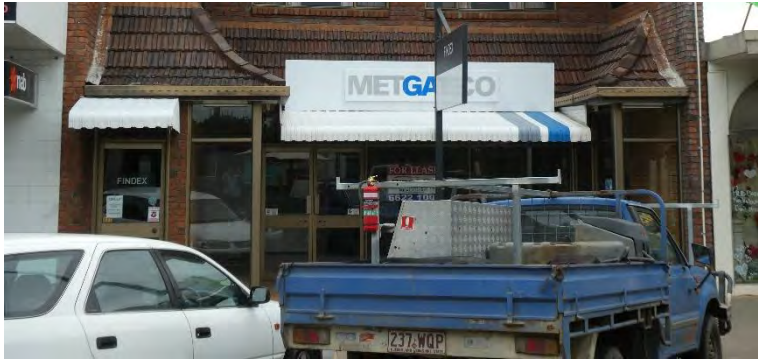
Name Address	Offices Findex / Vacant 117 Barker Street	
Heritage Item	No	
Contributory Item	No	SHI 2850237
Architectural Style	c1980s

Building Elements	Observations	Recommendations
Roof	Not visible, behind parapet.	Maintain
Gutter	Perforated square gutter profile to street on awnings.	Maintain. Use non perforated quad for future replacement.
Walls	Two storey dark brick building with main façade setback from the building line. Dark heavy tiled pitched roofed awnings with end returns project over windows.	Maintain
Windows	Aluminium bronze olive frames.	
Shopfronts	<p>White aluminium awnings over entry to east and main centre office appear as a later addition not in colour palette of original building.</p>

Consider a more muted colour for the awnings which harmonise better with the brick and tile material palette.
Awning	Suspended awning. Metal lining.	Maintain.
<p>Summary of Recommendations</p> <ul style="list-style-type: none"> • This is a modern infill building within the heritage conservation area, which does not relate to the built form of most commercial development in terms of form, materials and setback. • Consider changing colour of awnings to harmonise better with the brick and tile colour palette. • Potential exists to extend the development to the building line with some façade changes.

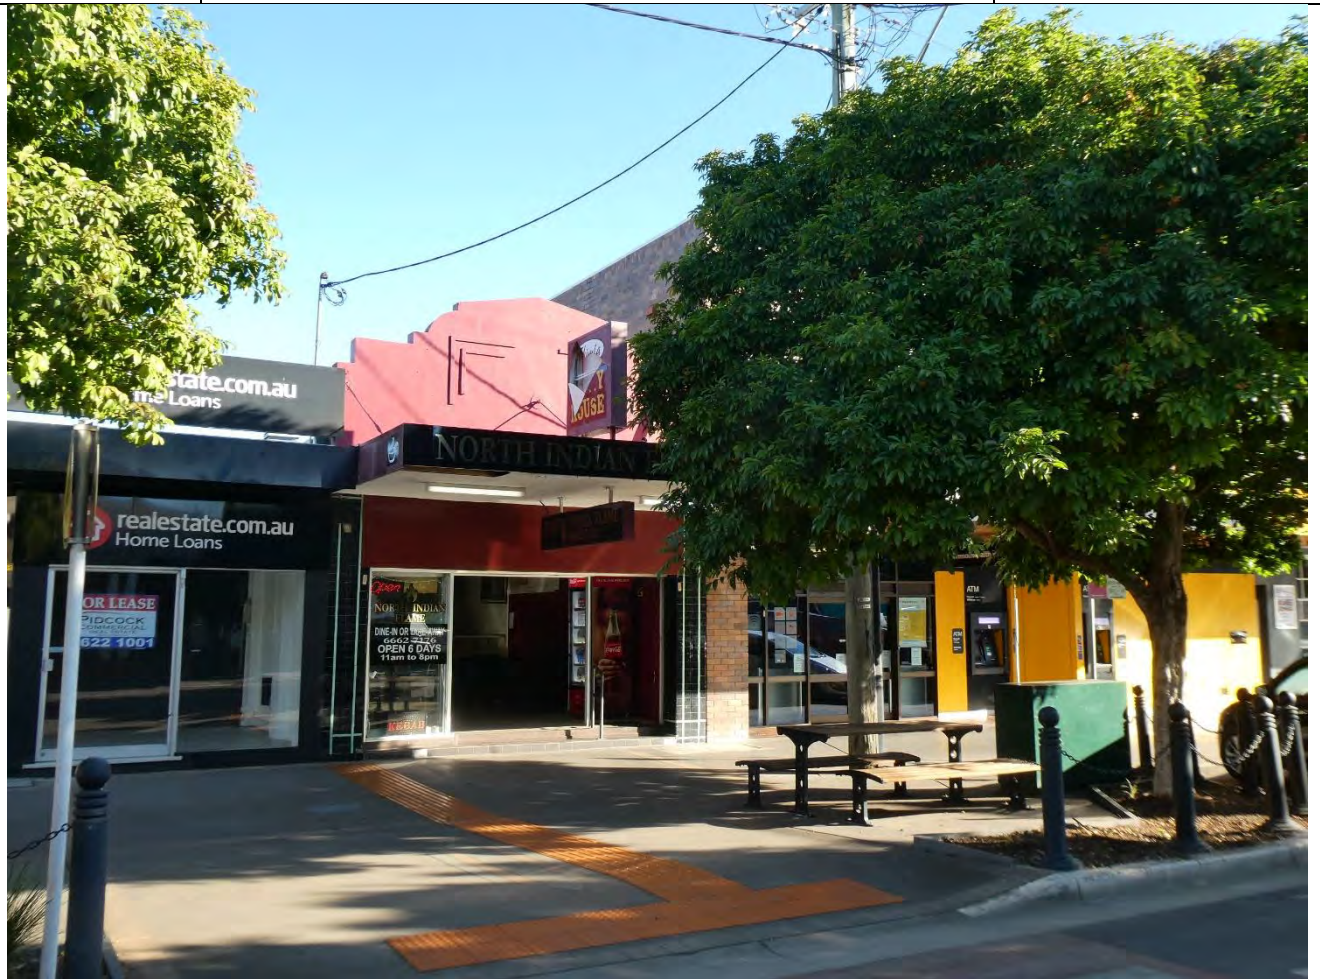
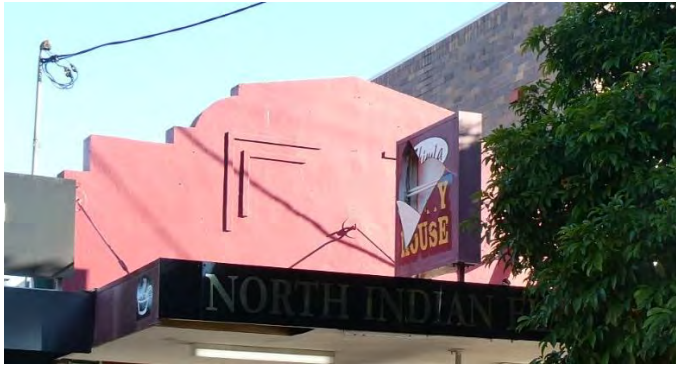
Name.	Restaurant North Indian Flame	
Address	115 Barker Street	
Heritage Item	No	
Contributory Item	Yes	SHI 2850237
Architectural Style	Interwar	c1930s

Building Elements	Observations	Recommendations
Roof	Not visible, behind parapet	Maintain
Gutter	Not visible	Maintain.
Walls	<p>Rendered masonry with a stepped pediment and decorative art deco style mouldings.</p>

<p>Carefully conserve original details of façade. Paint in a heritage colour scheme with contrasting tones to highlight the detail to the façade.</p>
Shopfronts	<p>Modern aluminium shopfront frames. Original tiling exists to pillars on either side of shopfront with contrasting green bands.</p>

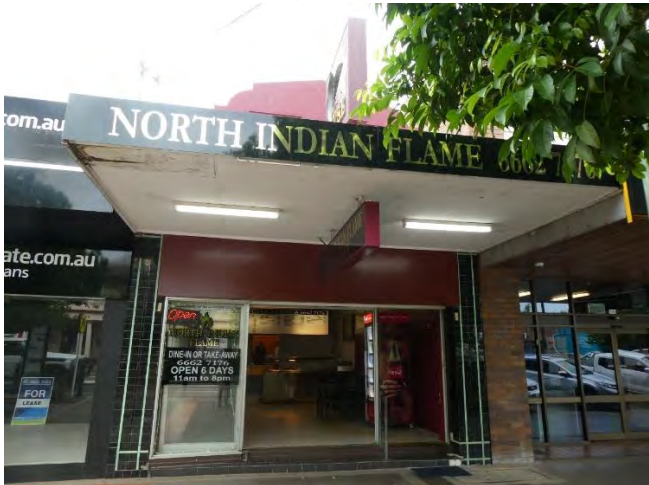
<p>Carefully maintain the original tiling.</p>
Awning and Signage	<p>Suspended awning. Water damage evident under awning on eastern corner. Neon sign above awning is damaged.</p>

<p>Consider reduction in depth of fascia to bring it back to original proportions.</p> <p>Remove above awning sign as it detracts from historic façade.</p>

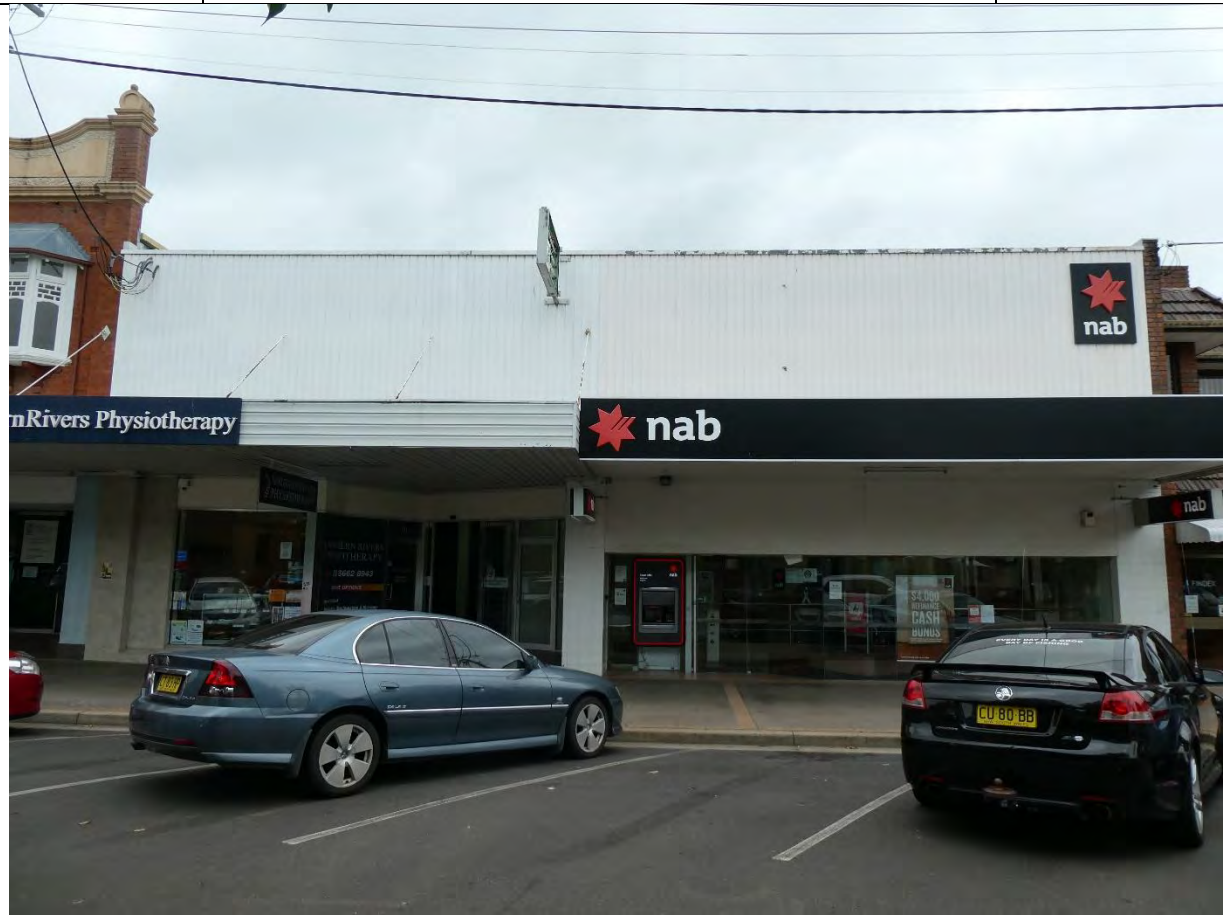
Name	Physiotherapist, National Australia Bank.	
Address	119 Barker Street	
Heritage Item	No	
Contributory Item	No	SHI 2850237
Architectural Style	c1970s (confirm Council files)

Building Elements	Observations	Recommendations
Roof	Not visible, behind parapet.	Maintain
Gutter	Not visible.	Maintain.
Walls	Straight edged parapet covered in a ribbed metal cladding painted off white.	Maintain
Shopfronts	<p>Modern aluminium framed shopfronts with recessed entry.</p>  	Maintain
Awning	Suspended awning. Metal lining.	Maintain.
<p>Summary of Recommendations</p> <ul style="list-style-type: none"> • This is a modern infill building within the heritage conservation area which contrasts with the heritage listed items nearby. • There is potential to consider future redevelopment of this site with a two storey building and shop top accommodation which could have potential to enhance the streetscape
