CASINO CBD HERITAGE CONSERVATION AREA MAIN STREET AUDIT

Prepared by
CLARENCE HERITAGE
FOR RICHMOND VALLEY COUNCIL
AUGUST 2020

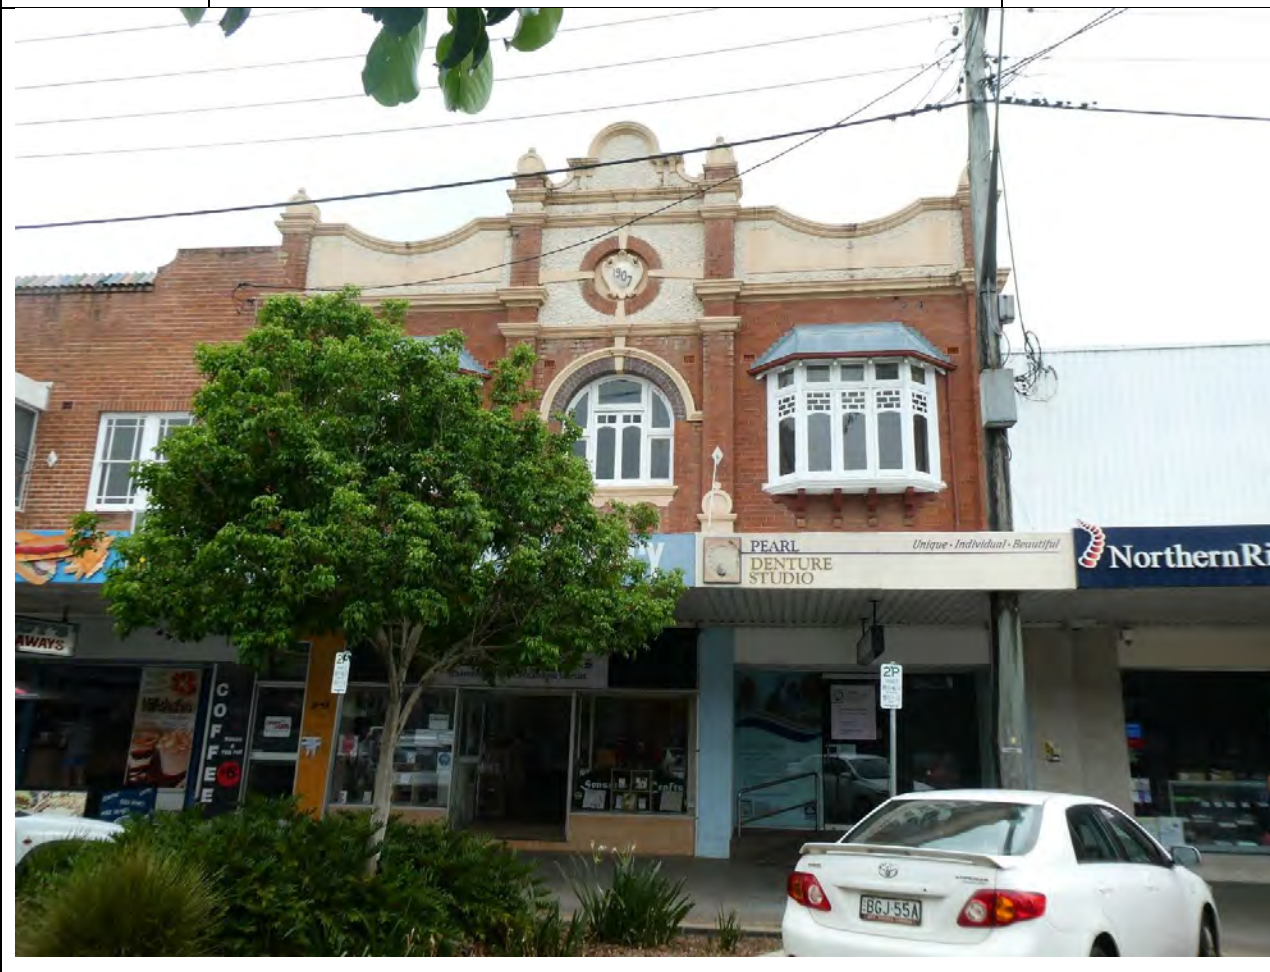
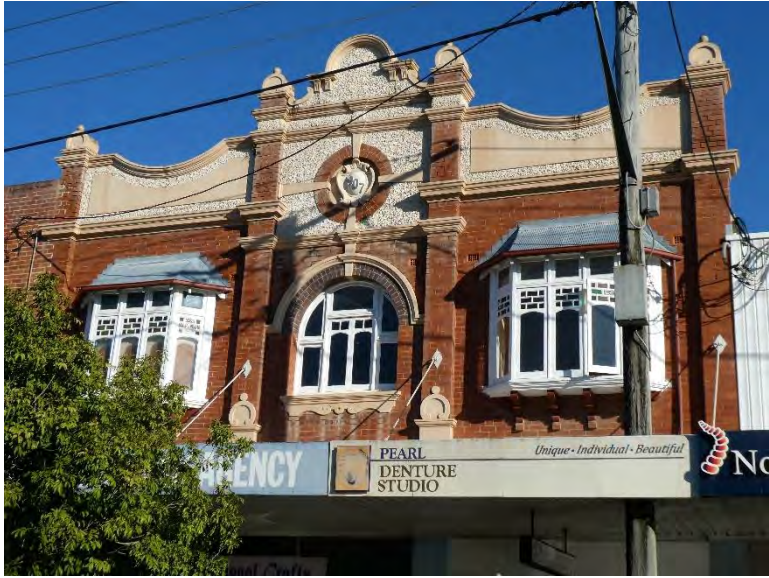
Building Elements	Observations	Recommendations
Roof	Not visible, behind parapet.	Maintain
Gutter	Not visible.	Maintain. Ensure all water is dispersing away from the base of the building.
Walls	Unpainted face brickwork combined with rendered mouldings and rough cast rendered infill panels. Ornate parapet capped by rounded painted rendered ornaments and details with a circular openings and date plaque.	Conserve to original details.
Windows and Doors	<p>Decorative oriel windows with window hoods project either side of a central arched window. Well maintained.</p>

Maintain all original fabric.
Shopfronts	The shopfronts have been replaced with aluminium windows and doors, so the ground floor holds little relationship to the handsome upper façade. Further research is needed to find original details of this shopfront and awning.	Reinstatement of shopfronts to period details based on historic evidence would be very positive to this building.

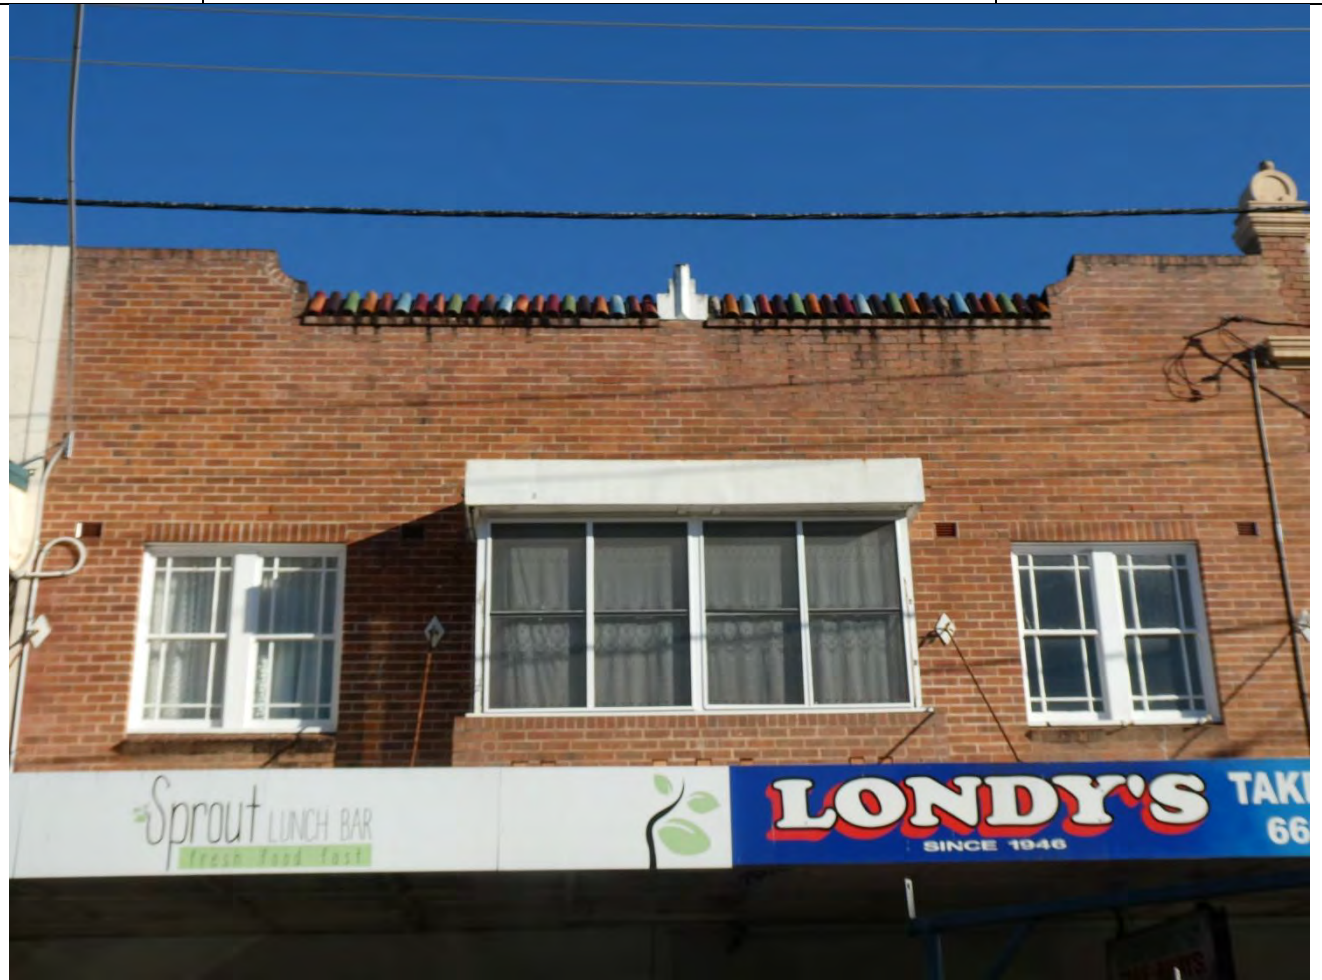
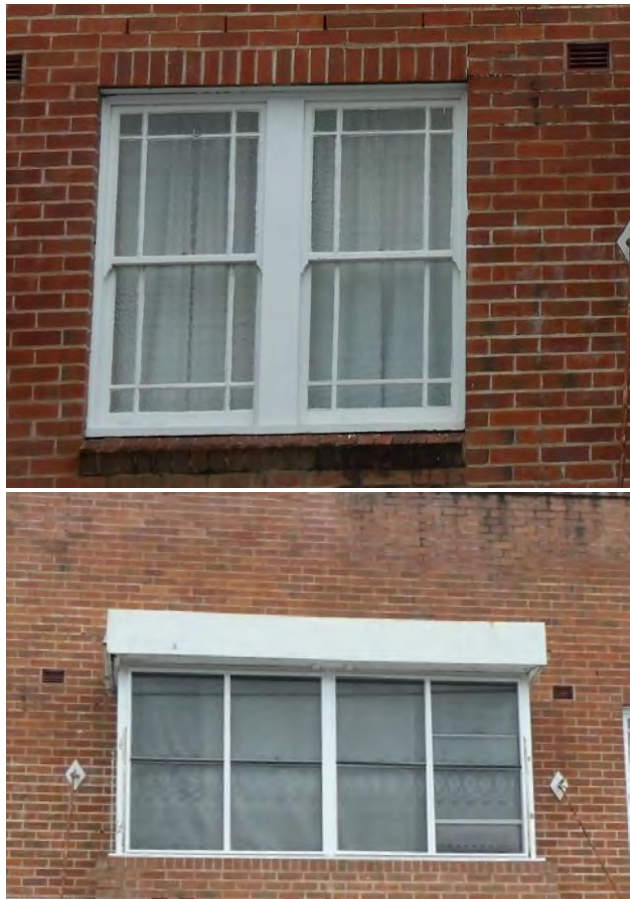
Building Elements	Observations	Recommendations
Roof	Not visible, behind parapet.	Maintain
Gutter	Not visible.	Maintain. Ensure all water is dispersing away from the base of the building.
Walls	Unpainted face brickwork with parapet which steps down in the centre, marked by central motif and capped with multi coloured terracotta tile which matches the adjoining Commercial Hotel.	Retain brickwork unpainted to upper façade.
Windows and Doors	<p>Pairs of margin glazed timber windows lie each side of a recessed balcony which has been enclosed with aluminium windows.</p>

<p>Maintain all original fabric.</p> <p>Consider opening up enclosed balcony to original details.</p>
Shopfronts	The eastern side has been replaced with modern aluminium windows and doors but the western side retains original fabric including geometric tiling and original black tiles to base. Render covers the stall riser and panels and original tiling may exist underneath.	<p>Carefully retain original elements.</p> <p>Consider reinstating black tiles to shopfront façade to match original.</p>

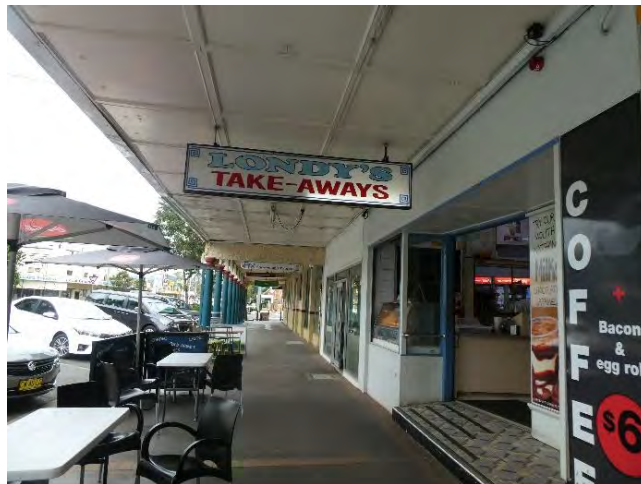
Suspended awning. Fibre cement lining with batten trim.

Maintain.

Place any future signage within the frame of the original fascia depth, to maintain original detail of building.

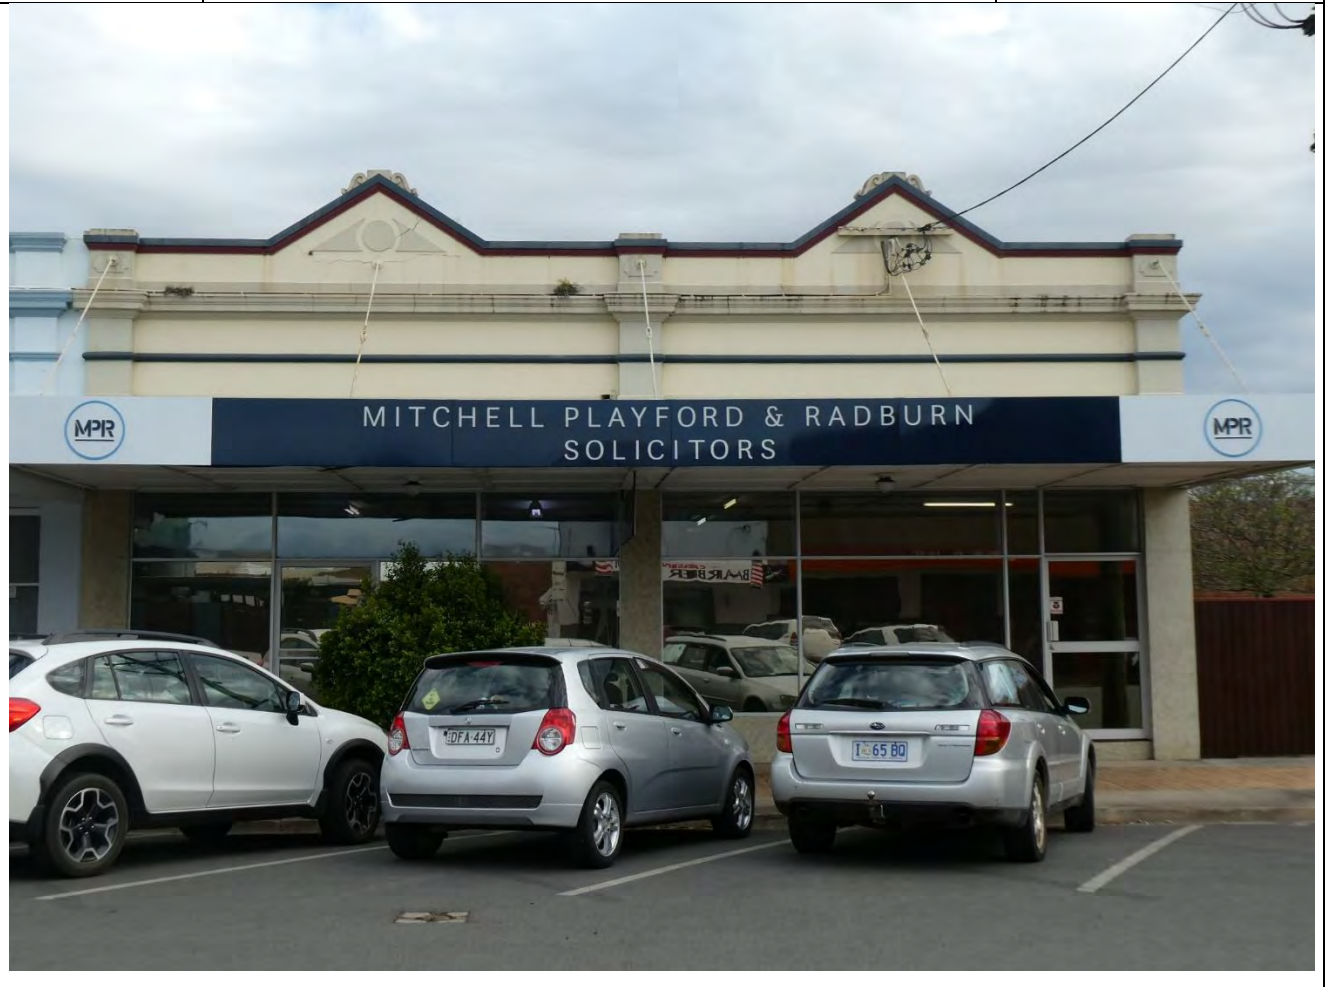
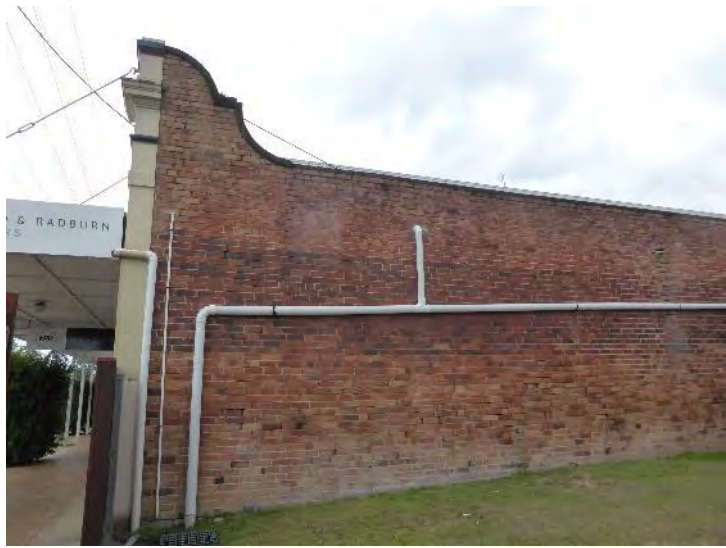
Building Elements	Observations	Recommendations
Roof	Not visible, behind parapet.	Maintain
Gutter	Not visible.	Maintain. Ensure all water is dispersing away from the base of the building.
Walls	<p>Painted brickwork and masonry mouldings with two triangular pediments above parapet line. Projecting piers and horizontal mouldings. Urns previously decorated the top of each brick pier. Side wall is face brick unpainted.</p>

<p>Maintain an authentic heritage colour scheme for any future repainting in keeping with the period of the building. Consider reinstatement of the urns to parapet.</p> <p>Rising damp with efflorescence on bricks evident. Advice previously provided on drainage, use of correct lime mortars for any repairs and allowing brickwork to breathe.. Do not seal brickwork.</p>
Windows and Doors	Below the awning the front has been replaced with modern aluminium windows and doors.	Maintain. Consider reinstatement of timber windows to original details.

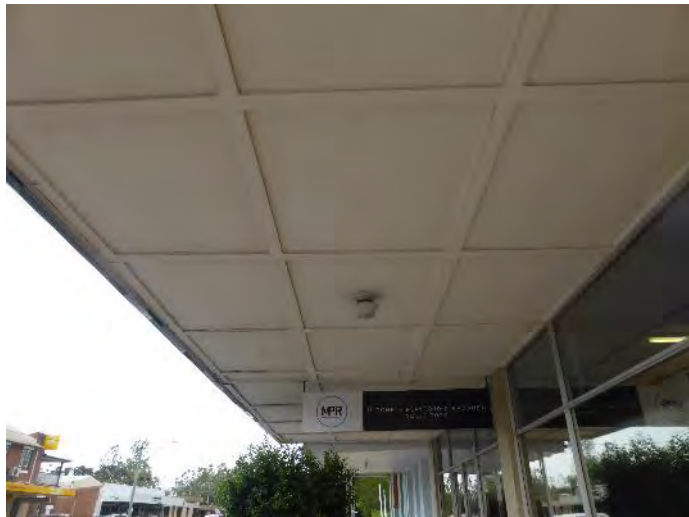
Verandah	<p>Suspended awning. Fibre cement lining with batten trim.</p>

<p>Maintain.</p> <p>Reinstatement of the verandah to original details with timber posts and fascia would enhance the building.</p>

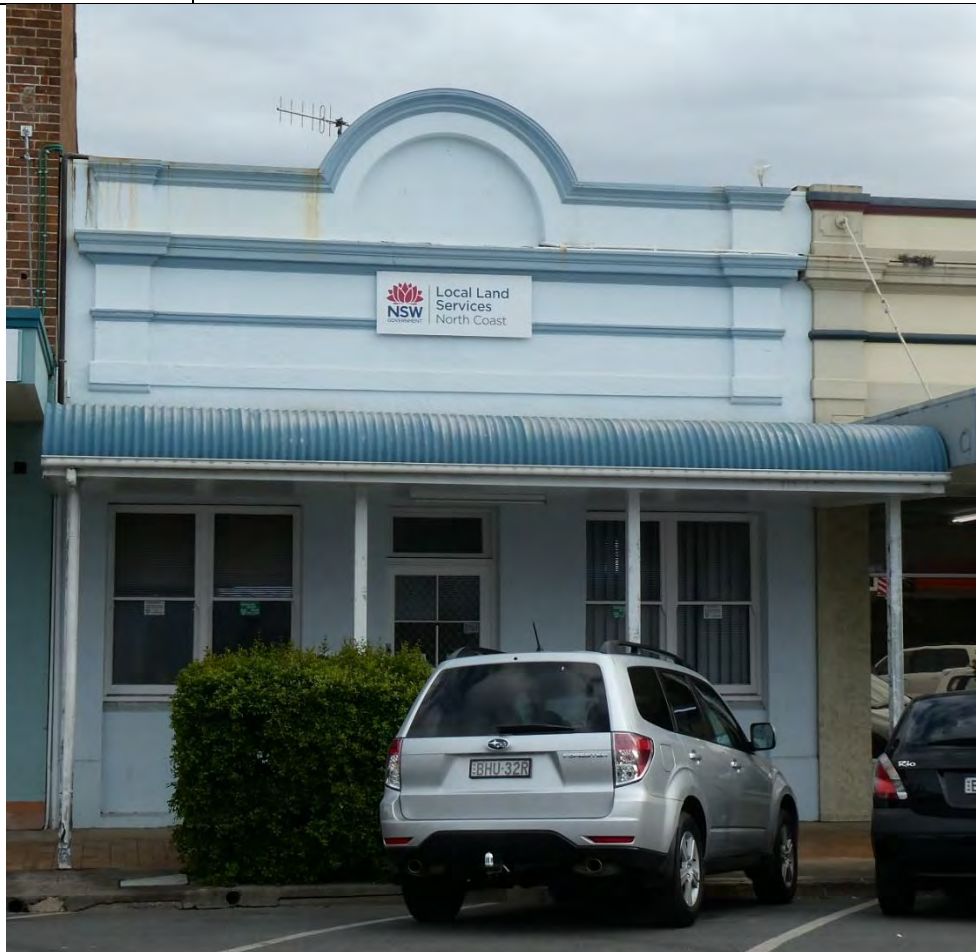
Building Elements	Observations	Recommendations
Roof	Not visible, behind parapet.	Maintain
Gutter	Not visible.	Maintain. Ensure all water is dispersing away from the base of the building.
Walls	Painted brickwork and masonry mouldings with central semi-circular pediment. Projecting piers and horizontal mouldings. Urns previously decorated the top of each brick pier	Maintain an authentic heritage colour scheme for any future repainting in keeping with the period of the building. Reinstate the urns to original detail.
Windows and Door	Pairs of timber framed double hung sash windows are located to each side of central doorway. These windows may have been a later alteration but are still early fabric. The door way appears original.	Maintain all timber joinery.
Verandah	<p>Bullnose verandah with narrow metal posts which has replaced a post supported awning with a fascia.</p>

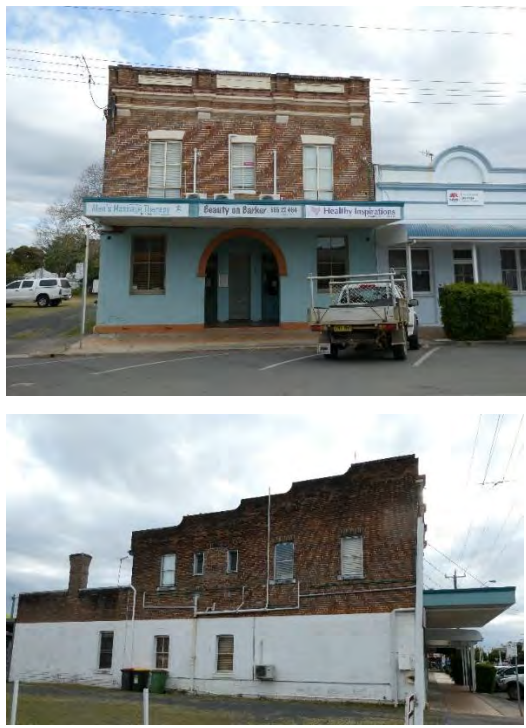
Building Elements	Observations	Recommendations
Roof	Not visible, behind parapet. Prominent chimney to rear.	Maintain
Gutter	Not visible.	Maintain. Ensure all water is dispersing away from the base of the building.
Walls	<p>Face brickwork to upper storey. Projecting piers and horizontal mouldings decorate the top section. Ground floor brickwork has been painted. Air conditioner units detract a little from front façade.</p>

<p>Retain face brick unpainted. Maintain an authentic heritage colour scheme for any future repainting in keeping with the period of the building.</p> <p>Consider relocation of air conditioning units to rear of building.</p> <p>Consider reinstatement of two storey verandah.</p>
Windows	<p>A few remaining windows are original timber framed double hung but many have been replaced in aluminium. The front façade was original a two storey verandah with French doors which have been removed and replaced.</p>

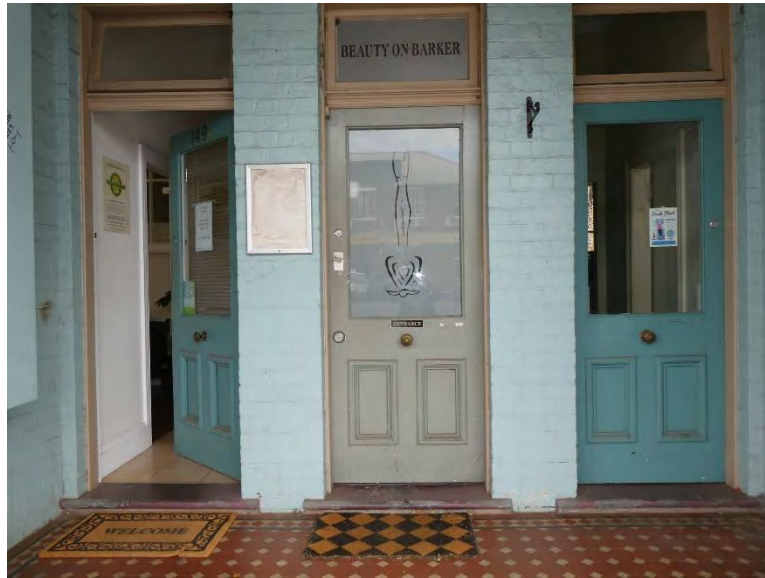
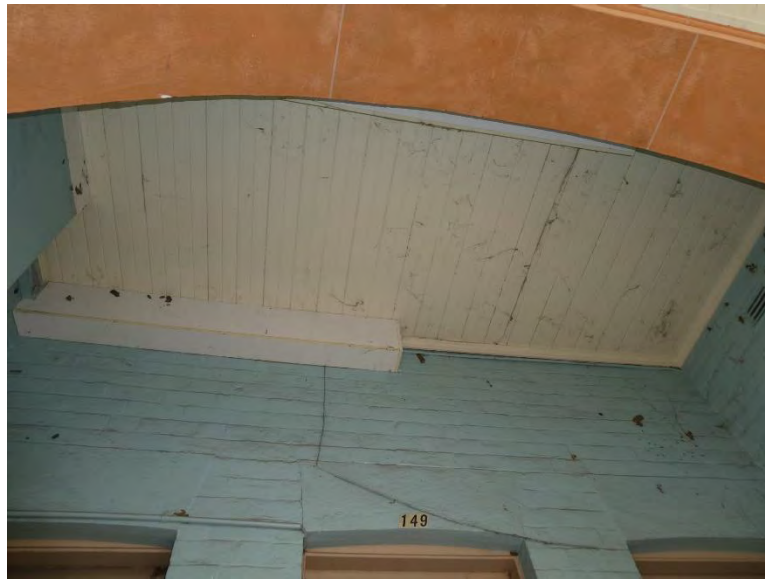
Triple entry; timber panelled doors to front façade with central door handle. New etched glass to centre door. Timber lined soffit.

Carefully conserve to original details.

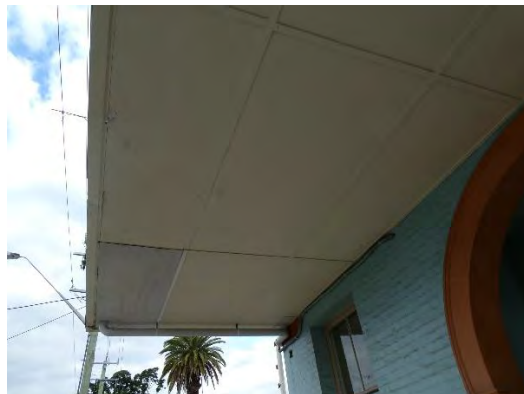
A suspended awning has replaced a former 2 storey verandah with posts. Underside is fibre cement lined with expressed batten.

Maintain. Ensure that signage is maintained within the depth of the fascia. Consider reinstatement of original two storey verandah.

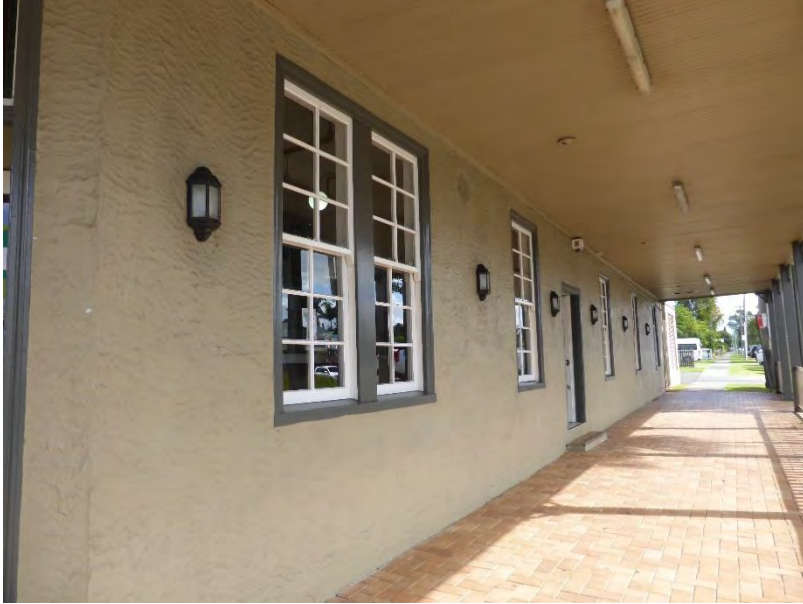
Maintain Ensure all drainage is dispersing from base of walls.
Walls	Two storey rendered brick building. Rendered finish in a neutral warm mid tone wall with dark and light trims.

Maintain.
Doors and Windows	Timber double entry doors with chrome push bars, and leadlight later additions. Inner French doors are non-original.

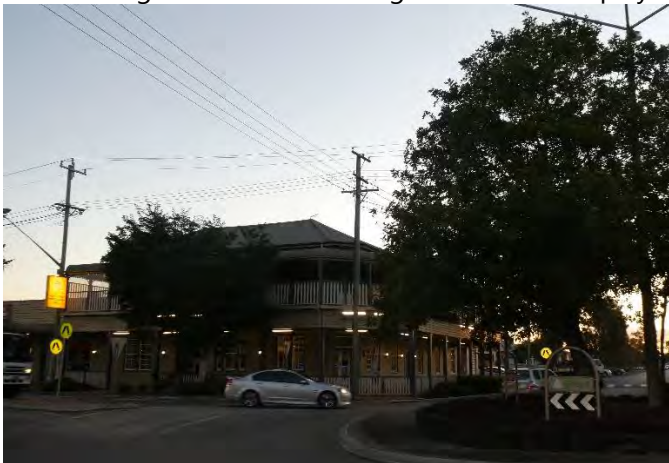
<p>Verandah and Signage</p>	<p>The two storey verandah is a major element of this building. Timber posts, brackets valances and roof beams. Vertical timber verandah balustrades. Signage is restrained and sympathetic to the building with raised lettering on the corner splay.</p>

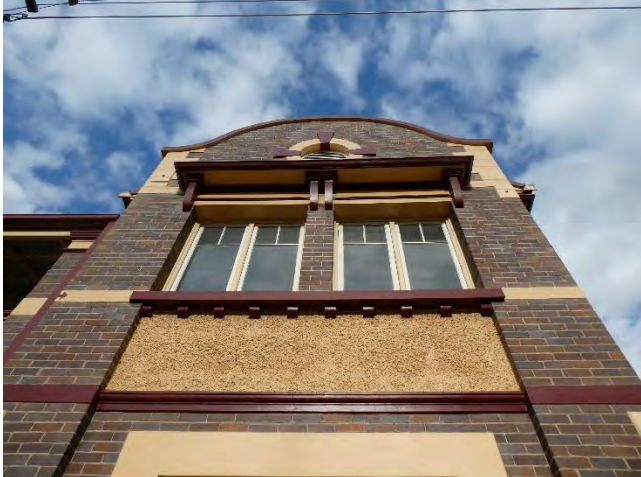
Building Elements	Observations	Recommendations
Roof	<p>Hipped Marseilles Terracotta tiled main roof. Red metal roofing to verandah elements. Prominent chimney with corbelled rendered detailing.</p>	<p>Retain original roof as long as possible, repair or replace as required to original details.</p>
Gutter	<p>Low front quad non-perforated.</p>	<p>Maintain and replace as necessary to original details.</p>
Walls	<p>Face brick in two tones with contrasting bands of rendered detail to quoins, string courses, plaques, window surrounds, arches. Roughcast feature panels. The arched parapets are the 1912 additions and the single storey section comprises the later 1960s addition.</p>

<p>Maintain all original fabric. Maintain an authentic heritage colour scheme for any future repainting.</p>
Windows	<p>Double hung timber framed with multi panes to upper windows and plain glass to lower panes. French doors to upper level opening onto balcony. Circular windows to arched parapet ends.</p>

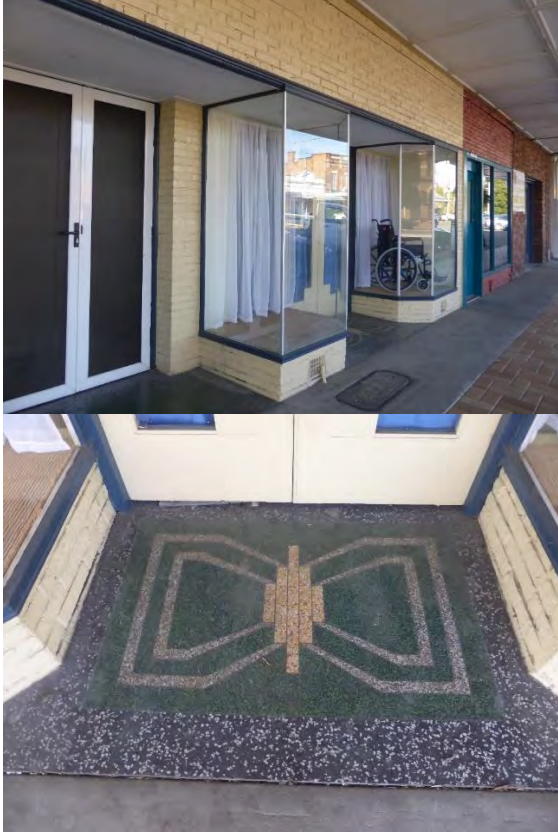
Building Elements	Observations	Recommendations
Roof	Metal roof behind parapet.	Repair or replace as required to original details.
Gutter	Not visible. Awning shows signs of severe water penetration and damage indicating drainage needs attention.	Ensure all drainage is dispersing Maintain and replace as necessary to original details. Urgent attention to awning drainage and repair of lining is required.
Walls	Two storey rendered brick with stepped parapet and applied mouldings. Painted in a sympathetic heritage colour scheme.	Maintain all original fabric. Maintain an authentic heritage colour scheme.
Shopfronts and Windows	<p>Original art deco shopfronts are still intact on the Barker Street frontage and including slender fine framing and projecting glass window displays and inlaid terrazzo with metal inlay to the entries.</p>

<p>The shop premises facing Walker Street are modern including some timber and some aluminium framed shopfronts. The reinstatement of shopfronts to original details would enhance this building and would be eligible for heritage grant support.</p>	<p>Carefully conserve all original shopfront detailing and tiling, to original details.</p> <p>It is not known if an original art deco shopfront existed on Walker Street but reconstruction to original details based on historical research and early photographs would enhance this building.</p>

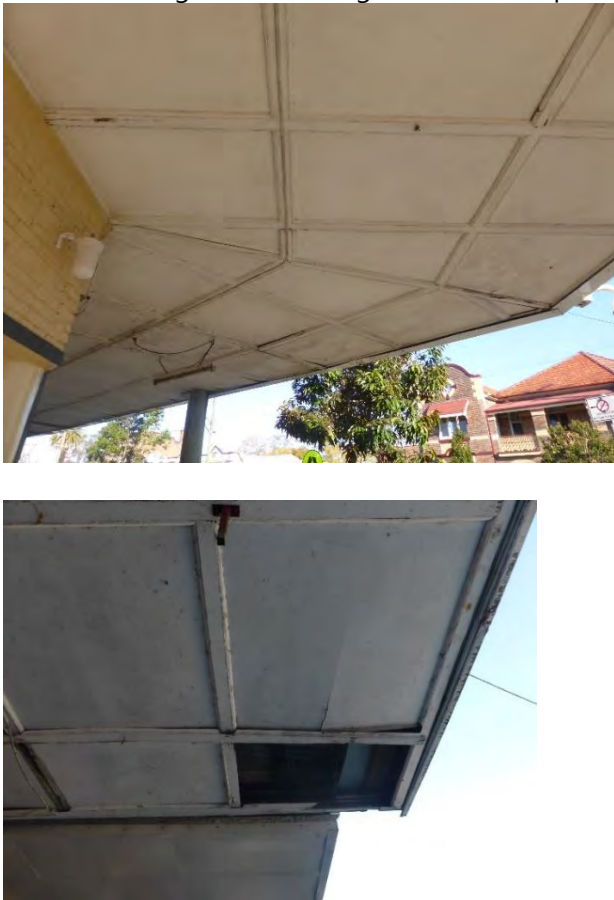
Maintain to original details.
Awning/ verandah	<p>Suspended awning over the footpath with fibre cement and batted lining. Water damage is evident to part of awning.</p>

Repair and replace to original details with fibre cement and batten trim.
Interior	Only chemist shop viewed.	Carefully conserve all remaining original fabric.

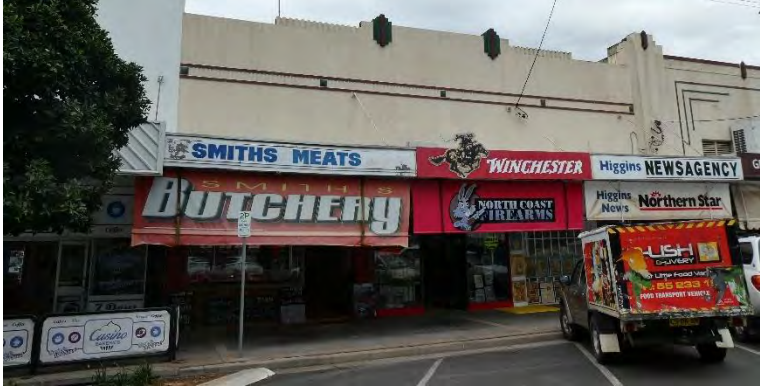
Building Elements	Observations	Recommendations
Roof	Metal roof behind parapet.	Repair or replace as required to original details.
Gutter	Not visible.	Ensure all drainage is dispersing Maintain and replace as necessary to original details.
Walls	Two storey rendered brick, stepped parapet with art deco motifs and applied mouldings. Painted in a sympathetic heritage colour scheme with details picked out in trim colours.	Maintain all original fabric. Maintain an authentic heritage colour scheme.
Shopfronts and Windows

<p data-bbox="395 1111 1166 1178">Original shopfronts are no longer intact under the awning but the firearms shop retains a traditional recessed entry.</p>	Reconstruction of shop fronts to original details based on historical research and early photographs would enhance this building.
Awning	<p data-bbox="395 1223 1145 1357">Suspended awning with pressed metal lining . Retains a traditional narrow fascia. Business signage is attached to the fascia and hanging signs below.</p>  	<p data-bbox="1230 1223 1497 1402">Carefully conserve pressed metal lining. Ensure drainage is in order to prevent damage.</p> <p data-bbox="1230 1408 1497 1738">The awning fascia depth should not be exceeded with any signage which projects beyond the original depth to maintain the proportions of the awning design.</p>

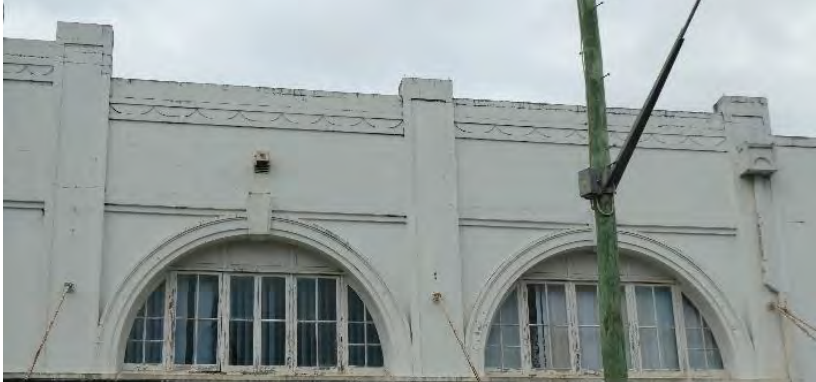
Building Elements	Observations	Recommendations
Roof	Metal roof behind parapet.	Repair or replace as required to original details.
Gutter	Not visible.	Ensure all drainage is dispersing Maintain and replace as necessary to original details.
Walls	<p>Expansive two storey rendered brick with a stepped parapet with art deco motifs and applied mouldings. The façade above the awning is divided by pilasters into a series of bays with large half round openings which house sets of timber framed multi paned windows. The façade is currently painted all white which does not highlight the detail of the façade mouldings. The property includes a section of infill plain upper façade between this main building and the adjoining Smiths Stores.</p>

<p>Maintain all original fabric. Utilise an authentic period heritage colour scheme which highlights the architectural detail of the façade. Paint scrapes would help inform the original colour scheme.</p>

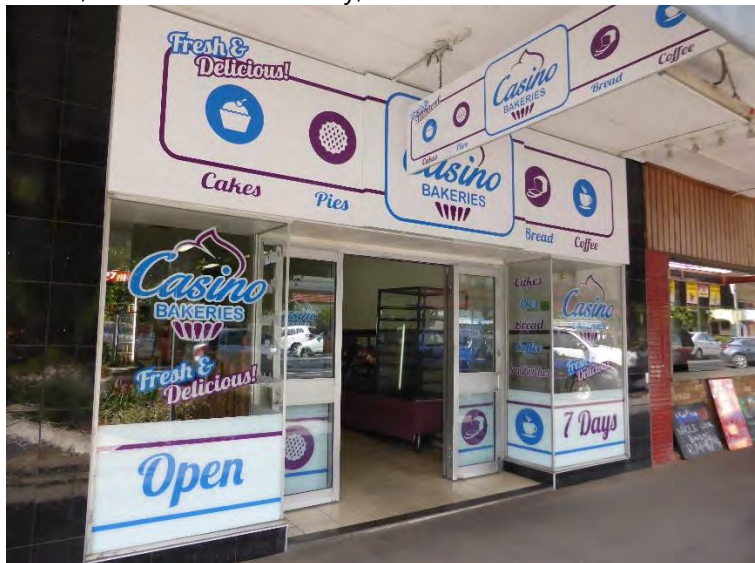
Shopfronts and Windows	<p>The building contains some remaining original shopfronts with anodised slender frames, original black tile work and recessed entries, Casino Centre Bakery;</p>

<p>Reconstruction of shop fronts to original details based on historical research and early photographs would enhance this building.</p>

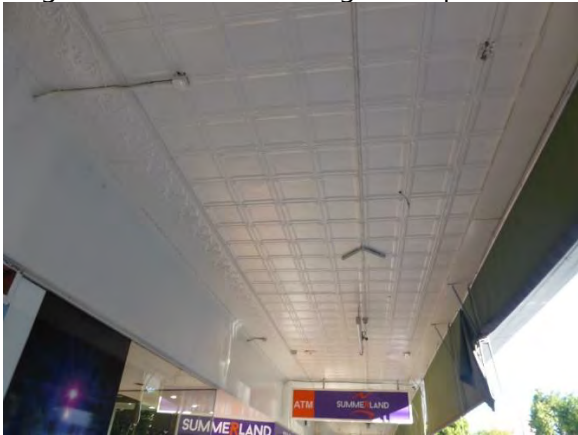
<p>Awning</p>	<p>Original cantilevered awnings with pressed metal lining .</p>

<p>Carefully conserve pressed metal lining. Ensure drainage well maintained to prevent damage.</p>
<p>Recommendations</p> <ul style="list-style-type: none"> • This is a heritage listed building which retains a high degree of original fabric to the upper façade, the original pressed metal awning and some shopfronts... • Carefully conserve and retain all original fabric to original details. • Utilise an authentic heritage colour scheme for repainting of the exterior, ideally based on original paint scrapes. • Remove above awning advertising as it detracts from the architectural detail of the upper façade. • Timber windows are showing deterioration and need immediate attention for repainting and checking. • Ensure all drainage is dispersing away from building. • Careful retention of remaining early shop fronts and reconstruction of altered shopfronts to original details based on historical research and early photographs would enhance this building. • Ensure that signage remains within the awning fascia depth. Consider a suite of related signage for businesses within a co-ordinated colour palette to unify the building façade. • A detailed researched report has been previously prepared for this property and can be made available by Council. • Conservation works are eligible for heritage funding through the annual heritage fund.

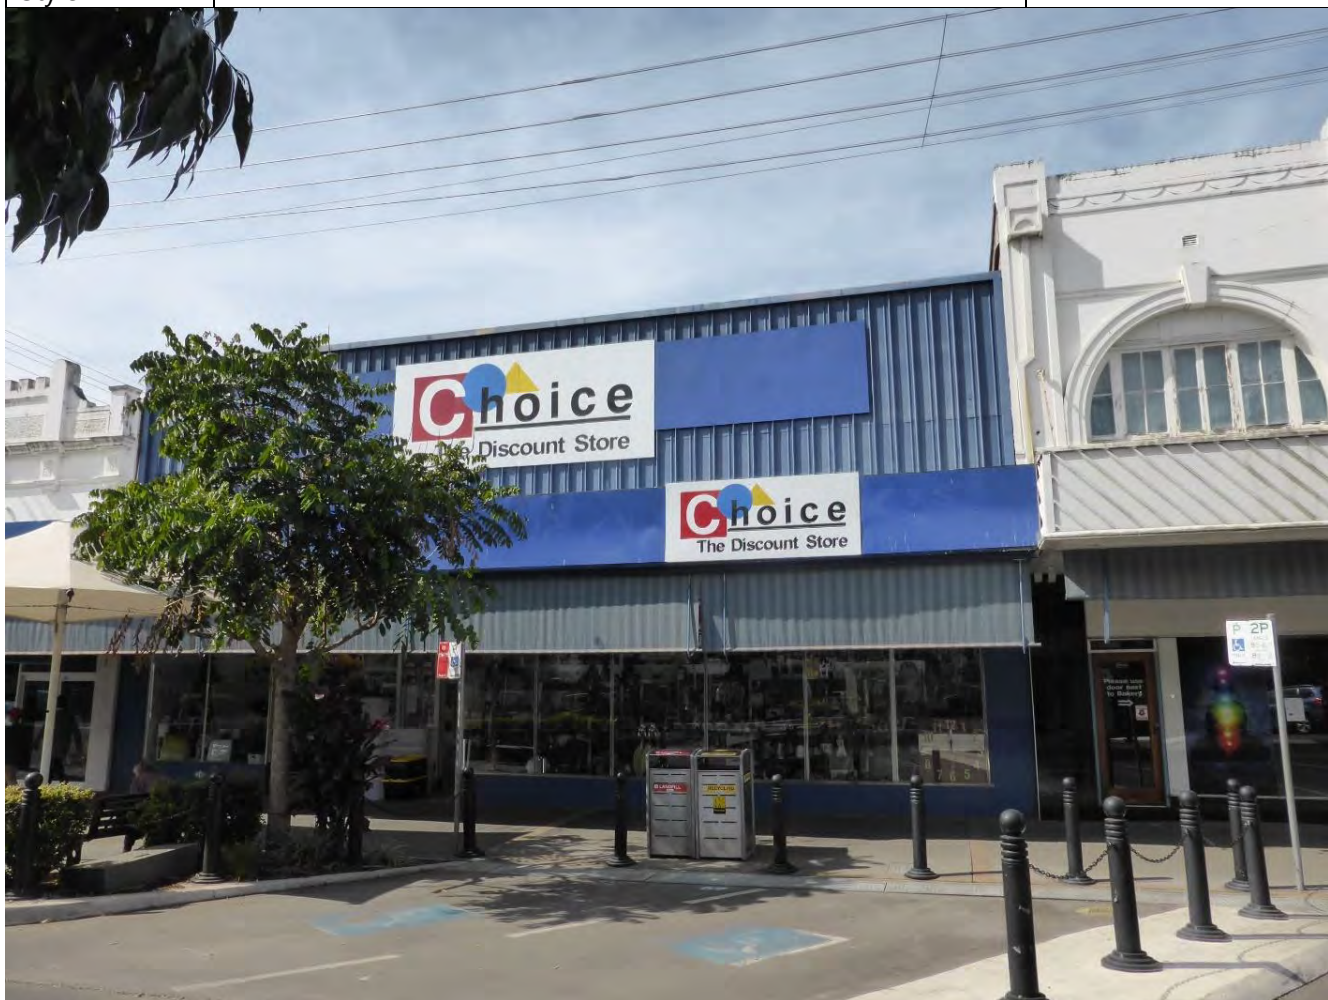
Name Address	Shop Choice Discount Store 71 Walker Street	
Heritage Item	No	
Heritage Conservation Area	Yes	
Contributory Item	Yes	
Notes	Sitting adjacent to the heritage listed former Heathwood Stores building, this building could be mistaken for having little value due to the cladding of the façade. A detailed site inspection however revealed that the building contains a considerable amount of original fabric including an original shopfront.	
Architectural Style	Mid century	circa 1950s

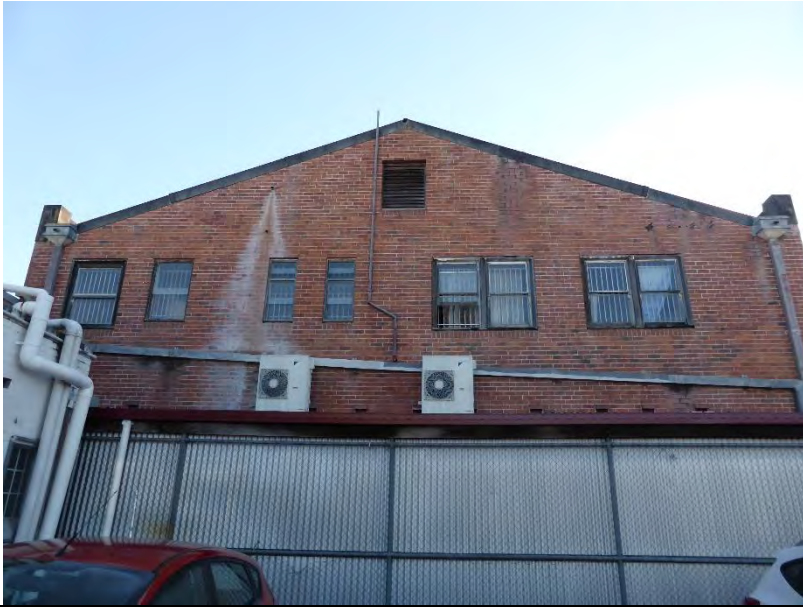
Building Elements	Observations	Recommendations
Roof	Metal gabled roof behind parapet.	Repair or replace as required to original details.
Gutter	Box gutters to sides of gable behind side parapet walls. Original rain water heads to rear elevation.	Ensure all drainage is dispersing Maintain and replace as necessary to original details. Maintain original rain water heads or replace to match.
Walls	<p>Brick construction. Investigation revealed that the two storey parapet faced with metal cladding does not have original façade beneath.</p>

<p>Investigate original façade appearance for future reconstruction. Maintain all original fabric. Utilise an authentic period heritage colour scheme which highlights the architectural detail of the façade. Maintain brickwork unpainted.</p>
Shopfronts and Windows	<p>The building retains the original shopfront with anodised slender frames, original tile work, now painted blue, and recessed entries.</p>

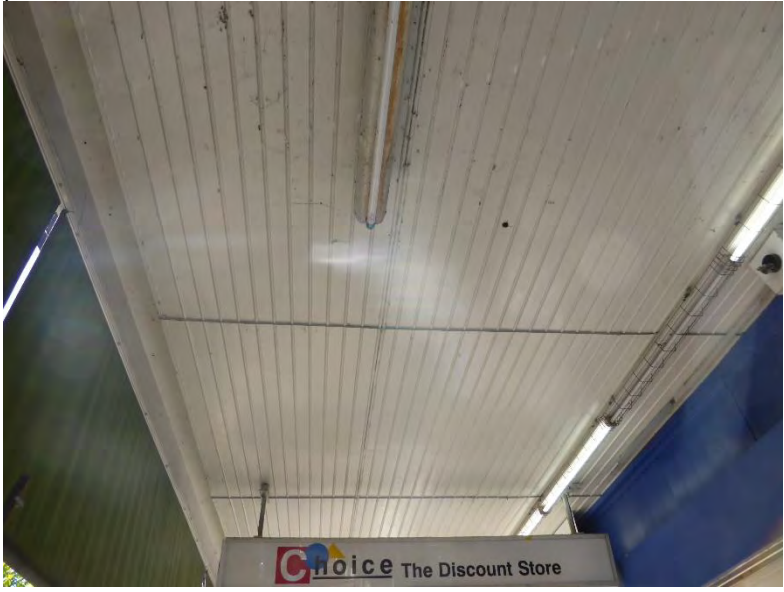
Awnings	<p>Original suspended awning with pressed metal lining in lineal pattern.</p>

<p>Carefully conserve pressed metal awning lining. Ensure drainage is in order to prevent damage. Signage should not project over the awning fascia depth, to maintain the proportions of the awning design.</p>
Interior	<p>Contains much original fabric. Upper floor has solid timber floor and steel roof trusses.</p>  	<p>Possibilities for adaptive re-use with improved access.</p>

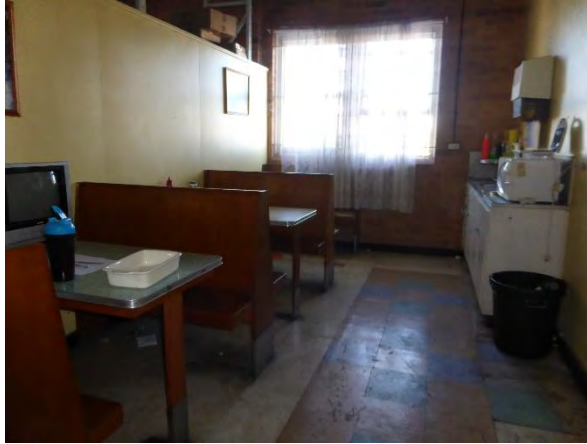
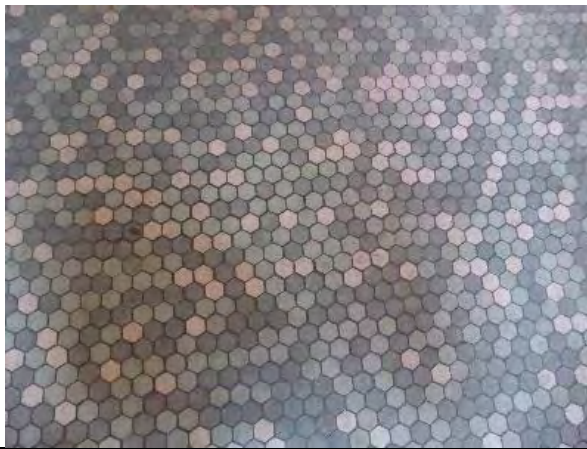
Original staff room and amenities with original tiling and fixtures.

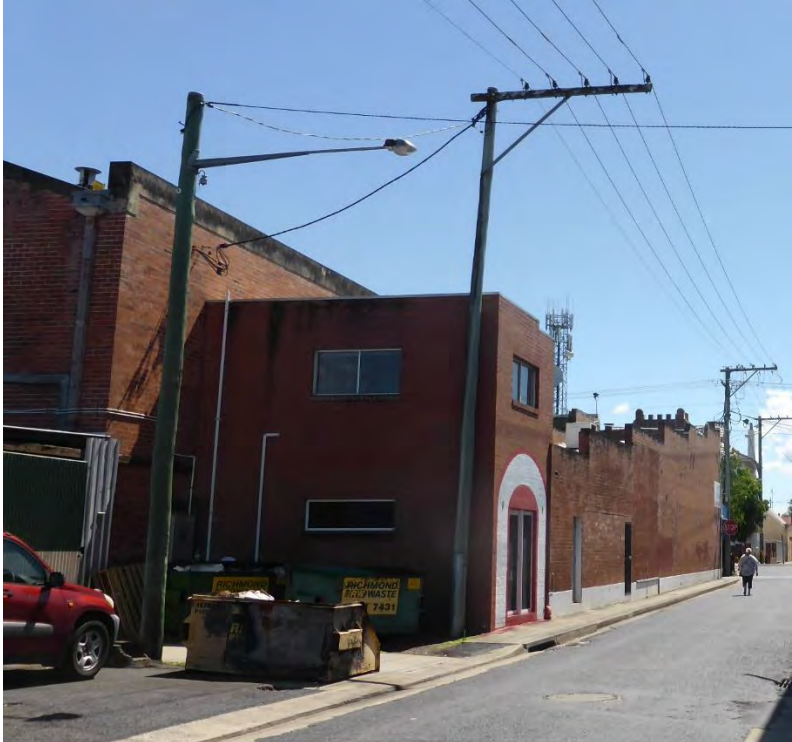
Building Elements	Observations	Recommendations
Roof	Metal roof behind parapet.	Repair or replace as required to original details.
Gutter	Not visible.	Ensure all drainage is dispersing away from base of masonry walls. Maintain and replace as necessary to original details. Maintain any original rain water heads or replace to match.
Walls	<p>Brick construction with a rendered parapet which has a castellated pediment and decorative features. The parapet is divided vertically with half height pilasters and horizontally by conspicuous mouldings. The detail of this is not apparent with existing white painted finish.</p> <p>The side wall faces Simpsons Parade with a nicely stepped parapet wall and original brickwork and has high visibility to the main street precinct. A later rear extension lies to the back of the property.</p>

Utilise an authentic period heritage colour scheme which highlights the architectural detail of the façade. Conserve original face brickwork unpainted.

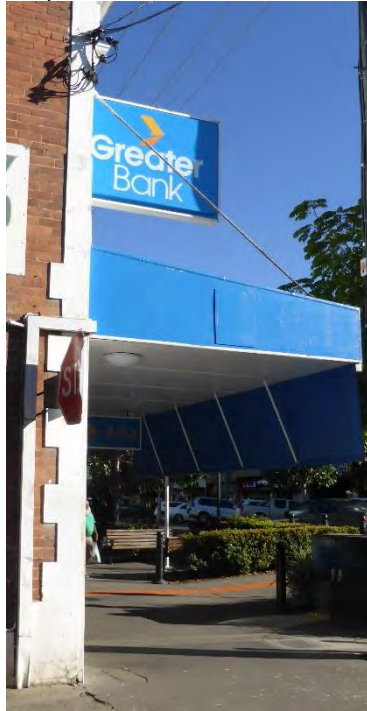
Suspended awning with fibre cement lining and blind in corporate colours. Above awning projecting sign.

Inspect original depth of fascia under signage panel. Reduce if appropriate to original proportions. Remove above awning signage and keep signage on or below fascia level.

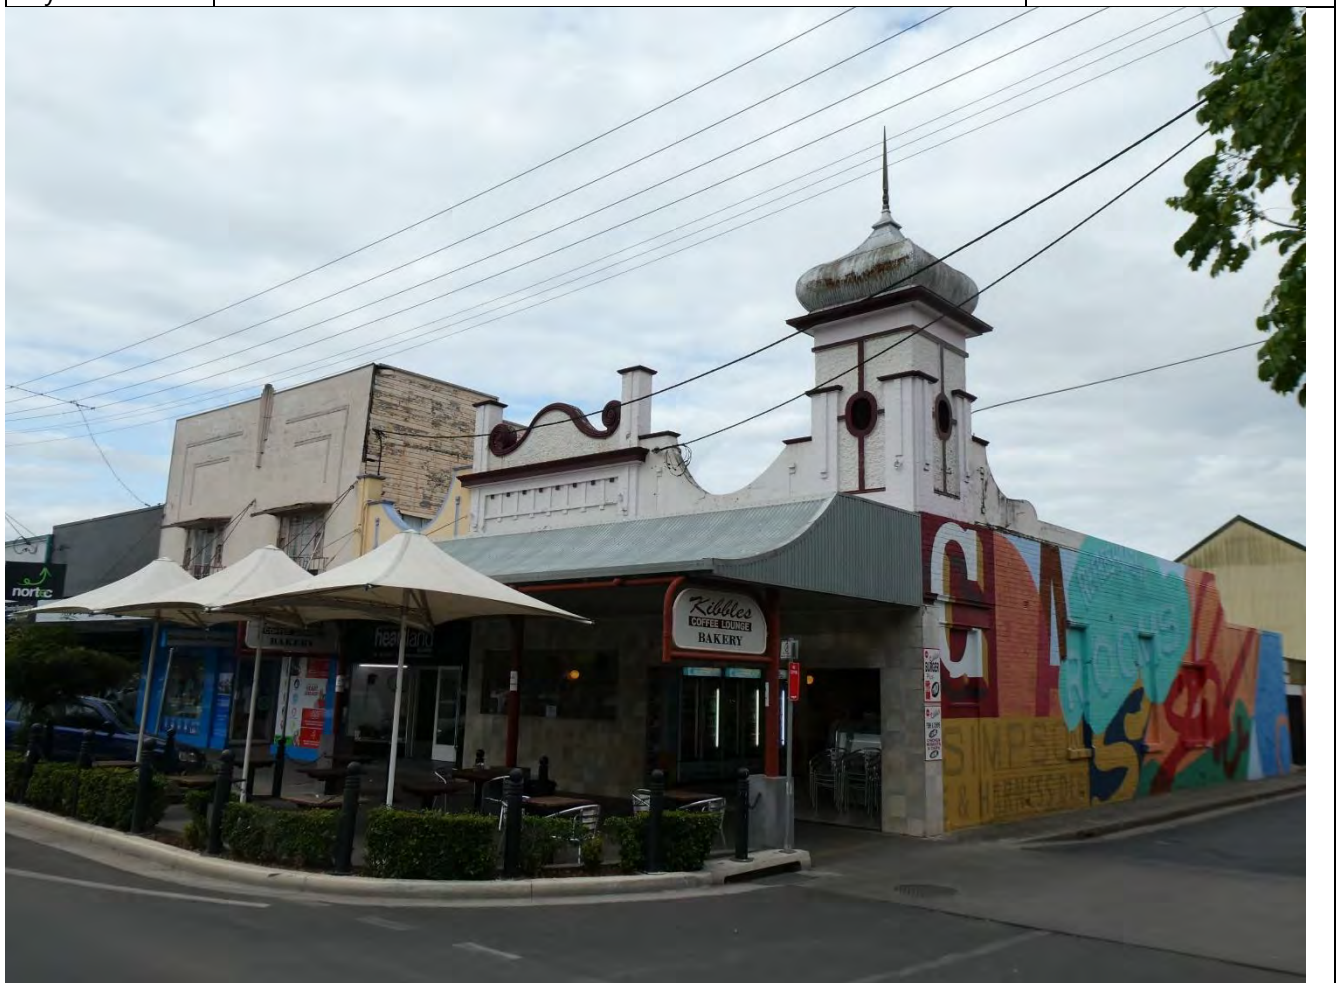
Building Elements	Observations	Recommendations
Roof	Metal roof behind parapet. Onion dome shows some signs of surface corrosion.	Carefully conserve to original details. Detailed inspection of the onion dome is required to check condition and address any corrosion.
Gutter	Not visible.	Ensure all drainage is dispersing away from base of masonry walls.
Walls	Brick rendered parapet with a scalloped pediment, vertical pilasters and rendered motifs. The parapet is divided into three sections, two of which are over the bakery and the third section over a separate shop. These are painted in two different colour schemes. The southern wall faces Simpsons Parade and has recently had a mural painted on the wall.	A period heritage colour scheme is recommended to unify the entire parapet and highlight more of the architectural detail.
Shopfronts and Windows	<p>The original shopfront of the bakery has been replaced with a modern aluminium fit out. The façade is faced with a stone type tile.</p> <p>The adjoining premises retains an early recessed shop entry, slender anodised window framing and timber framed double doors.</p>
