CASINO CBD HERITAGE CONSERVATION AREA MAIN STREET AUDIT

Prepared by
CLARENCE HERITAGE
FOR RICHMOND VALLEY COUNCIL
AUGUST 2020

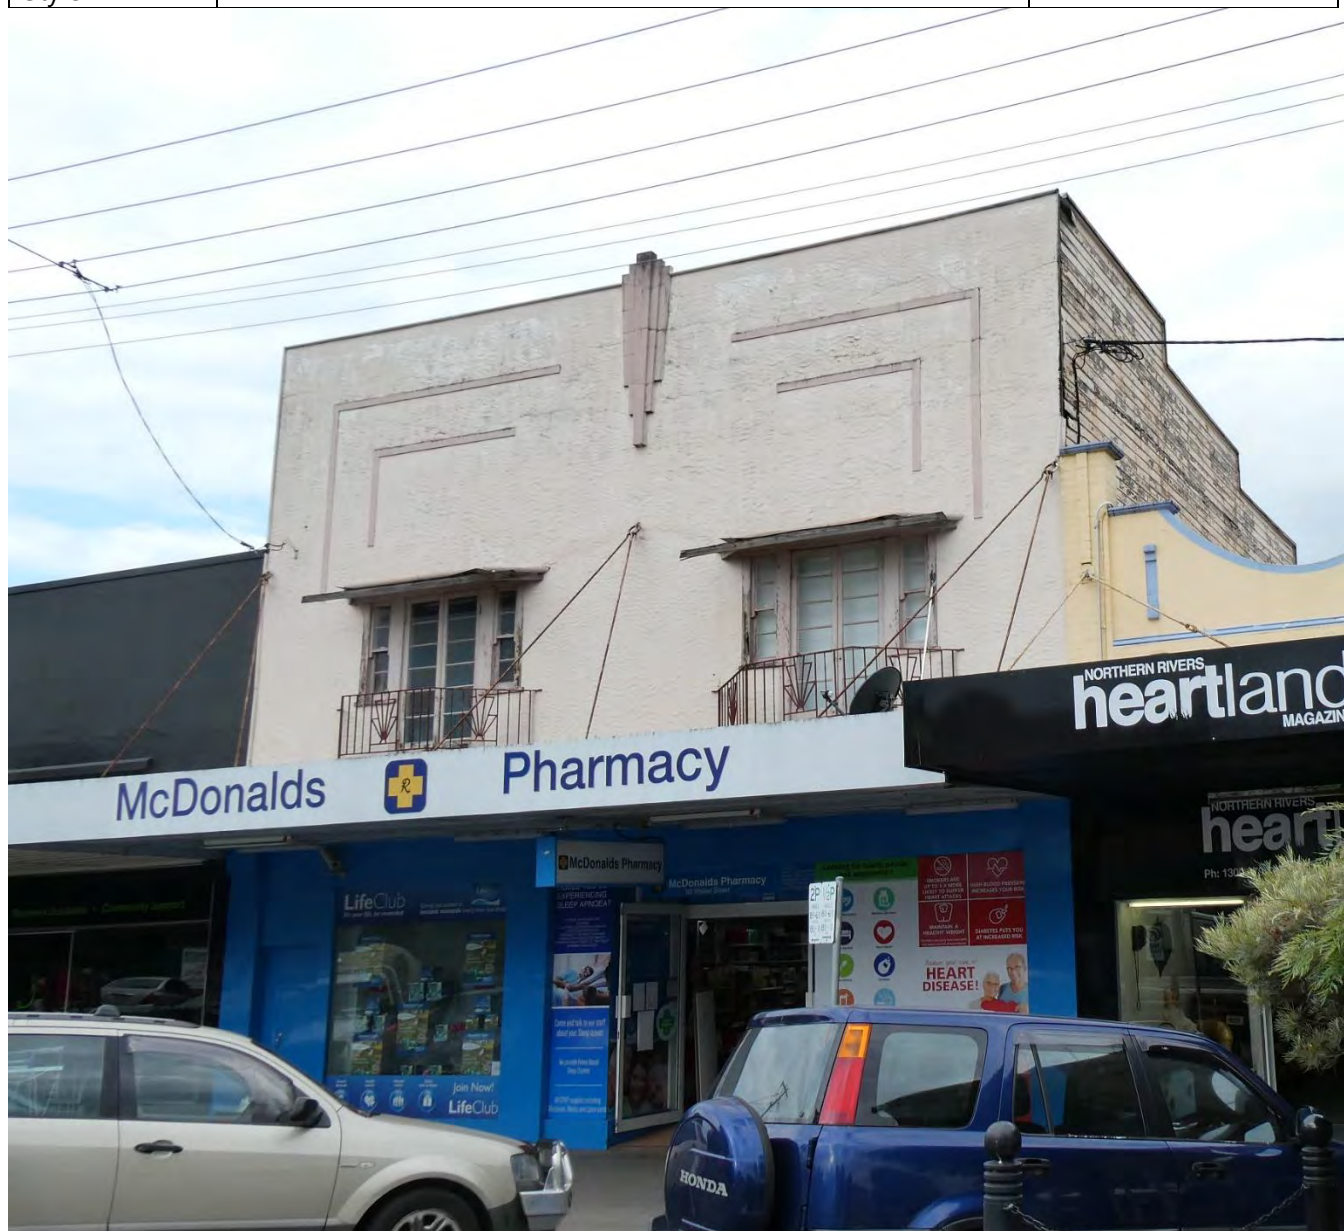
Building Elements	Observations	Recommendations
Roof	Metal behind parapet. Solar panels installed.	Maintain.
Gutter	Not visible.	Ensure all drainage is dispersing away from base of walls.
Walls	<p>Timber building with a straight edged rendered parapet with banded details and a central geometric motif.</p> <p>The render is a rough cast with a stippled type finish. There is some minor cracking to the decoration and render.</p>

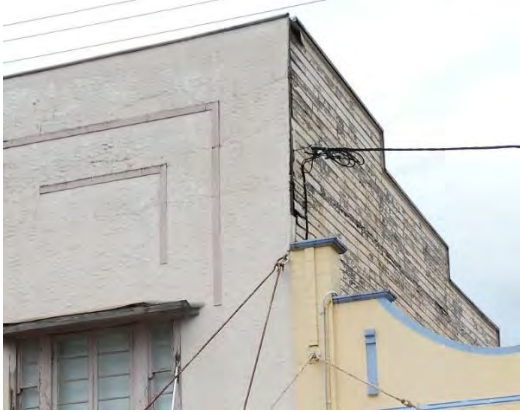
<p>Side elevations are plain timber weatherboards in need of repainting.</p>

<p style="text-align: right;">Southern wall</p>	<p>Repainting is required.</p> <p>Carefully conserve all original fabric and detailing.</p> <p>Unify the building façade by utilising a heritage colour scheme for the top and lower halves, restricting the corporate blue colour to more restrained signage or lettering.</p>

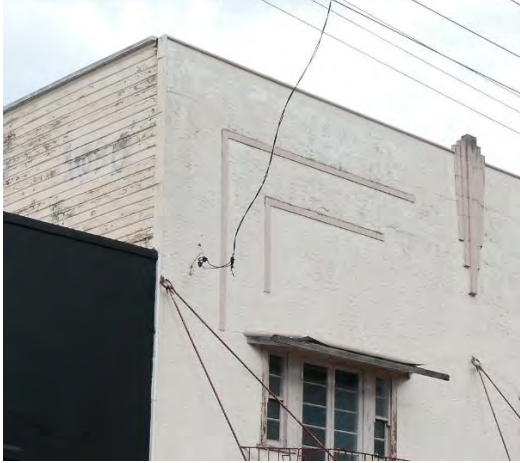
Shopfronts and Windows	<p>Northern wall</p> <p>The original shopfront has been replaced with a modern aluminium fit out. The blue powder coated finish has been extended across the all the lower walls Any future works to the shopfront may be informed by reconstruction of a shopfront detail</p>	appropriate to the era. Removal of the bold blue wall colour would enhance the heritage value of the façade.
Awning	<p>Suspended awning with anchor points on façade. Two sets of timber French doors open onto small balconies with metal balustrades. Small awnings extend over French doors and appear to need maintenance.</p>

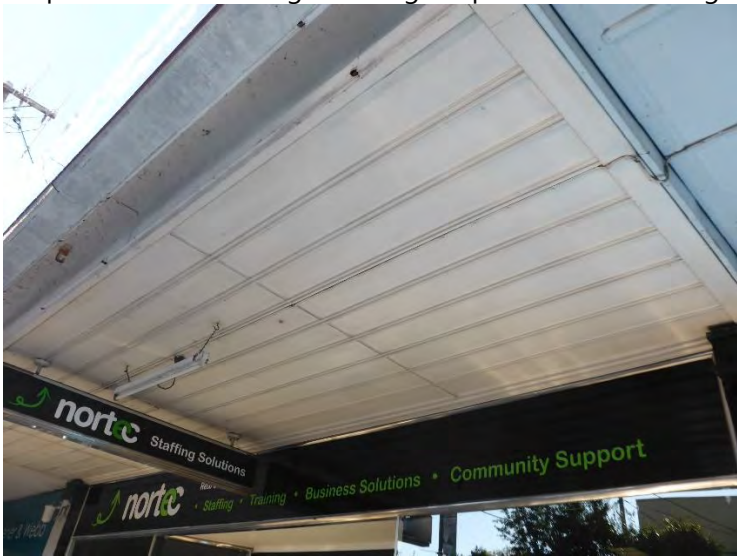
Awning	<p>Suspended steel awning with original pressed metal lining.</p>

<p>Carefully conserve awning, and ensure drainage is functioning.</p> <p>Investigate the detail under the current signage panel on fascia. Utilise a sympathetic fascia background colour as part of the overall heritage colour scheme and limit the black to signage lettering.</p>

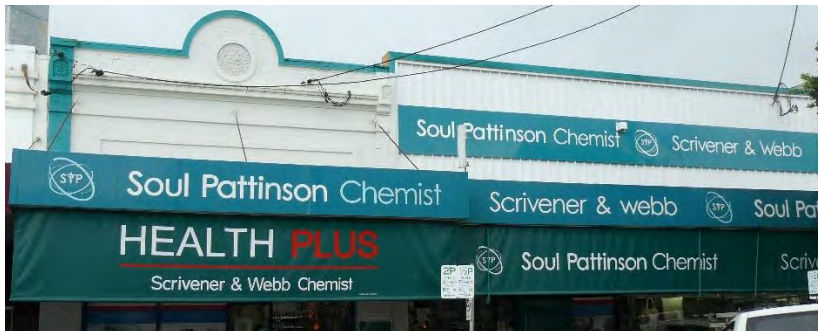
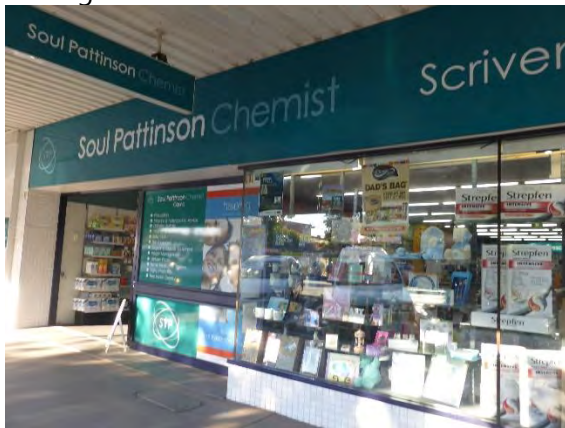
Shopfronts and Windows	<p>The southern end retains a section of early shopfront with slender glazing bars and a tiled stall riser. Tiles are not likely to be original. The northern end has modern framing.</p>	Carefully retain the early shopfront element and stall riser.
Awning	Suspended awning with modern lining.

- This is a contributory historic building with a notable parapet to no 91 and a section of early shopfront which should be carefully conserved.
- Repainting of the façade in a period heritage colour scheme is recommended and highlighting of architectural mouldings in subtle contrast colours.

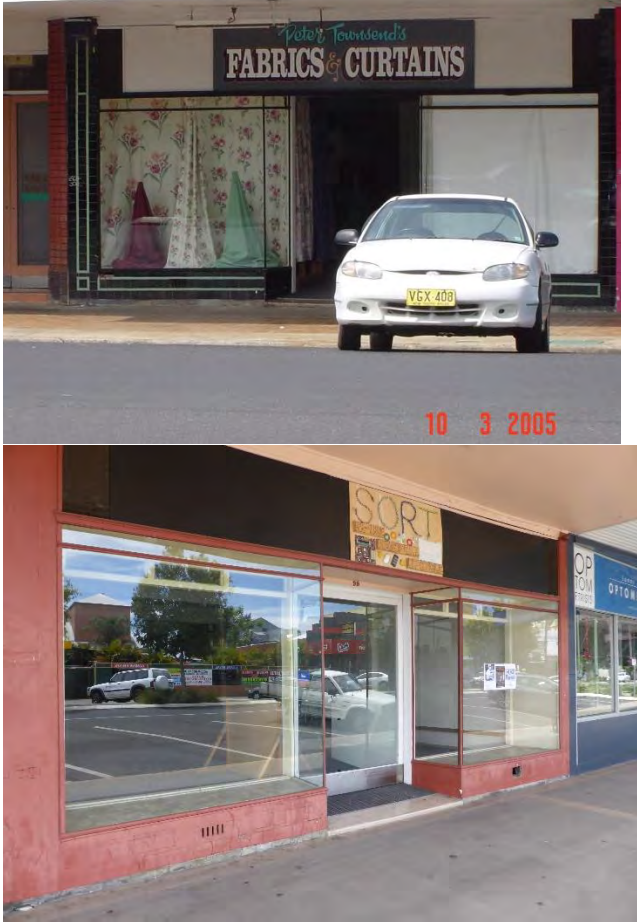
Building Elements	Observations	Recommendations
Roof	Metal roof behind parapet.	Maintain.
Gutter	Not visible.	Ensure all drainage is dispersing from base of walls.
Walls	Single storey rendered brick façade spanning four shopfronts. The facades are decorated with corbelled horizontal banding aside two plumes to the centre of each pair. Two multi paned timber windows of horizontal proportions are located above the awning level of each shopfront.	Repainting of the four façades in a consistent period heritage colour scheme is recommended together with the highlighting of architectural mouldings in subtle contrast colours.
Shopfronts and Windows	93, 95, 97 Non original 99 Highly intact original shopfront with slender framing, and a tiled stall riser, pillars and decorative tiling but non-original door. Compared to the 2005 photograph this has been painted over.	Note- Consent is required for alterations to the fabric finish and appearance of Heritage items and all buildings in the Conservation Area.

<p>Removal of the paint from shopfront 99 tiling by careful non-abrasive methods is recommended. A minor works application can be used for this proposal.</p> <p>New tenancy February 2020.</p>

<p>Awning</p>	<p>Suspended awning with fibre cement lining.. Most original fascia signage exists at 99 . Other signage extends over the original depth of the original signage fascia. Particularly at 97.</p>	<p>Signage should be contained within the original signage fascia depth. Complementary signage can be designed whilst allowing for individual business identities.</p>

- This is a significant historic building with a distinctive parapet and one early shopfront which should be carefully conserved.
- Repainting of the four façades in a consistent period heritage colour scheme is recommended together with highlighting of architectural mouldings in subtle contrast colours.
- Removal of the paint from shopfront 99 tiling by careful non-abrasive methods is recommended.
- Signage should be contained within the original signage fascia border. Complementary signage for the façade can be designed whilst allowing for individual business identities. Utilise a sympathetic fascia background colour as part of the overall heritage colour scheme and only utilise the corporate colours for signage lettering.
- Heritage grants are available to assist with conservation work through the annual heritage fund.

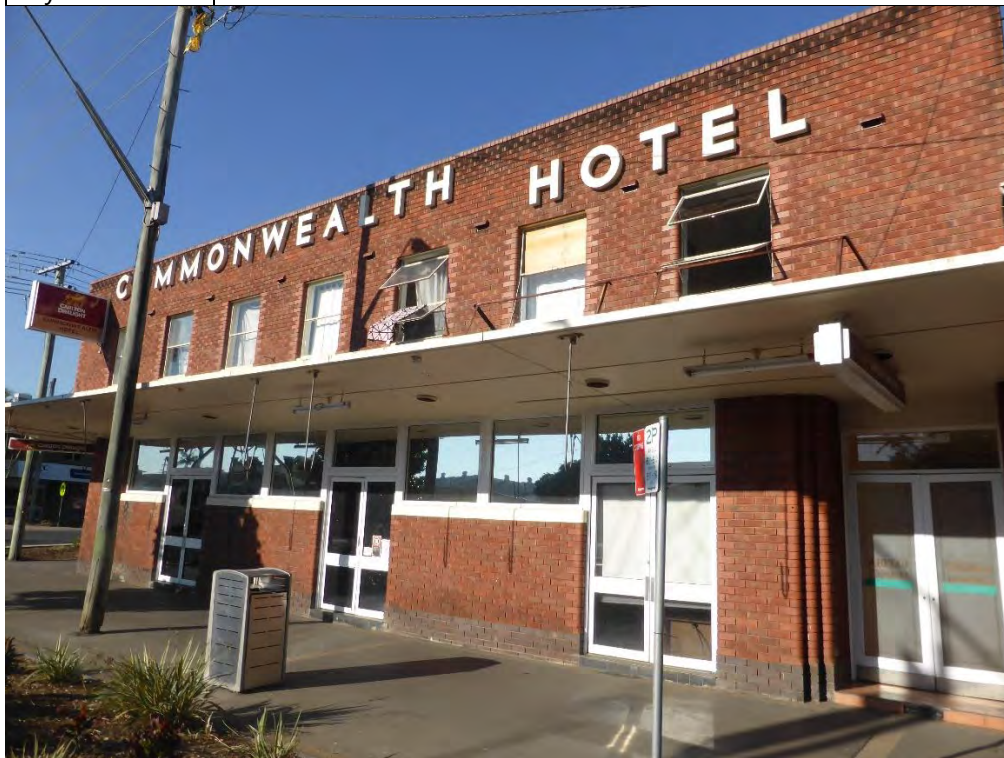
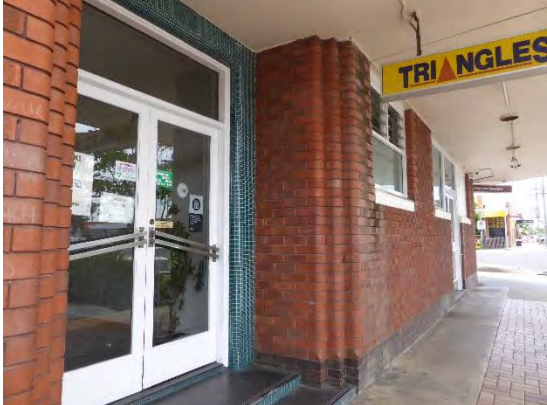
Name Address	Commonwealth Hotel 101 -105 Walker Street	
Heritage Item	No -	
Heritage Conservation Area	Yes	
Contributory Item	Yes	
Notes	<p>The Commonwealth Hotel is historically significant, having been first established on this site in 1901, the year of Federation and has had ongoing use as a hotel on this site for over 115 years. The current building constructed in 1957 is historically significant as it demonstrates confidence in the development of the Casino business district during the post war era.</p> <p>It is distinct in its appearance, signalling a new era of 'post war international' design style and construction and remains an important anchor building on the corner of Canterbury and Walkers Streets. It remains fairly intact in its original form and external finish. It demonstrates a less ornamented style than previous historical styles, with its detailing expressed through the decorative brickwork. It has a rhythm of vertically proportioned upper level glazing. The original narrow reinforced concrete awning together with the raised individual lettering of the hotel signage, is very stylistic of the era.</p>

Building Elements	Observations	Recommendations
Roof	Metal roof behind parapet.	Maintain.
Gutter	Not visible.	Ensure all drainage is dispersing from base of walls.
Walls	<p>Brick with contrast decorative curved brick entry doors custom brick bullnose and single bullnose stops.</p>

Carefully maintain brickwork.
Doors and Windows	Retains some original timber double entry doors with chrome push bars. It has a rhythm of vertically proportioned upper level glazing. Lower glazing has been altered previously with aluminium frames.	
Awning and Signage	<p>The original narrow reinforced concrete awning is stylistic of the era. Some water penetration was observed in the gaps between the concrete panels and has stained brickwork.</p> <p>The original raised lettering hotel signage is a key feature of the building and contributes to the historical and aesthetic significance of the Conservation Area.</p>	Carefully retain to original details. Address leaks to concrete awning.

- This is a significant post war building which should be carefully conserved. The brickwork, narrow concrete awning and raised lettering signage are important elements which contribute to the CBD.
- A Development Application has been approved by Council for upgrades and alterations. Heritage input was provided which resulted in an approved design which incorporated conservation of the significant elements of the building.
- Maintain original fabric and details as closely as possible.
- Heritage grants are available to assist with conservation work through the annual heritage fund.

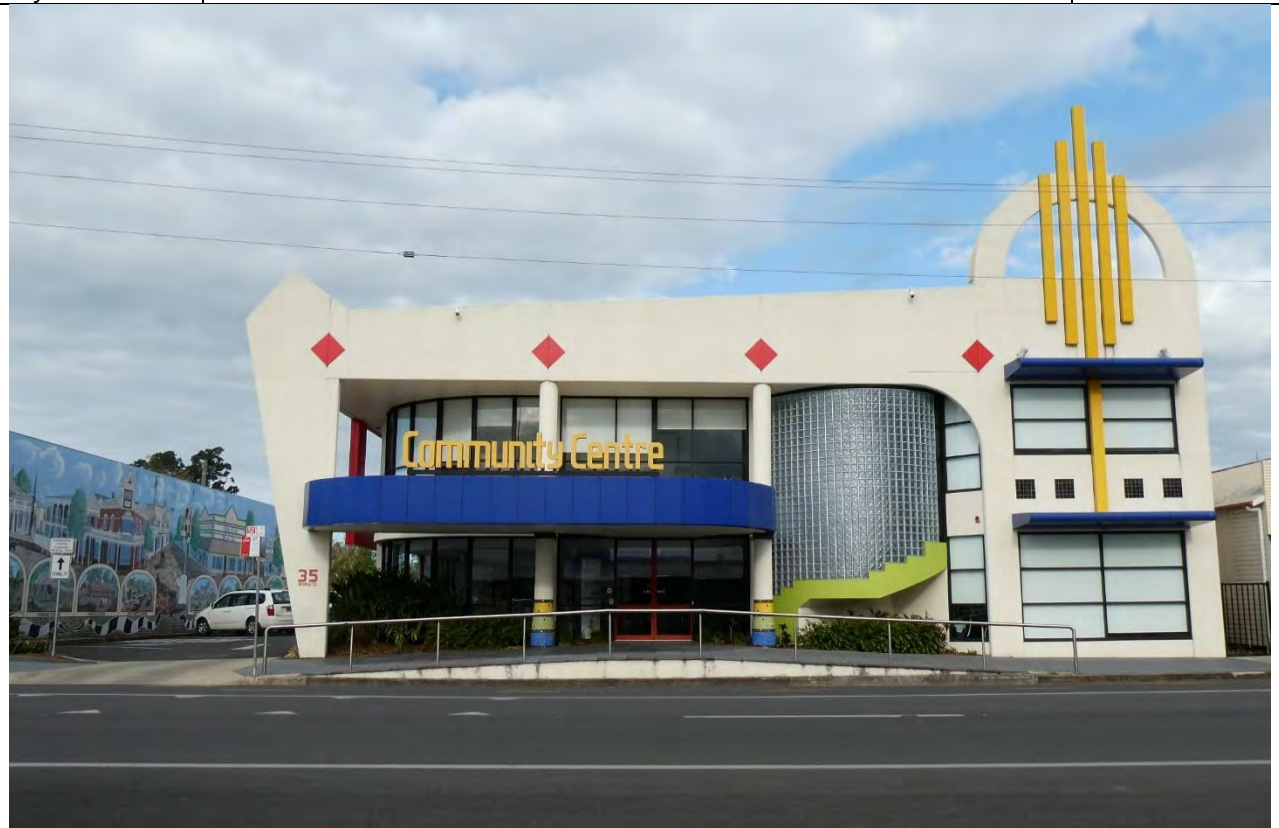
Name Address	Community Centre 35 Walker Street	
Heritage Item	No	
Heritage Conservation Area	No	
Contributory Item	Not as a historic item but forms part of the gateway to the historic precinct and lies in proximity to heritage listed items.	
Notes	A playful interpretation of art deco elements in a modern purpose built centre. Located in the civic precinct area. Community centre use.	
Architectural Style	Modern- influenced with art deco themes.	1990s

Building Elements	Observations	Recommendations
Roof	Metal roofing behind parapet.	
Gutter	Not visible	
Walls	<p>Rendered masonry with decorative motifs. Glass brick curved wall stairwell feature. Main wall colour is light neutral. Decorative features picked out in several primary colours.</p>	<p>Maintain light neutral body colour. Consider alternative contrast colours which are complementary to nearby heritage listed items and CBD Conservation Area context.</p>
Windows and Doors	Aluminium framed.	
Awning/verandah	Curved awning with a deep fascia and round columns which are not a feature common in the Casino CBD.	
<p>Recommendations</p> <ul style="list-style-type: none"> • Maintain a light neutral body colour. • Consider non-primary colours for the contrast trims sympathetic to the nearby heritage listed items and the CBD Conservation area colour palettes, and in accordance with Councils DCP policies.

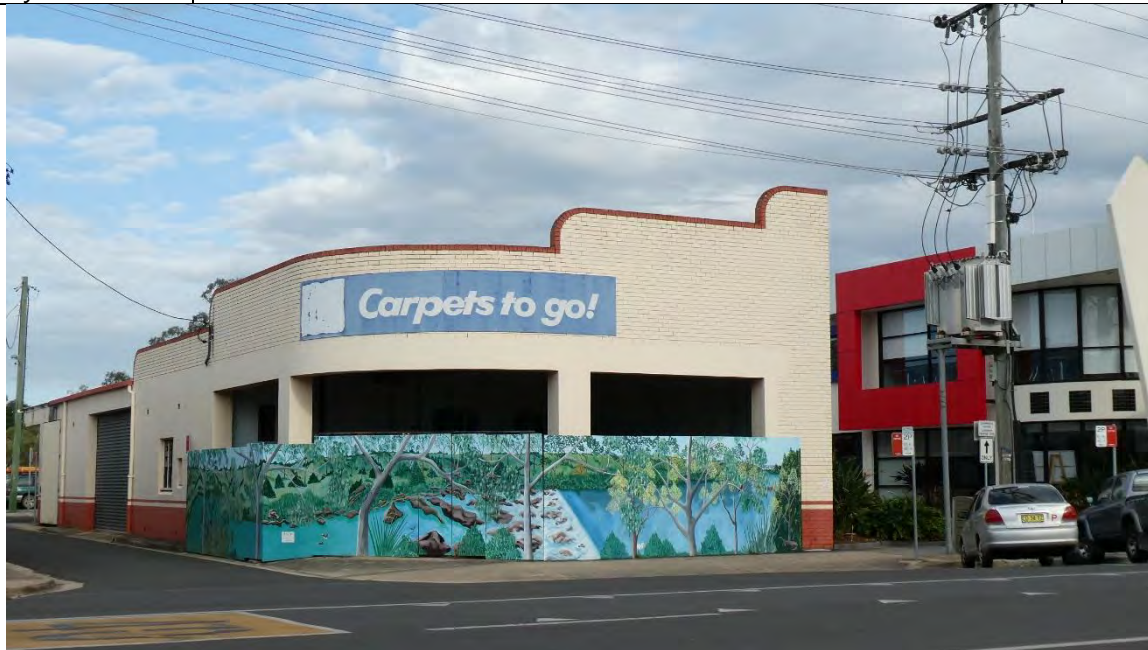
Name Address	Commercial Building 39 Walker Street	
Heritage Item	No	
Heritage Conservation Area	No	
Contributory Item	No	
Notes	One of a pair of modern infill commercial buildings with a waterfall parapet design facing each other, located in the civic precinct area with close proximity to heritage listed items.	
Architectural Style	Modern- Art Deco/P and O Liner influenced modern infill	1990s

Building Elements	Observations	Recommendations
Roof	Metal roofing behind parapet.	Maintain
Gutter	Not visible	Maintain
Walls	Painted face brickwork Curved façade Main wall colour is light neutral. Little ornamentation	Maintain light neutral body colour and trims complementary to nearby heritage listed items and CBD Conservation area colour palettes.
Windows and Doors	Not in place	
Awning/ verandah	Not in place	
Recommendations <ul style="list-style-type: none"> • Maintain a light neutral body colour and trims complementary to nearby heritage listed items and CBD Conservation area colour palettes in accordance with Councils DCP policies. • Utilise sympathetic discreet signage. Do not place any adverts above awning level.

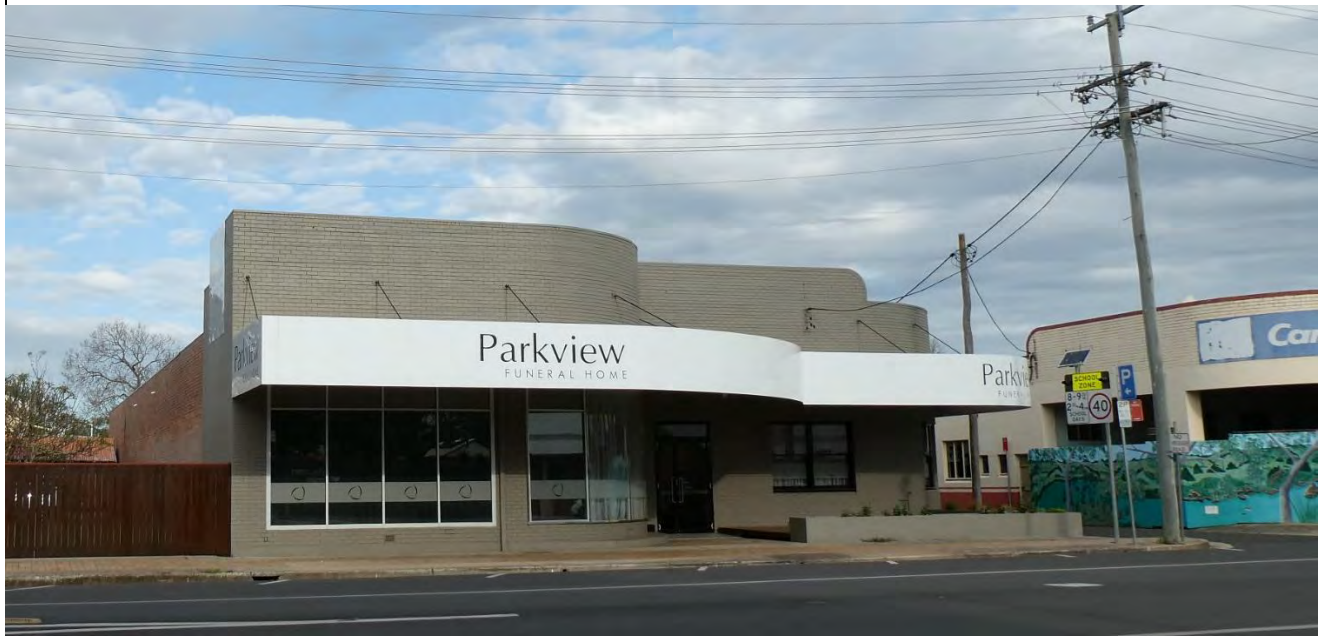
Name Address	Parkview Funeral Home 41 Walker Street	
Heritage Item	No	
Heritage Conservation Area	No	
Contributory Item	No	
Notes	One of a pair of modern infill commercial buildings with a waterfall parapet design facing each other, located in the civic precinct area in proximity to heritage listed items.	
Architectural Style	Modern- art deco/P and O Liner influenced infill	1990s

Building Elements	Observations	Recommendations
Roof	Metal roofing behind parapet.	Maintain
Gutter	Not visible	Maintain
Walls	Painted face brickwork Curved façade with curved awning. Main wall colour is light neutral. Little ornamentation	Maintain light neutral body colour and trims complementary to nearby heritage listed items and CBD Conservation area colour palettes.
Windows and Doors	Aluminium framed, vertically proportioned elements within wider openings which follow curve of wall.	
Awning/verandah	A curved awning is suspended from the façade, and follows the form of the building. It has a deep fascia, with white background and discreet signage. The depth of fascia is quite heavy.	Consider reduction of the depth of sign fascia to streamline this detail and enhance the façade.
<p>Recommendations</p> <ul style="list-style-type: none"> • Maintain a light neutral body colour and trims complementary to nearby heritage listed items and CBD Conservation area colour palettes in accordance with Councils DCP policies. • Utilise sympathetic discreet signage. Do not place any adverts above awning level. • Consider a reduction of the depth of the sign fascia to streamline this detail and enhance the façade.

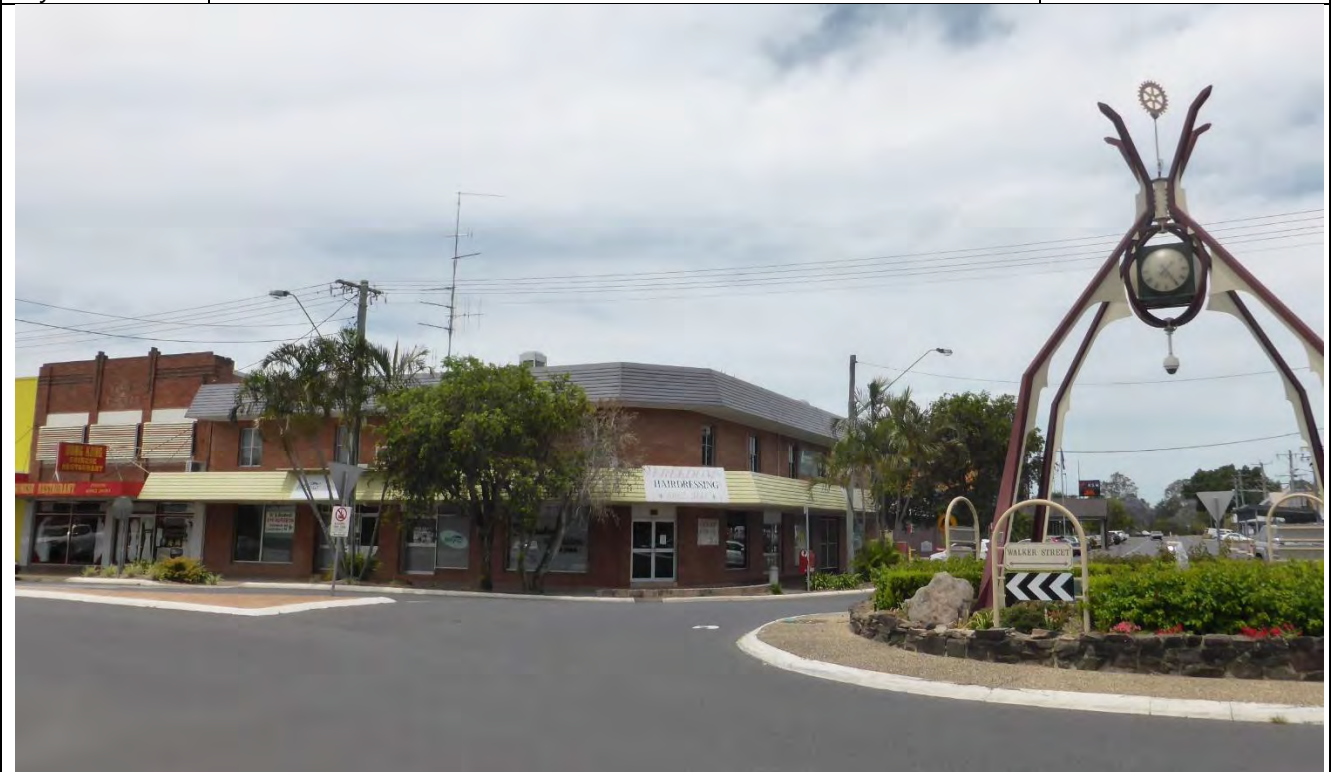
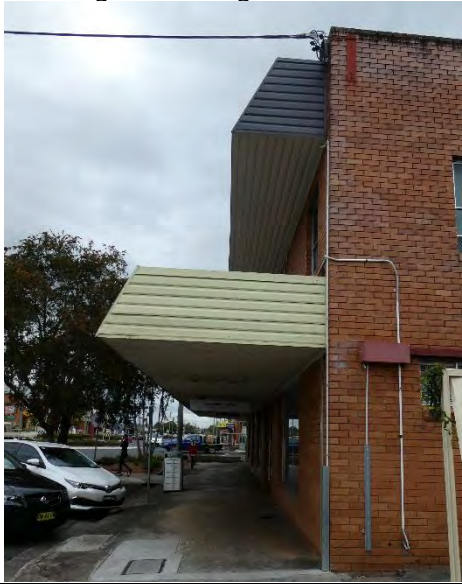
Name Address	Offices –Richmond Arcade 107 Walker Street Cnr of Walker and Canterbury Streets	
Heritage Item	No	
Heritage Conservation Area	No	
Notes	Located on a prominent corner site in the CBD and anchors this corner of the streetscape on the entry to the historic precinct and is part of the setting and entry to the historic CBD.	
Contributory Item	No	
Architectural Style	Post War	Circa 1970s

Building Elements	Observations	Recommendations
Roof	Concealed behind parapet.	
Gutter	Not visible	Ensure all stormwater and drainage is working and water is dispersed away from edges of building.
Walls	Two storey commercial building of face brick construction.	Maintain unpainted or paint in a sympathetic light neutral colour.
Shopfront and Doors	Aluminium	
Awning	<p>A deep angled cantilevered metal awning extends over the footpath to match the angled fascia on the top of the building. These elements are out of character with the character and finer detailing of buildings in the Casino CBD precinct.</p>

Consider the replacement of metal awnings, with a more slender horizontal profile and narrower fascias in a contemporary style to enhance this prominent corner on the edge of the historic precinct.
<p>Recommendations.</p> <ul style="list-style-type: none"> • Ensure building is well maintained and watertight. • Ensure all stormwater and drainage is working and water is dispersed away from edges of building. • Consider redesign of the metal awnings with a more slender horizontal profile and narrower fascias to enhance this prominent corner on the edge of the historic precinct. • Maintain brickwork unpainted or any painting of this surface should be in a light neutral colour sympathetic to the setting of the adjoining heritage conservation area precinct. • Consider a co-ordinated set of signage to provide unity to this building and enhance its streetscape presentation.

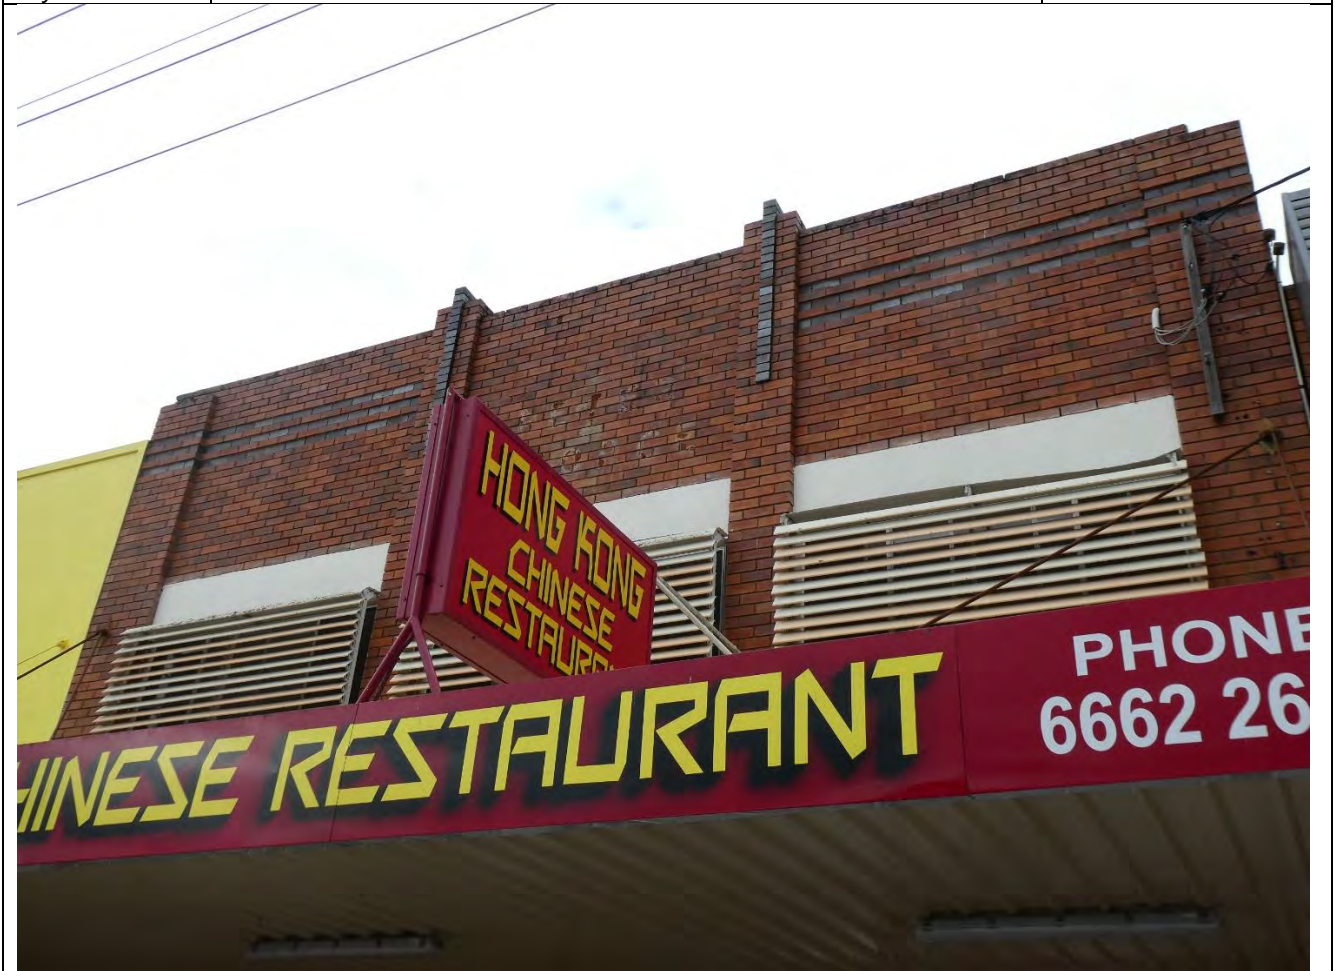
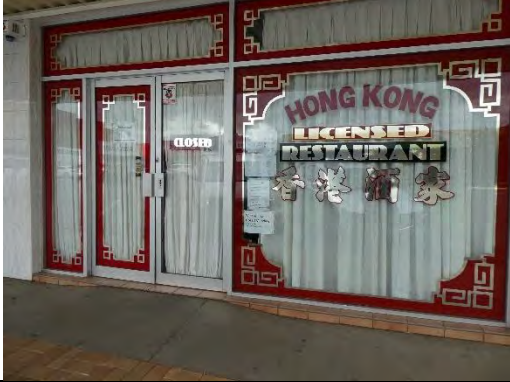
Name Address	Shop/Restaurant 115 Walker Street	
Heritage Item	No	
Heritage Conservation Area	No	
Contributory Item	Yes	
Notes	This two storey interwar building contributes to the streetscape and the entry to the historic part of the CBD and is similar to buildings of the interwar era within the Heritage Conservation Area.	
Architectural Style	Interwar	1930-40

Building Elements	Observations	Recommendations
Roof	Concealed behind parapet.	Maintain
Gutter	Not visible	Maintain and ensure all drainage is dispersing from base of building.
Walls	Face brick, unpainted. Two storey building with a simple parapet including decorative recessed banding in darker contrast brick colour and four vertical piers, two of which extend above the top of the parapet. A balcony exists at the first floor level which is screened by louvered blinds, which detract somewhat from the largely intact original façade.	Carefully conserve the brickwork façade and original details. Do not paint over the brickwork. Consider replacement of external blinds with internal blinds.
Shopfront and Doors	Aluminium with applied signage.

Awning	Suspended awning with metal supports. Metal clad lining.	
Signage	The signage applied on the fascia may extend deeper than the original fascia. Above awning sign.	Replace the above awning sign with an under awning hanging sign.

<p>Recommendation.</p> <ul style="list-style-type: none"> • Carefully conserve the brickwork façade and original details. Do not paint over the brickwork. • Consider replacement of the external blinds with internal blinds. • Consider removal of above awning sign and replace with under awning hanging sign. • Investigate whether the original fascia /border remains under the current signage and whether the signage can be placed within this border.

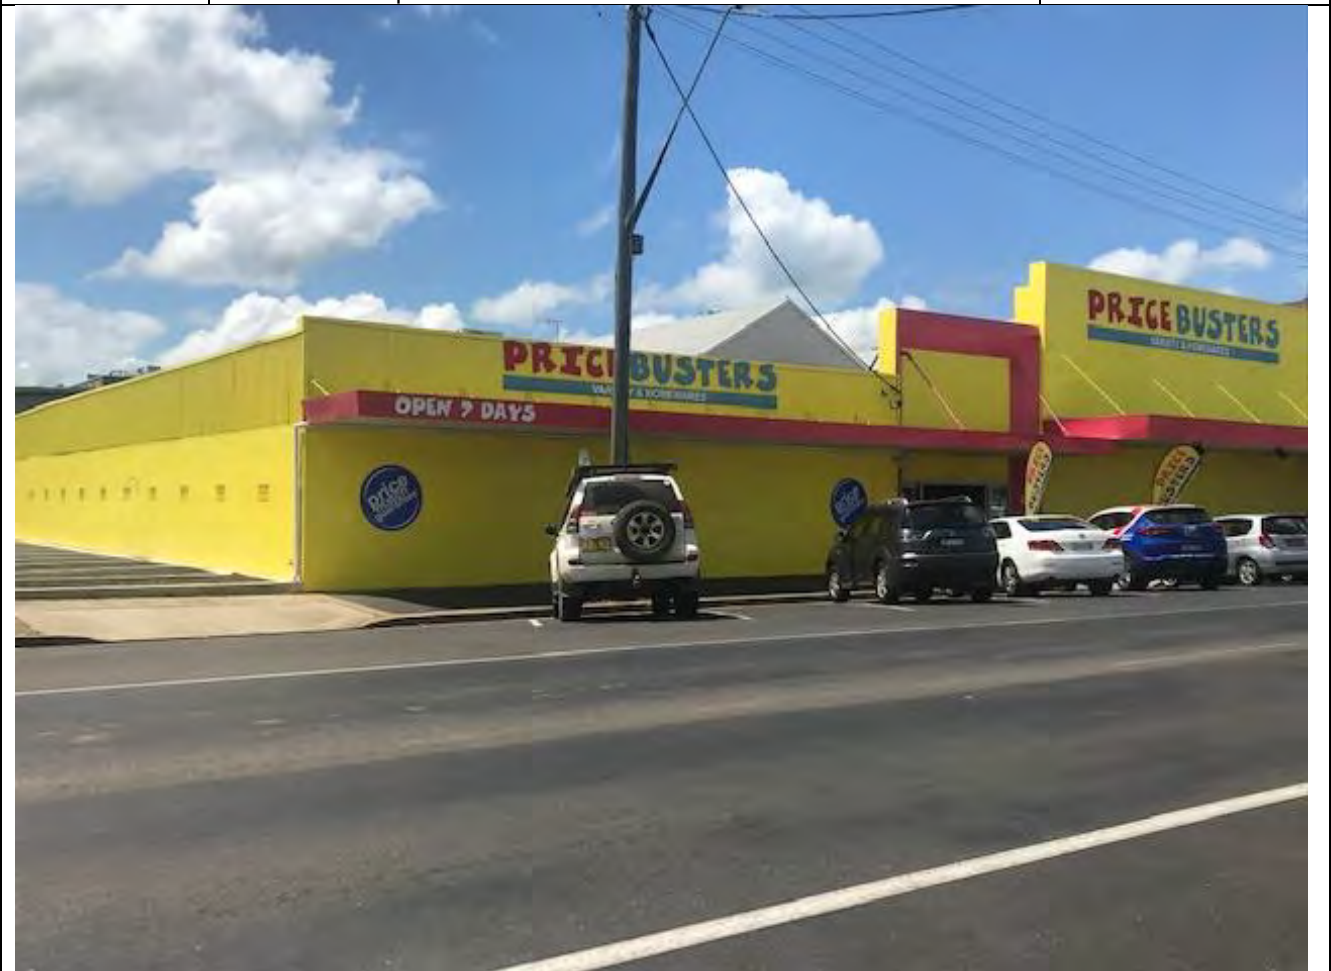
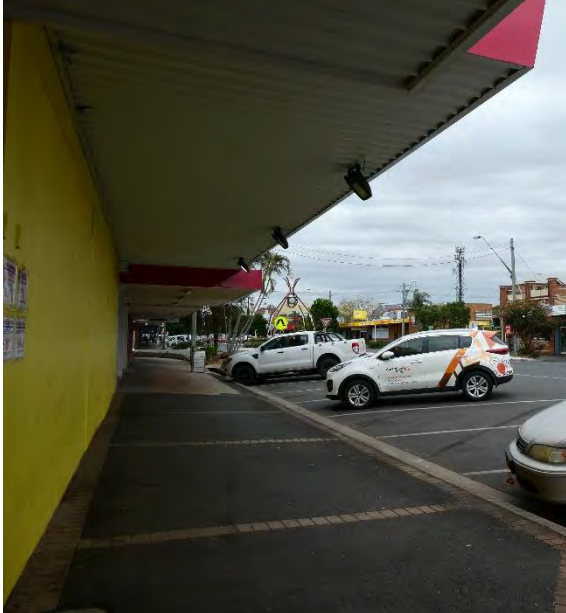
Name Address	Shop Pricebusters,-formerly Mitre 10 127 Walker Street	
Heritage Item	No	
Heritage Conservation Area	No	
Notes	Although located outside of the boundary of the Heritage Conservation Area this building forms part of the gateway into the historic CBD and adjoins a contributory period interwar building.	
Contributory Item	No	
Architectural Style	The two storey building adjoining 115 Walker Street with the gabled roof to the rear of the parapet may be 1950s. Further research is required. Later modern infill to the north.

Building Elements	Observations	Recommendations
Roof	Concealed behind parapet. Gabled roof to building at rear.	
Gutter	Not visible	
Walls	<p>Comprises two buildings, one a brick building adjoining the restaurant at 115 Walker Street with a high brick parapet and cantilevered awning. This part of the building appears to be older and has a narrow traditional style awning fascia.</p> <p>Adjoining this to the north is a raised portico entry and the rest of the building extends to a lower section with a deep metal cladding to the parapet. The whole façade and side elevation is painted in bold yellow with primary colours for signage.</p>	<p>Repaint the building in a neutral background colour to harmonise with the character and setting of the nearby historic CBD precinct. Minimise corporate colours to distinct adverts.</p>
Shopfront and Doors	<p>Closed off to the streetscape other than entry doors. There is little window display and the building presents a dead frontage to the streetscape.</p>

<p>Installation of regular spaced window openings would enhance this façade and activate the frontage.</p>

Awning	Suspended awning with metal supports.	Maintain
<p>Recommendation.</p> <ul style="list-style-type: none"> • Repaint the building in a neutral background colour to harmonise with the character and setting of the nearby historic CBD precinct. • Minimise corporate colours to distinct adverts. • Addition of full height window openings along the frontage for shop displays would enhance this façade and create a more interesting active frontage to the CBD.

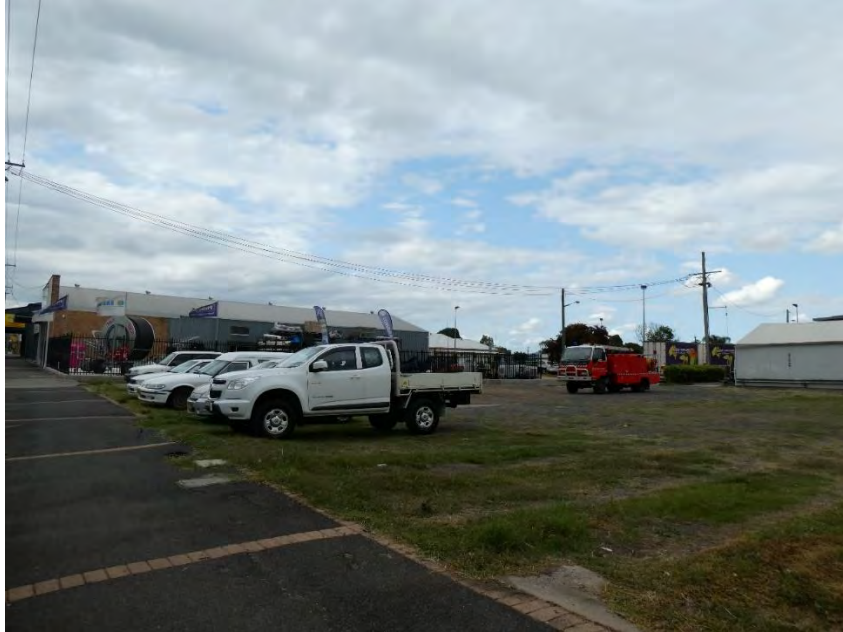
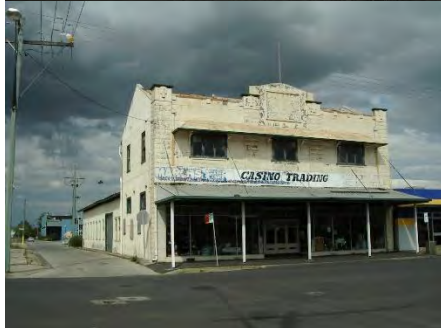
Name Address	• Vacant Site 139 Walker Street	
Heritage Item	Yes. Note site is still mapped on LEP as heritage item	
Notes	Vacant site with scope for redevelopment in a sympathetic form to enhance CBD

Former building demolished 2013/14.

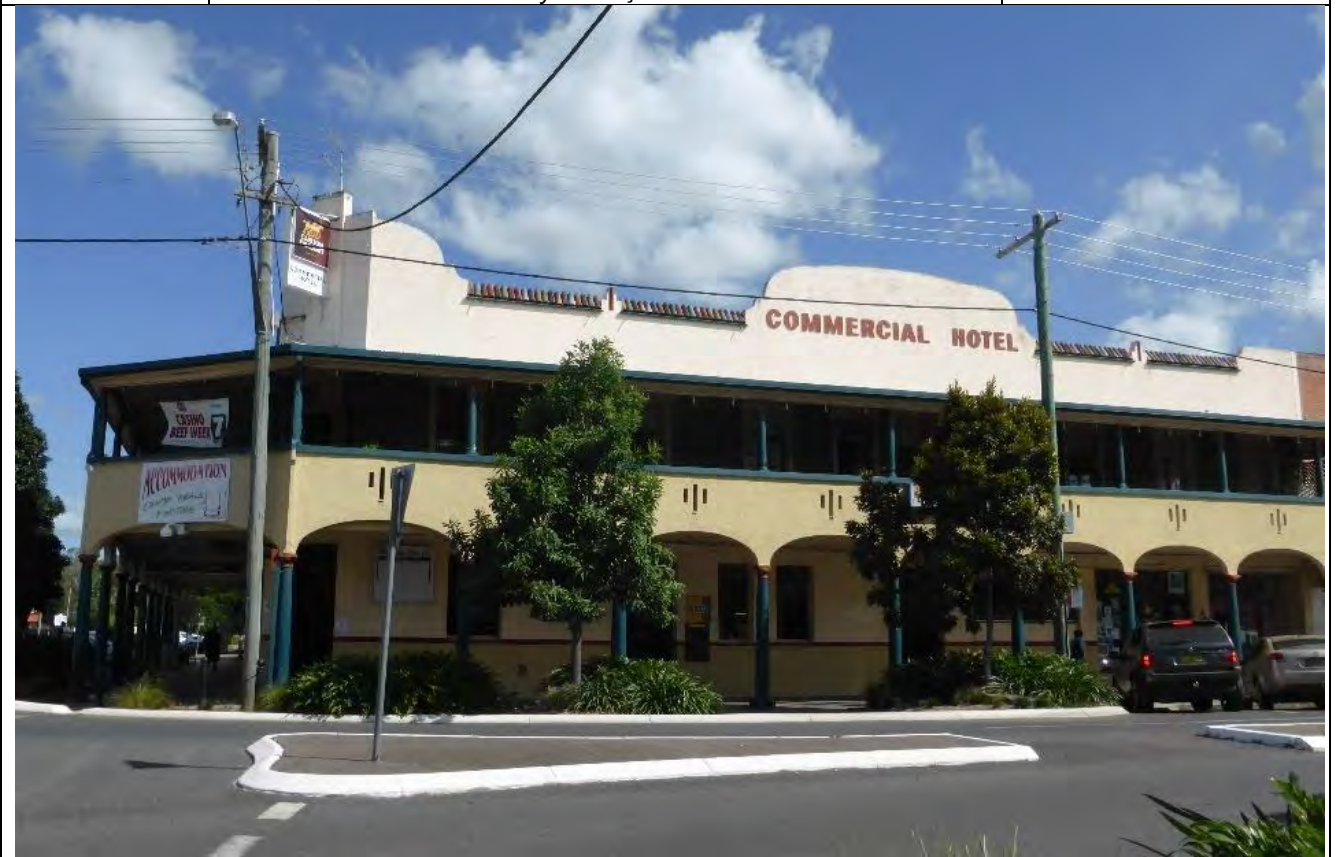
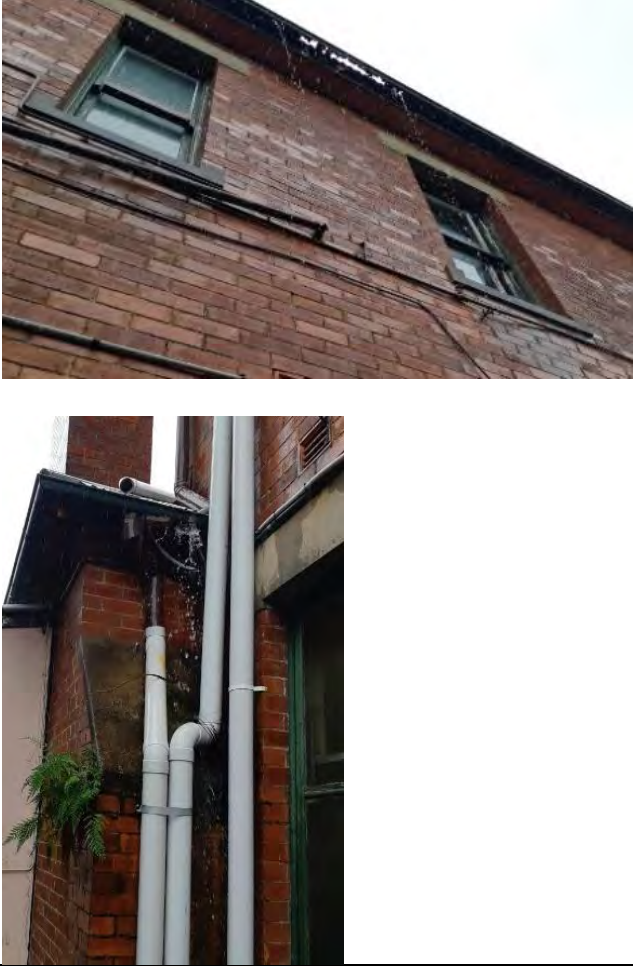
Name Address	Commercial Hotel 70-74 Walker Street	
Heritage Item	Yes	SHI 2850278
Contributory Item	Yes	
Statement of Significance	The Commercial Hotel, is reputedly the second oldest business house in Casino and is historically significant for its association with the growth and development of the town. Located on the corner of Walker and Barker Streets this building has landmark qualities and the site has archaeological potential. While substantially modified it could be refurbished to its pre 1900 style, however the 1937 Spanish Mission façade remodel is also significant as it reflects a major period of growth in the town.	
Architectural Style	Dates 1869, 1890, 1937. Earlier Victorian building phases modified by Interwar Spanish Mission/Mediterranean styled façade alterations.

Building Elements	Observations	Recommendations
Roof	Hipped and gabled Galvanised iron/steel.	Replace as required to original details.
Gutter	<p>Low front quad, non-perforated.</p>

<p>Gutter is rusted out on southern elevation and causing water to pour on foundations. Guttering needs to be checked over whole building. Replace as required to original details of low front quad profile. Replace downpipes in round metal.</p>
Walls	<p>Rough cast render to street facades in Spanish Mission style. Parapet capped with curved multi coloured terracotta tiles. Original unpainted face brick to rear and side walls and courtyard in original condition. Rear elevations retain the Victorian earlier architectural style.</p>

- The top priority is to ensure the building is water tight and that stormwater is being dispersed away from the edge of the building.
- Replace rusted guttering with matching low front or ogee non perforated profile gutter.

- Check downpipes and ensure all stormwater is discharged away from the edges of building to ensure no pooling on foundations.
- Carefully conserve and retain all original external fabric.

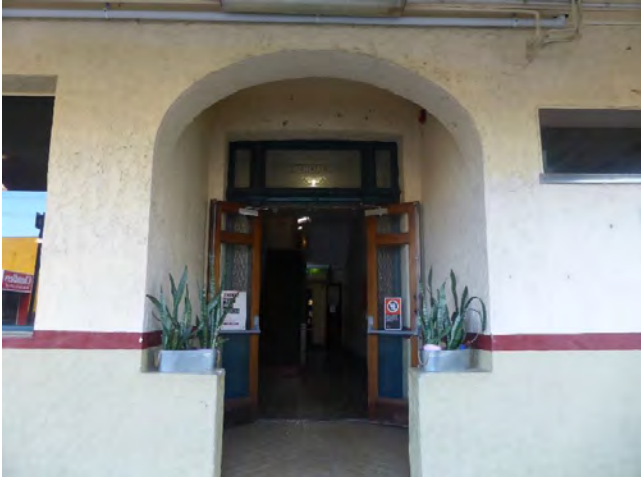
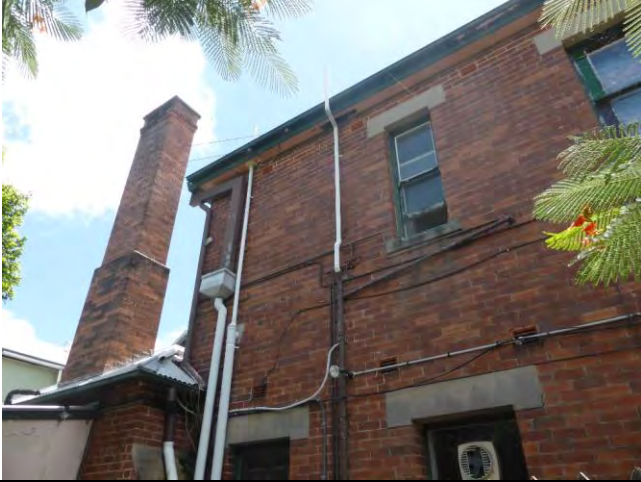
<p>Maintain an authentic heritage colour scheme for any future repainting.</p> <p>Ensure that all original face brick remains</p>

<p>unpainted. Maintain chimney.</p>
<p>Windows</p>	<p>Original shopfronts and windows, including leadlight transom windows to shop fronts at southern and western ends of building. Etched lettering on Dining Room glass and entry transom window.</p>

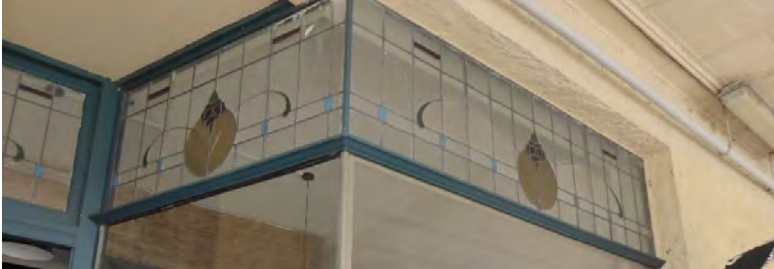
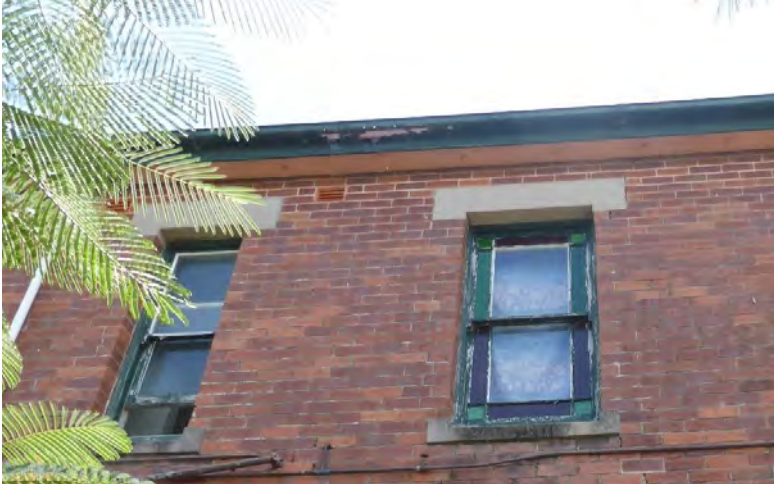
<p>Double hung sash windows with double margin glazing bars and coloured glass side panels to original windows.</p>

<p>Carefully conserve all original doors and windows to original details.</p> <p>Repairs and painting are urgently required to timber sash windows to protect original timber joinery.</p>

- Timber window joinery and repainting are showing clear signs of deterioration.
- The current signage is discreet.
- Any future signage should complement the scale and proportion of this building.

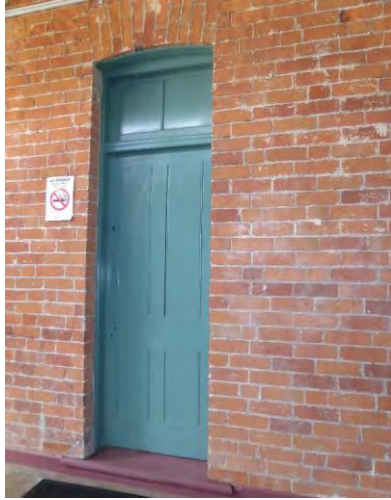
Original doors include panelled vertical jointed timber doors with transom lights to rear courtyard rooms.

Carefully conserve to original details.

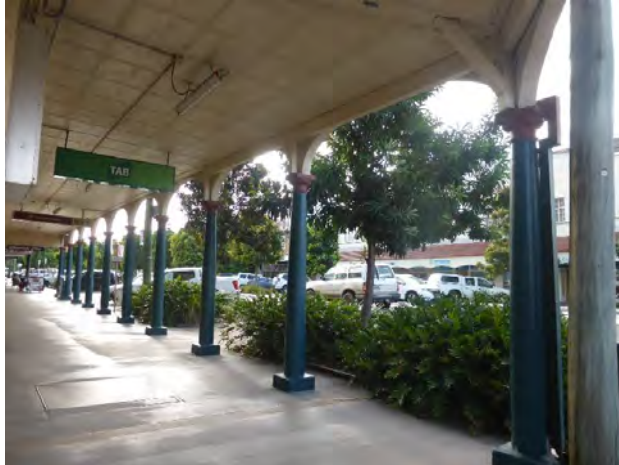
Post supported verandah with tapered Tuscan columns. The tapered columns encase the original metal capitals. Pressed metal lining featuring art deco motif.

Carefully conserve existing fabric.
