CASINO CBD HERITAGE CONSERVATION AREA MAIN STREET AUDIT

Prepared by
CLARENCE HERITAGE
FOR RICHMOND VALLEY COUNCIL
AUGUST 2020

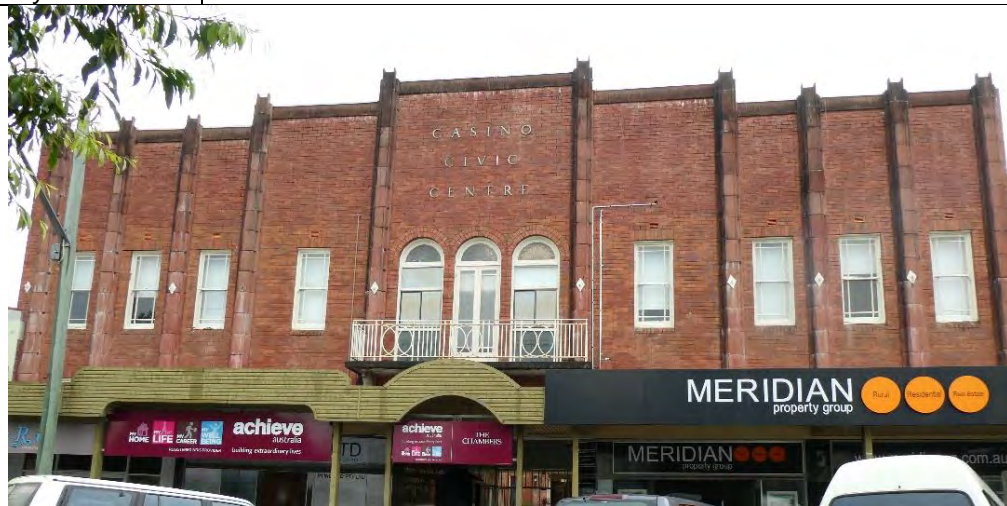
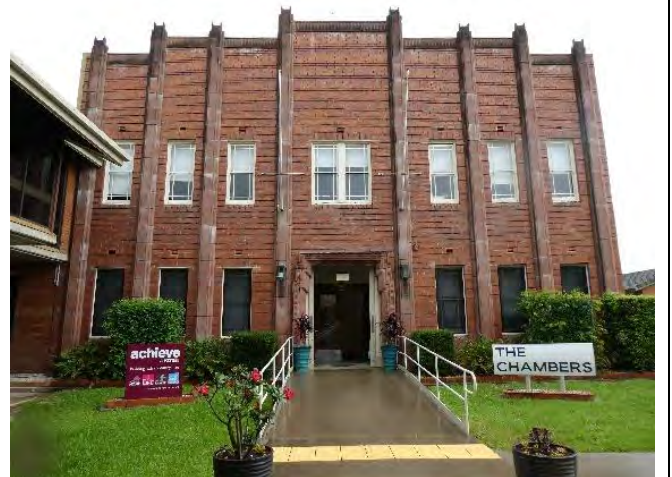
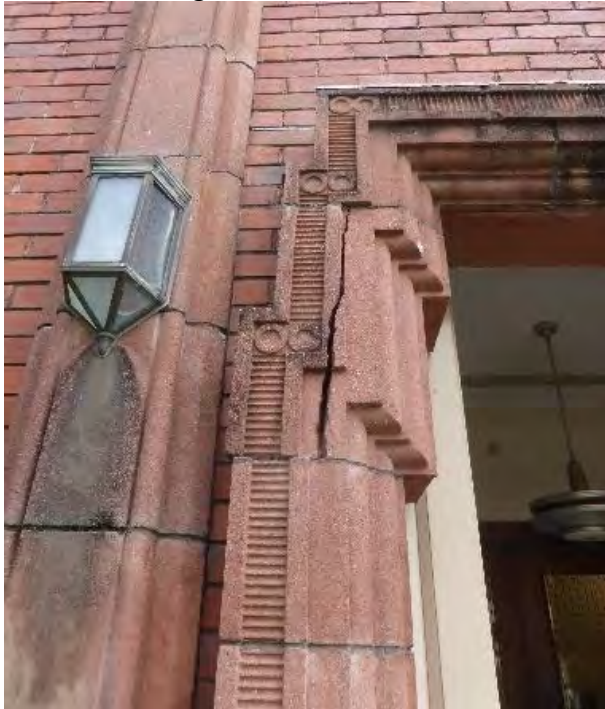
Name Address	Former Casino Municipal Council Office Complex 94-102 Walker St	
Heritage Item	Yes.	SHI 2850013
Statement of Significance	The Casino Civic Centre is an extremely good example of inter-war building in the Art Deco style. Both internal and external decoration embody the characteristics of this style and the complex forms an integral part of a strong stylistic theme that extends throughout the Casino CBD. In addition the buildings are historically significant for their association with local government in Casino and they have social significance to the community and those who have worked here. The listing comprises the 2 former civic buildings, one to the street frontage and one built behind, forming a courtyard between and includes the arcade, shops, courtyard and interior fittings.	
Contributory Item	Yes	
Architectural Style	Interwar Art deco style	1936-7

Building Elements	Observations	Recommendations
Roof	Metal hipped and gabled roof behind parapet	Repair or replace to original details.
Gutter	Not visible.	Ensure stormwater is well maintained and water is dispersing away from the base of the building.
Walls	<p>Red brick with stepped parapet and ornate mouldings. The façades are divided into bays with vertical precast concrete block ribs. The centre bay to Walker Street contains a small cantilevered balcony with wrought iron balustrade on the street frontage. There is cracking in the stepped mouldings to the entry doorway to the rear building.</p>

<p>Carefully maintain all original fabric.</p> <p>Do not paint the brickwork or cement mouldings.</p> <p>Address repair and reason for cracking.</p>
Windows	<p>Double hung timber windows with double margin glazing bars. Screened on lower floor</p>

- The preparation of a Conservation Management Plan is strongly recommended to guide the future conservation of this building which contains a very high degree of original fabric and interior detailing. This should include a detailed schedule and assessment of all elements including all original interior elements.
- A building complex of this size would benefit from preparation of a Conservation Management Plan and Maintenance Plan which will provide schedules to ensure that ongoing maintenance occurs on a regular basis and can be budgeted for accordingly.
- A heritage grant can be sought for preparation of these plans as well as maintenance and conservation works.
- Carefully conserve and retain all original external and internal fabric.
- Regularly address water management and stormwater management
- Address cracks to and terrazzo and mouldings to entry by specialist trades.

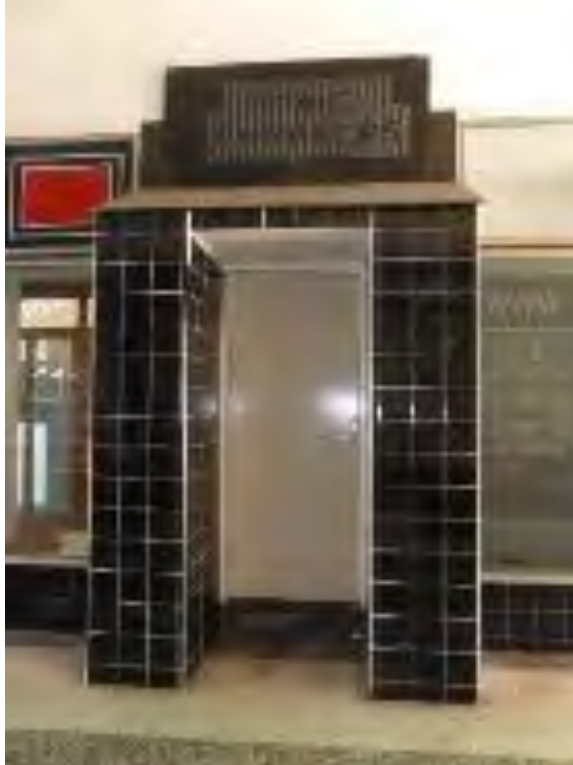
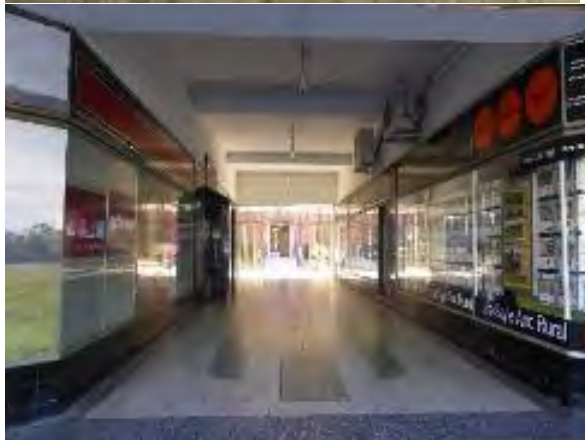
Chromium plated steel was used in the shopfronts A tiled grand doorway is located on the concourse to the rear courtyard
Some shopfronts to the streetscape have been modified to newer details.

Carefully conserve all original fabric.

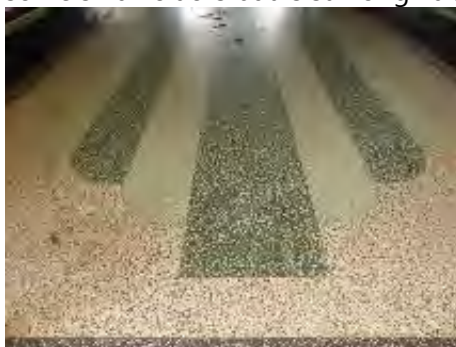
The original terrazzo floor in contrasting bands with inlaid metal decoration forms a grand concourse to the rear building. It shows some small cracks but is still original.

Repair cracking by specialist trades. Details of method and materials to be confirmed prior.

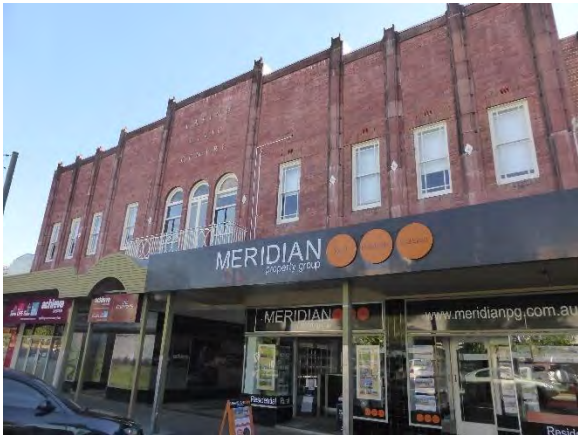
<p>Awning</p>	<p>The suspended footpath awning clad in metal sheeting is circa 1980s. Fascias on each side of the central arched portion are not symmetrical which detracts from the original façade. The Meridian fascia is now deeper and heavier in proportion compared to the southern end.</p>

<p>Consideration should be given to redesign of the awning and fascia to complement this fine building.</p>
<p>Interior</p>	<p>The interior of these buildings are as significant at the exterior. Internal doors are particularly beautiful and are an excellent example of their type. Internal lighting was typically Art Deco in style and decorative mouldings on the ceilings used lined motifs. Timber panelling, with chrome trim, was used in the stairwell and in the Council Chambers. In the chambers the timberwork was stepped to provide a backdrop to the mayoral seat.</p>

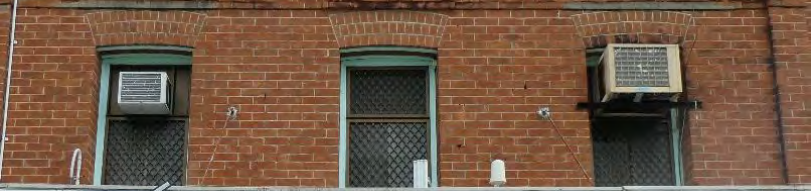
Building Elements	Observations	Recommendations
Roof	Metal roof behind parapet.	Repair or replace as required to original details.
Gutter	Not visible.	Ensure all gutters are in good condition and water is dispersing away from edges of building.
Walls	<p>Red brick building with straight edged parapet and six small decorative brick panels over the three windows.</p> <p>The building originally had a two storey verandah and a decorative top to the parapet as seen in early photograph. The building was stripped of this decorative detail in a modernisation phase. Air conditioning units and metal screens detract from the front façade. Reconstruction is encouraged.</p>	Maintain original fabric. Brickwork must remain unpainted.
Windows	<p>Window openings are original but are obscured with aluminium security screens, due to the removal of the verandah and replacement with an awning.</p>

Relocation of the air conditioning units and removal of security screens would enhance the façade.

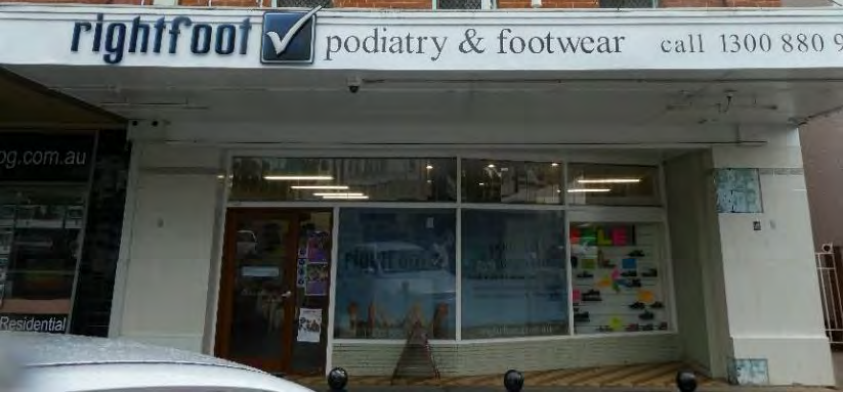
Shopfront and Doors	<p>The shopfront has a mid-20th century timber framed splayed design with louvre windows to the transom. It has a tiled stall riser and walls. Missing areas of tiles reveal a painted masonry base with a number of earlier paint layers.</p>

Maintain or reinstate to original details. As guided by early photos. Consider removal of modern ceramic tiling from walls and replace with painted masonry or a smaller tile.

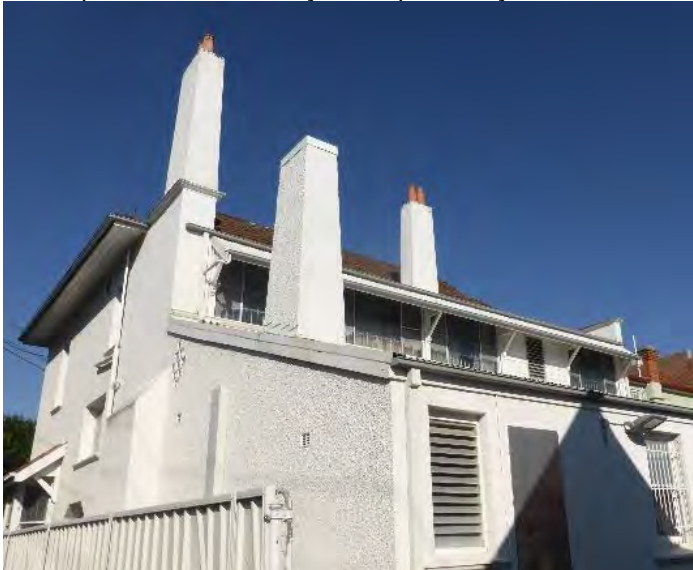
Building Elements	Observations	Recommendations
Roof	<p>Hipped Marseilles terracotta tiled roof Three prominent chimneys of tapered style</p>

<p>Retain tiles as long as possible, repair or replace as required to original details and materials.</p>
Gutter	<p>Low front quad, non perforated.</p>	<p>Replace as necessary to original details.</p>
Walls	<p>Roughcast white render to exterior with contrasting exposed red brick detailing to windows and doors surrounds and light mortar joints. Grand brick arched entry to main doors.</p>

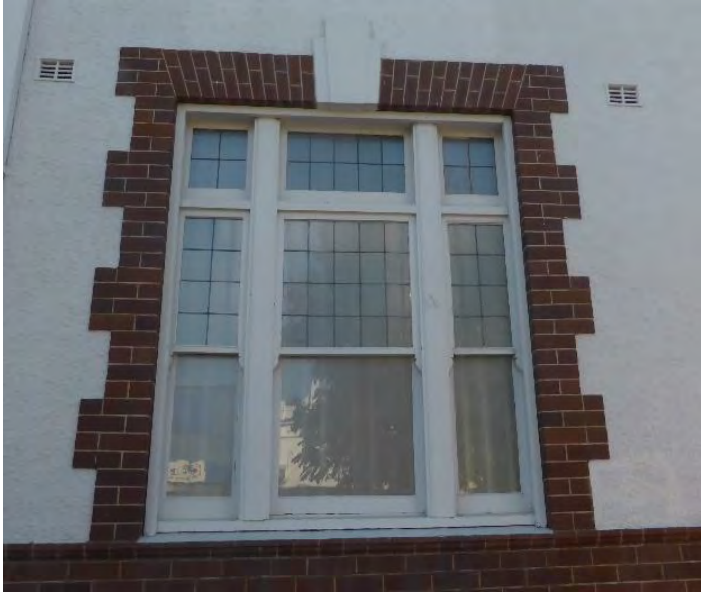
Windows	<p>Double hung timber framed with small lead light multi panes to upper windows and plain glass to lower panes. The windows are a significant aesthetic element of the building. A bay window faces the laneway with a tiled awning over.</p>

Carefully conserve original timber and leadlight windows to original details.
Doors	Timber, recessed accessed from central semi arched entry with an ornamental keystone in the centre."	Maintain to original details.
Awning/ verandah	<p>Balcony central to upper floor. Some evidence of water ingress/damage to fascia</p>

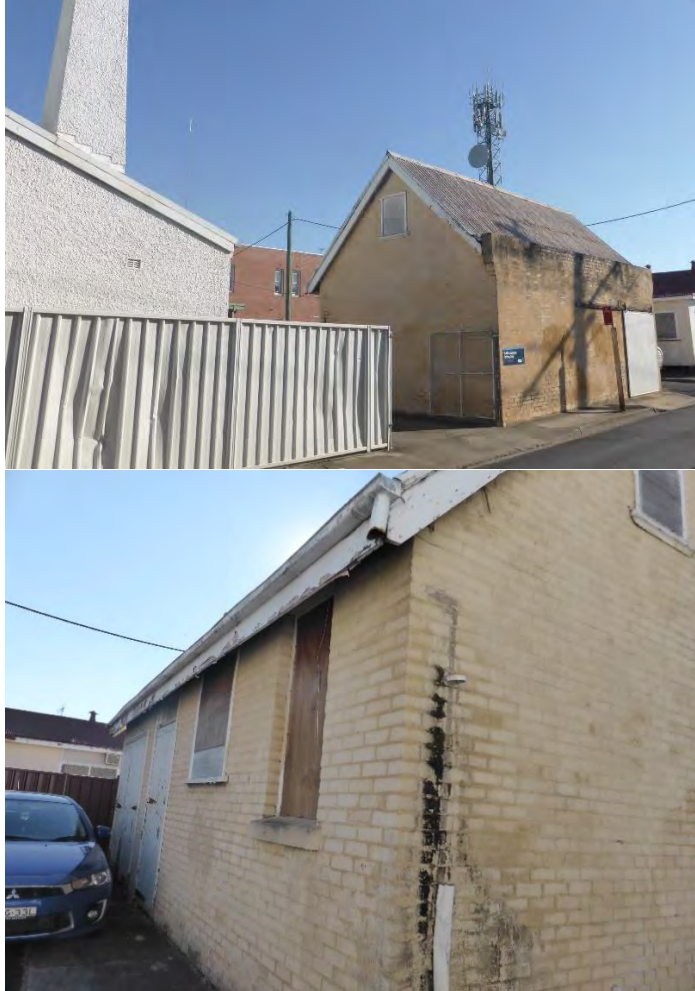
The early stable building is an important historical component of the site, but is not maintained in the same manner as the bank building. The downpipes are broken with water dispersing to base of the building. The building needs urgent maintenance. The colorbond fence detracts from the setting of this significant building.

Maintenance of the stables should be given urgent attention. Repairs should be like for like to original details. Urgently address stormwater and make watertight as first priority. Consider the replacement of fence.

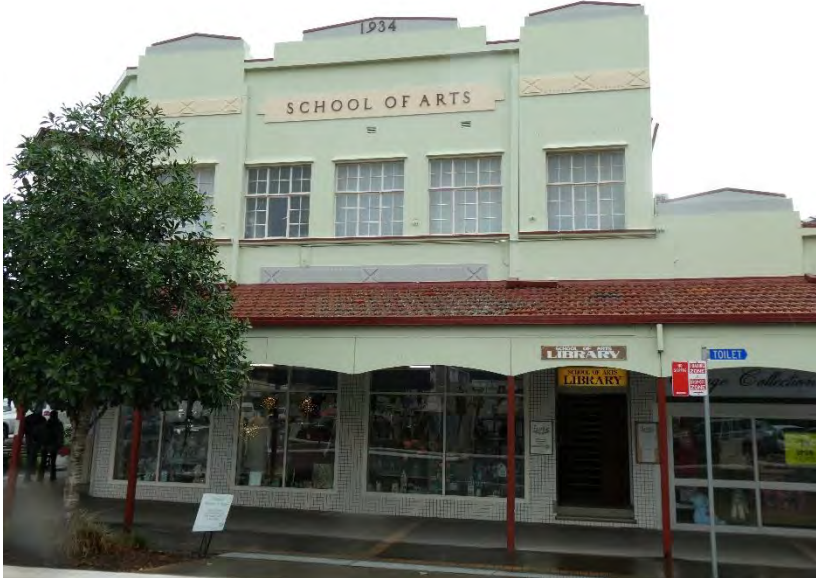
Building Elements	Observations	Recommendations
Main Roof	Hipped Marseilles terracotta tiled roof	Conserve as long as possible. If replacement is deemed necessary it should be replaced to match original materials and details.
Gutter	Non-original square perforated gutters to awning fascia.	Use a traditional low front quad gutter for any future replacement.
Walls	<p>Smooth rendered facade with stepped parapet and banded mouldings. The main façade facing Barker Street is symmetrical with four slightly projecting wall elements. Additional decoration is added by painted recessed panels in the render. Repainted in 2017.</p>

Maintain all original fabric. Maintain authentic heritage colour scheme with any future repainting.
Windows	<p>Steel framed multi-paned windows subdivided into 3 vertical divisions of 6 panes with upper transoms of 4 panes within the opening, evenly spaced on façade. The steel framed windows are a significant element of building.</p>

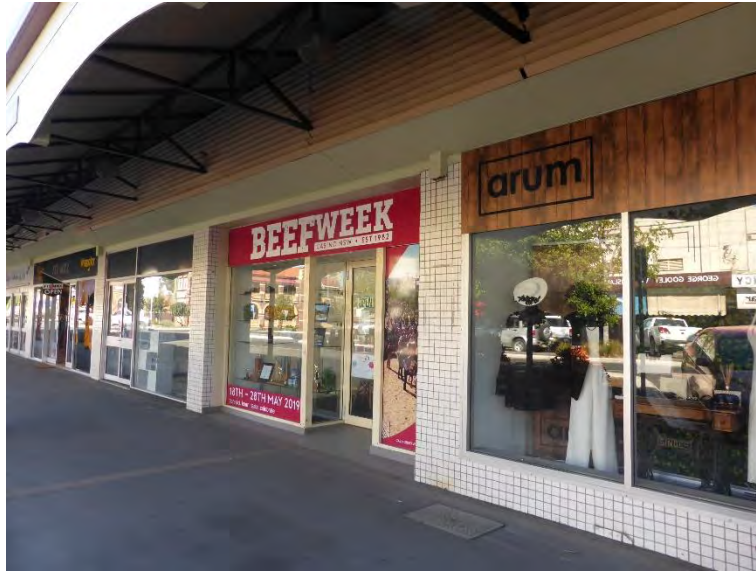
The original shopfronts to the ground floor have been replaced with aluminium frames and tiled surrounds. There are scalloped fascia panels for business signage.

Maintain.

The reinstatement of shop fronts to original details as guided by early photos and evidence could be pursued as a long term conservation goal if substantial funding was available.

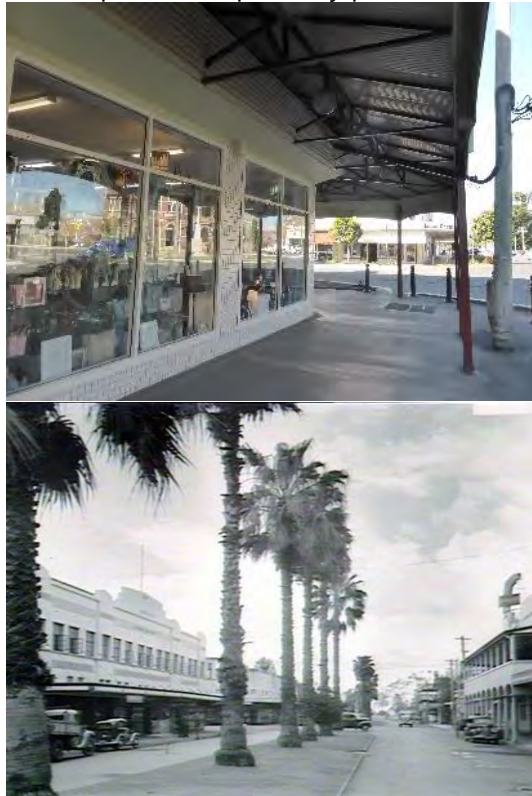
The awning was installed circa 1970s and has a modern tiled roof with metal trusses and posts to pavement. The original awning was suspended as per early photo.

Reinstatement to original details could be pursued if major funding was available.

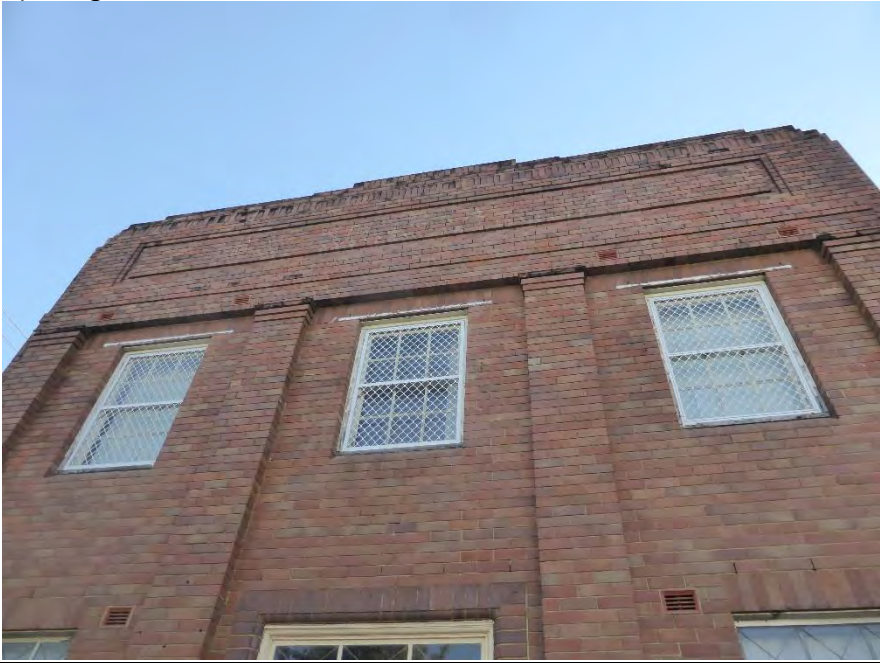
Building Elements	Description	Recommendations
Roof	Metal roof behind parapet.	Repair or replace as required to original details.
Gutter	Low front quad unperforated visible on rear section.	Ensure all gutters are in good condition and water is dispersing away from edges of building.
Walls	<p>Red brick building with stepped parapet in free classical style. The brickwork is likely to be from Coombell brickworks and is of high quality featuring four tied piers which add vertical emphasis, recessed brick panels and raised soldier courses surrounding the lower openings.</p>

<p>Maintain original fabric. Brickwork must remain unpainted.</p>
Windows	<p>Steel framed window with diagonal lead light panels are highly intact to original details but require repainting.</p>

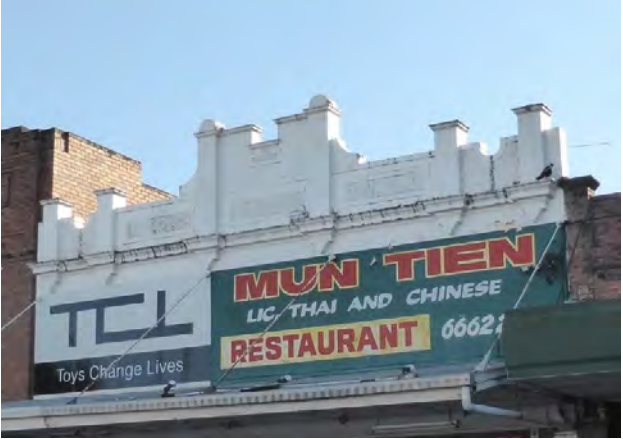
Building Elements	Description	Recommendations
Roof	Metal roof behind parapet.	Repair or replace as required to original details.
Gutter	<p>Perforated square box gutter on awning is non original and non-contributory to the historic significance of building.</p>  	<p>Replace with a low front quad or ogee profile. Ensure all gutters are in good condition and water is dispersing away from edges of building.</p>
Walls	<p>Upper walls are rendered masonry painted white. Historic photos showed this with dark panels between the pediments.</p>

<p>The lower part of the wall has been substantially modified and does not contain any original shopfront details. The mosaic tiles are non original and could be replaced or removed and replaced with a plain rendered masonry and painted.</p>

<p>Maintain all original fabric.</p> <p>There is potential to repaint this façade in a heritage colour scheme to bring out the detail of the façade.</p> <p>The advertisement panels above the awning should be removed or substantially reduced as they detract from the architectural detail of the façade.</p> <p>A modest fascia could be added to the awning as a replacement for the above awning signage..</p> <p>A plain render and painted finish to the lower walls help to unify the building.</p> <p>The recently painted red wall is out of keeping with the heritage significance of this building and has not been endorsed as work within the Heritage Conservation Area.</p>

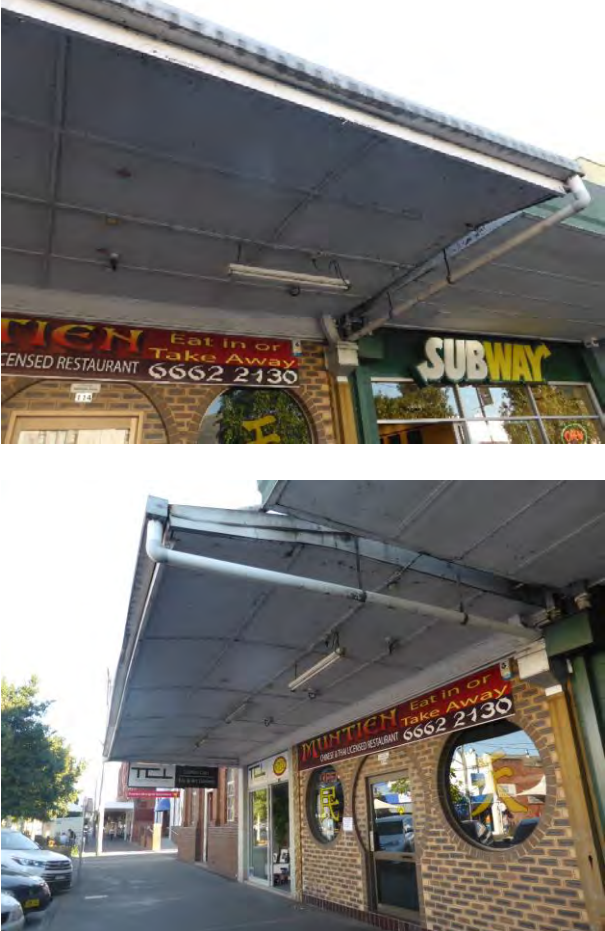
Awning	<p>The awning is original and still retains the curved pressed metal lining which is highly contributory.</p>

<p>Façade prior to being painted red.</p>	<p>The awning should be carefully conserved. Ensure that all roof water is dispersed correctly. Repaint in a traditional heritage colour scheme.</p>
Windows	<p>No original windows are visible on the upper part of the parapet.</p>	<p>.</p>
Interior	<p>Not inspected.</p>

- Check all roofing and guttering and ensure building is watertight and drainage is dispersing away from building.
- Carefully conserve and retain all original fabric including the façade and original awning.
- Repaint the masonry façade in a heritage colour scheme and highlight the architectural details.
- Consider the removal of tiles, render the lower walls and repaint to match the upper façade shopfront in a heritage colour scheme to unify the building facade.
- Replace the above awning signage on a fascia panel of 300mm depth.
- Heritage grants are available to assist with this work.

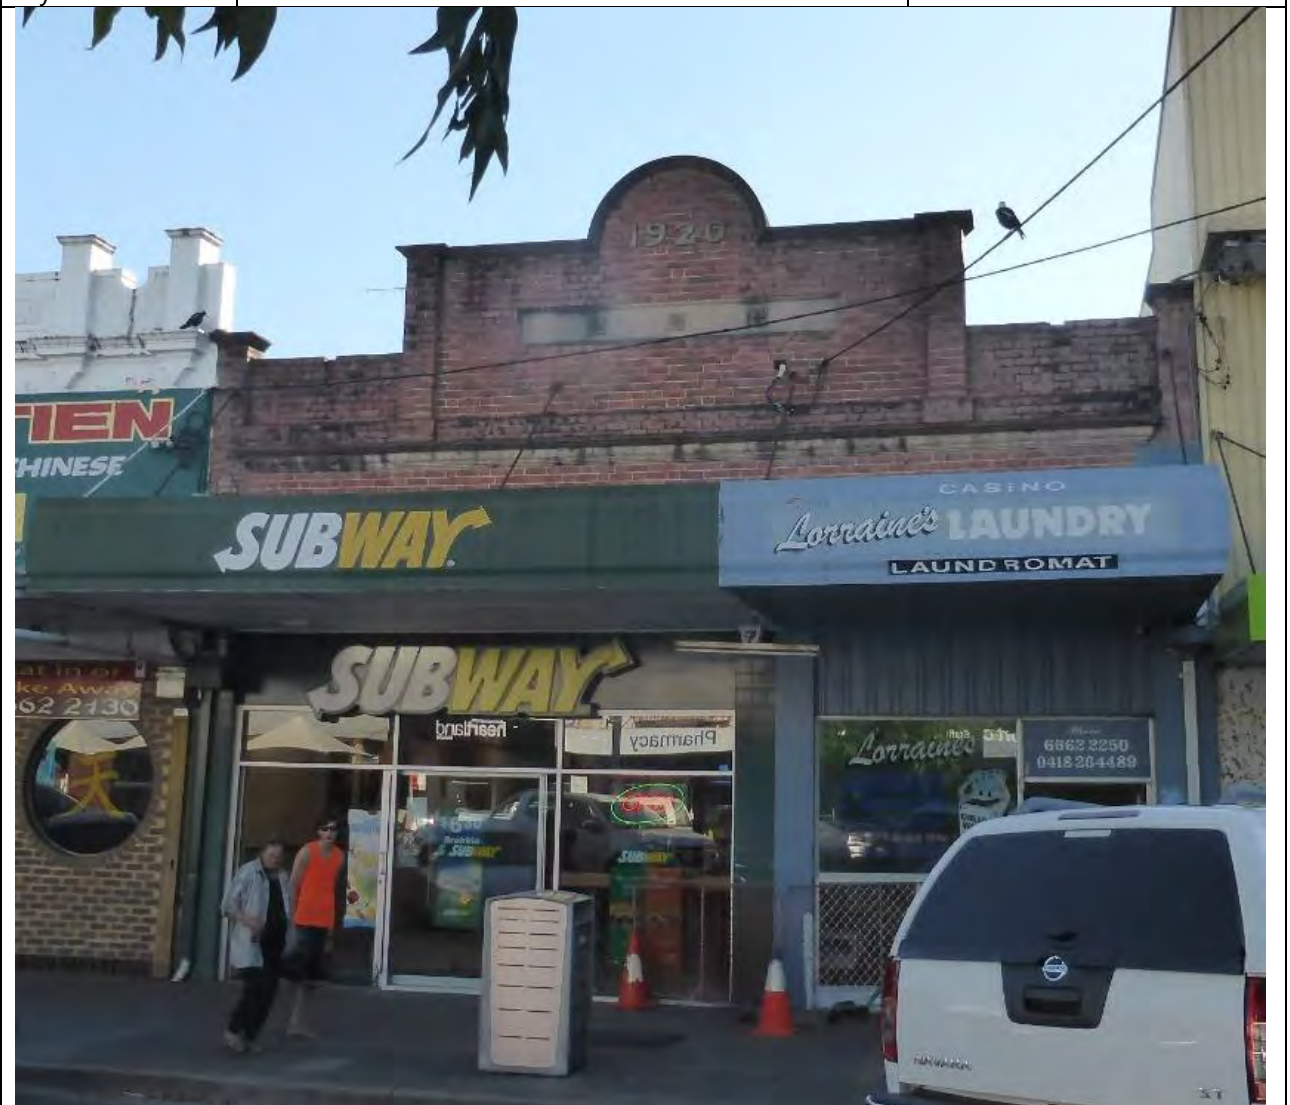
Building Elements	Observations	Recommendations
Roof	Metal roof behind parapet.	Repair or replace as required to original details.
Gutter	Not visible.	Ensure all gutters are in good condition and water is dispersing away from edges of building.
Walls	Upper parapet of face brickwork with arched design to centre. 4 pilasters subdivide the façade. A recessed panel sits to the centre and a raised horizontal band provides decoration.	Maintain to original details. Do not paint original brickwork.
Shopfronts

<p>Recommendations</p> <ul style="list-style-type: none"> • Check all roofing and guttering and ensure building is watertight and drainage is dispersing away from building. • Carefully conserve and retain all original fabric. • Retain upper façade original brickwork unpainted • Consider repainting of the awning and underside in a unified colour scheme.

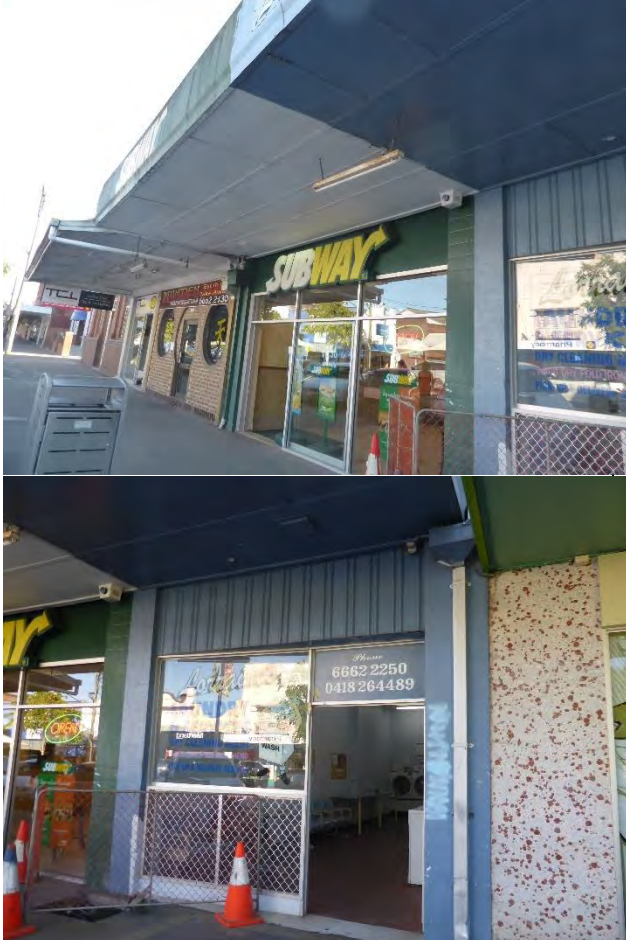
<p>Non original. Aluminium frame to Subway shop.</p> <p>1960s design with splayed frontage to Laundromat.</p>

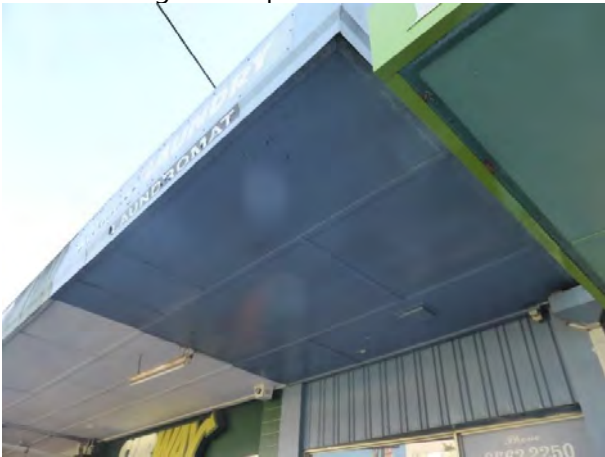
<p>Awning</p>	<p>The awning is original and still retains the fibre cement lining with exposed batten trim.</p>

<p>It should be carefully conserved and ensure that all roof water is dispersed correctly.</p> <p>A unified colour to the fascia and underside would improve streetcape appearance. Repaint in a traditional heritage colour scheme.</p>
---------------	--	--

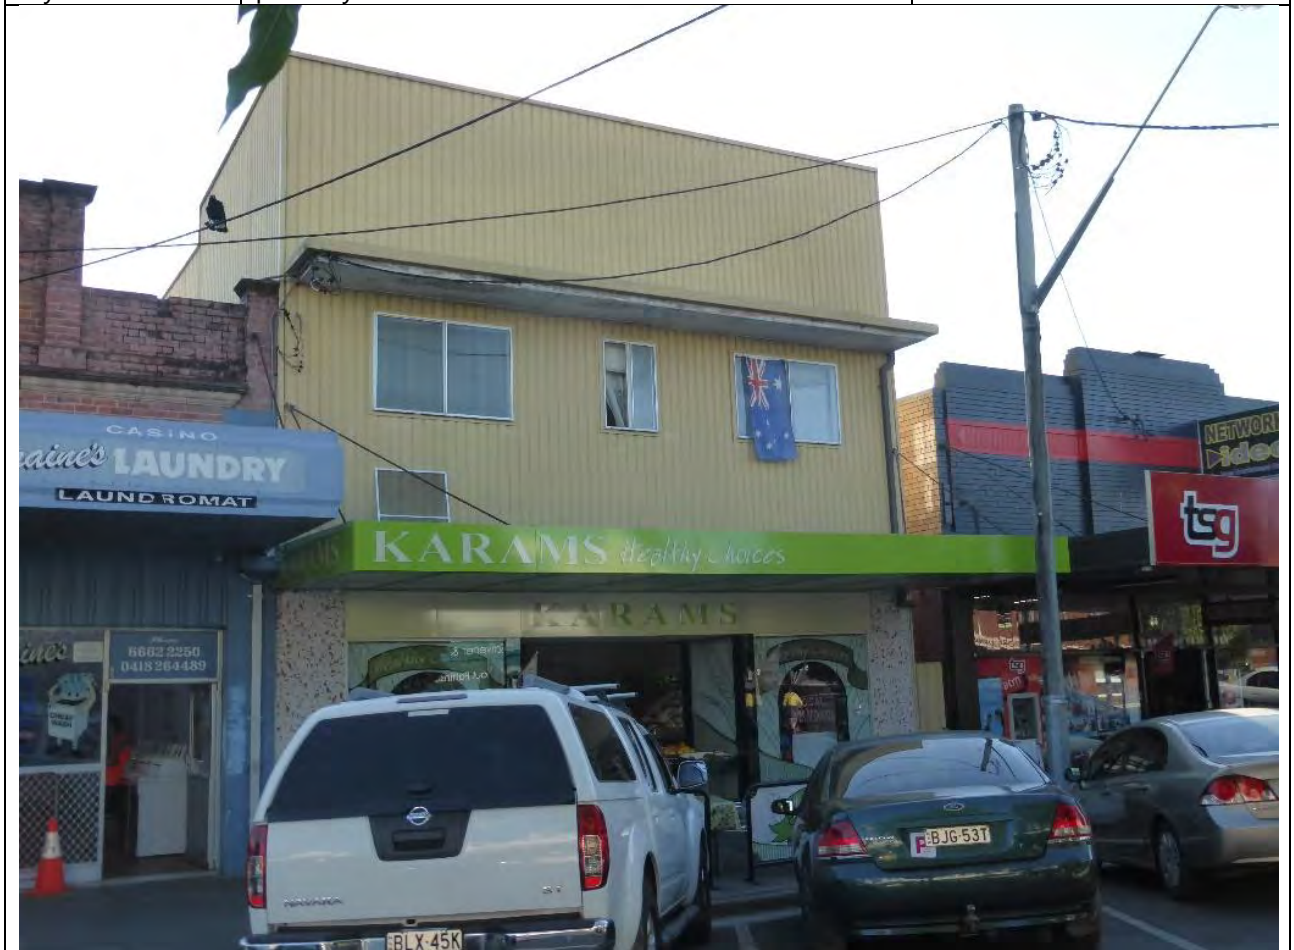
Building Elements	Observations	Recommendations
Roof	Metal roof behind parapet.	Repair or replace as required to original details.
Gutter	Not visible.	Ensure all gutters are in good condition and water is dispersing away from edges of building.
Walls	The building comprises a two storey timber framed building with a high straight edged parapet. The façade is now clad in ribbed metal sheeting.	Consider removal of sheet metal cladding and replacement in timber weatherboard or similar cladding.
Shopfront	<p>The shopfront is well maintained and includes a recessed central entry and traces of the early anodised shop window frames. Side entry pillars are now aluminium frames. The pillars are finished in a pebbled glazed tile.</p>

<p>Recommendations</p> <ul style="list-style-type: none"> • Check all roofing and guttering and ensure building is watertight and drainage is dispersing away from building. • Consider the removal of sheet metal cladding and restoration to a more sympathetic façade treatment such as timber cladding or a rendered finish and replacement of the upper windows to vertical proportions. • A full restoration to original details is a long term option. • This would be eligible for heritage grant assistance.

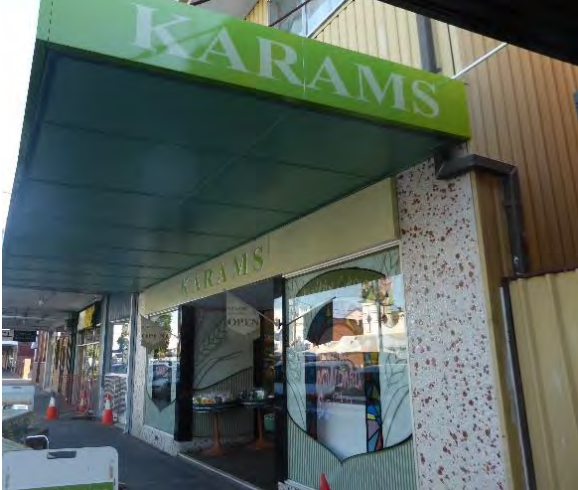
Windows	Aluminium framed.	
Awning	The awning has a deep fascia and the underside is finished in fibre cement panels with expressed batten trim.	The awning should be carefully conserved and ensure that all roof water is dispersed correctly. Repaint in a traditional heritage colour scheme.

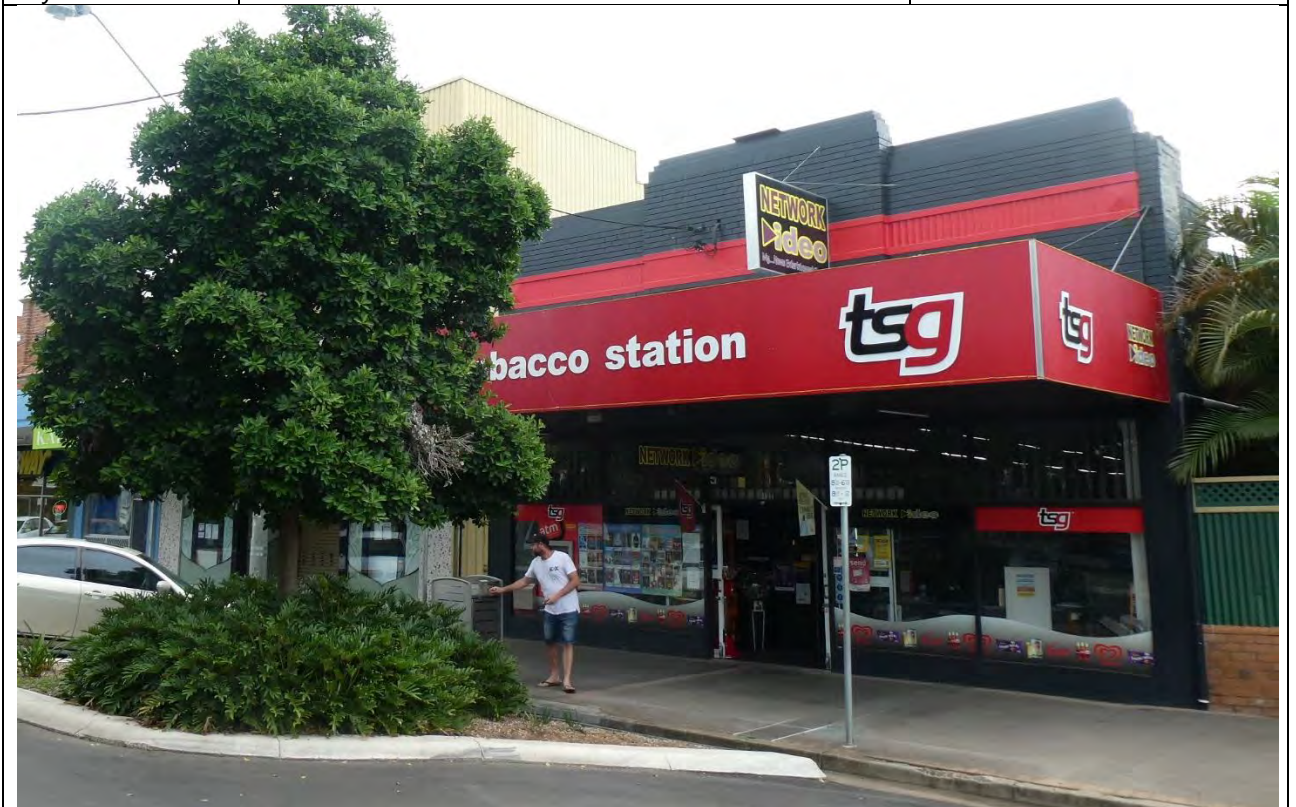
Building Elements	Description	Recommendations
Roof	Metal roof behind parapet.	Repair or replace as required to original details.
Gutter	Not visible.	Ensure all gutters are in good condition and water is dispersing away from edges of building.
Walls	The parapet is painted brickwork with a banded detail of soldier brick as a decorative feature. The building is painted in a dark grey and bright red trims. The side elevation still remains unpainted.	A sympathetic colour scheme from the heritage palette would enhance this building.
Shopfront	<p>Timber shopfront windows with vertical louvres to transom. Stall riser at base. Unlikely to be the original to the building, possibly a 1950s-60s era alteration.</p>

- Check all roofing and guttering and ensure building is watertight and drainage is dispersing away from building.
- Repaint façade and shopfront in a sympathetic heritage colour scheme
- Reduce signage fascia size to the original depth of the side fascia to create a more aesthetically balanced elevation and façade in keeping with the original building.

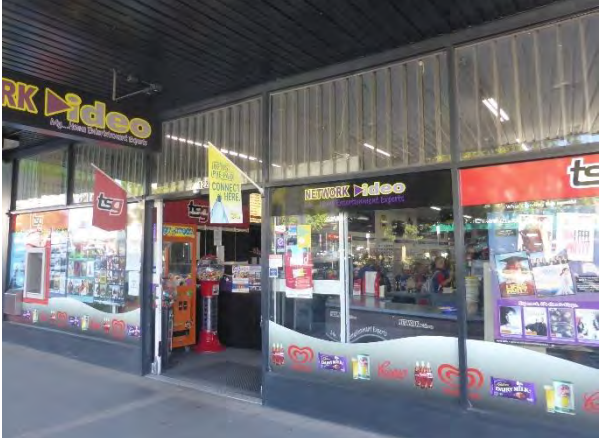
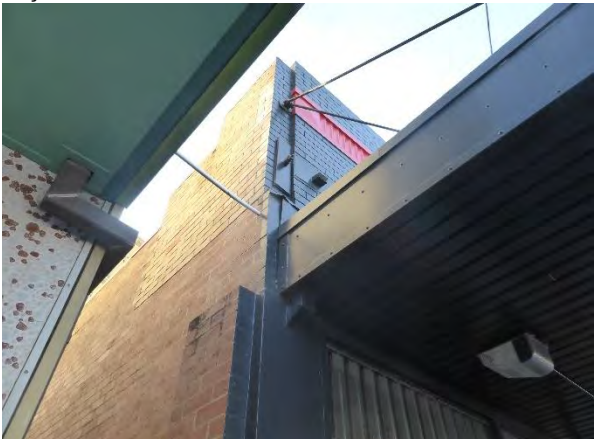
Maintain timber shopfront framing.
Awning	<p>Suspended metal clad awning with a narrower fascia depth on the ends. The fascia signage to the street frontage is excessive in depth, being more than double the size of the original fascia, and detracts from the proportions of the building façade.</p>

The signage fascia size should be reduced to the depth of the original return fascia section to create a more aesthetically balanced elevation and façade in keeping with the original building.

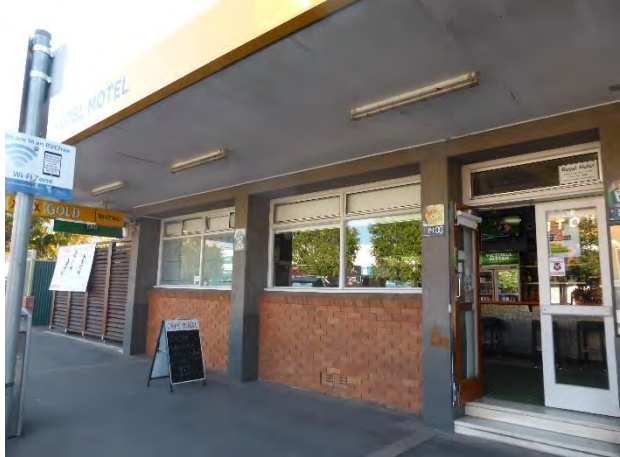
Building Elements	Observations
Roof	Shallow pitched metal roof. No parapet to street.
Gutter	Not visible.
Walls	Face brickwork unpainted.
Windows and Doors	<p data-bbox="379 432 1412 465">Timber framed windows and doors in recessed bays between projecting brick piers.</p>

<p>The photograph shows the entrance of a building. A prominent feature is a cantilevered metal awning over the entrance area. The building's facade consists of brickwork, with windows and doors set in recessed bays between projecting brick piers. The entrance is a glass door with a small sign above it. To the left, there is a utility pole with a sign that says 'HOTEL' and another sign that says 'GOLD'. A small blackboard sign is on the sidewalk in front of the entrance.</p>
Awning	Suspended cantilevered metal awning with a metal fascia signage.
<p data-bbox="204 1008 443 1041">Recommendations</p> <p data-bbox="204 1041 1474 1153">This site is suitable for redevelopment and holds considerable potential to enhance the historic CBD with a well designed contributory new infill development. Early discussions are encouraged in relation to a response to the heritage context of the site.</p>

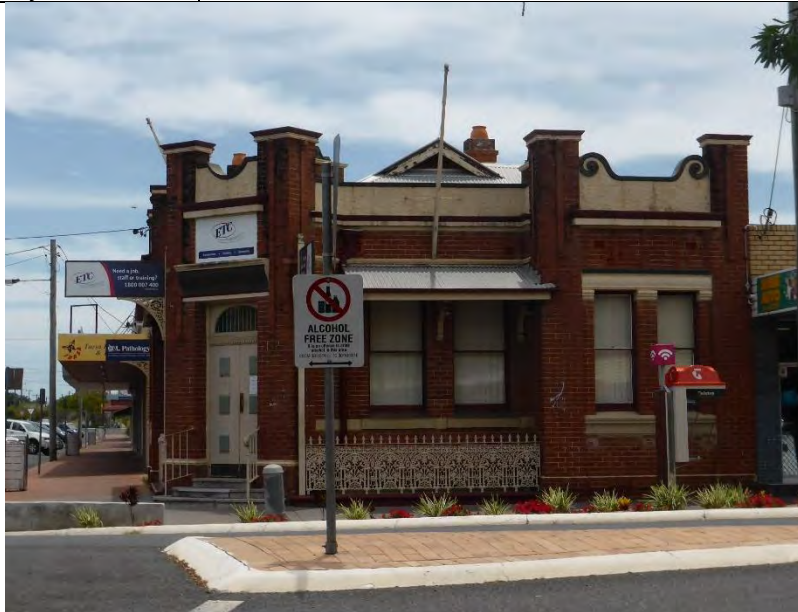
Building Elements	Observations	Recommendations
Roof	Uncoloured metal roof. Two original chimneys are prominent elements	Use galvanised steel in any roof replacement.
Gutter	Low front non-perforated quad.	Maintain and replace as necessary to original details.
Walls	Face red brick with stucco decorative parapet. The façade is divided vertically with brick piers which project above the parapet line. The piers are enhanced with vertical projecting brick courses. The parapet is a combination of straight edges and curves. A horizontal moulding divides the face brick below from a painted stucco band between the brick piers.	Maintain all original fabric. Do not paint face brickwork. Maintain an authentic heritage colour scheme for any future repainting of painted sections.
Windows	Double hung timber framed plain sashes. There is peeling paint on some areas.	Carefully conserve timber windows to original details. Repainting is required to conserve timber joinery. Repair rather than replace.

- This is a substantial commercial building on a prominent corner location, with a high degree of original fabric intact to original details.
- The preparation of a Conservation Management Plan and a Maintenance Plan with regular maintenance schedules would be of benefit to guide the future conservation of this building. A heritage grant can be sought for preparation of these plans as well as maintenance and conservation works.
- Ensure building is water tight and all drainage is dispersing away from edges of building.
- Regular maintenance is essential and repainting is required.
- Maintain authentic heritage colour scheme for painted surfaces.
- Do not paint the brickwork.
- Carefully conserve and retain all original external and internal fabric.
- Current signage is discreet.

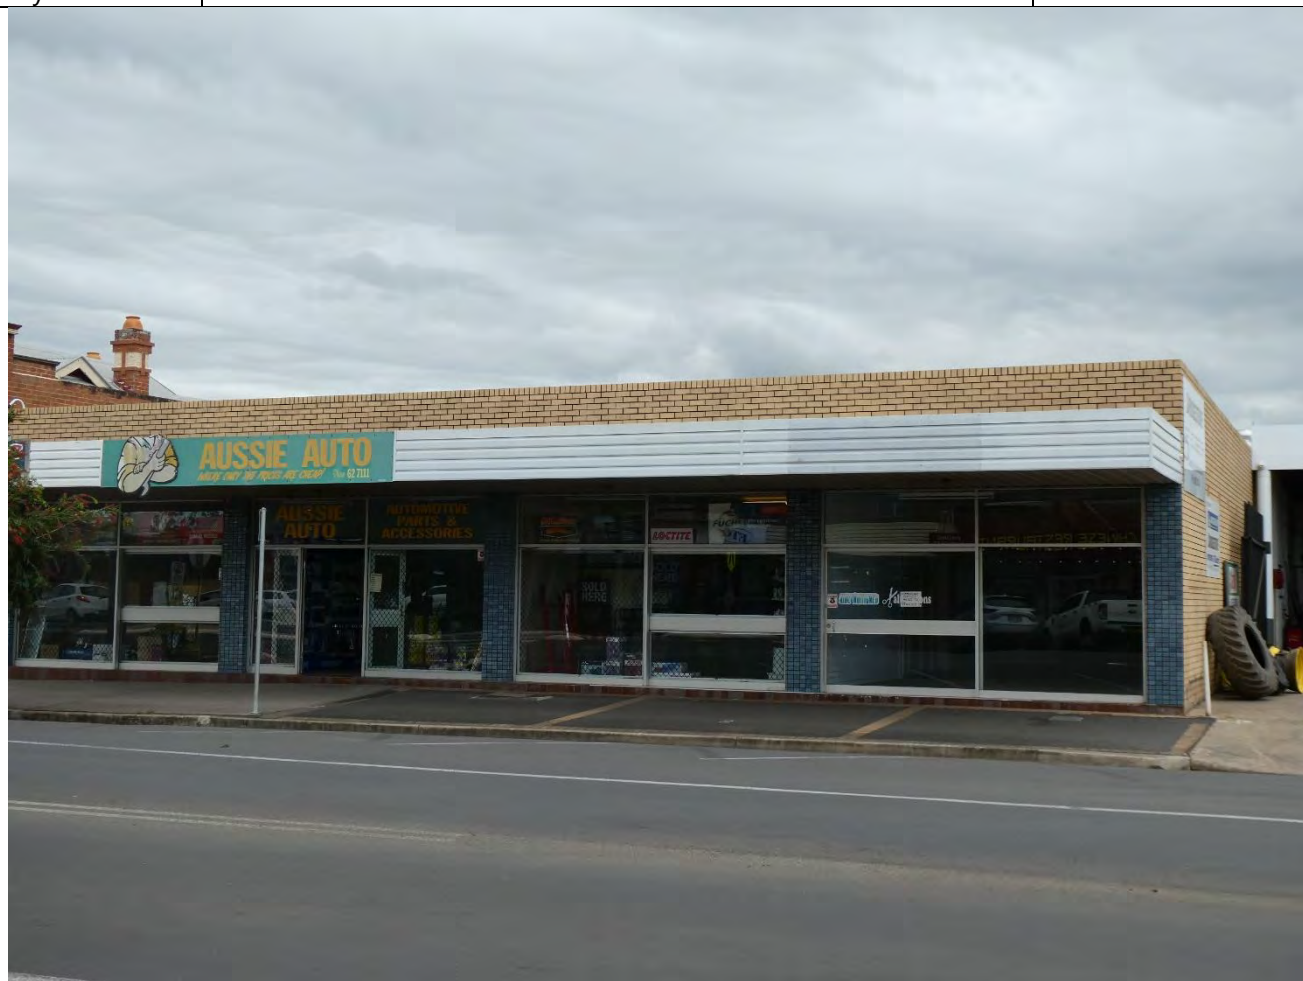
Building Elements	Observations	Recommendations
Roof	Metal behind parapet	Maintain
Gutter	Not visible.	Maintain and replace as necessary.
Walls	Unpainted beige brick to low straight edged parapet. Painted sections below awning. The façade is divided into three shops with aluminium shopfronts. Tiling to vertical bands between shops.	Maintain
Windows	Anodised Aluminium	Maintain
Doors	Anodised Aluminium.	Maintain
Awning	A cantilevered awing extends uniformly across frontage	Maintain signage on fascia and not above awning. Use a single background colour for the fascia in a sympathetic colour to complement the adjoining heritage building, unify the façade, and place signs within this framework.
Interior	Not inspected.	
<p>Recommendations.</p> <ul style="list-style-type: none"> • Use a single background colour for the fascia in a sympathetic colour to complement the adjoining heritage building, unify the façade, and place signs within this framework. • Although this building lies outside the boundary of the Conservation Area it forms part of the visual setting of the adjoining heritage item and entry gateway into the historic precinct. Any future redevelopment needs to be sympathetic to the setting.

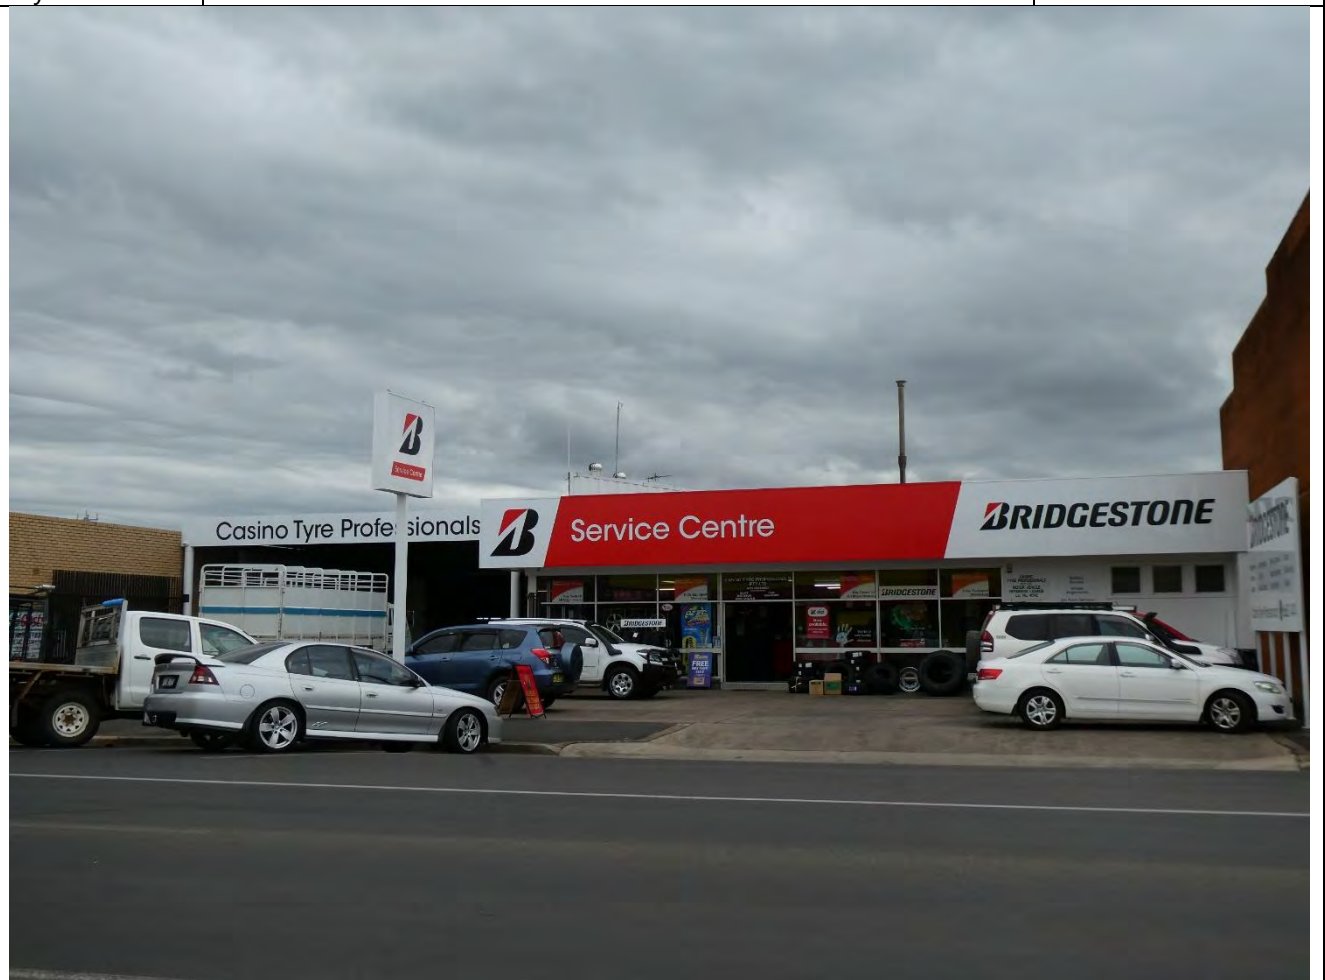
Building Elements	Observations	Recommendations
Roof	Metal behind parapet	
Gutter	Not visible.	
Walls	Painted white with straight edged parapet and a deep fascia signage panel. Element of red signage is limited to part of fascia. The building is set well back from the street frontage behind a large concrete forecourt.	
Windows	Aluminium	
Doors	Aluminium.	
Awning	No awning	
<p>Recommendation. A landscaping plan with canopy trees and shrubs would enhance and add amenity to the site providing shade, and softening the large set back area.</p>
