CASINO CBD HERITAGE CONSERVATION AREA MAIN STREET AUDIT

Prepared by
CLARENCE HERITAGE
FOR RICHMOND VALLEY COUNCIL
AUGUST 2020

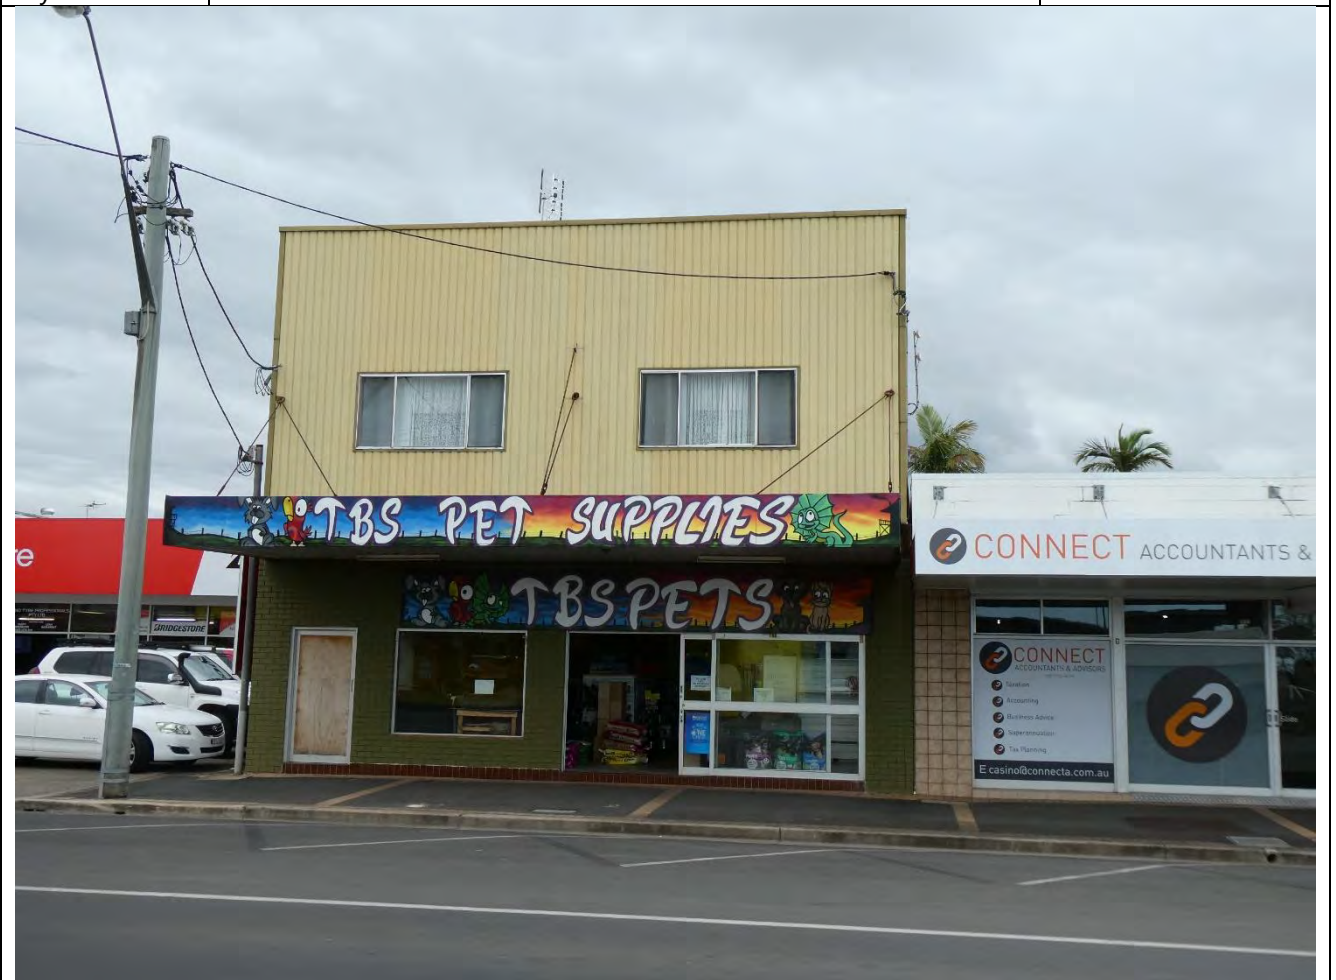
Building Elements	Observations	Recommendations
Roof	Metal behind parapet	
Gutter	Not visible.	Maintain and replace as necessary.
Walls	Two storey with a high parapet clad with sheet metal which may conceal an original brick wall. Straight top parapet. Side walls are of face red brick.	Investigate what lies behind cladding and the potential for restoration. Add façade panel to parapet to create more interest. Repaint in sympathetic colour scheme.
Windows	Aluminium of horizontal proportions. Possibly altered from previous building.	Consider replacement with vertically proportioned windows. Include window hoods or an awning across façade.
Shopfront and Doors	Aluminium.	
Awning	Cantilevered awning	
<p>Recommendation.</p> <ul style="list-style-type: none"> • This two storey building lies on the gateway to the historic precinct and provides contrast to the single storey buildings along most of this frontage. It has potential for repainting and some modest alterations to improve the streetscape façade. • Further research is encouraged on the origins and date of this building, and early photographs would be useful to inform future reconstruction.

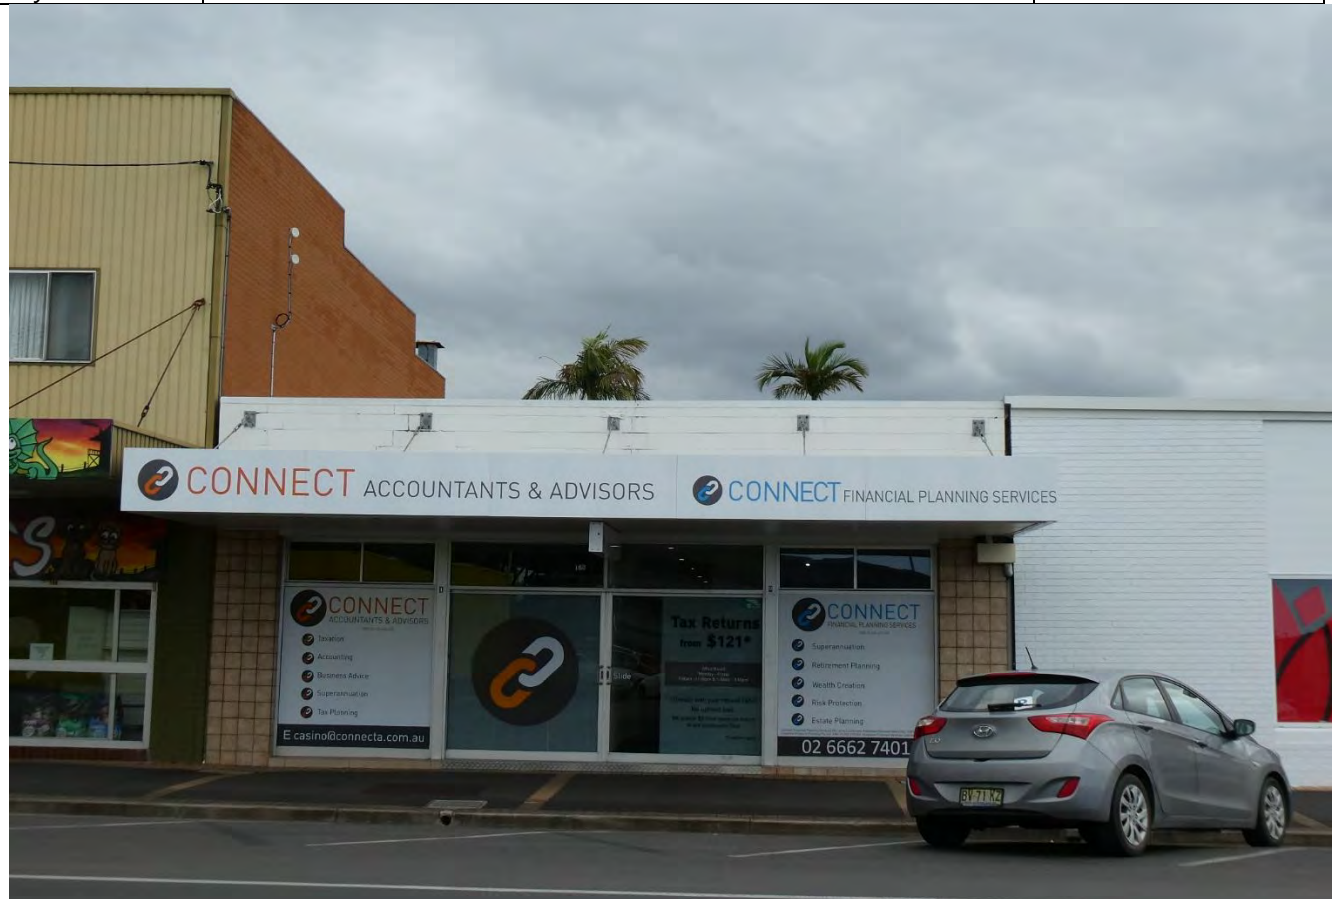
Building Elements	Observations	Recommendations
Roof	Metal behind parapet	Maintain
Gutter	Not visible.	Maintain
Walls	Single storey with a low parapet of painted brick. Lower walls clad with ceramic tiles.	Maintain-repaint. Consider parapet interest.
Shopfront and Doors	Aluminium with transom windows. Advertising within window panes.	Maintain
Awning	Cantilevered awning with fascia painted in one colour. Business signage within existing fascia.	Maintain signage on fascia and do not extend above awning.
<p>Recommendations</p> <ul style="list-style-type: none"> • A small parapet addition could create more interest to the façade. • Keep signage within the depth of existing fascia. • Use a paint scheme which is complementary to nearby historic precinct. A matching colour for the tiling/walls and above the awning would help unify the building.

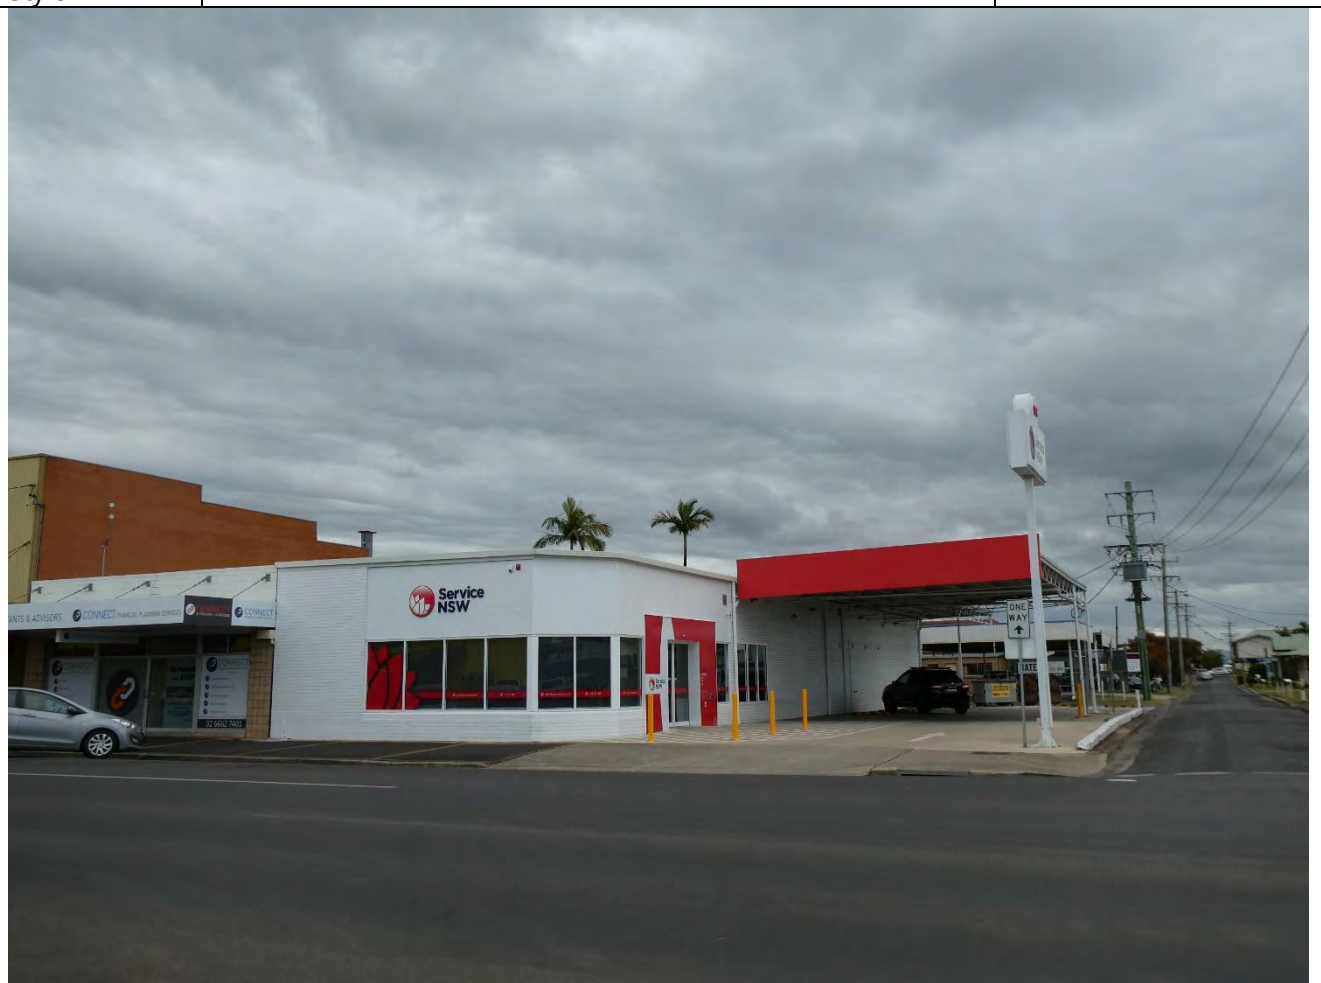
Building Elements	Observations	Recommendations
Roof	Metal behind parapet	Maintain
Gutter	Not visible.	Maintain
Walls	Single storey brick building with a low parapet, now painted white with primary red fascia to awning and around entry.	Minimise bold corporate colours on gateway to heritage precinct of CBD
Shopfront and Doors	White Aluminium. Pole Sign

- Maintain a neutral background colour for the building to harmonise with the character and setting of the historic CBD precinct.
- The addition of landscaping with canopy trees would enhance the amenity and shade for this site and the adjoining public footpath and enhance the gateway to the historic precinct.

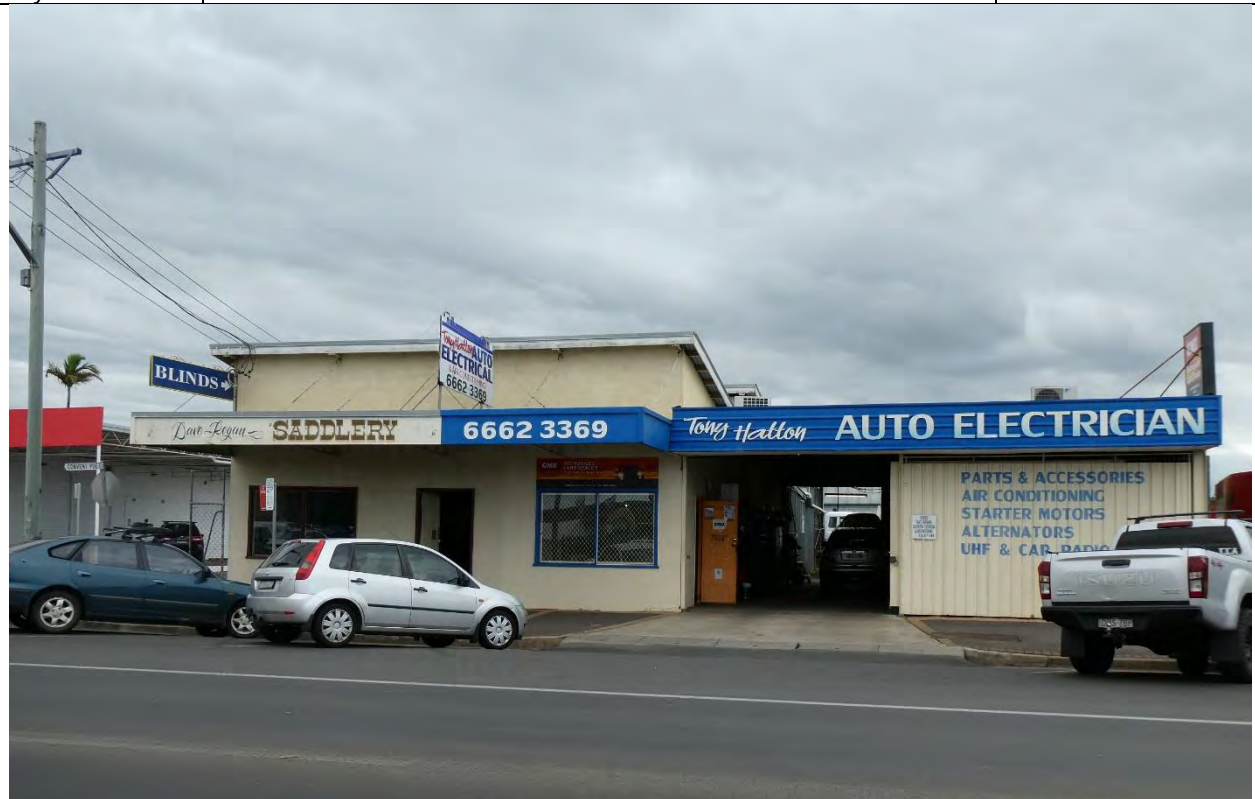
Name Address	Saddlery and Auto Electrician 160 Walker Street	
Heritage Item	No.	
Heritage Conservation Area	No	
Contributory Item	No	
Notes	Located outside of the Heritage Conservation Area but forms part of the gateway to the historic precinct.	
Architectural Style	Modern

Building Elements	Observations	Recommendations
Roof	Skillion roof behind parapet	Maintain
Gutter	Not visible. Timber fascias in need of repainting.	Maintain
Walls	Single storey painted in a mid neutral colour.	Maintain
Shopfront and Doors	Central doorway with windows to each premises.	Maintain
Signage	Traditional signage on saddlery fascia Bold blue to Electrician signage on fascia which extends at larger depth to adjoining premises. Above awning signs.

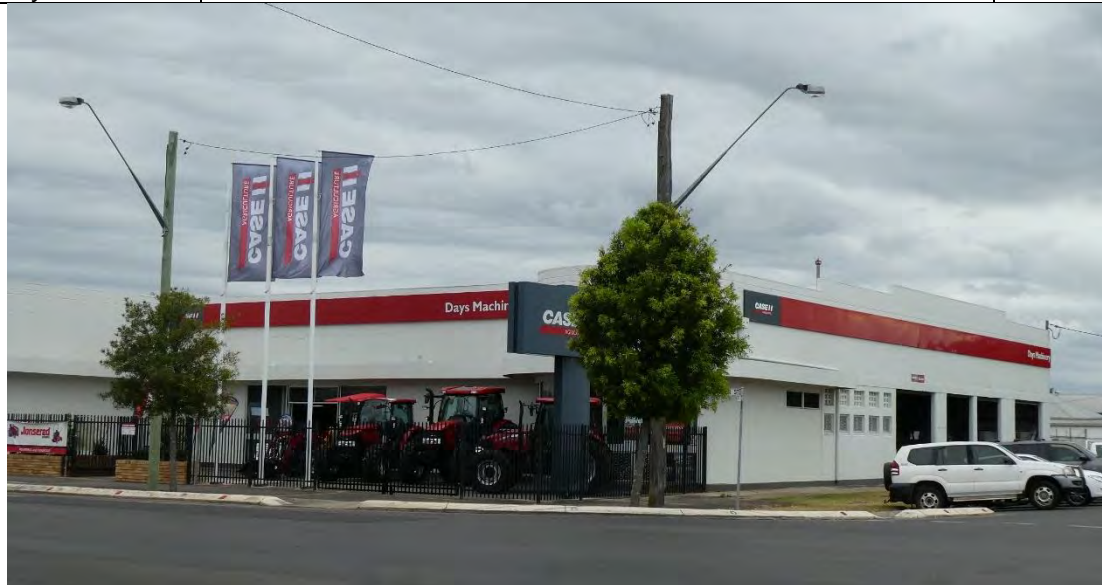
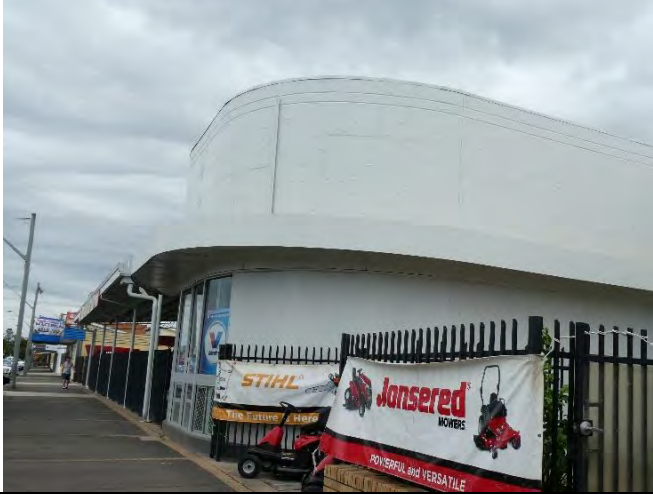
Building Elements	Observations	Recommendations
Roof	Large metal gabled roof and skillion sections behind a high parapet.	Maintain
Gutter	Not visible.	Maintain and replace as necessary.
Walls	<p>Single storey rendered masonry and steel building with a partly stepped two storey parapet and projecting curved facades to each end in P and O liner style. Double banded scored detail to upper façade.</p> <p>Painted white with a banding of corporate signage on façade.</p>

Recommendation.

- Carefully conserve all original elements and building fabric to original details.
- Maintain a light neutral background colour for the building. Investigate a colour scheme for any future repainting based on original paint scrapes.
- Ensure that advertising signage does not clutter the facades and detract from the architectural quality of the building.
- Consider some interpretation about the history of this site and the architectural style of the building as part of a heritage trail.

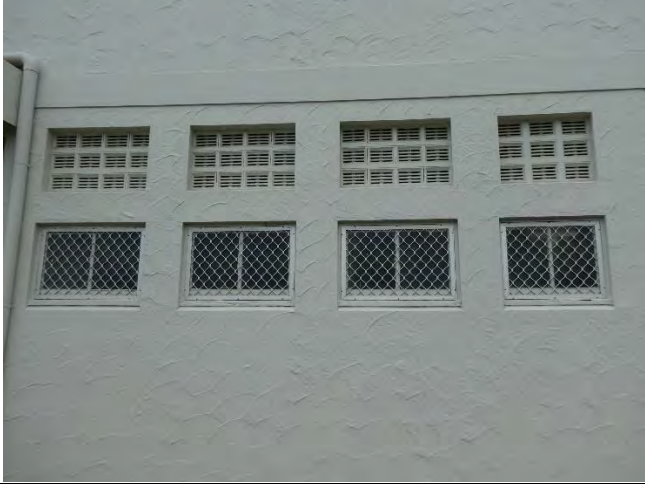
Windows	<p>The North Street façade has a set of 8 openings with original decorative grille work which is a functional and interesting architectural detail.</p>

Carefully conserve all original detail.
Awning	A narrow reinforced cantilevered concrete awning shields the shopfronts.	Maintain
Shopfront and Doors	Aluminium.	
Fencing	The building is set back from the street frontage with a forecourt for display. The boundary is marked by a more contemporary low brick fence with black pool fence infill. The site is well maintained and presented.

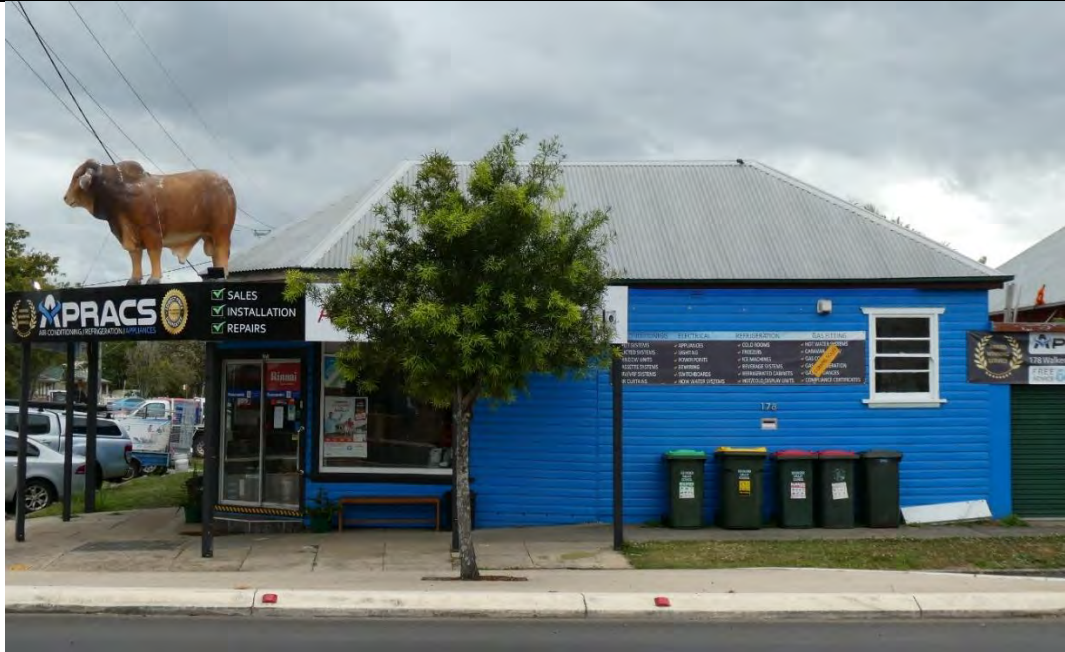
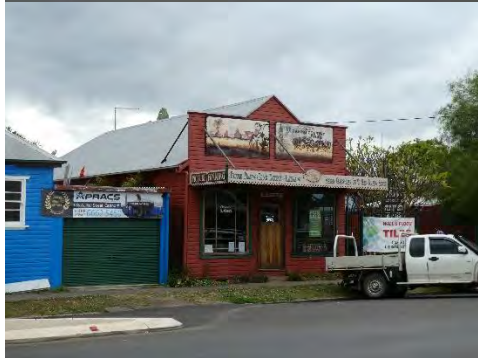
Building Elements	Observations	Recommendations
Roof	Steeply pitched hipped galvanised corrugated roof.	Maintain as to original material in galvanised steel Z600. Do not replace with colorbond.
Gutter	Traditional non-perforated Low Front Quad to Walker Street. Perforated square gutters on North Street. Any replacements should maintain the traditional profile.	Maintain and replace as necessary to original low front quad non-perforated profile.
Walls	Single storey timber weatherboards. High ceilings. Splayed corner. Now painted in a bold cobalt blue. Previously painted in a red oxide and stone colour heritage scheme.	Use a colour scheme from the heritage palette in keeping with the historic building.
Awning	A post supported awning wraps round the corner. A large bull is suspended on the top of the awning as an advertising feature.	Maintain awning.
Shopfront and Doors	Original timber shop windows to the splayed corner with transom lights to upper sections. Small step to entry. 2 x 4 pane double hung sash windows face North Street to side elevation. One double hung sash to Walker Street with horizontal glazing bars of later vintage, which may have been a replacement.	Maintain all timber glazing.

Recommendations.

- Carefully conserve all original elements and building fabric to original details.
- Maintain roof to original materials. Do not replace with colorbond.
- Maintain and replace gutters as necessary using original low front quad non-perforated profile.
- Consider using a heritage colour scheme appropriate to the historic character of the building and restrict business colours to smaller areas of signage.
- Consider reinstating the fascia to a narrower profile in any future replacements to reinstate the original proportions.
- Investigate the history of this site for inclusion of the building in a heritage trail for the town centre.

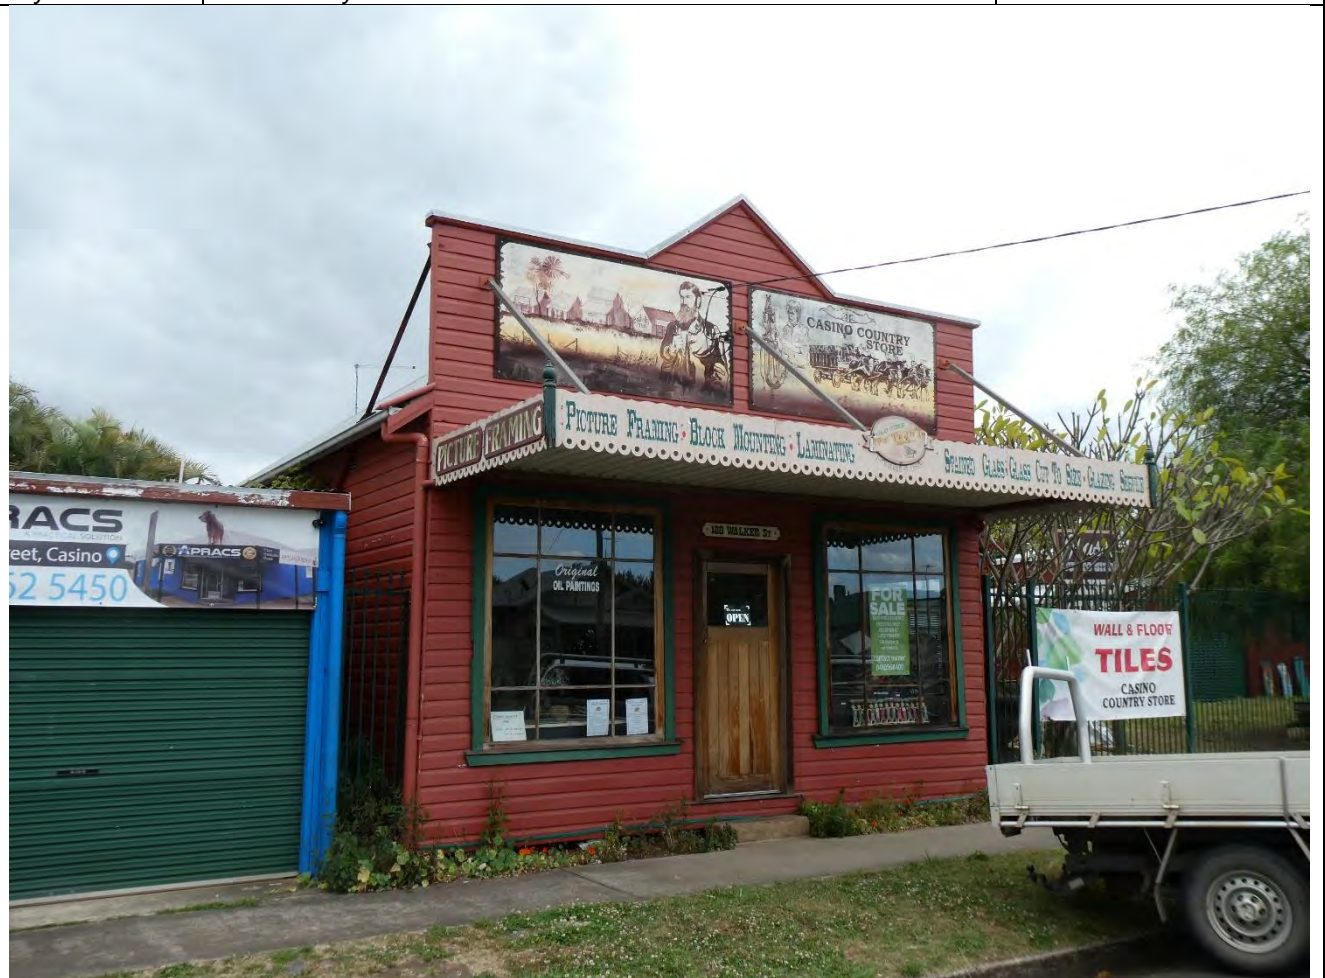
Building Elements	Observations	Recommendations
Roof	Hipped galvanised corrugated roof Skillion extension to northern side of building.	Maintain as to original materials. Do not replace with colorbond.
Gutter	Traditional non-perforated low front Quad profile. Any replacements should maintain the traditional profile.	Maintain and replace as necessary to original low front quad non-perforated profile.
Walls	Single storey timber weatherboard gabled building with a straight edged high timber parapet to street. High ceilings. Painted in a red oxide colour heritage scheme with dark green trims. Historic scenes are depicted in two paintings attached to the parapet.	Maintain a heritage colour scheme as it complements the building.
Awning	Suspended awning from the parapet.	Maintain
Shopfront and Doors	High waisted timber entry door with multi paned timber framed shop windows. Small step to entry.	Maintain timber joinery

Recommendations.

- Carefully conserve all original elements and building fabric to original details.
- Maintain roof to original materials with use of Galvanised Steel for any future replacement. Do not replace with colorbond.
- Maintain and replace gutters as necessary to original low front quad or ogee non-perforated profile.
- Retain heritage colour scheme appropriate to the historic character of the building and restrict business colours to smaller areas of signage.
- Investigate the history of this site for inclusion of the building in a heritage trail for the town centre.
