REVIEW OF ENVIRONMENTAL FACTORS FOR THE AINSWORTH ROAD EMBANKMENT AND CULVERT WORKS, MIDDLE CREEK, MONGOGARIE

Ainsworth Road Embankment Stabilisation Ainsworth Road, Mongogarie NSW 2470 Review of Environmental Factors September 2022

Revision 1

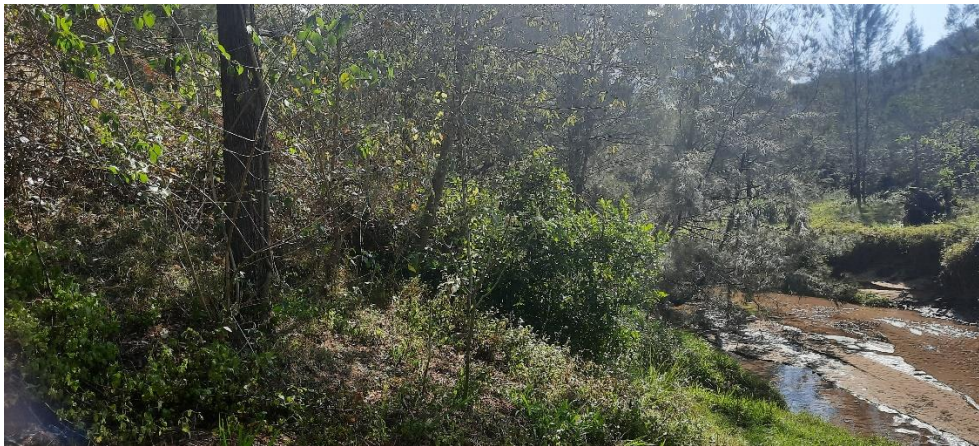
Plate 4.3 View facing west of Middle Creek and riparian vegetation at the site

The remaining riparian vegetation consists of Forest Oak (*A. torulosa*) with exotic shrubs and ground cover species (refer to **Plate 4.3**).

Middle Creek runs adjacent the northern portion of site along Ainsworth Road. It features disturbance to the bank from previous flooding, past land clearing of its riparian zone and damage caused by cattle that graze through the area.

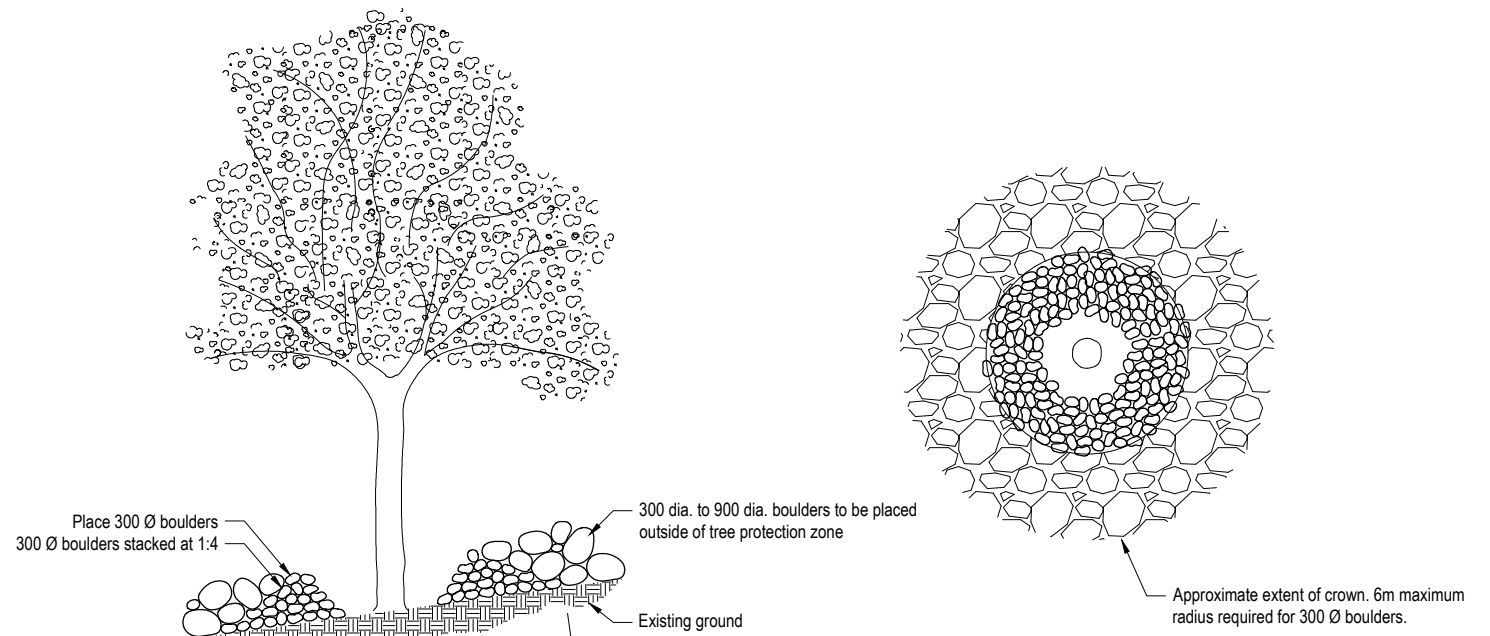
Tree Protection Detail: Section
N.T.S.

Tree Protection Detail: Plan
N.T.S.

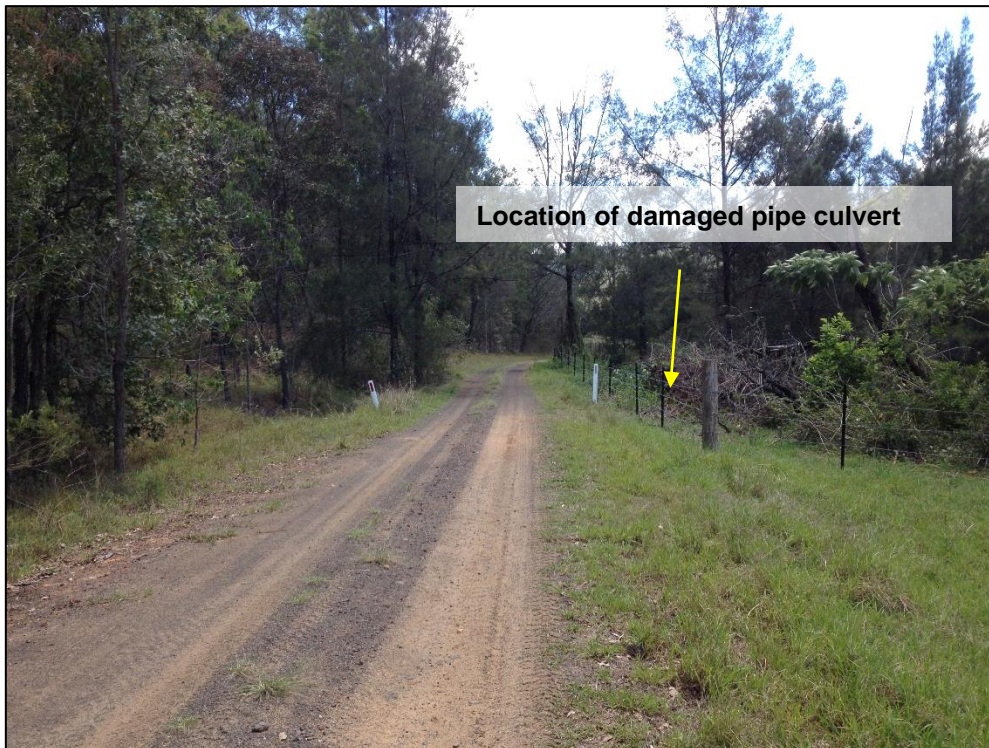
Figure 1: Ainsworth Road. Middle Creek on right hand side of fence

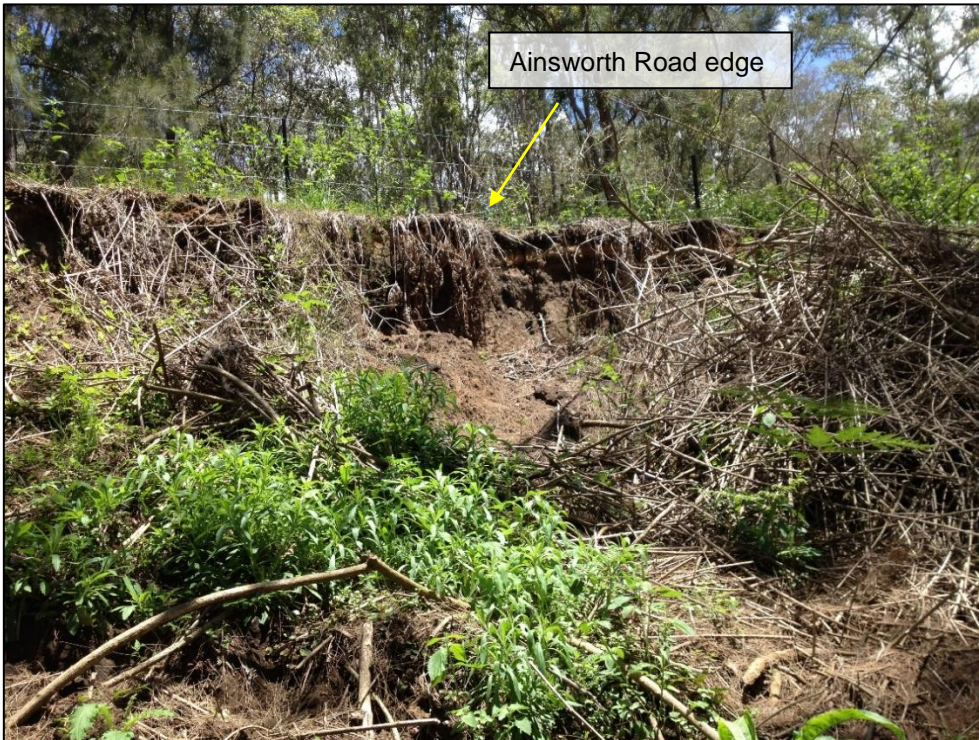
Figure 2: Creek bank erosion adjacent to Ainsworth Road

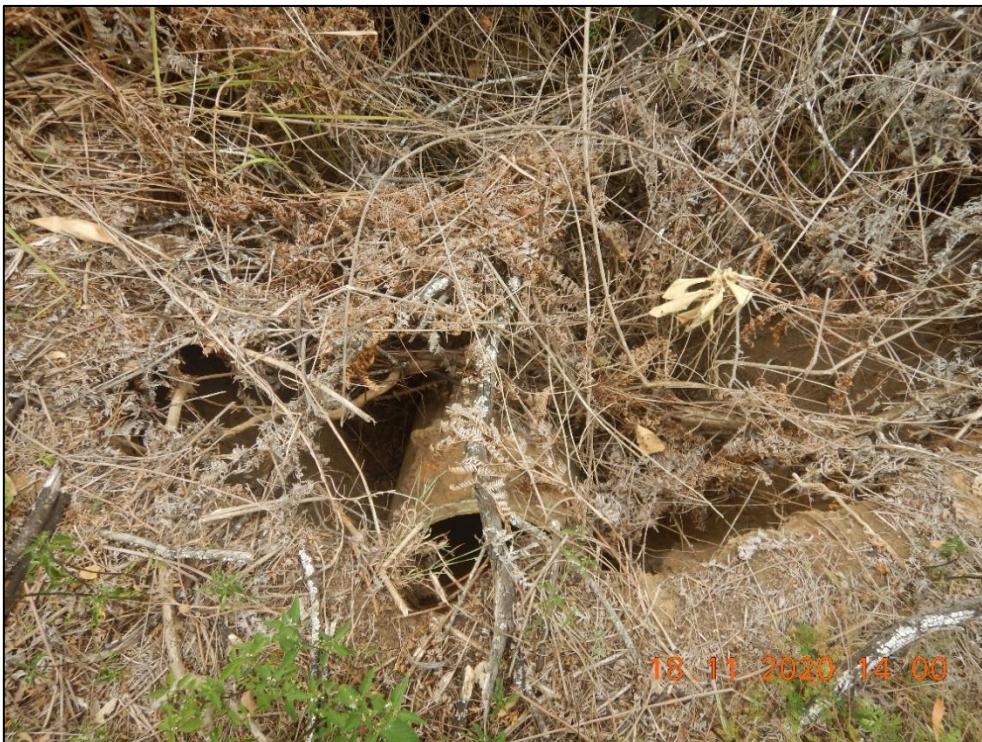
The downstream segment of a 0.6 m diameter existing concrete pipe culvert has been damaged (Figure 3). The hillside is situated on the upstream side of the culvert and Middle Creek is situated on the downstream side of the culvert.

Figure 3: Damaged pipe culvert (downstream outlet)

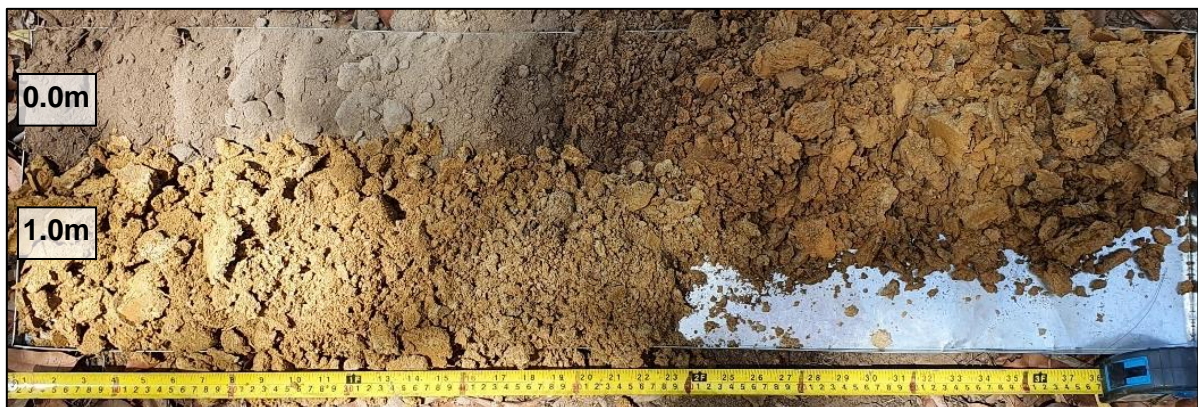
The auger cuttings obtained while drilling Bore A3 are shown in Figure 4.

Figure 4: Bore A3 auger cuttings

Groundwater was not observed in the bores during the time they remained open. It should be noted that groundwater levels are affected by factors such as climatic conditions and soil permeability and will vary with time.
