Salty Lagoon

Post Closure Monitoring

Project Management and Ecosystem Health Report

June 2022

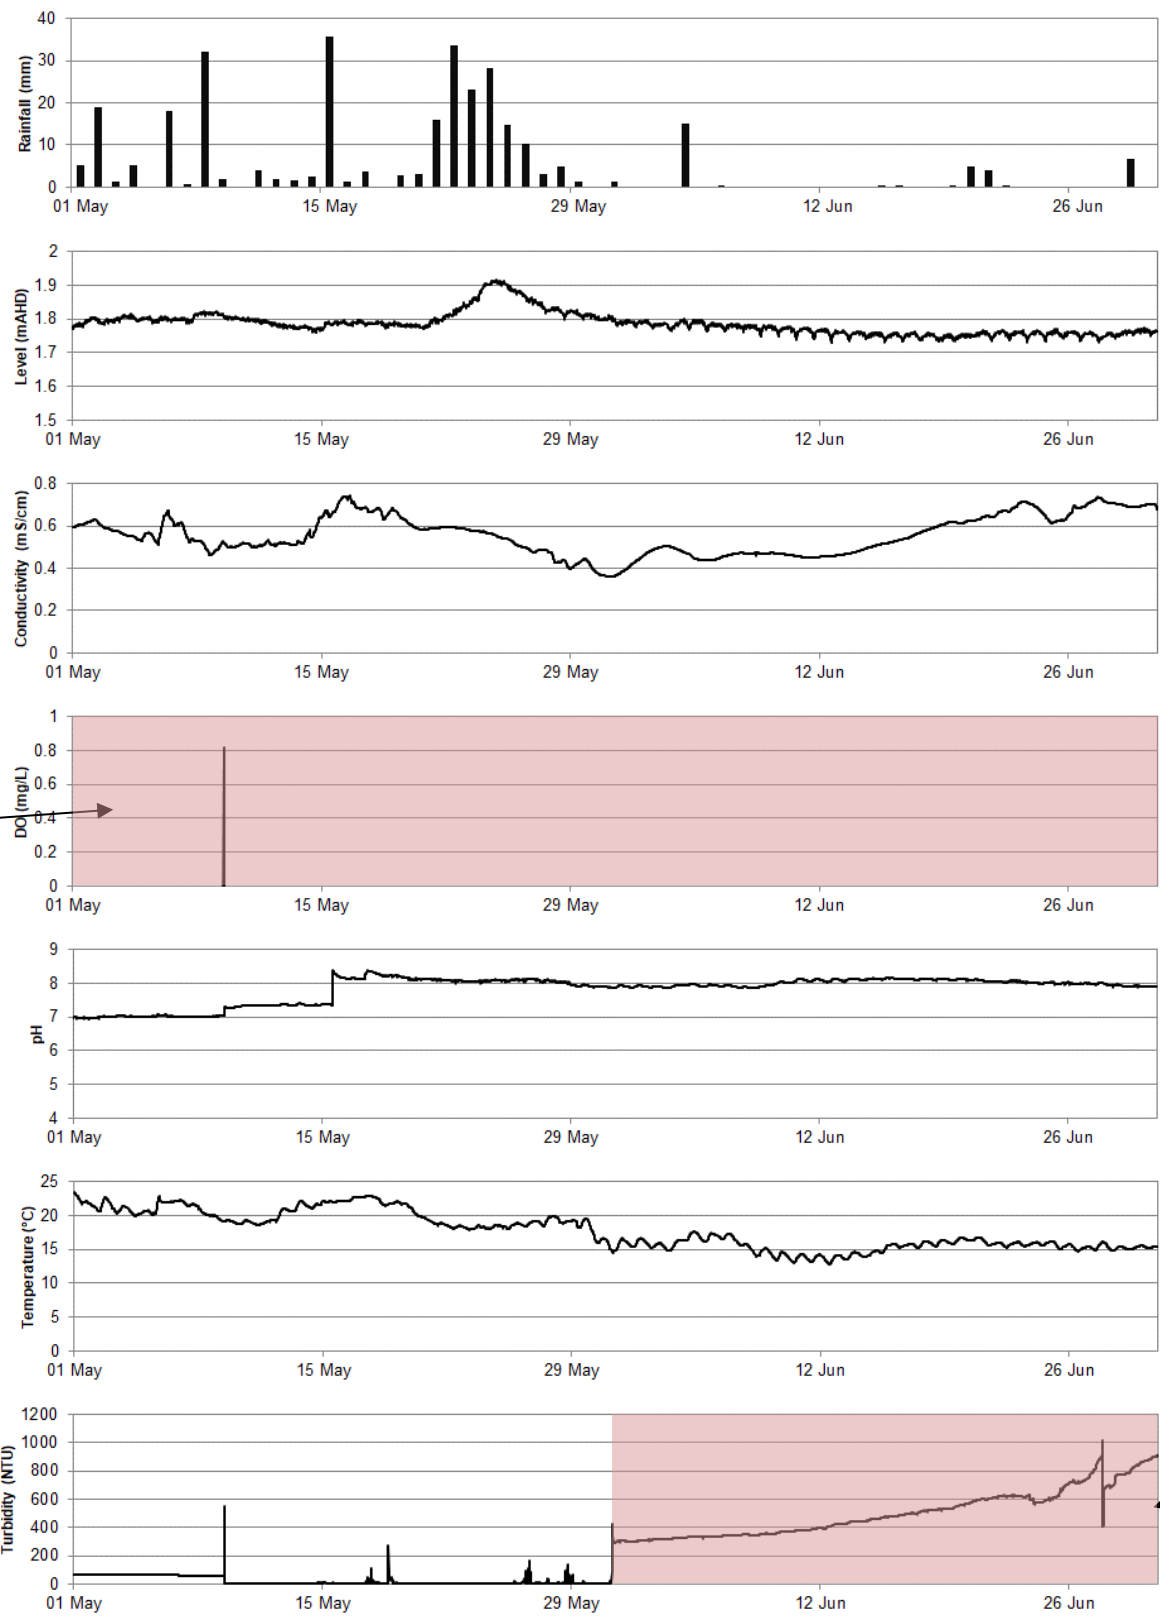
Illustration 3.1 Salty Lagoon Rainfall and Water Quality Monitoring Station Data 1 May 2022 to 30 June 2022

The data collected at the PWQMS, and rainfall data correlating to the reporting period are presented in **Illustration 3.1** and **Illustration 3.2**.

The conductivity measured at the Salty Lagoon PWQMS remained very low during this reporting period in response to consistent rainfall runoff. Small fluctuations detected at the Salty Lagoon PWQMS occurred in response to the variable influences of rainfall or evaporation. The conductivity measurements from the Salty Creek PWQMS varied between freshwater conditions or almost marine conditions in response to either rainfall runoff or tidal movements. At the end of the reporting period (and at the time of the site inspection on 6 July 2022) the water in Salty Lagoon was fresh and the water in Salty Creek was stratified into a brackish top layer and a highly saline bottom layer. The conductivity measurements collected on 6 July 2022 complied with guiding values at all sites except S5, where the result from deeper water was above the upper guideline limit as a result of the very strong influence from earlier tidal movements.

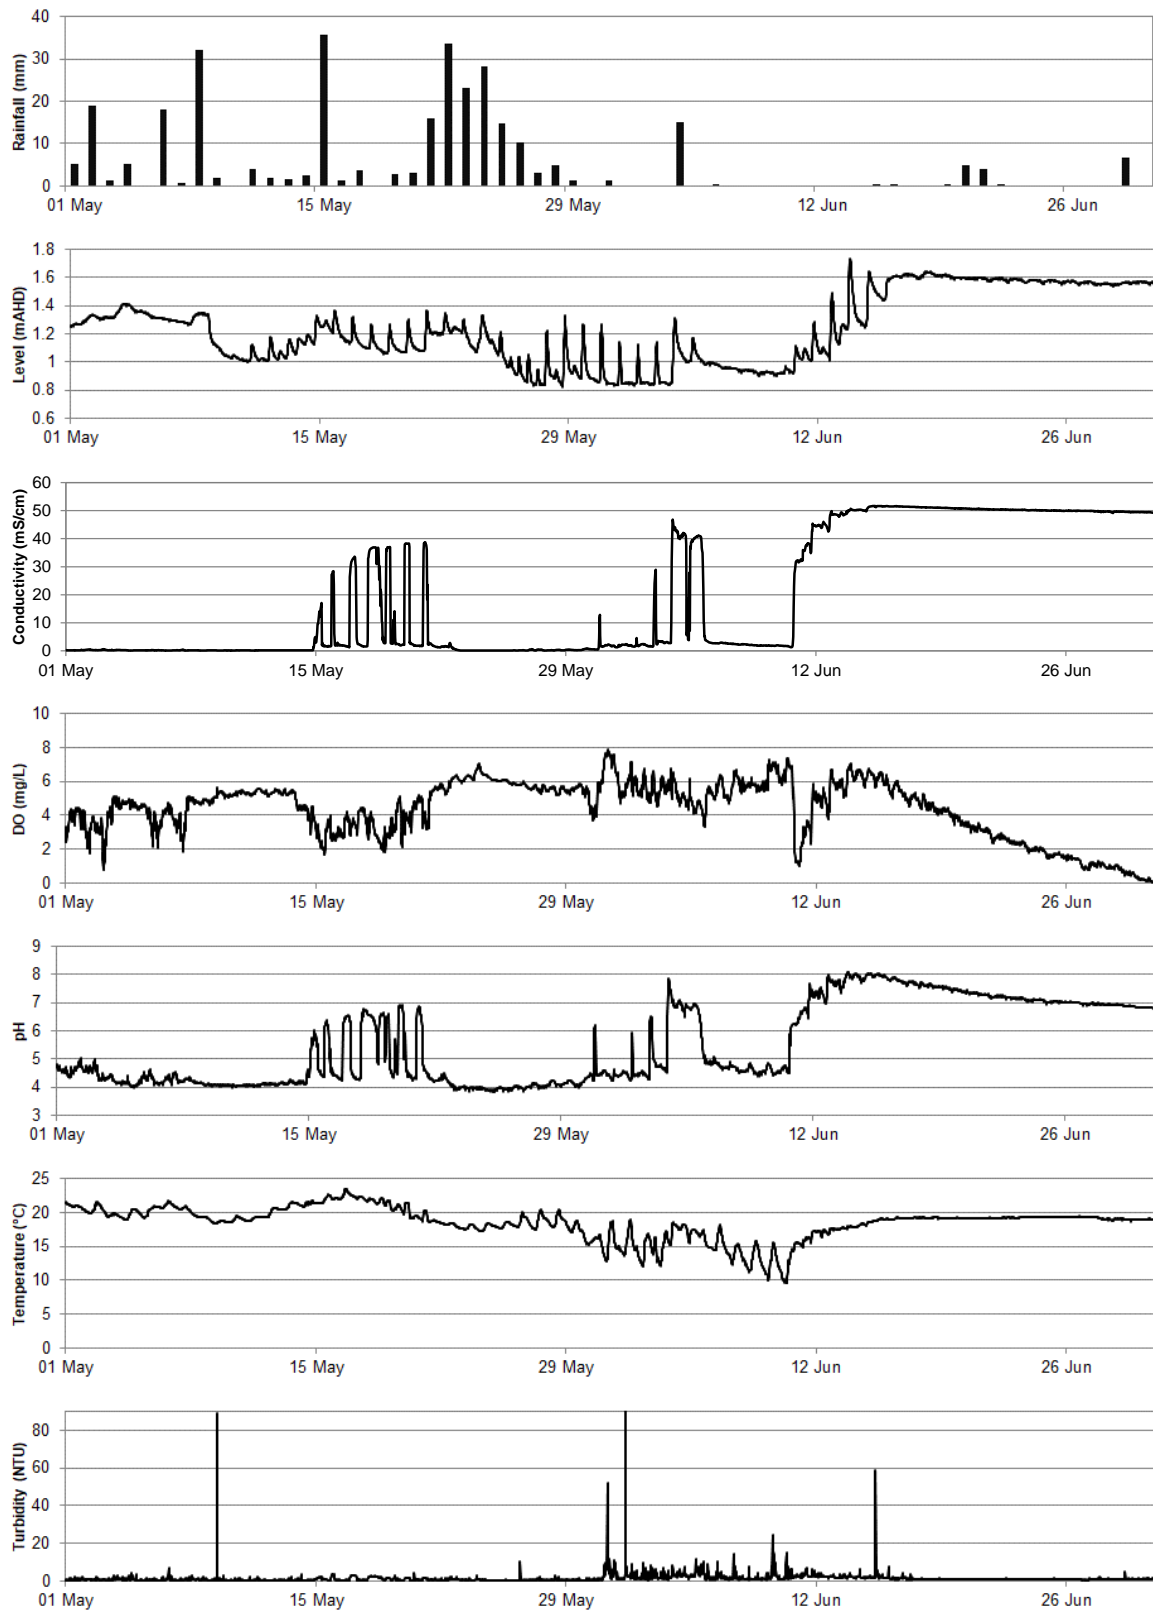
Illustration 3.2 Salty Creek Rainfall and Water Quality Monitoring Station Data 1 May 2022 to 30 June 2022

The water level at the Salty Creek PWQMS was particularly dynamic again during this reporting period, in response to rainfall runoff, seawater ingress, the entrance opening and tidal movements. The data indicates that the entrance to Salty Creek was open for most of the reporting period, and operating tidally for more than half of it. Water levels in Salty Lagoon remained high for the majority of the reporting period, with an increase to approximately 1.9 mAHd in response to sustained heavy rainfall around 24 May 2022. Water would have flowed from Salty Lagoon into Salty Creek for the entire reporting period. This flow led to an advance of the eroding head cut (**Illustration 3.3**) although most of the advance was westwards rather than southwards towards Salty Lagoon (**Plate 4.3**).

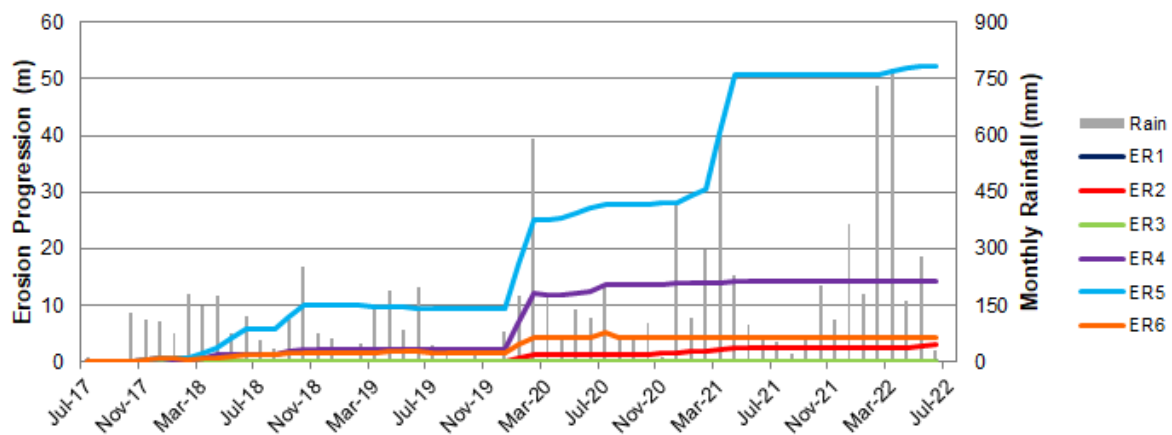
Illustration 3.3 Erosion Progression Plotted against Monthly Rainfall since July 2017

The data collected at the erosion monitoring stations is presented in **Table 3.2** and **Illustration 3.3**. There was no significant advance of the head cut at ER5 in relation to the previous measurements on 9 May 2022. The head cut has advanced more than 50 m towards Salty Lagoon since the monitoring began in July 2017.

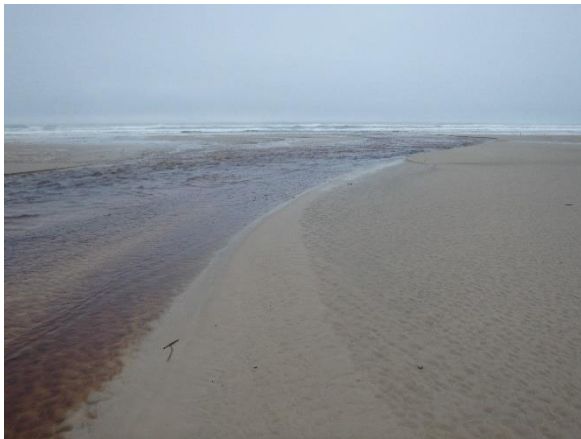
The entrance to Salty Creek was open and flowing on 6 July 2022 (**Plate 4.1**). Few birds were observed incidentally during the site inspection. The species observed were Pacific Black Duck, White-eyed Duck, Little Pied Cormorant and Black Swan. A native aquatic plant, hornwort (*Ceratophyllum demersum*), was observed throughout Salty Lagoon in unusually high densities.

Plate 4.1 The open entrance to Salty Creek on 6 July 2022

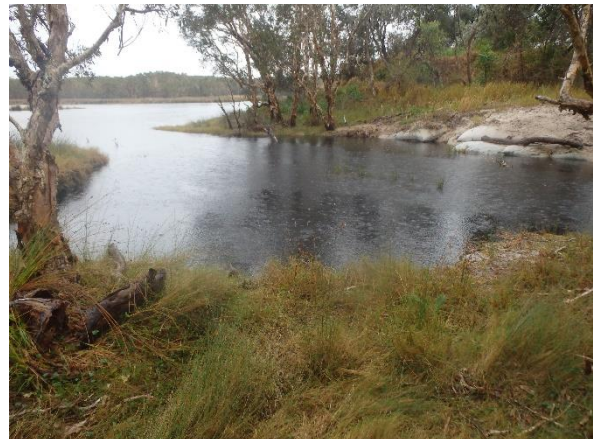
Plate 4.2 The erosion control structure has been outflanked and is collapsing.

5. The erosion control structure has been outflanked, is damaged and is no longer functional.
6. In accordance with the project Environmental Response Protocol (GeoLINK 2017b), the risk rating from the Salty Lagoon Response Protocol is uncertain. This is due to the potential for a new permanent channel to form between Salty Lagoon and Salty Creek. Adaptive management site visits are recommended for periods of potential head cut progression, with the following triggers:

- >50 mm of rainfall with 24 hrs.
 - >200 mm of rainfall within a week.
 - Other high risk events, for example >100 mm of rainfall within 72 hours, significant storm surge, atypically large tides, etc. Due consideration would be given to rainfall intensity and volume, and the Salty Creek entrance status when known as appropriate.

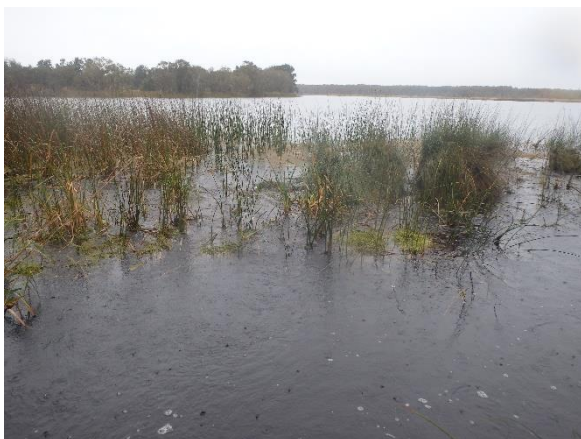
Erosion monitoring showed a small movement of the primary head cut towards Salty Lagoon since the previous measurements taken on 9 May 2022. Although the southward advance towards Salty Lagoon was approximately 0.2 m during this reporting period, the eroding channel extended approximately 1.5 - 2 m in a westward direction (**Plate 4.3**).

Plate 4.3 The position of the headcut on 6 July 2022 showing a westwards advance

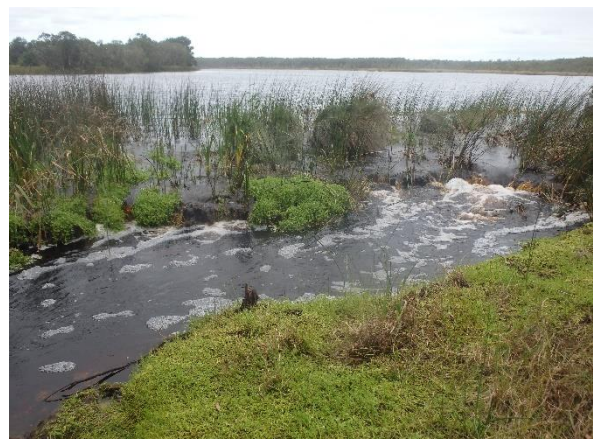
Plate 4.4 The position of the headcut on 9 May 2022
