Review of Environmental Factors

Bridge Replacement on road from
Whiporie to Bungwalbin over Jacky
Bulbin Creek
March 2023

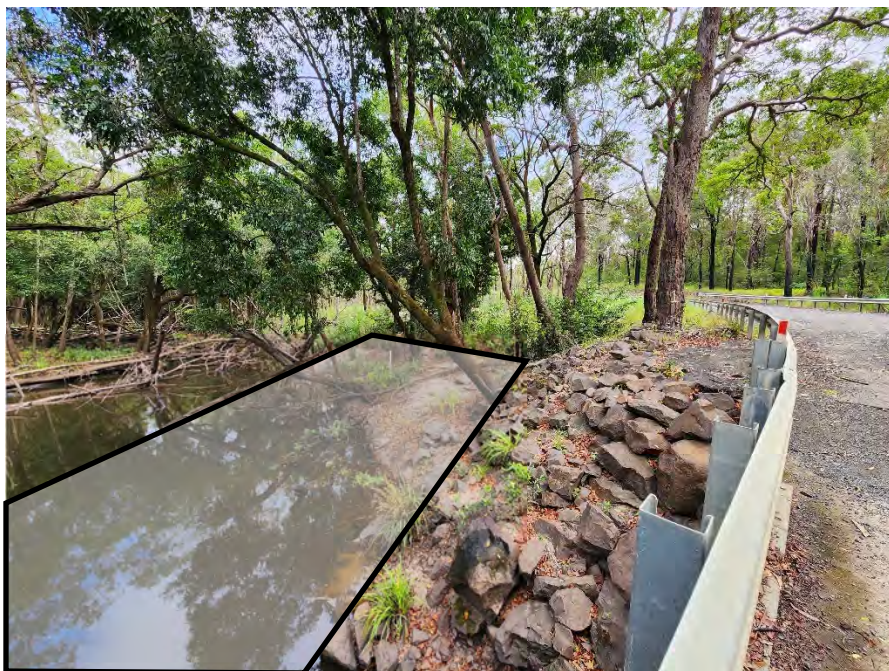
Plate 3 – Temporary steel bridge location – looking north

Plate 3 shows the location of the temporary steel bridge and northern abutment looking north.

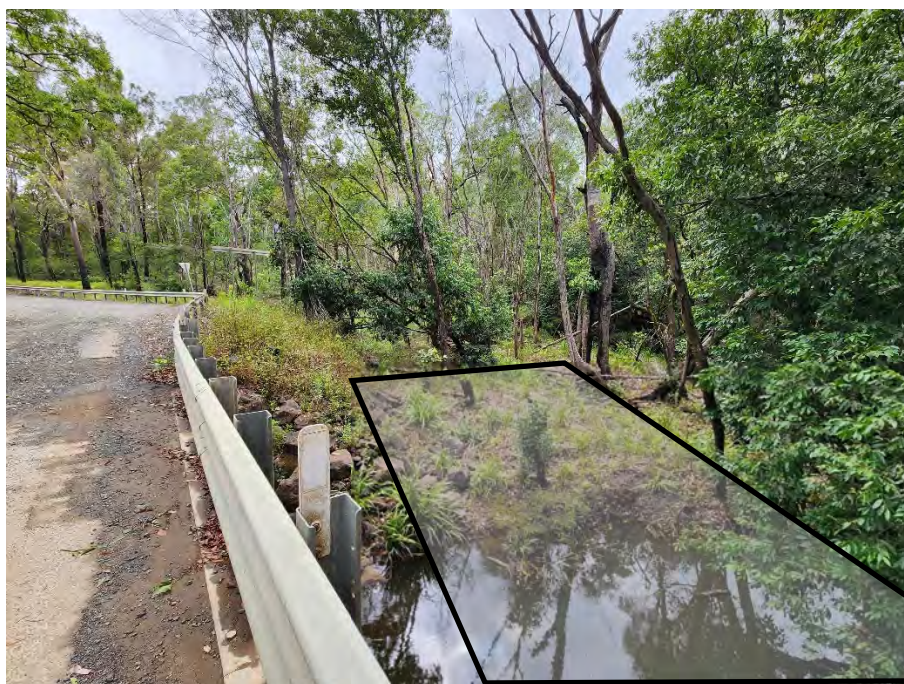
Plate 4 – Temporary steel bridge location – looking south

Plate 4 shows the location of the temporary steel bridge and southern abutment looking south.

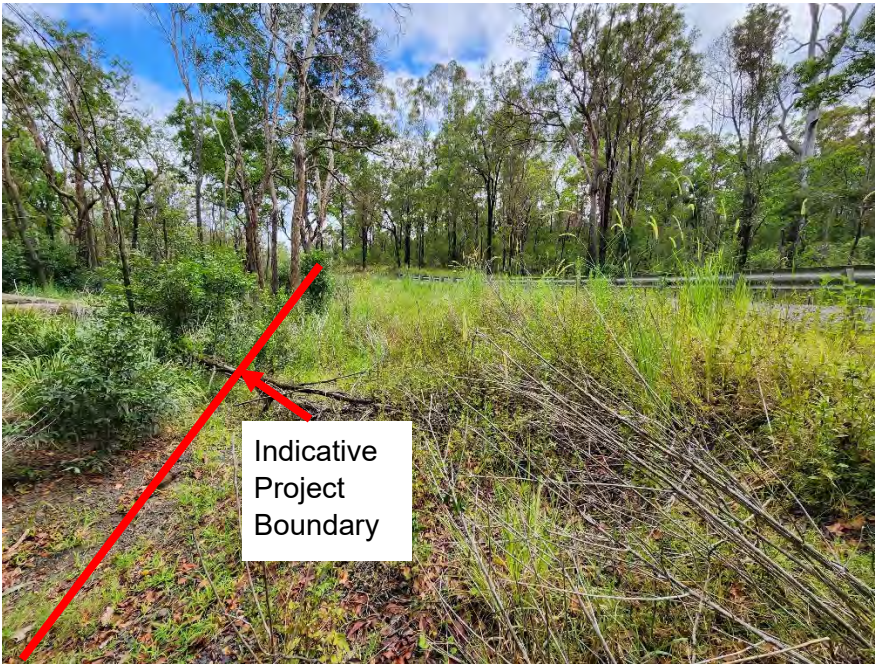
Plate 5 – Northern Project boundary extent – looking north

Plate 5 shows the location of the northern project extent and the existing road looking north.

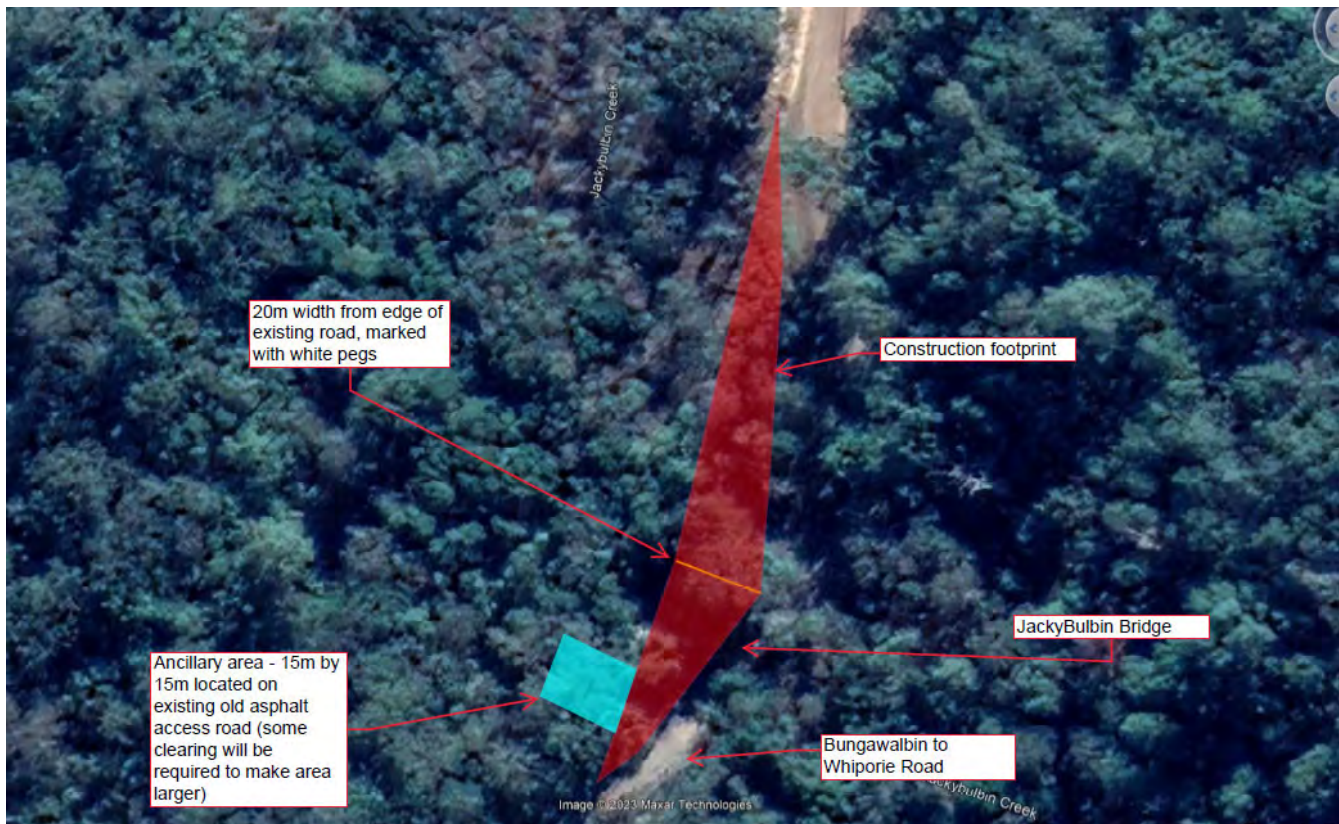
Figure 3 shows the general works footprint and the proposed Project Boundary.

Figure 3 – General Project Footprint (google maps www.google/maps).

- 1) Initial clearing of the vegetation within the construction works footprint (see Figure 3 for details on the construction works footprint);
- 2) Removal and stockpiling of topsoil and any soil material that is not deemed suitable for construction in accordance with relevant engineering specifications.

Ancillary areas such as a stockpiling area and laydown area will be provided within the Road Reserve as shown on Figure 3 on existing disturbed ground. A construction compound is not required for this site.

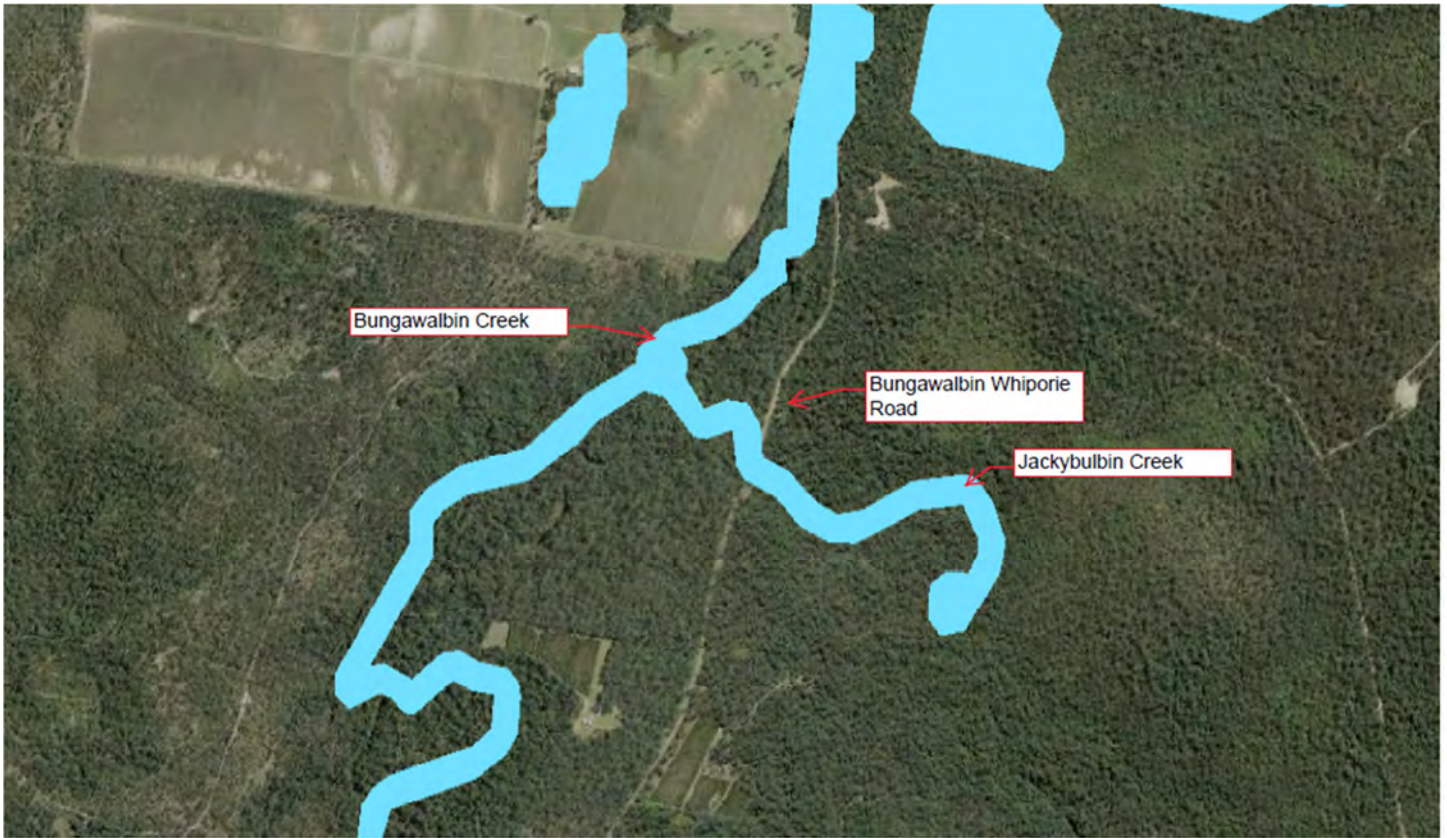
LEP mapping shows that the site does not have a risk of Acid Sulphate Soil. The proposal does require works over Jackybulbin Creek which is mapped as having Key Fish Habitat upstream of the proposal site (See Figure 7 below). The proposal site does not have any mapped heritage items or conservation areas. The proposal site is also mapped as having biodiversity significance. The management of biodiversity is discussed in Section 7.1 below. Further discussion regarding the implications of key fish habitat are discussed in Section 5.4 and 7.1 below.

Figure 7 – Key Fish Habitat mapping (shown in Blue).

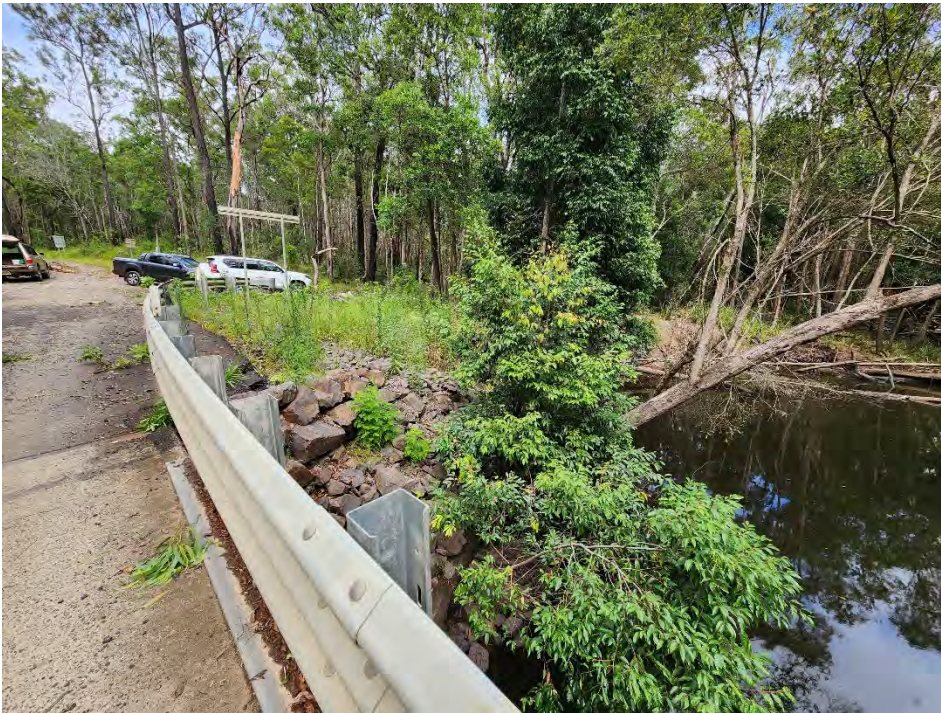
There are signs of scouring and erosion within the creek bank on the southern creek bank as shown in Plate 6 below.

Plate 6 – Photo showing southern creek bank with signs of erosion and scour. Scour rock has been placed to reduce erosion.

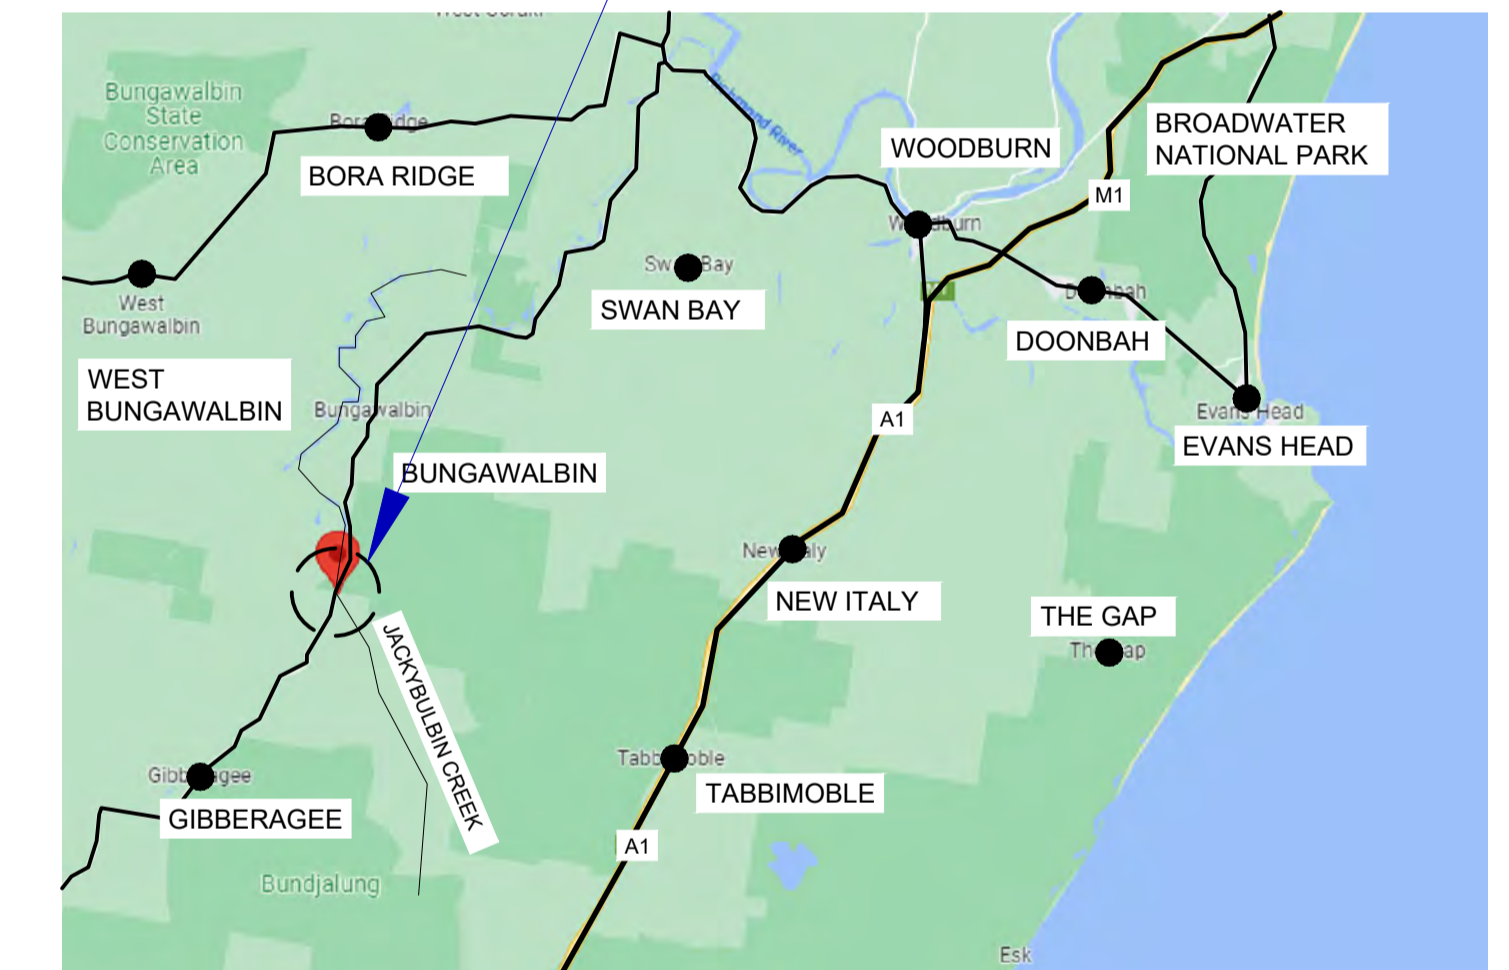
LOCALITY PLAN
THIS BRIDGE IS APPROXIMATELY
5.2 km SOUTH BY ROAD FROM BUNGAWALBIN
(NOT TO SCALE)

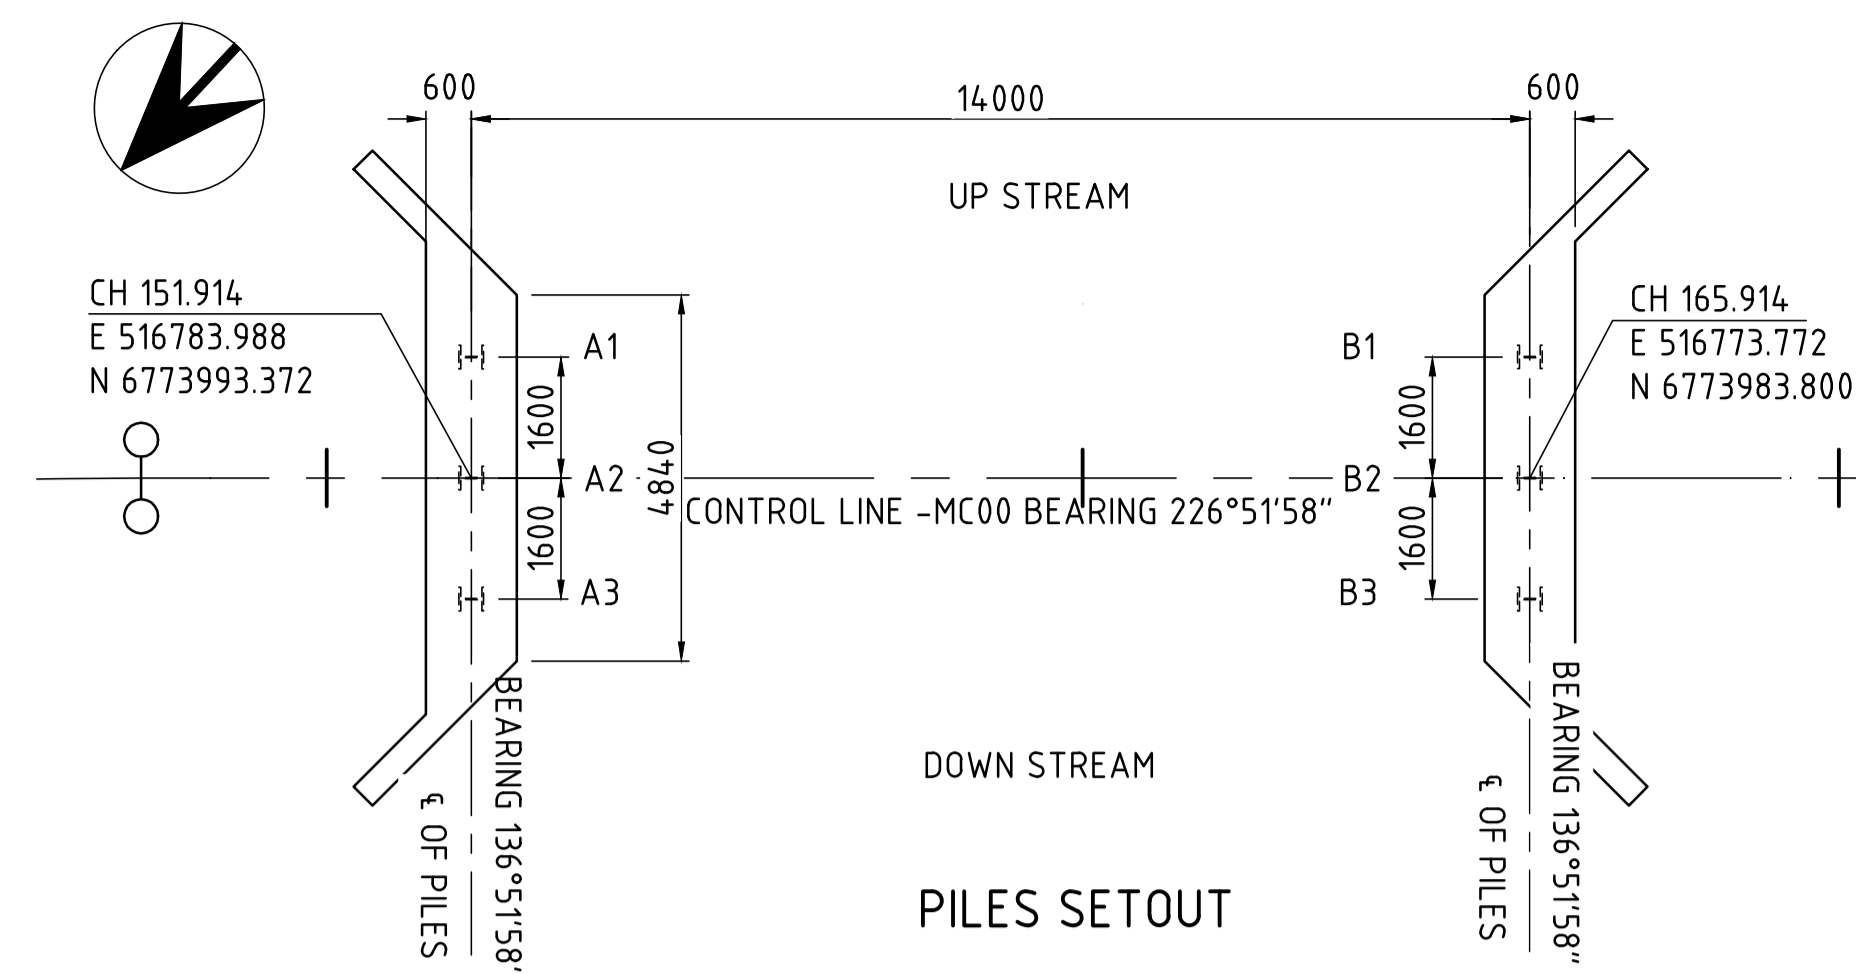
TABLE 1 - PILE DATA

BOREHOLE	PILE No	APPROXIMATE PILE LEVELS		ESTIMATE LENGTH (m)	MINIMUM PILE LENGTH L (m)	MAXIMUM DESIGN AXIAL LOAD (KN)		MAXIMUM DESIGN BENDING MOMENT (kNm)	PILE SIZE
		TOP OF PILE LEVEL RL. A(m)	PILE TOE LEVEL RL. B(m)			ULS	SLS		
BH1 (N)	A-1	4.536	-14.0	18.536	7.8	969	621	326	310UC137
	A-2	4.488	-14.0	18.488	7.8				
	A-3	4.440	-14.0	18.440	7.8				
BH2 (S)	B-1	4.688	-13.0	17.688	7.8	969	621	326	310UC137
	B-2	4.640	-13.0	17.640	7.8				
	B-3	4.592	-13.0	17.592	7.8

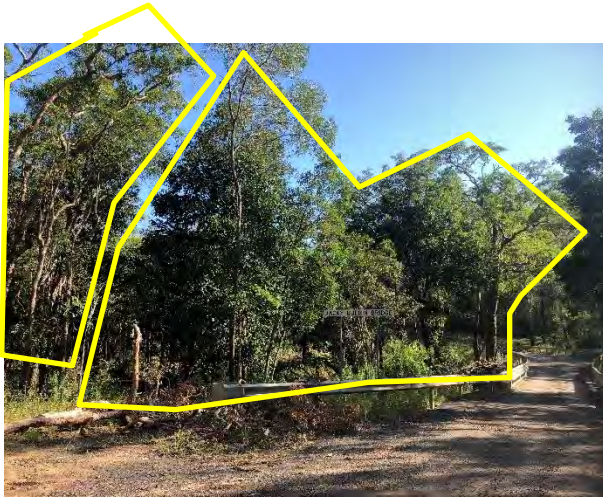
Plate 3.1 View north of Jacky Bulbin Bridge and riparian vegetation west of bridge to be removed (yellow polygons)

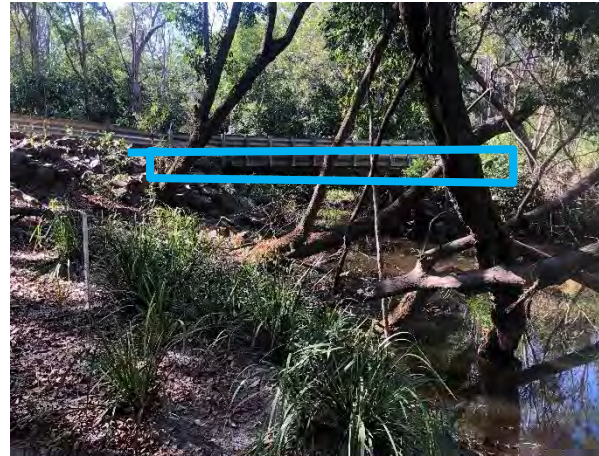
Plate 3.2 View east of riparian vegetation upstream of Jacky Bulbin Bridge (blue polygon indicates new bridge alignment)

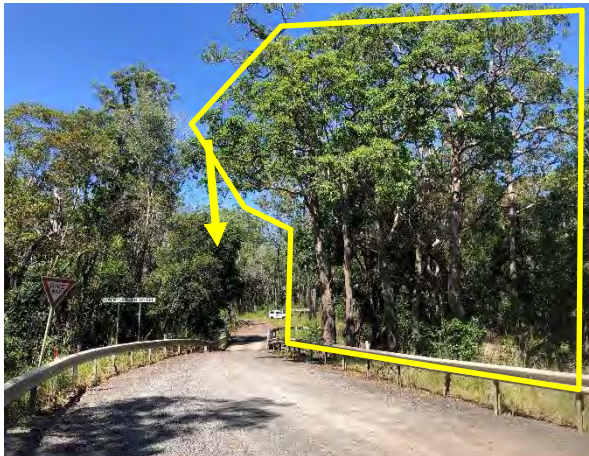
Plate 3.3 View south of Jacky Bulbin Bridge and vegetation west of bridge to be removed (vegetation in yellow polygons to be pruned)

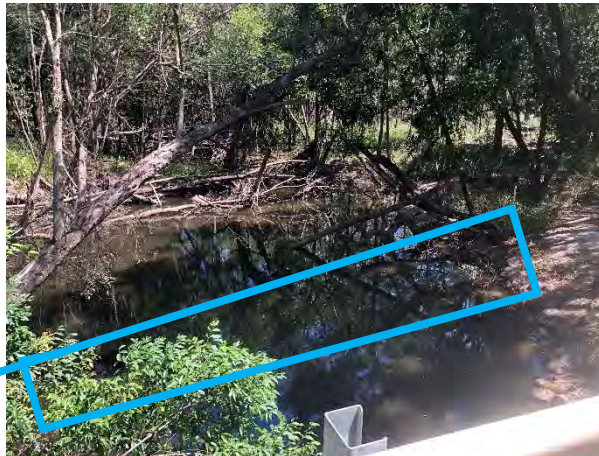
Plate 3.4 View west (upstream) of Jacky Bulbin Bridge (blue polygon indicates new bridge alignment)

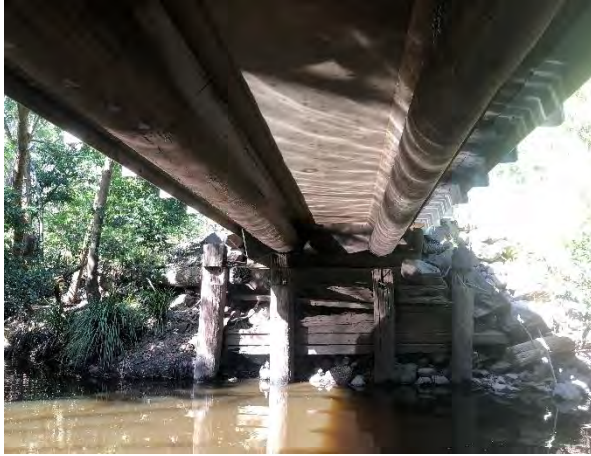
Plate 4.1 View beneath Jacky Bulbin Bridge of low-quality opportunistic microbat roost habitat

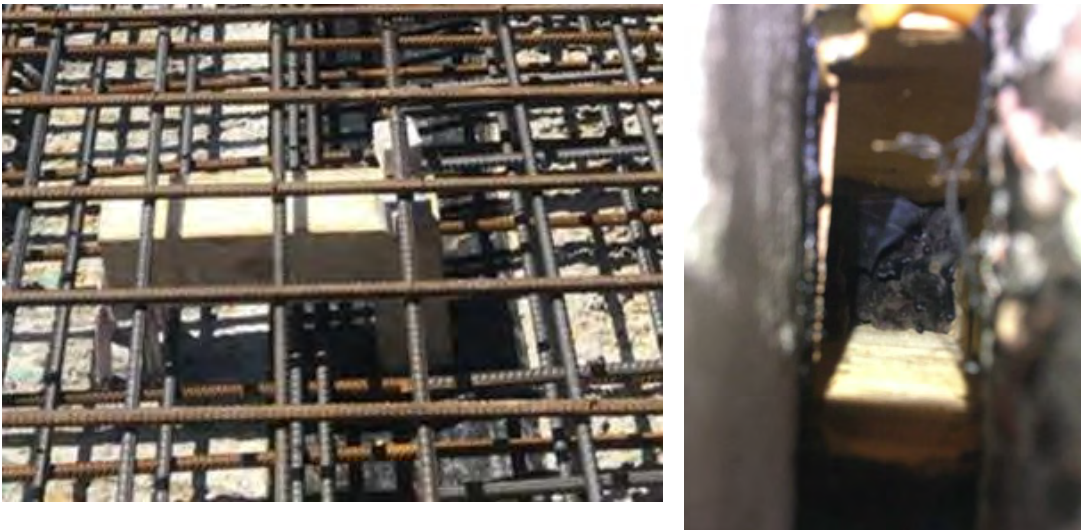
Description	Photo
<p>Super-t bridge inbuilt microbat habitat</p> <p>Microbat box in situ concrete slab above expansion joint below footpath. Features include:</p> <ul style="list-style-type: none">Expansion joint width: 30 mm.Vertical section: 100 x 100 mm wide box, 150mm long.Horizontal shaft: 100 x 100 mm wide box, 400 mm long; sloped for drainage. <p>Carrying capacity 30 Southern Myotis. Proven effective for Southern Myotis at Barrington Bridge (Barrington).</p> <p>Photo source (right): G. Jenkins, Transport for NSW.</p>

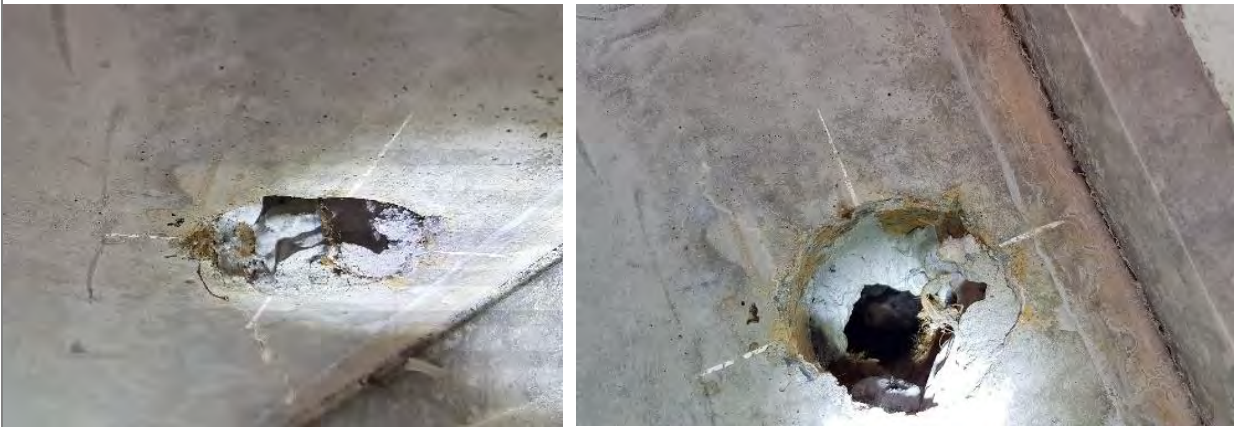
<p>Cylindrical prism in-situ concrete slab, with opening in super-t girder flange below footpath. Features include:</p> <ul style="list-style-type: none">150 mm long by 90 mm diameter cylindrical prism in in-situ slab.55 mm diameter hole/ opening on underside of super-t girder flange.Can be positioned at girder lift holes to avoid drilling into super-t girder flange. <p>Carrying capacity 10 Southern Myotis. Proven effective for Southern Myotis at Sportsmans Creek Bridge, Lawrence. Use by individuals Large Bent-winged Bats also observed.</p> <p>False scuppers (with suitable material) may also be suitable.</p>

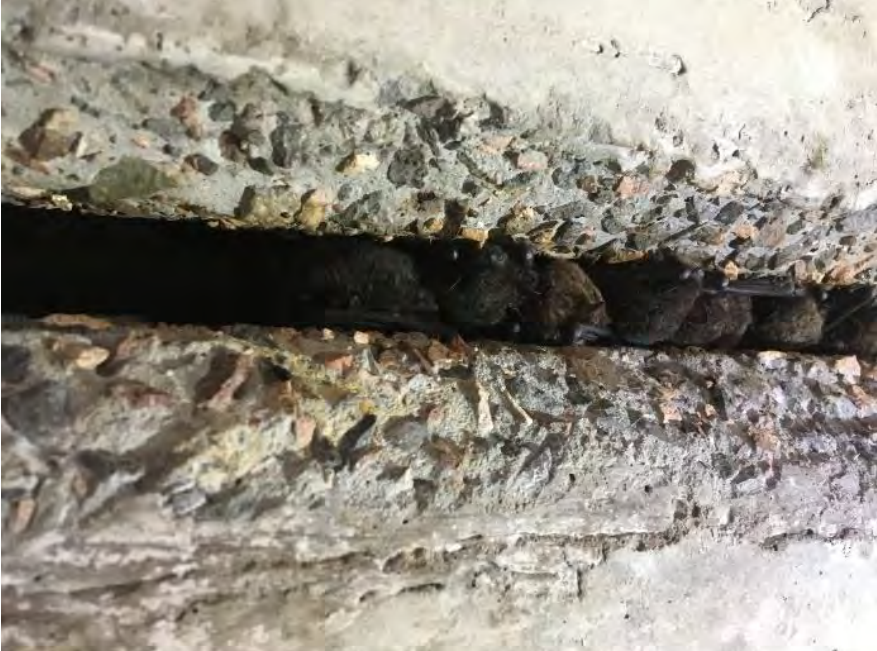
Description	Photo
<p>Roughened expansion joints. Comprises 25 – 30 mm wide and 75 mm deep expansion joint located over water with concrete roughened.</p> <p>Brightness of habitat (including reflection from water) needs to be considered for determining suitability.</p> <p>Generally considered non-breeding habitat. Carrying capacity of 100s of microbats. Proven effective for Southern Myotis at Barrington Bridge (Barrington Bridge). Opportunistic use by individual Southern Myotis and Large Bent-winged Bats also recorded at Sportsmans Creek Bridge, Lawrence.</p>

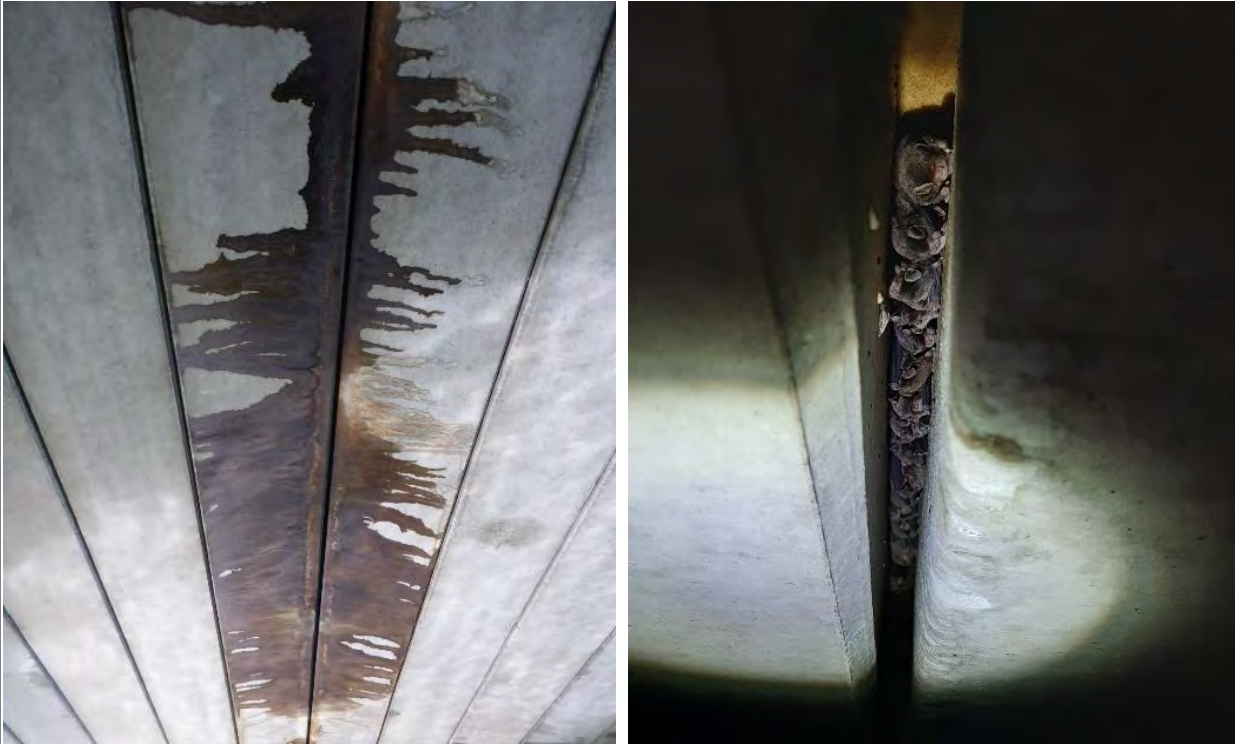
Description	Photo
<p>Plank bridge inbuilt microbat habitat</p> <p>Plank gaps: 20-40 mm wide and 150-200 mm deep.</p> <p>Carrying capacity of 100-1000s of microbats.</p> <p>Proven effective for Southern Myotis at Shark Creek Bridge (Tyndale) and Little Bent-winged Bats at Pacific Highway (Jacky-Bulbin locality).</p>

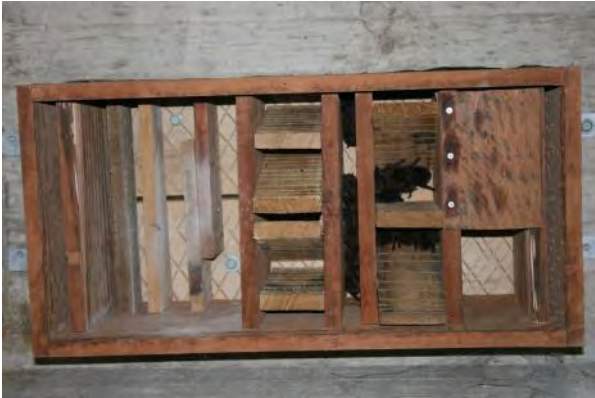
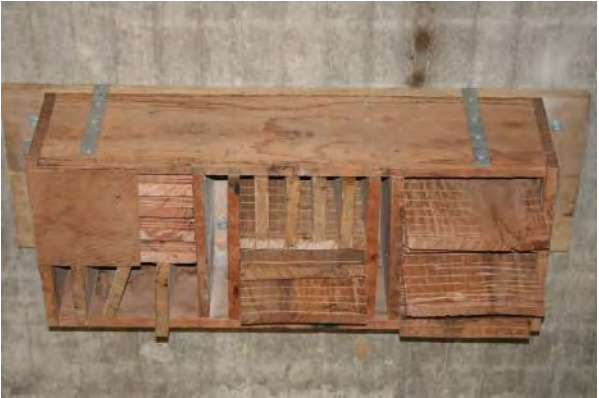
<p>Hebel block with drilled in chambers (photo source: N. Williams).</p> <p>Proven effective for Southern Myotis. Potentially suitable for bent-winged bats.</p>

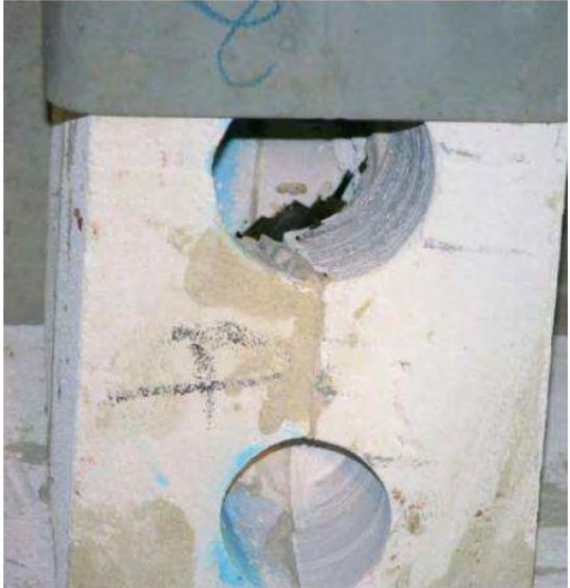
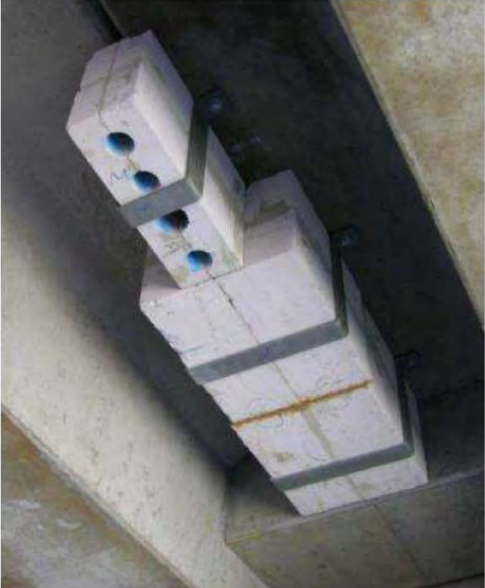
Temporary bat boxes secured with anchor bolts into in-situ slab (between expansion join).

Effective for Southern Myotis. Not suitable for bent-winged bats.

Bat boxes constitute **temporary habitat only**.

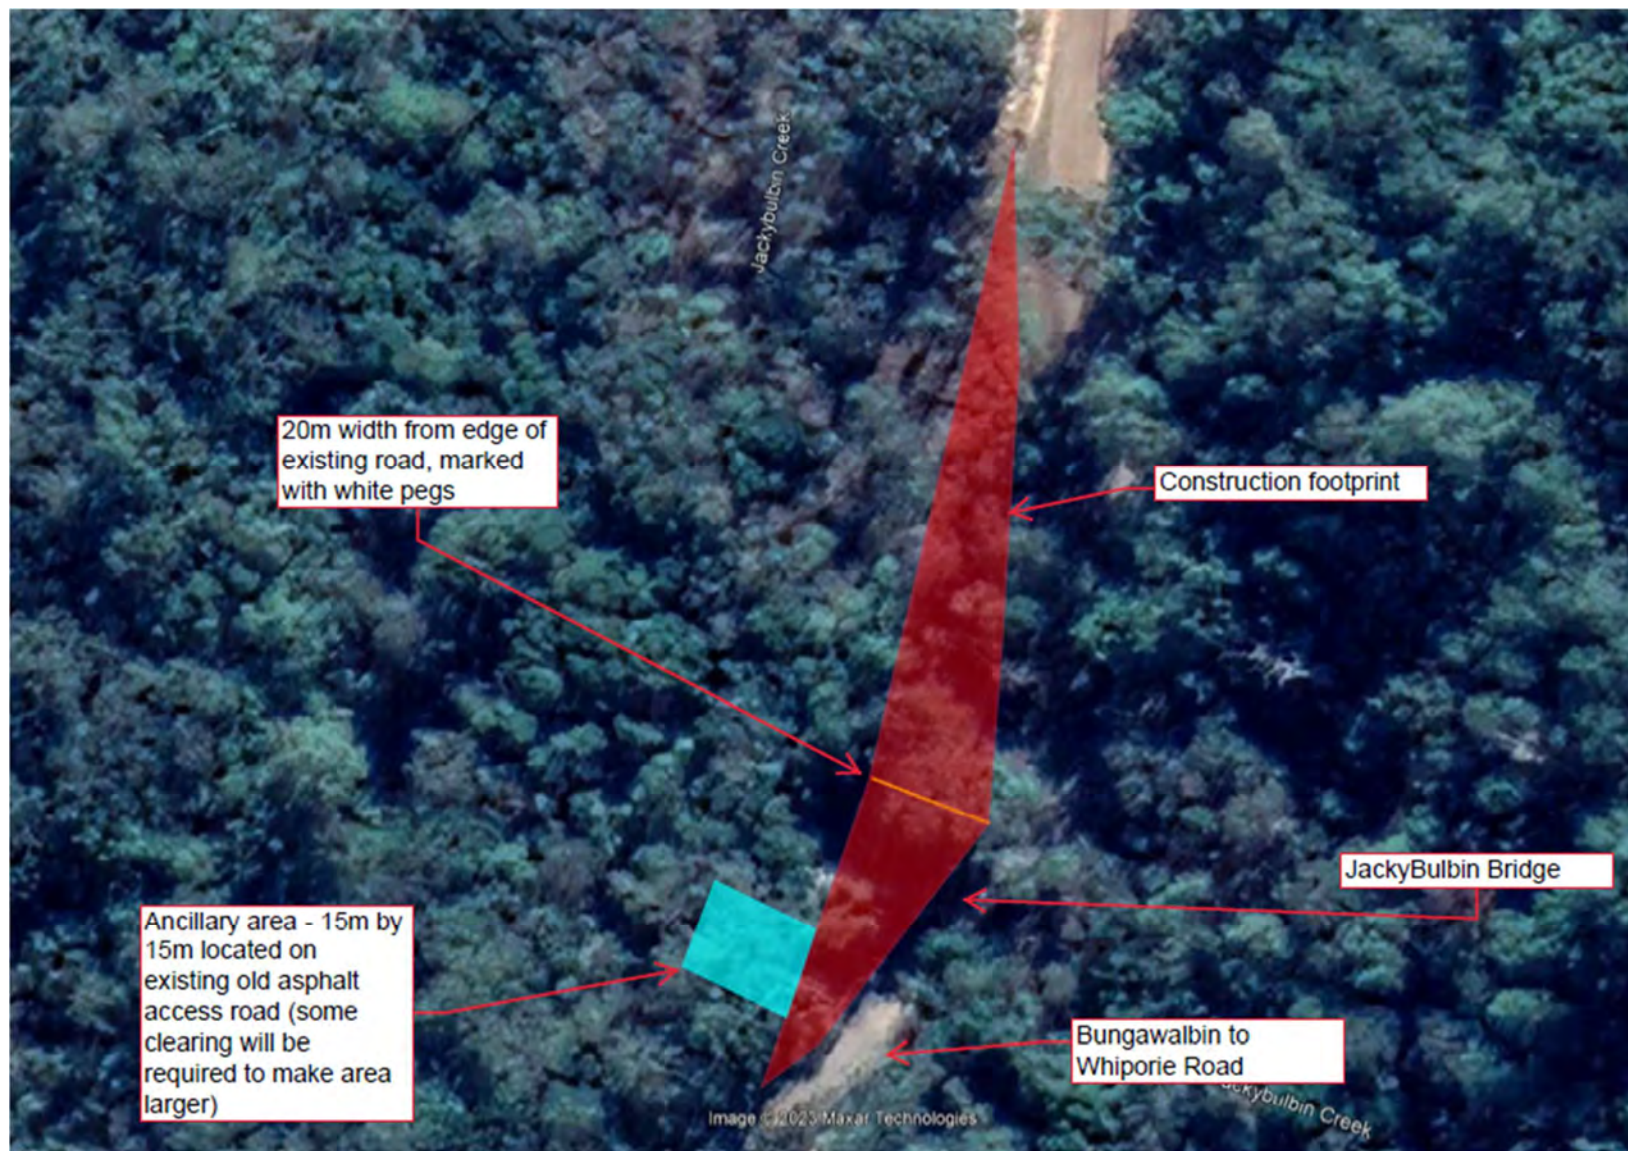
Figure 2: Location of Jackybulbin Bridge replacement in relation to the existing bridge (Envirocivil Consultants)

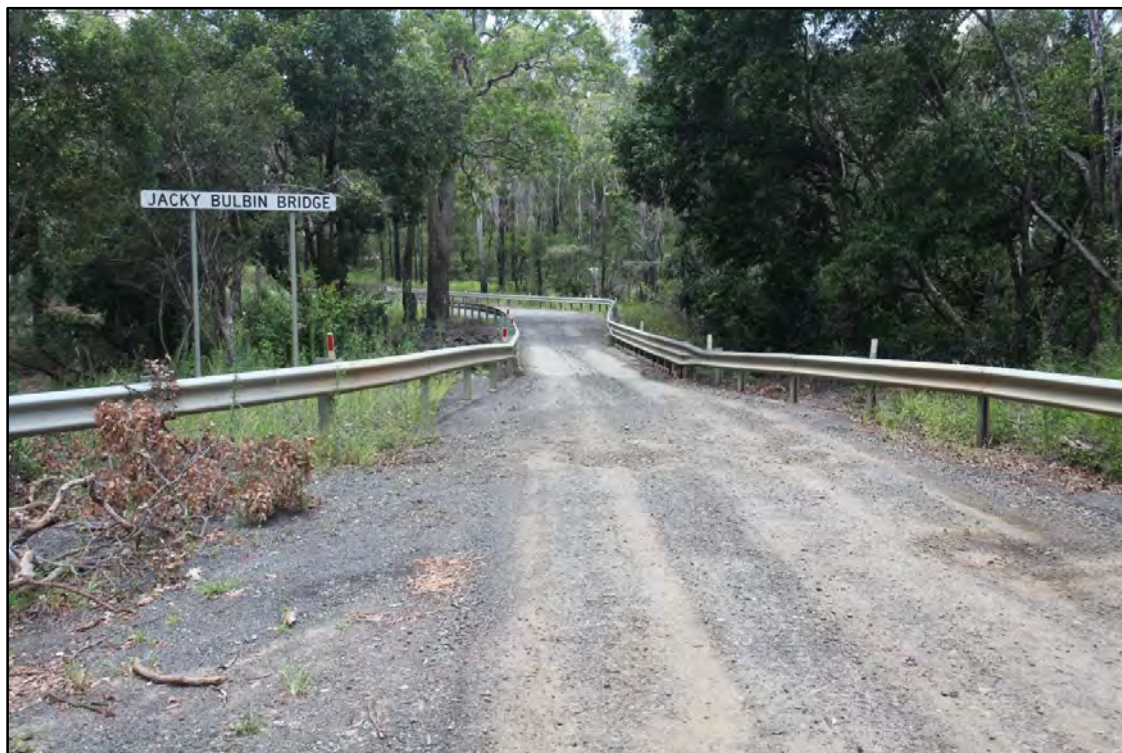
Figure 14: Jacky Bulbin Bridge looking north

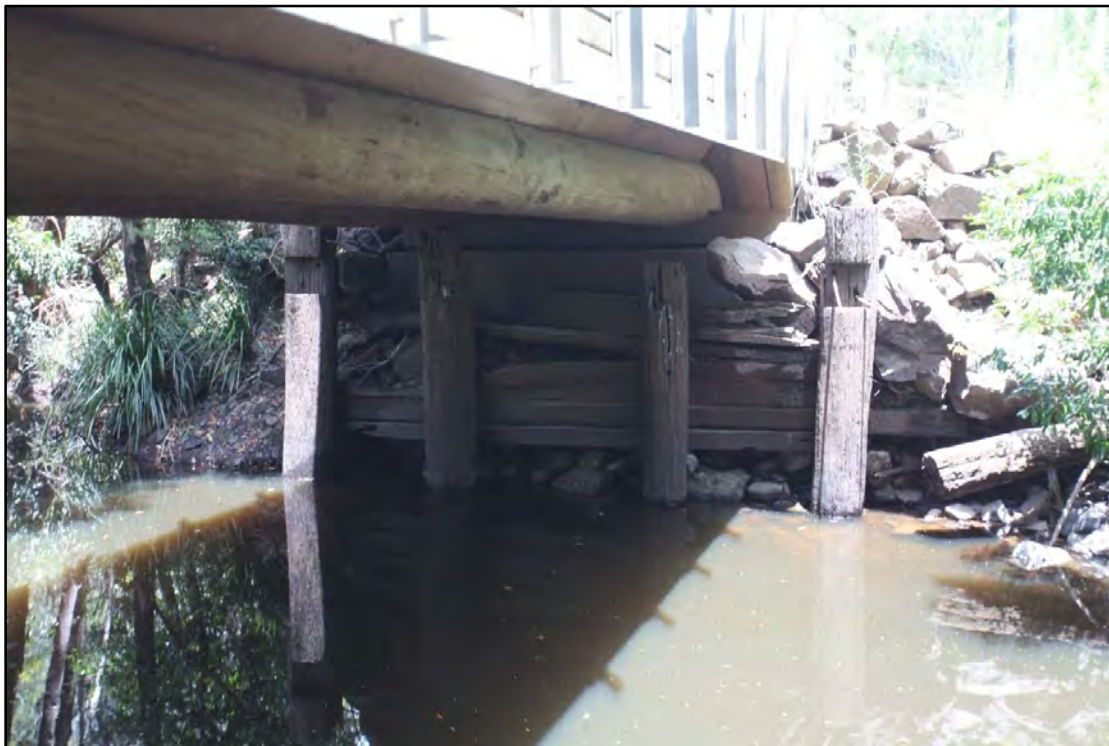
Figure 15: The southern abutment showing original timbers and replacement concrete/ timber bridge

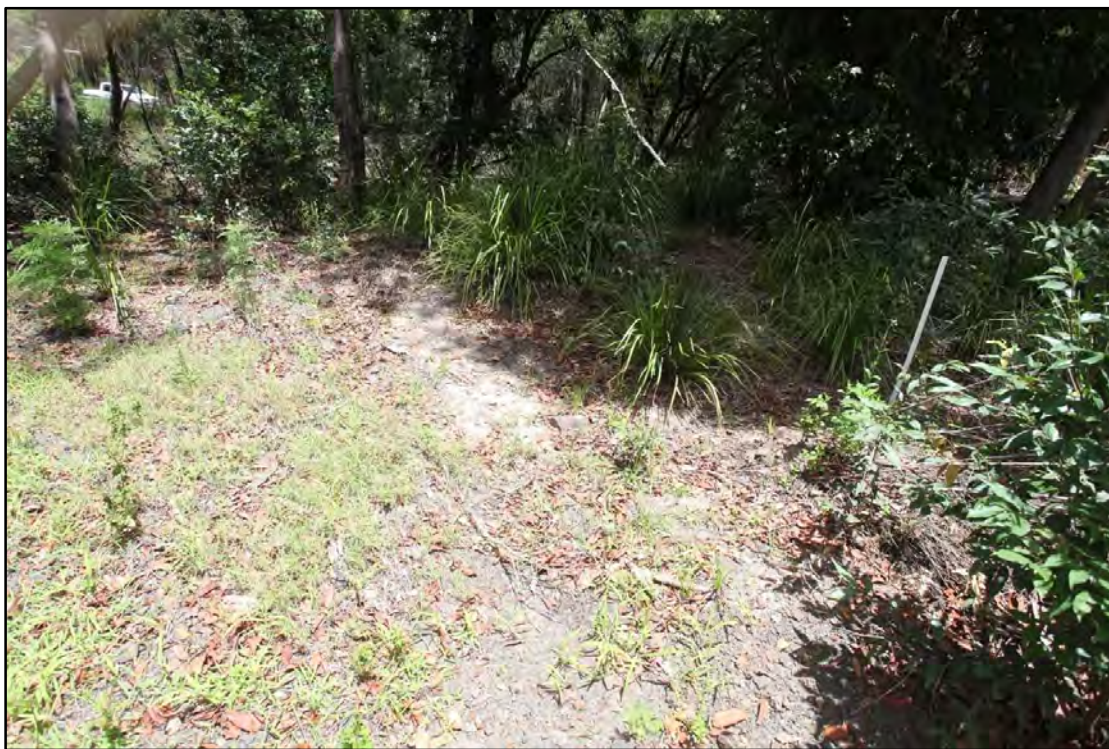
Figure 16: sandy soil on the northern creek bank (white post shows proposed bridge alignment)

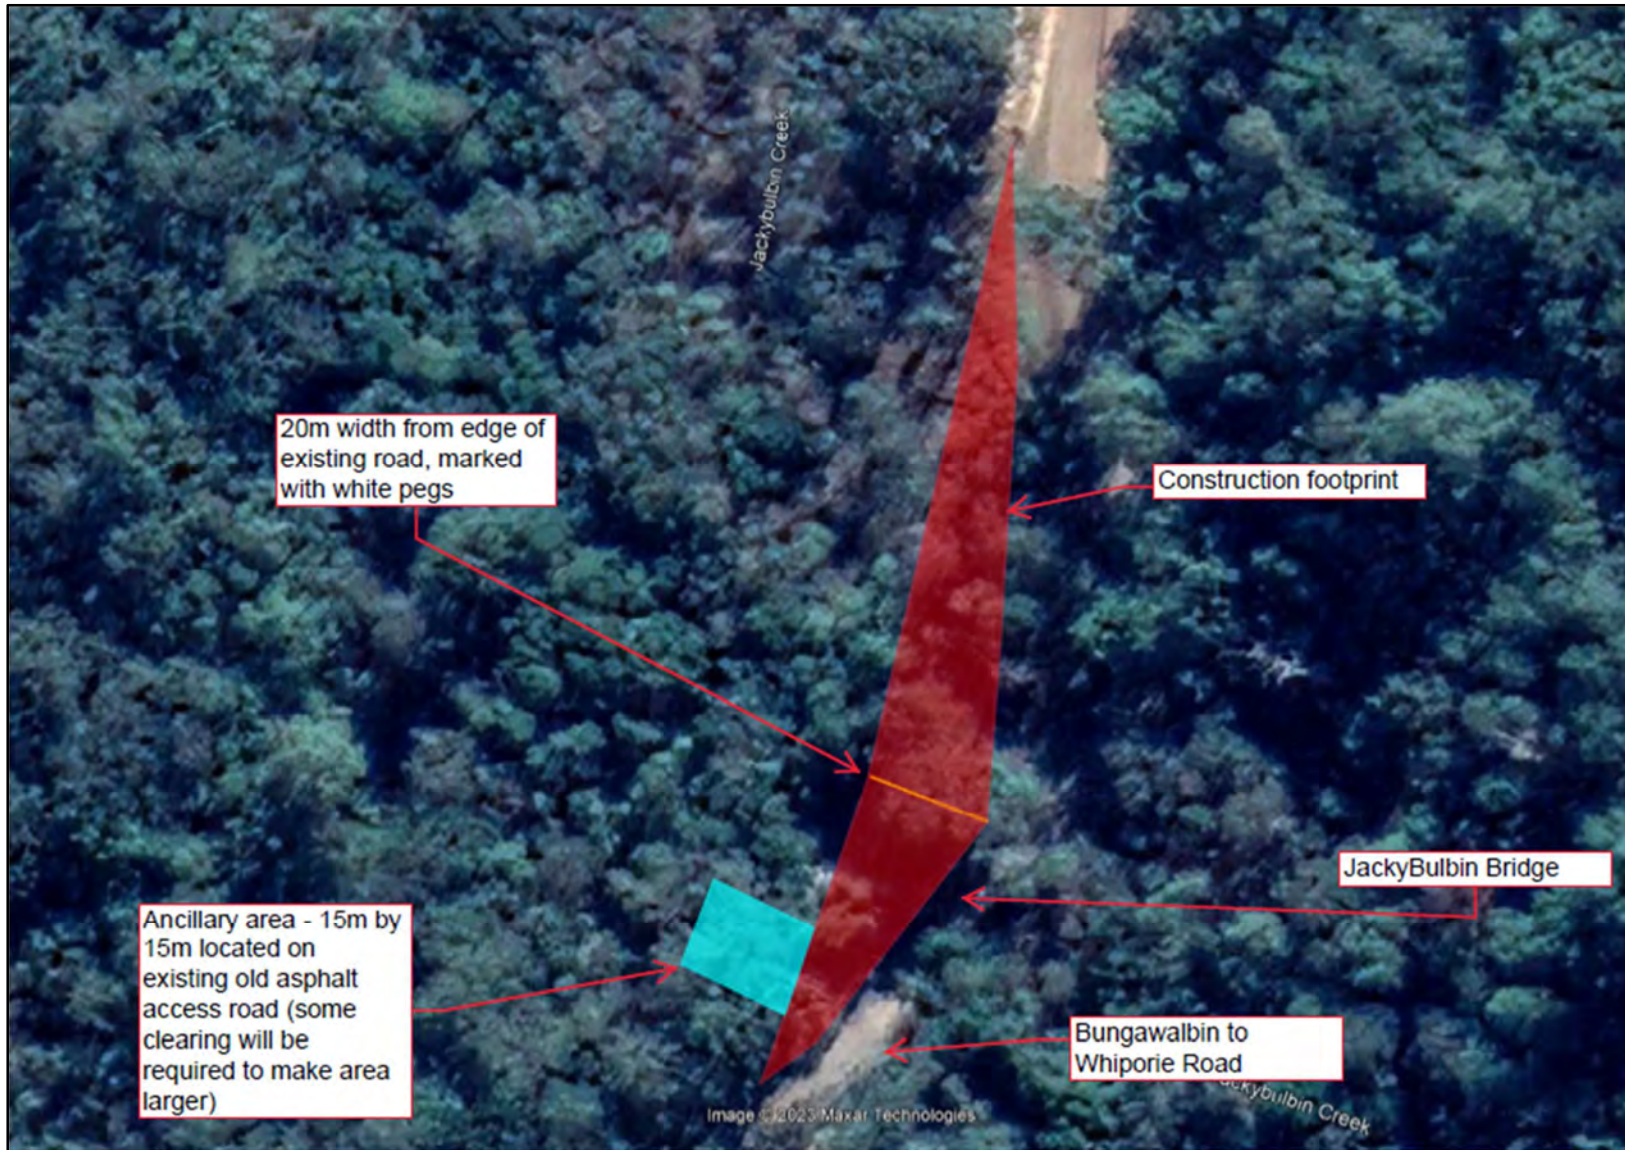
Figure 3: Location of Jackybulbin Bridge replacement in relation to the existing bridge (Envirocivil Consultants)

The existing JackyBulbin Bridge on the Bungawalbin Whiporie Road currently consists of a single span Doolan deck (composite timber and concrete) type bridge founded on pad footing abutments, with an overall length of 12 metres. The bridge consists of 1 deck unit which provides a narrow bridge with a maximum width of 3.4 metres between barriers. Both approaches are asphalt sealed ranging in 4 to 5 metre formations with MASH compliant safety barriers. The asphalt sealed approaches and the structural integrity of the northern and southern headstocks of the existing bridge were significantly damaged during the recent flood events in March 2021 (**Figure 3, Figure 4 and Figure 5**).

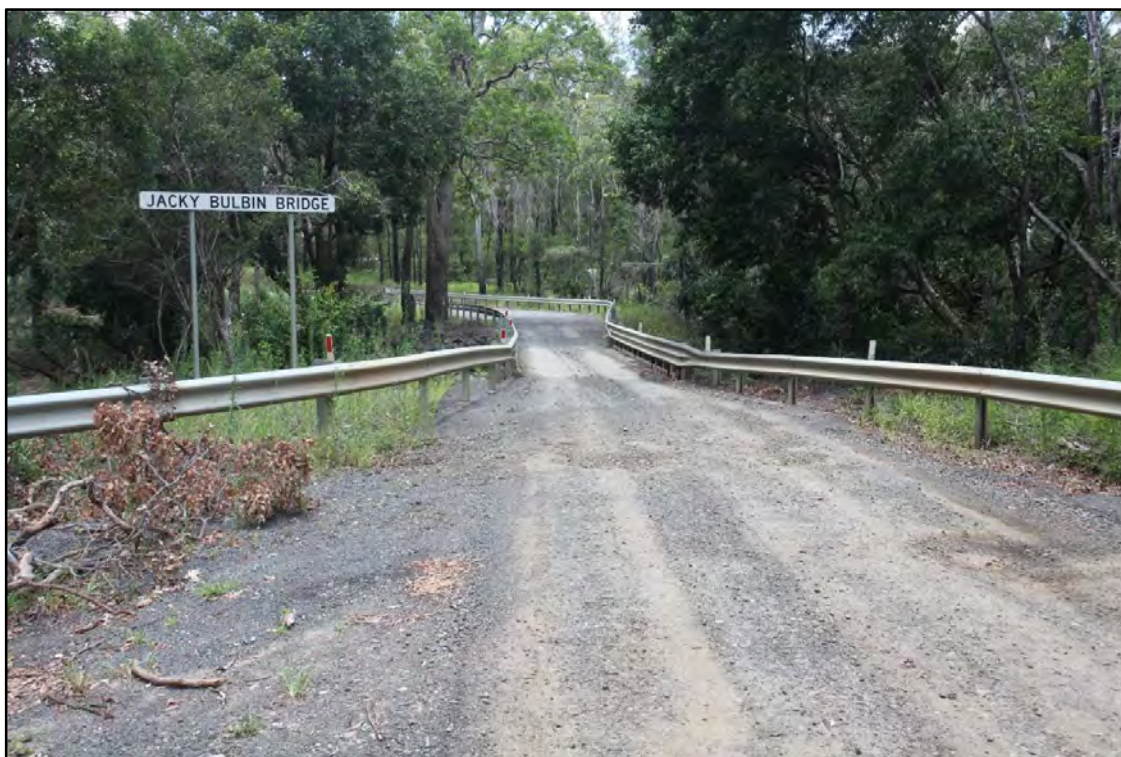
Figure 14: Jacky Bulbin Bridge looking north

- the bridge comprises a concrete deck on top of treated log girders and has a concrete abutment (**Figure 14**, **Figure 15** and **Figure 16**)
- remains of an older timber girder bridge are visible in front of the existing concrete abutments and comprise four hardwood logs piles recessed for timber bearings/ capwale (bearers are retained on northern piles) and hardwood sheet (sleeper) abutments

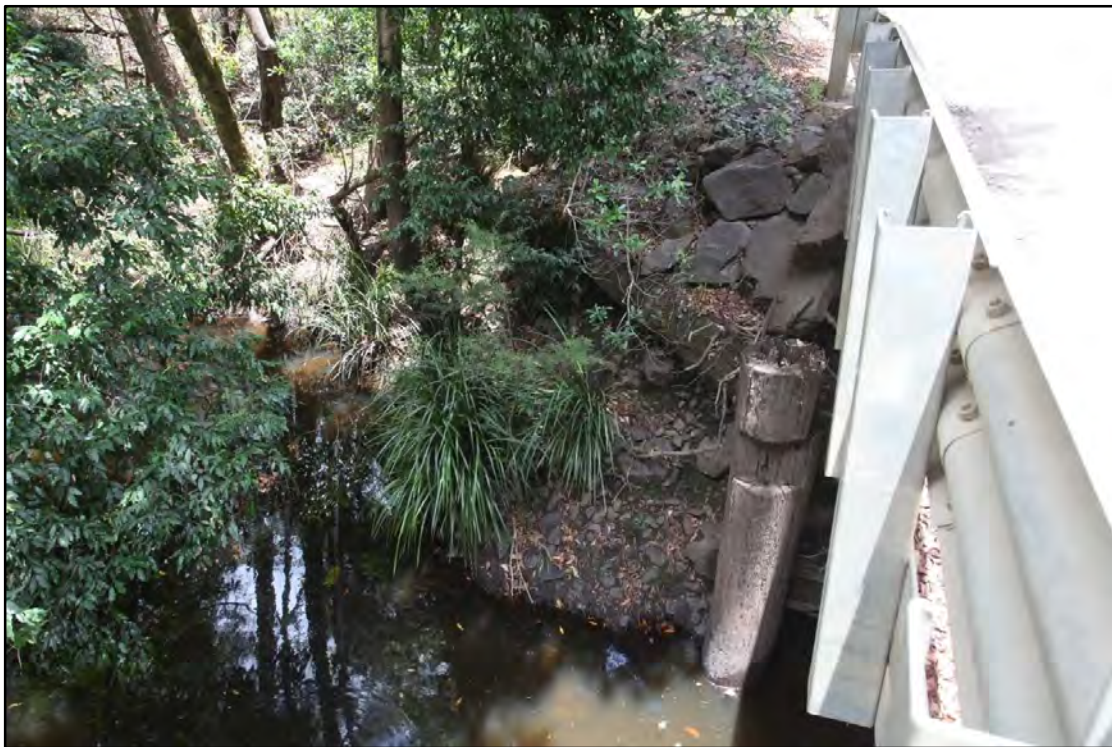
Figure 17: Timber log and wing wall on the southern bank

- hardwood logs are located on either side of the abutments indicating that the original bridge had timber wingwalls, however they could also be cast off piles that were not removed (see **Figure 17**),
