Review of Environmental Factors

Bridge Replacement on road from
Whiporie to Bungwalbin over Jacky
Bulbin Creek
March 2023

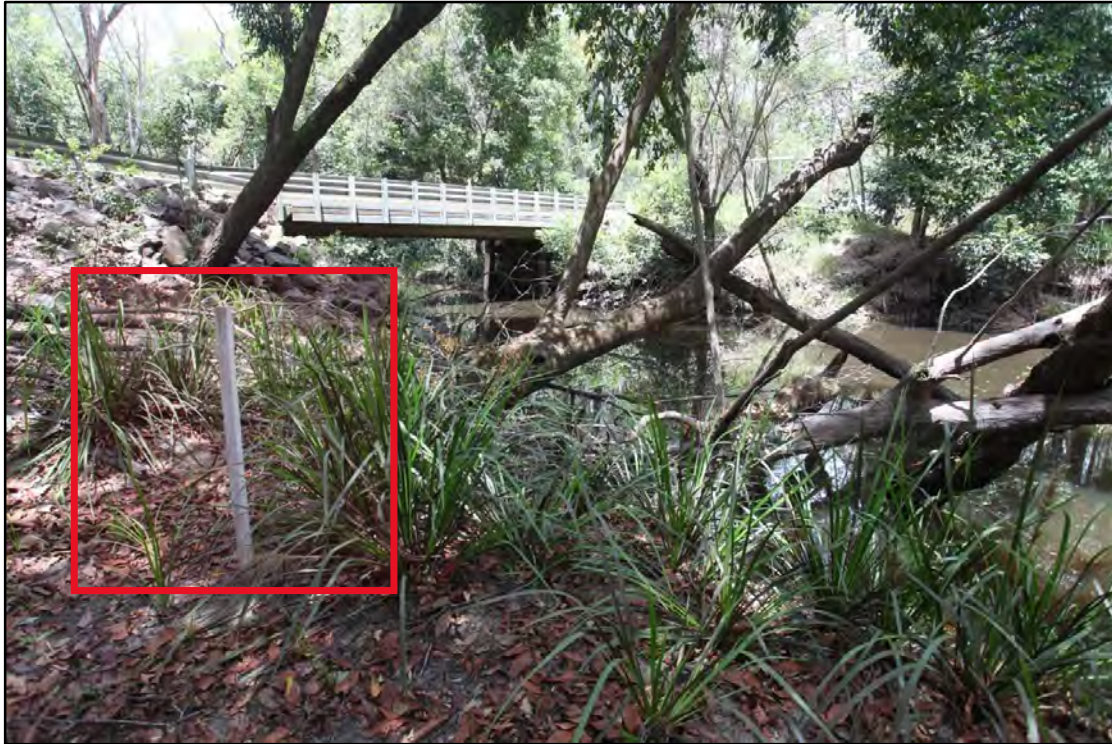
Figure 18: Relationship between the current bridge and proposed new bridge (white post)

- the original timber abutment is not visible from the road pavement however will be visible from the proposed new bridge alignment should it be retained (**Figure 18**)

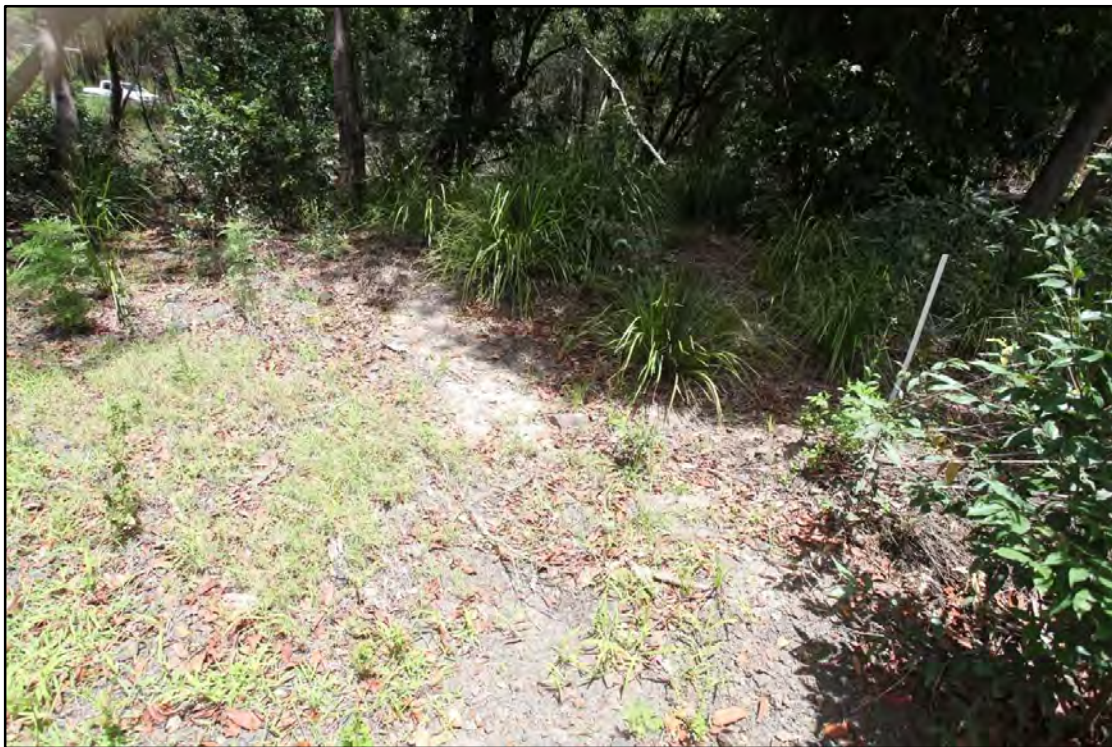
Figure 19: Sandy soil on the northern creek bank (white post shows proposed bridge alignment)

- there are no timber deck, rails or kerbing from the original bridge retained at the crossing
- no historic structures or moveable heritage is visible in the area marked out for the new bridge alignment which comprises riparian vegetation and sand deposits (**Figure 19**), and

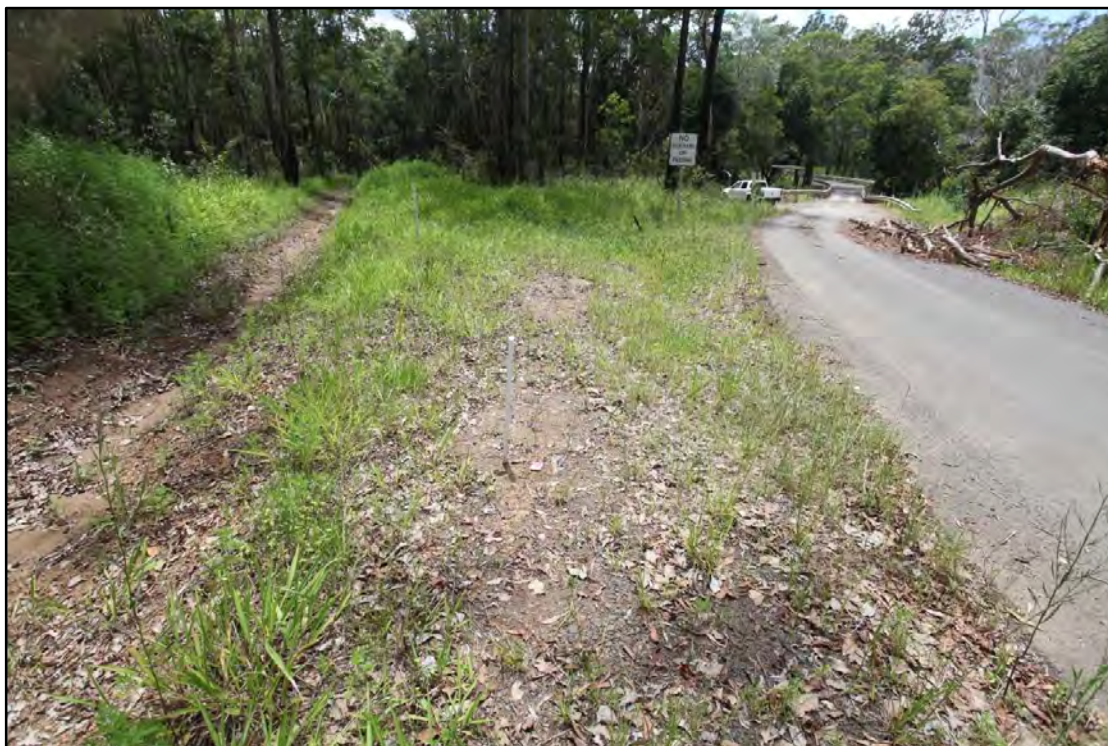
Figure 20: Typical road verge and drain south of Jacky Bulbin Bridge

- the road pavement is gravel and there is no indication that the a former / older road has been located within the alignment of the proposed replacement bridge (**Figure 20** and **Figure 21**).

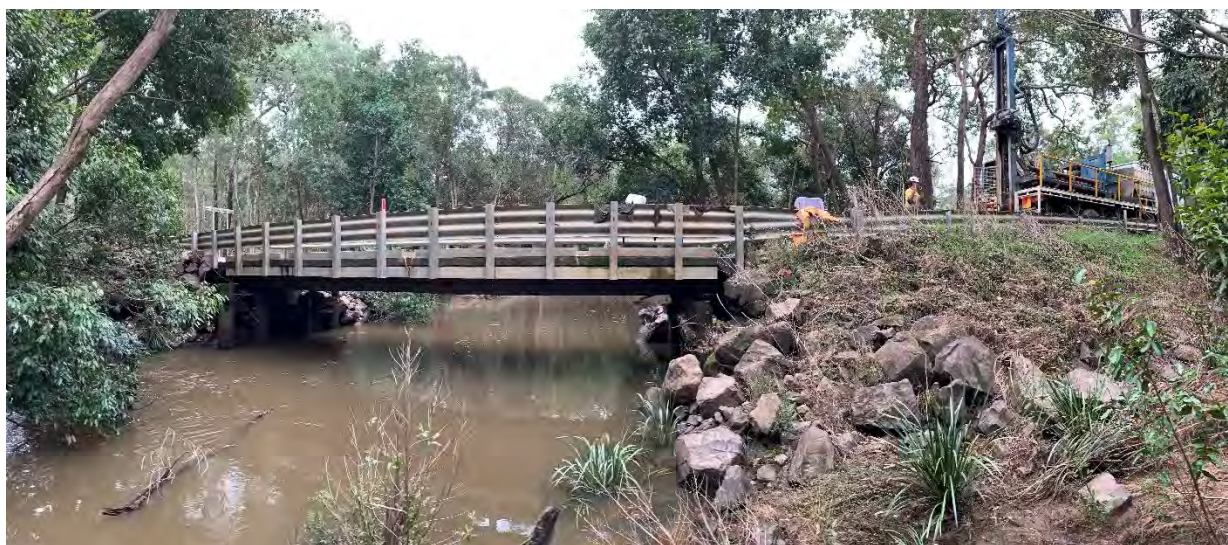
Looking west towards the bridge, drill rig setup at BH1.

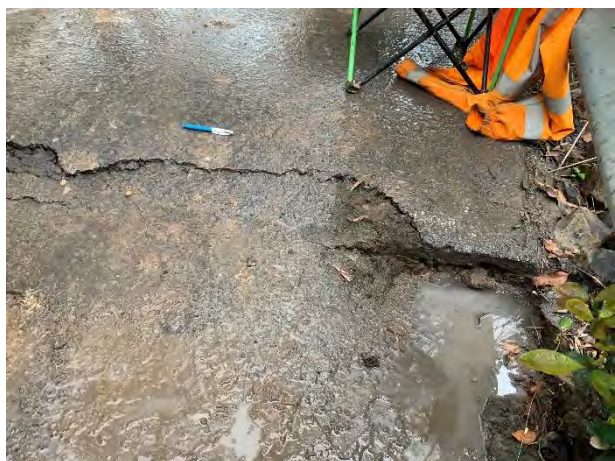
Differential movement between the bridge deck and the northern abutment pavement

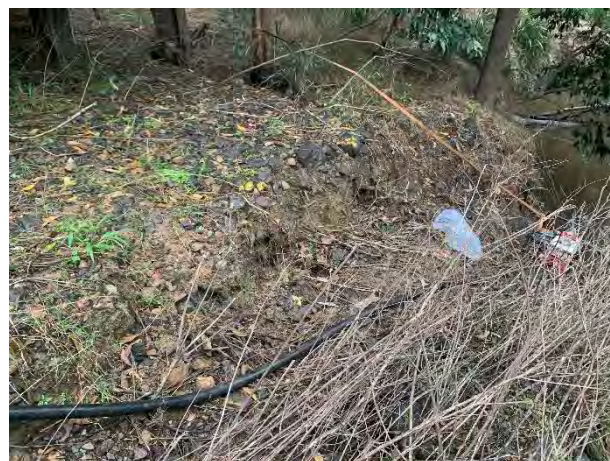
Looking west at the landslide, showing fill mixed with alluvial sands exposed along the slip.

The identified instability is likely to have been triggered by the alluvial sand being scoured during high flow events and it is likely that the instability will continue to regress. It is therefore recommended that the instability be remediated by the construction of a rockfill batter. Stability modelling of the rockfill option is reproduced below. A factor of safety against instability has been achieved.
