Broadwater Public School **9 Byrnes Street, Broadwater NSW 2472**

Contamination Investigation

Report reference number: 754-SYDGE319200-R03

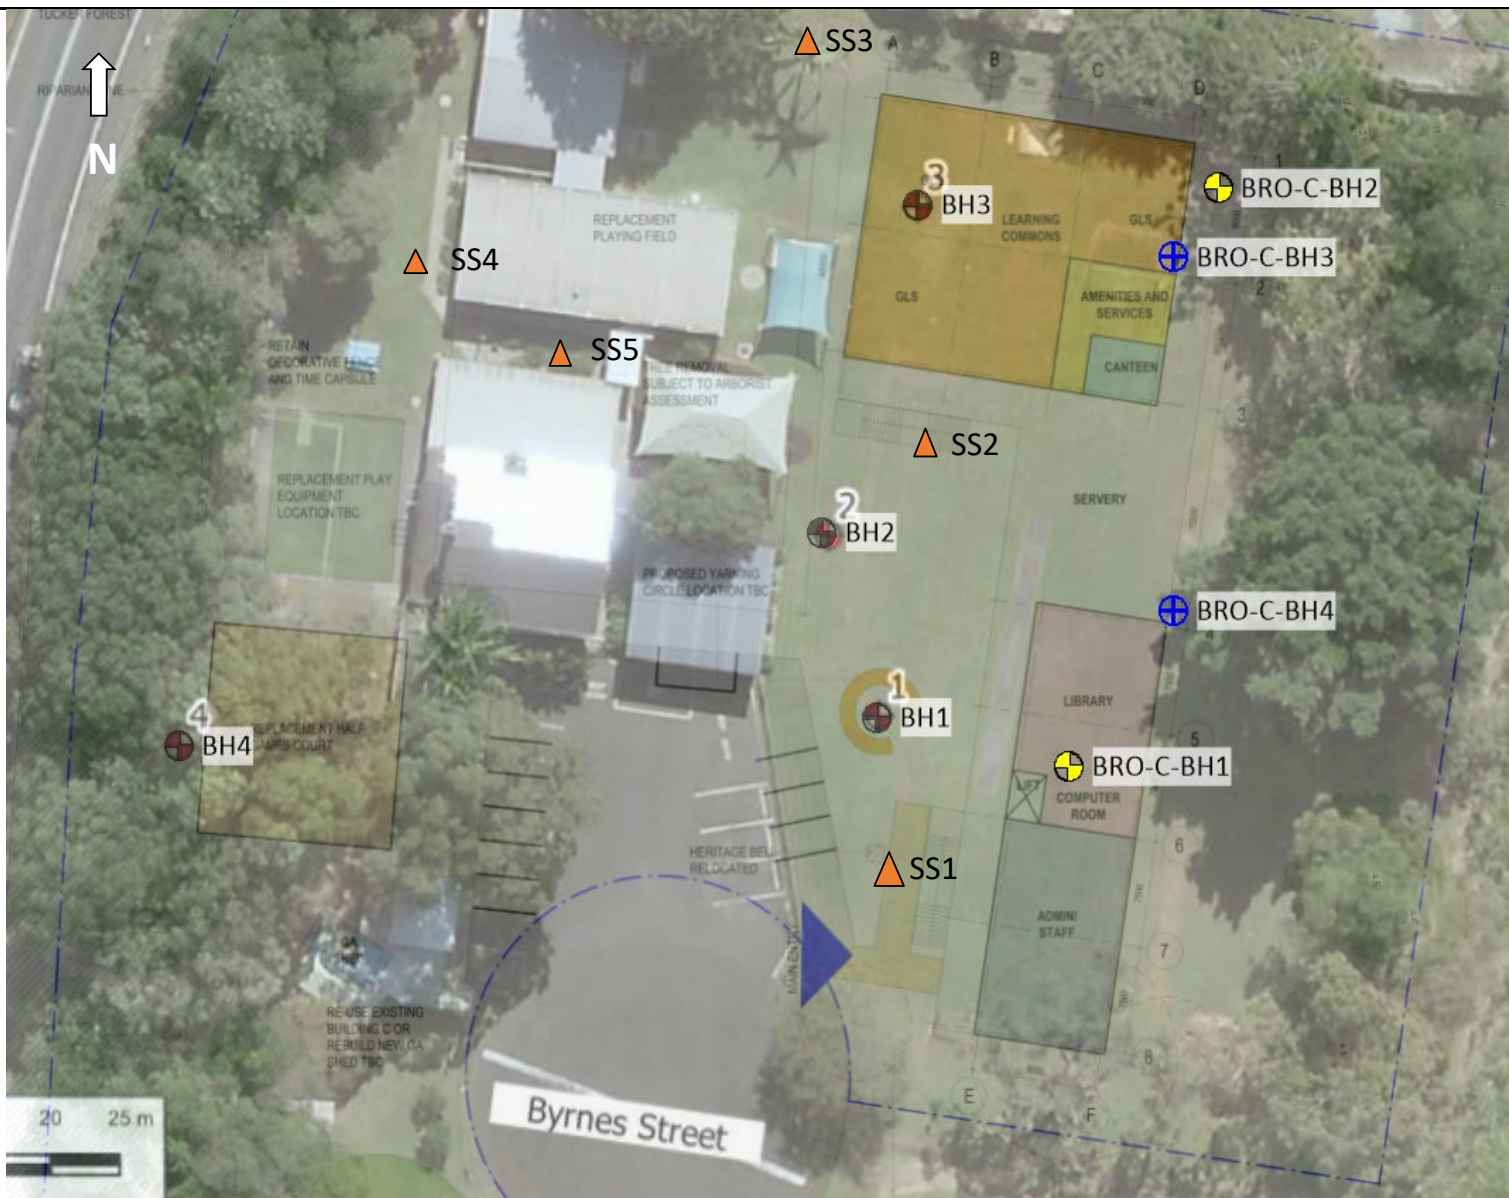
client:	ADCO Construction Pty Ltd	
project:	Northern River School Cluster	
title:	Borehole Location Plan	
project no:	SYDGE319200	figure no: 1

Coffey completed a total of nine sampling locations (five surface samples and four boreholes) concurrently with the geotechnical investigation. The locations were positioned across the subject development area to provide general coverage with some of these sampling points targeting the weathering/remnants of hazardous building materials in the vicinity of existing/demolished buildings.

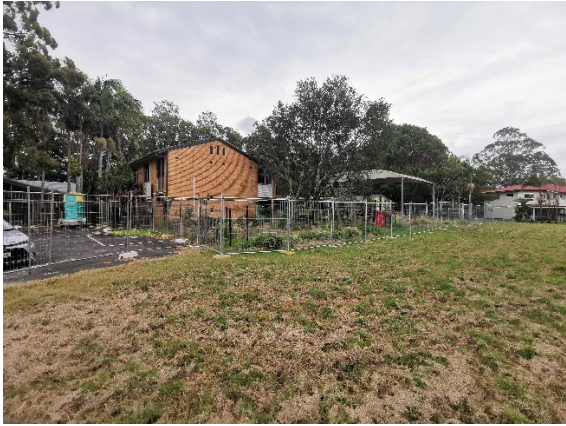
- The site was observed to be predominately grass covered with areas of hardstand in good condition.
- The school was unoccupied at the time of the walkover and is understood to be closed to students/teachers. Flood damaged buildings were barricaded with chain link fencing.

- Upon inspection of the exterior of the unoccupied, flood damaged buildings and given the observed age it is considered possible for building materials to comprise asbestos containing material (ACM).

Photograph 1: Unoccupied, flood damaged buildings barricaded with chain link fencing

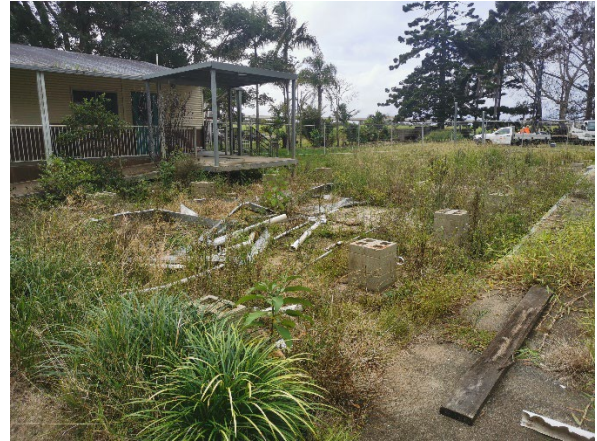
- Foundations of a previous structure were observed in two locations, to the south and to the west of the playground. These areas contained cinder blocks, PVC pipes, bricks and sandy surface soils. No asbestos containing material (ACM) was identified.

Photograph 2: Foundations of a previous structure, cinder blocks and PVC pipes, located west of the playground

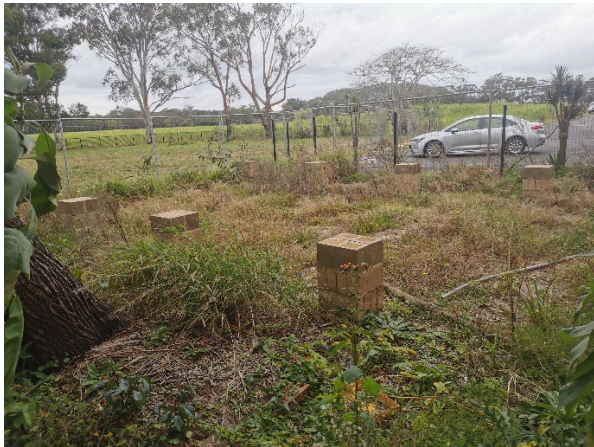
Photograph 3: Foundations of a previous structure, bricks, located south of the playground

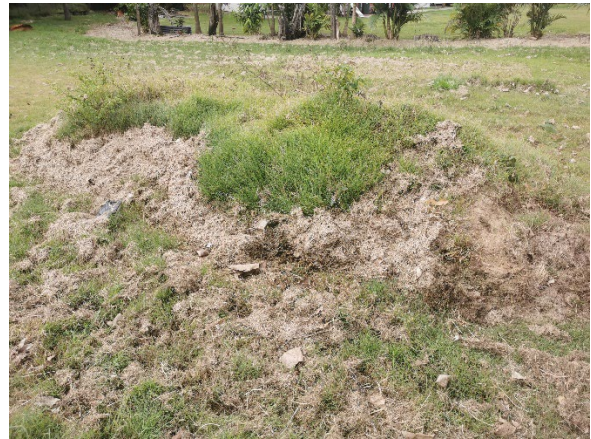
- A septic tank was observed in the ground to the north of the playground.
- One grass covered stockpile (2m x 1m x 1m) was identified towards the northeast boundary, comprising grey sandy soils. Visual observations were obscured by the grass cover, however anthropogenic material was not identified.

Photograph 4: Stockpile, comprising sandy soils, located within the north east portion of the site

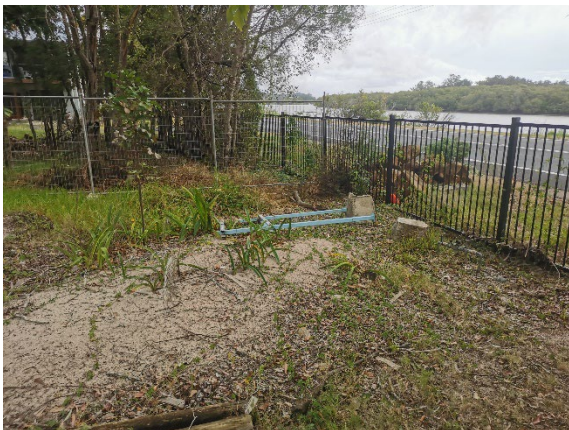
- A drainage culvert was observed offsite in the southwest corner.

Photograph 5: drainage culvert located offsite in the southwest corner.

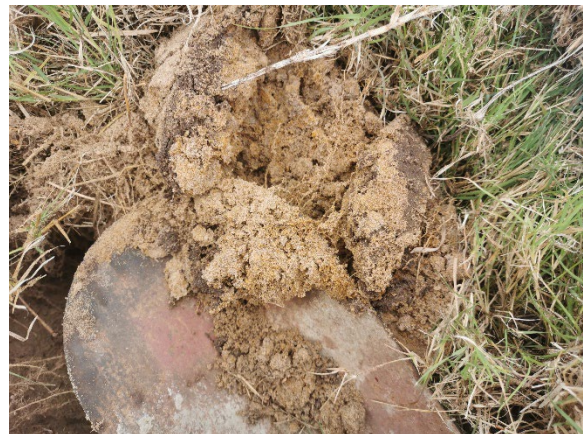
Photograph 6: Example of clay surface soils at SS2
