# PRELIMINARY ACID SULFATE SOIL INVESTIGATION

PROPOSED SHOP-TOP DEVELOPMENT

Lot 7 DP 14089  
17 McDonald Place  
Evans Head NSW

**HMC2023.531.01**

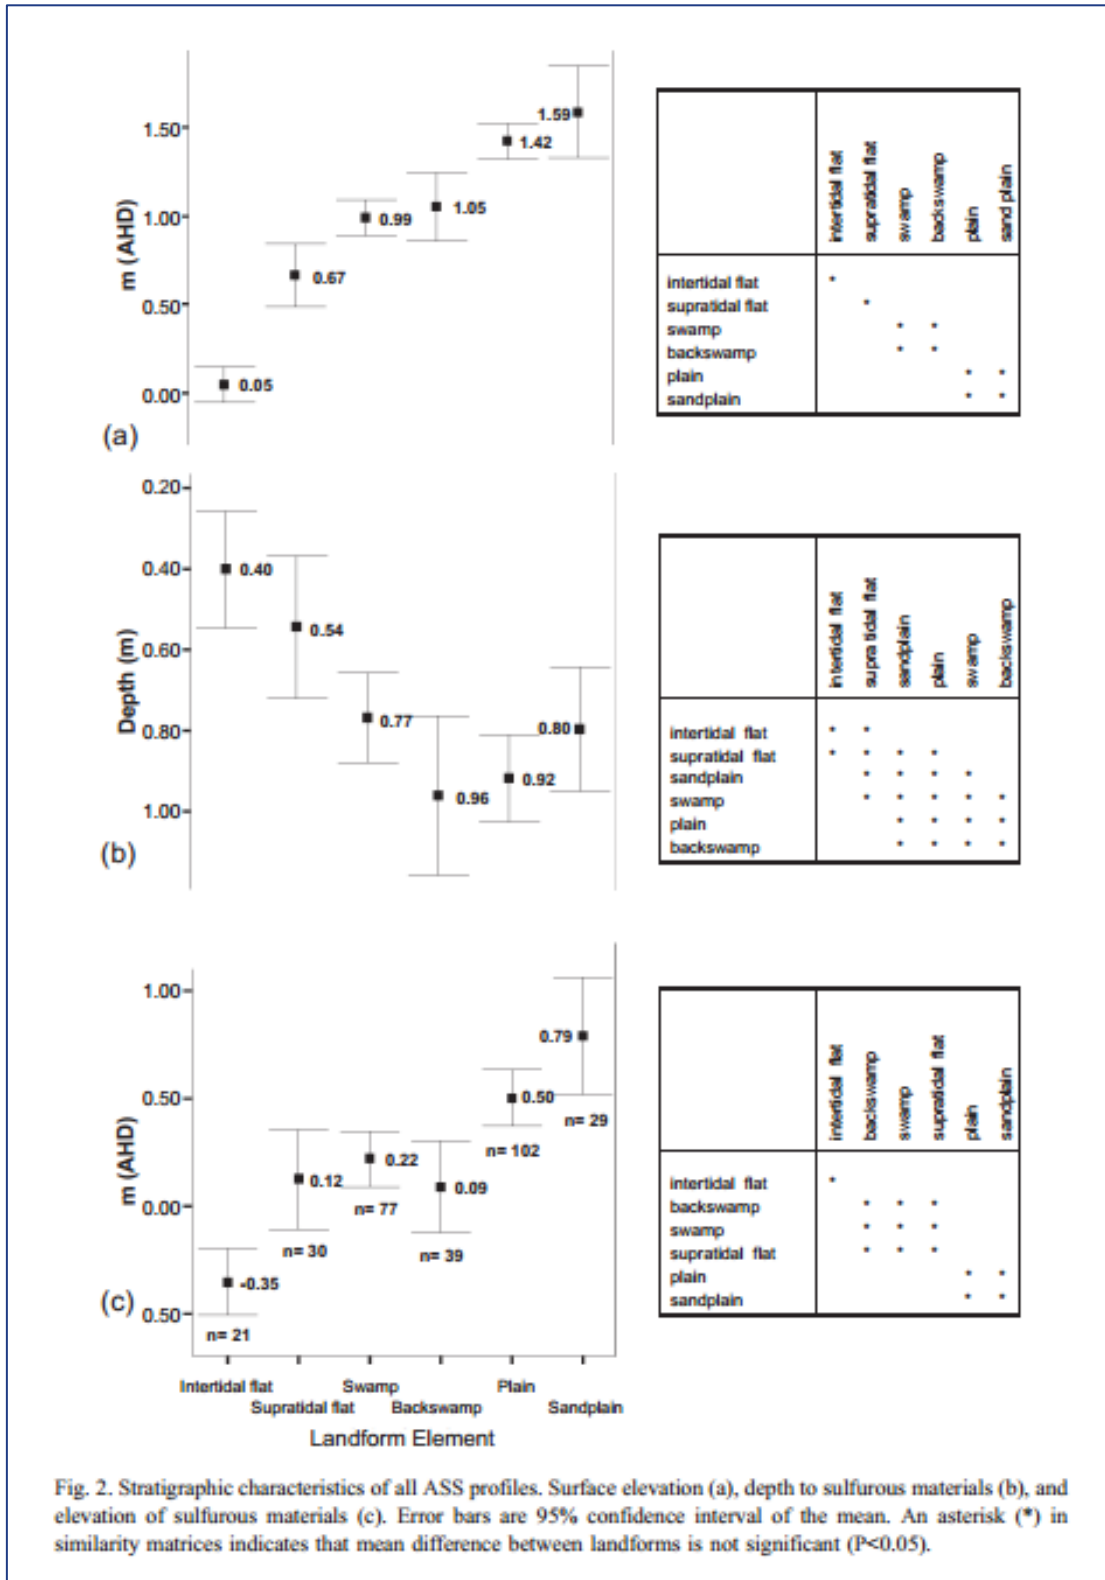
# **APPENDIX 3 - ELEVATION OF ASS IN NSW (WILSON ET AL FIG. 2)**

Fig. 2. Stratigraphic characteristics of all ASS profiles. Surface elevation (a), depth to sulfurous materials (b), and elevation of sulfurous materials (c). Error bars are 95% confidence interval of the mean. An asterisk (\*) in similarity matrices indicates that mean difference between landforms is not significant (P<0.05).

Wilson (2005) also reports a maximum elevation of ASS of 1m AHD after reviewing soil investigation results for the NSW ASS mapping program (see appendix 3).

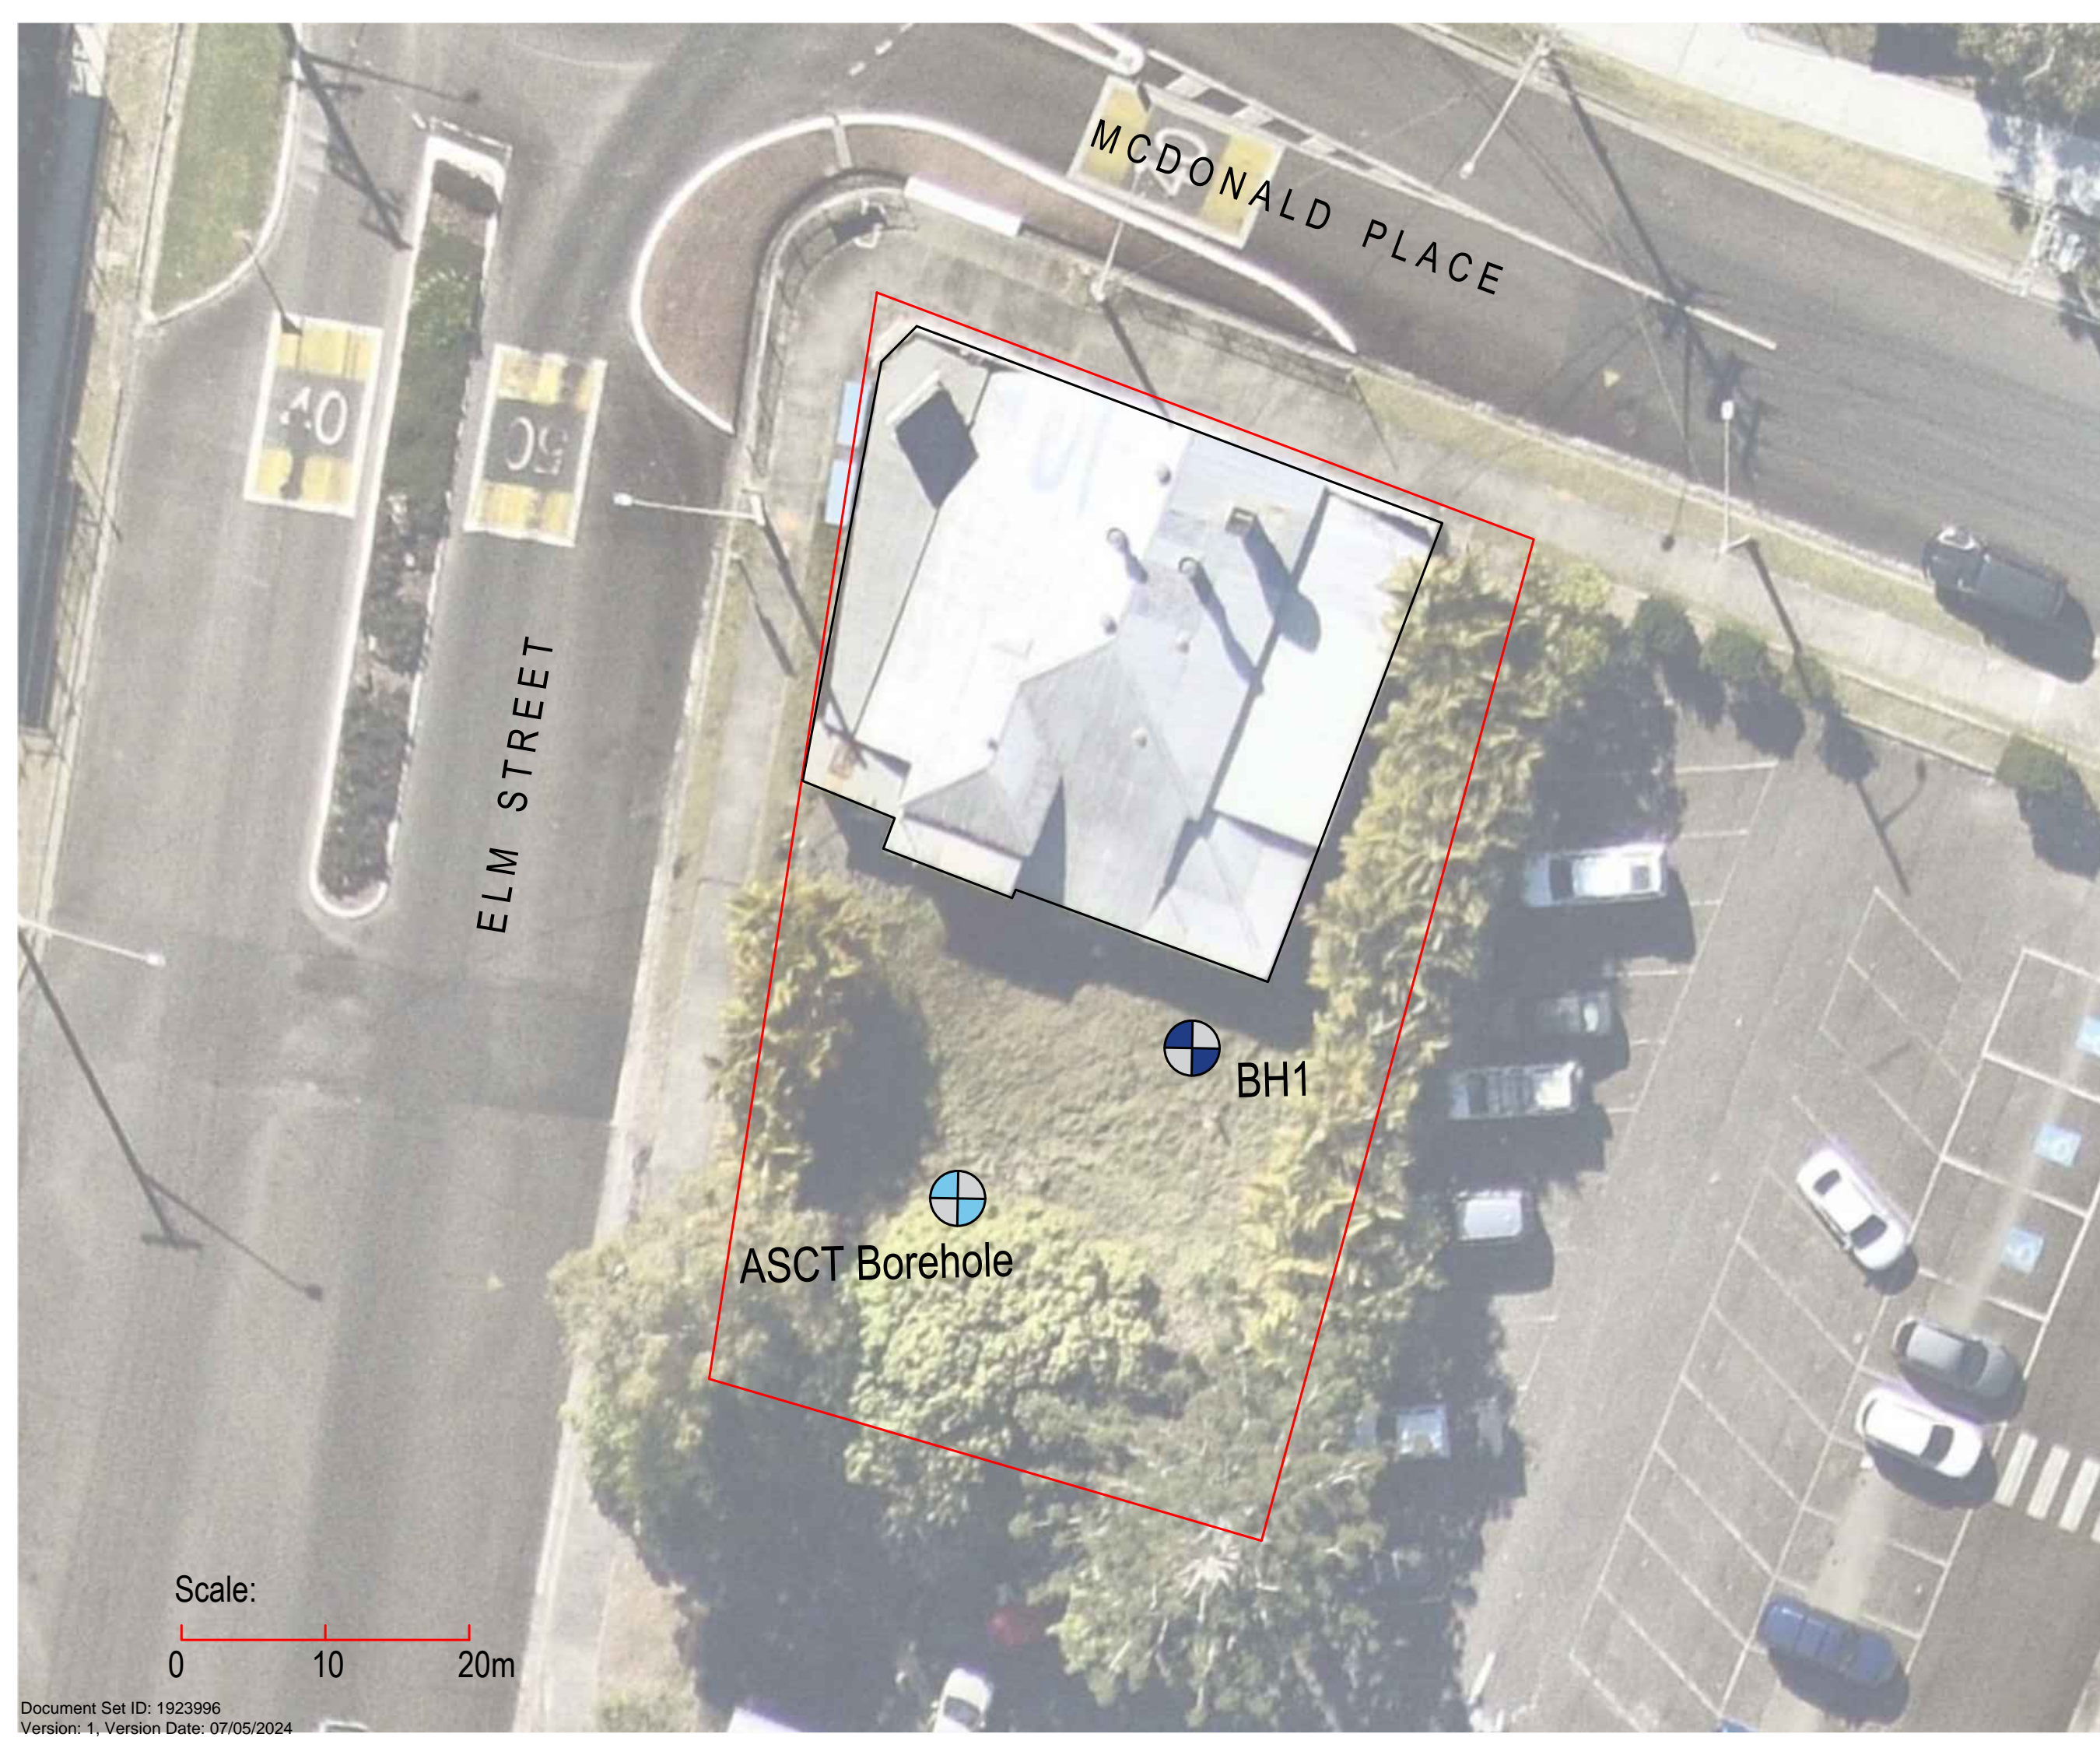
**SAMPLING LOCATIONS**

HMC Sampling Location  
23.08.2023

Previous Australian Soil &  
Concrete Testing Pty Ltd  
(ASCT) Borehole Location  
- June 2023

To assess ASS within the local soil profile, Mazlab completed drilling on 31 August September 2023, with samples collected by M. Tunks of HMC. One borehole was drilled to a maximum 2.5m depth, with samples generally collected at 0.25m intervals through the soil profile to 2.5m. Locations are shown in Appendix 4.

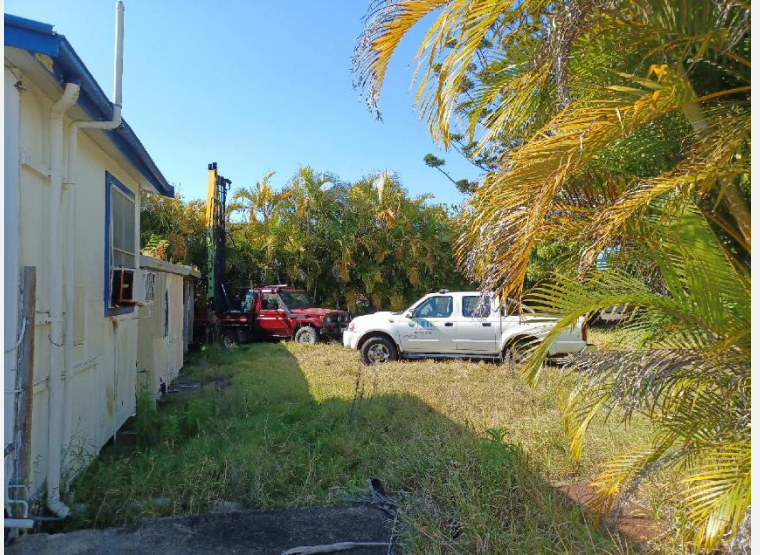
Photo No. 2 | Date 31.08.2023

Description:  
Drilling rig onsite

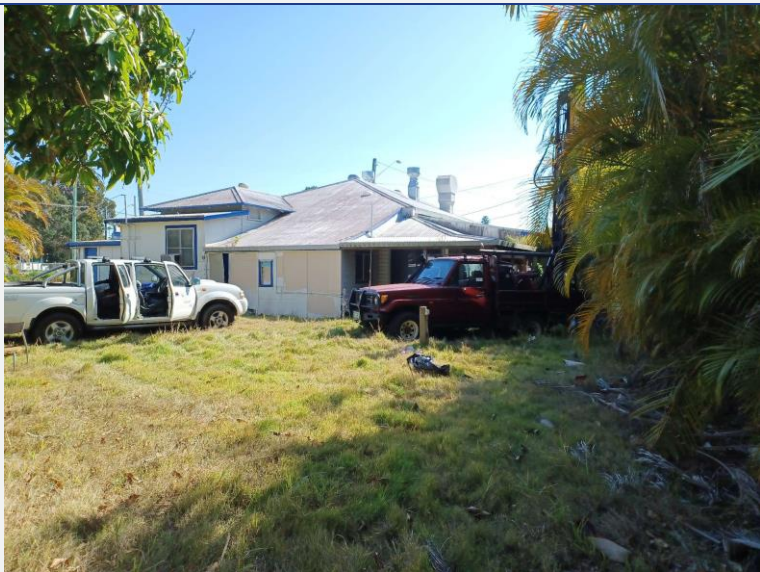
Photo No. 3 | Date 31.08.2023

Description:  
Drilling rig onsite
