# Arboricultural Impact Assessment Report

## Broadwater Public School

File No: 2324  
Version: Final  
13 Sept 2023

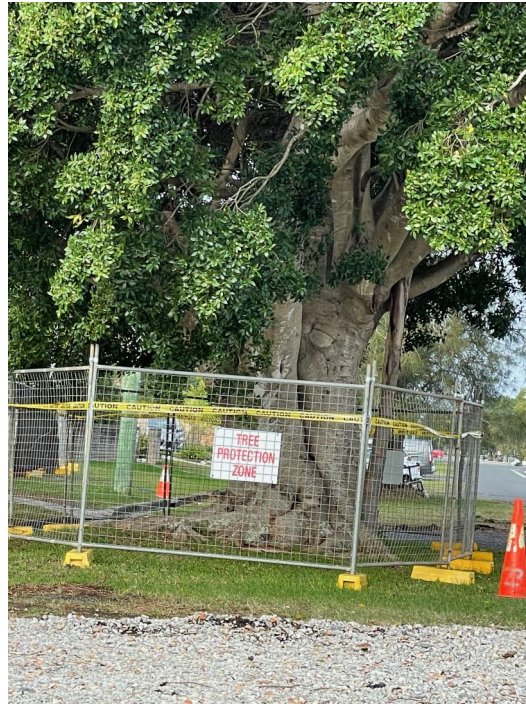
Figure 2. Example of a suitable protective fence

9.3 The proposed construction of the development is planned to be undertaken within the TPZ of some trees. In order to ensure that the trees remain viable it is important to protect them during construction as much as is practicable. Any of the activities detailed above should not be undertaken in the TPZ of the tree unless absolutely necessary. A 1.8 m wire panel fence should be erected around the trees. An example of a suitable fence is shown in Figure 2. The location of the fence is shown in Figure 3.

9.4 The protective fencing must be installed before commencement of works and not removed before the building works are completed.
