### Salty Lagoon Post Closure Monitoring

Project Management and Ecosystem Health Report October 2017

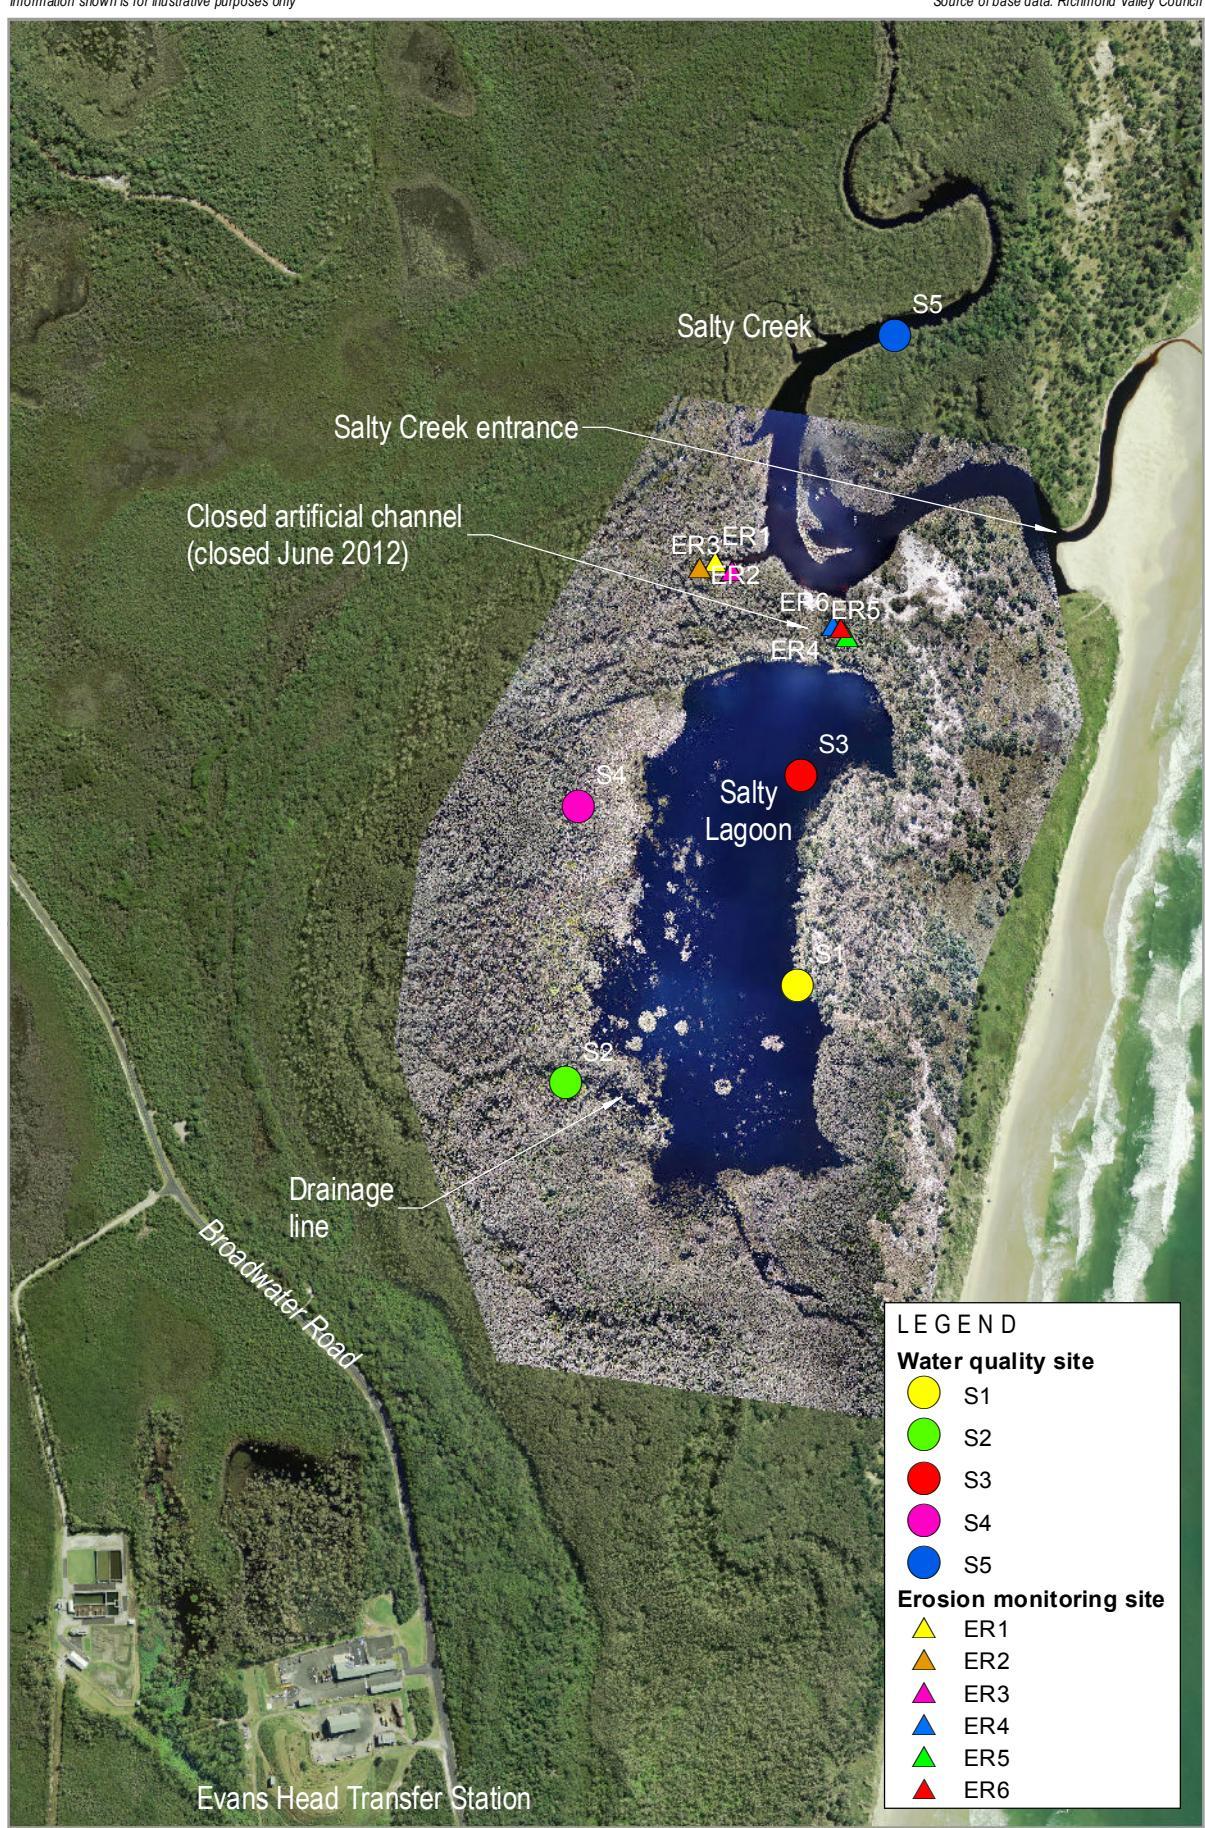
### Water Quality and Erosion Monitoring Site Locations

Discrete water quality samples were taken from surface water (approximately 0.2 metre depth) at four sites in Salty Lagoon and a single site (S5) in Salty Creek. An additional quality assurance (QA) replicate sample was collected at S3. The specific locations of all sites sampled are presented in **Table 2.1** and **Illustration 2.1**. They are the same sites previously used for the MPPC (GeoLINK 2017).

A series of stations have been set up around the active head cut to the east of the infilled channel and some nearby control sites to assess the progression of erosion between Salty Lagoon and Salty Creek. The specific locations of all sites sampled are presented in **Table 2.2** and **Illustration 2.1**.

The stations were set up in July 2017 at the head cut (Stations 4, 5 and 6), with control sites at points where lateral tributaries from Salty Creek lead towards Salty Lagoon (Stations 1, 2 and 3). At each site the monitoring involves a fixed point photo and a measurement from a fixed peg to the nearest point of the head cut.

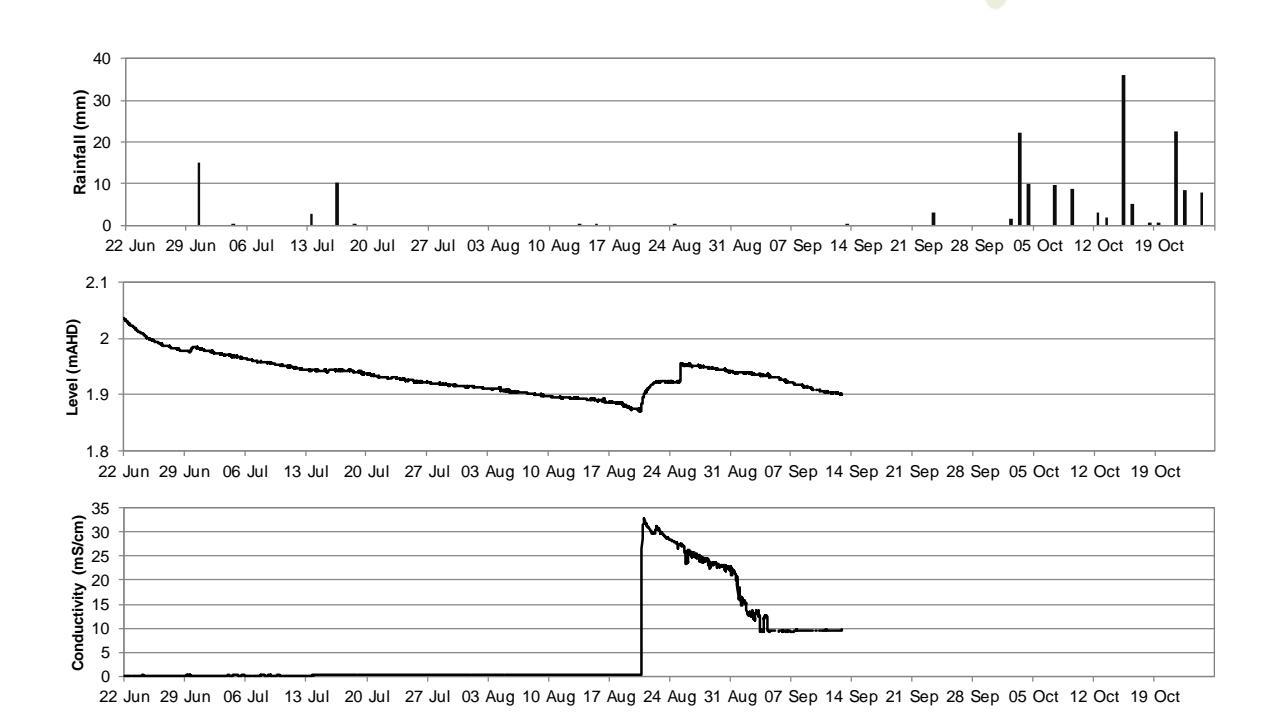
The data collected at the PWQMS, and rainfall data correlating to the same period, are presented in **Illustration 3.1** and **Illustration 3.2**. The PWQMS data presented is the last data collected from the old YSI 6 series sondes before they were removed. Only the level and conductivity data is presented; the DO, pH and turbidity data was unreliable due to the period that the equipment had remained in place without servicing.

Rainfall between 21 June 2017 and 25 October 2017 was characterised by a long dry period followed by several moderate to heavy rainfall events in October. Water level data from Salty Lagoon indicates that Salty Lagoon remained at high levels for the duration of this period and that water levels increased around 21 August 2017 in response to water flowing in from Salty Creek. The water level in Salty Creek fluctuated regularly in the interim period in response to tidal movements and seawater ingress. The final data points available from the old PWQMS equipment show very high water levels resulting from seawater ingress on 21 August 2017. The water level in Salty Creek increased at that time by over 0.3 metres in response to an unusually large storm surge event that was well documented across the east coast (Brassington 2017). At the time of the site inspection on 25 October 2017 the entrance to Salty Creek was closed (**Plate 5.1**) and water levels in Salty Creek were still very high.

Conductivity measurements from the PWQMS show the impact of seawater ingress on Salty Creek and the impact of saltwater intrusion from Salty Creek into Salty Lagoon. At the time of the site inspection the conductivity measurements in Salty Lagoon were still higher than normal, and exceeded guiding values at S1 and S3. The saltwater penetrated up to S2 and S4 resulting in high conductivity measurements at those sites. The water column was well mixed at the Salty Lagoon sites but distinctly stratified at the Salty Creek site into a freshwater surface layer and a saline layer at the bottom.

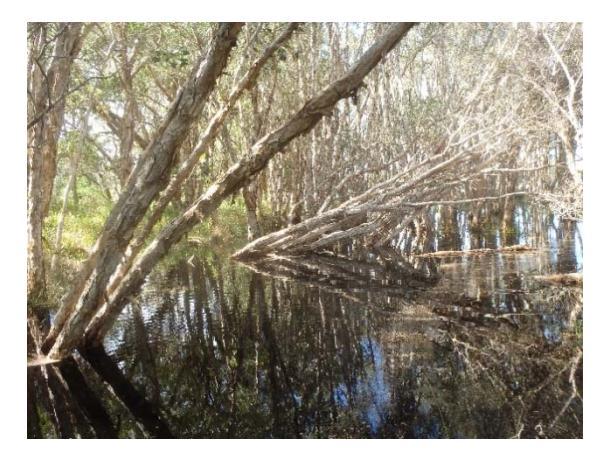
Erosion monitoring did not find any advancements among the cuts resulting from water draining out of Salty Lagoon. The lack of erosion is associated with the high water levels in Salty Creek, restricting hydraulic capacity out of Salty Lagoon. Water levels at the time of the site inspection were so high that the fixed point photos do not show the position of the cuts.

The entrance to Salty Creek was closed on 25 October 2017 (**Plate 5.1**). The headcut located to the east of the in-filled artificial channel was stable from 21 June to 25 October 2017. A variety of birds were observed incidentally during the site inspection including Australasian Grebe, Pacific Black Duck, Pelican, Great Egret, Great Cormorant, Little Black Cormorant and Pied Cormorant.

Plate 4.1 The Headcut to the east of the old channel on 25 October 2017

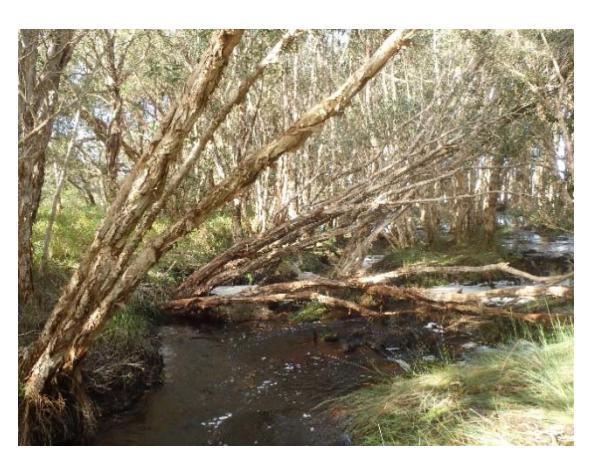
Plate 4.2 The Headcut to the east of the old channel on 21 June 2017

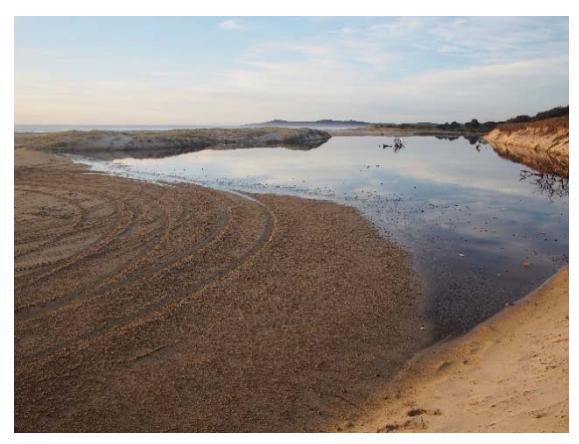
Plate 5.1 The closed entrance to Salty Creek on 25 October 2017

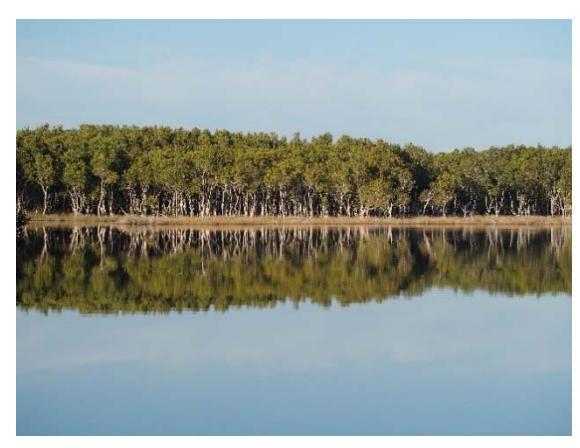
Plate 5.2 Calm conditions on Salty Creek
