Salty Lagoon Post Closure Monitoring

Project Management and Ecosystem Health Report April 2018

Prepared for: Richmond Valley Council © GeoLINK, 2018

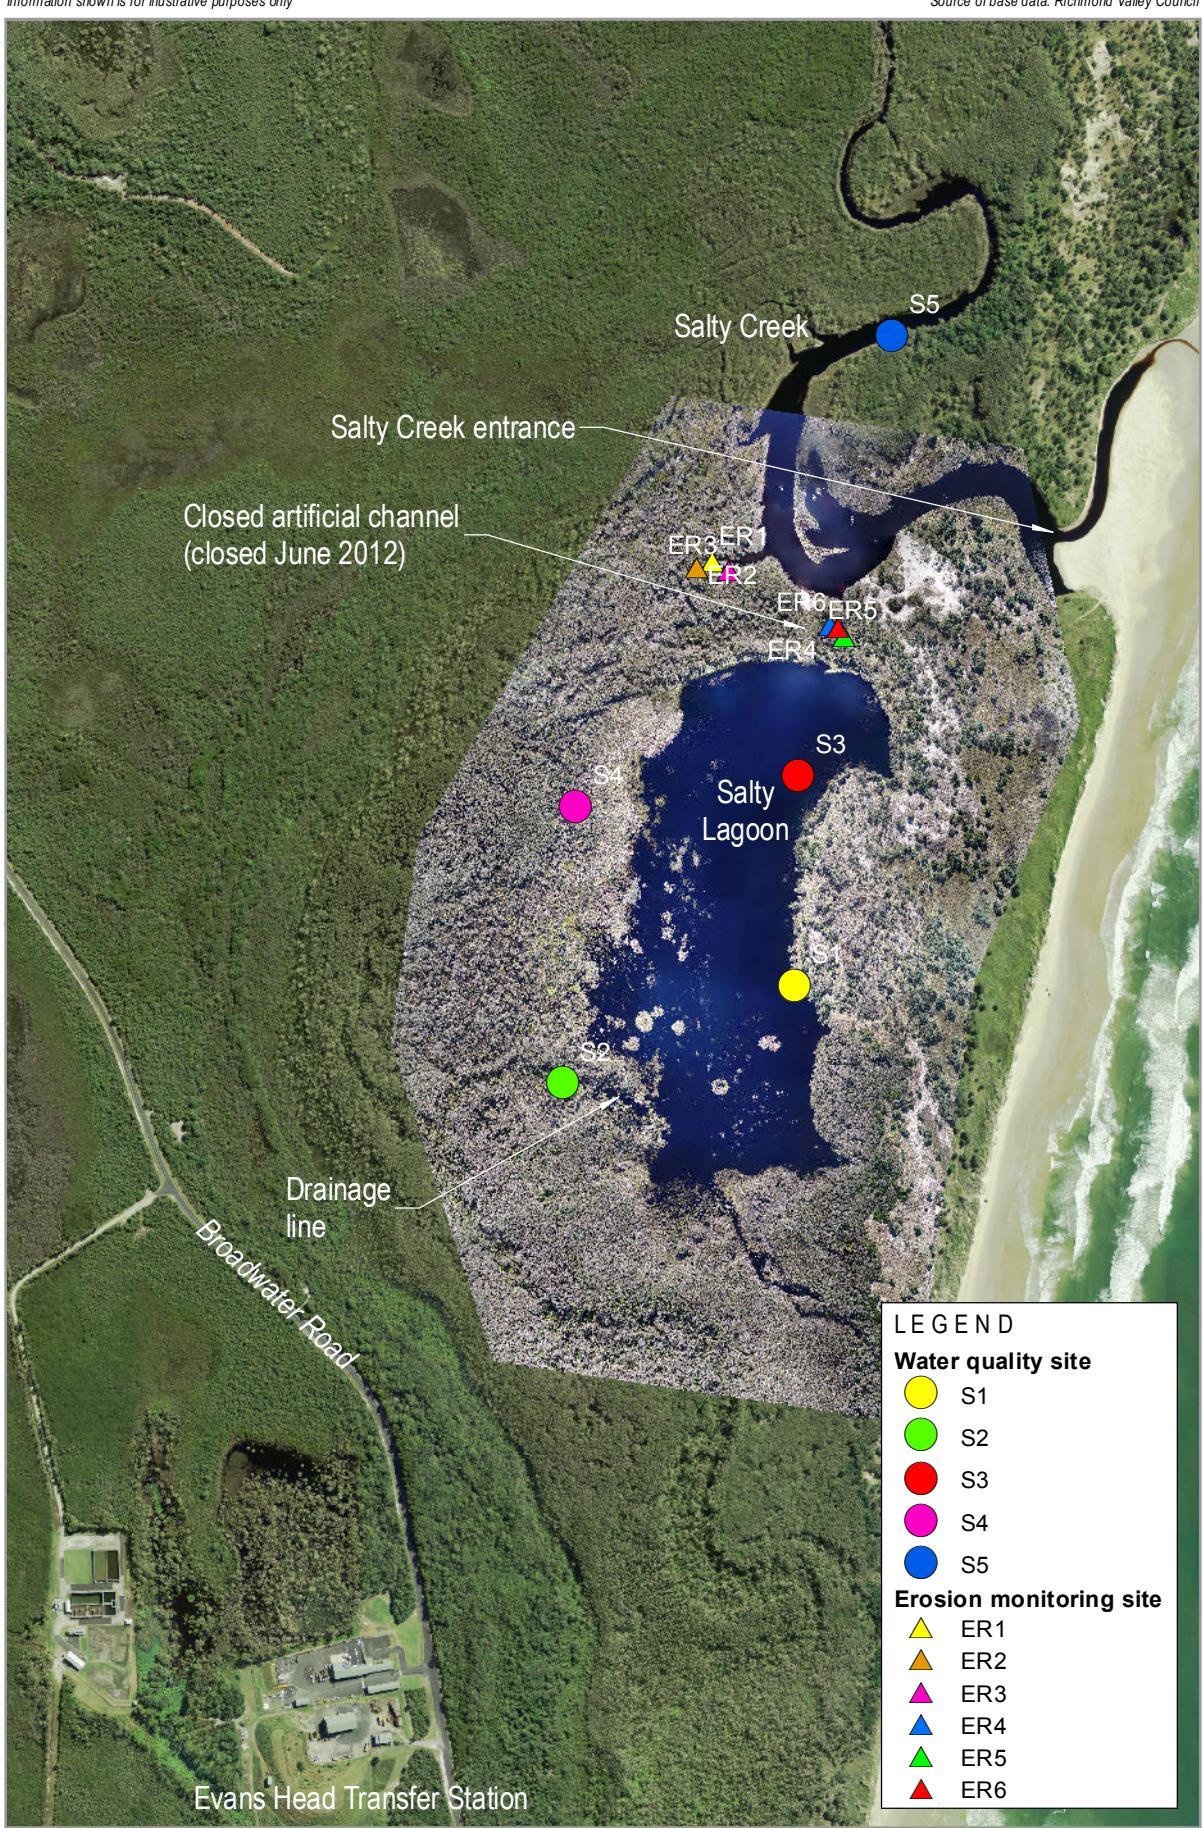
Water Quality and Erosion Monitoring Site Locations

Discrete water quality samples were taken from surface water (approximately 0.2 metre depth) at four sites in Salty Lagoon and a single site (S5) in Salty Creek. An additional quality assurance (QA) replicate sample was collected at S1. The specific locations of all sites sampled are presented in **Table 2.1** and **Illustration 2.1**. They are the same sites previously used for the MPPC (GeoLINK 2017).

A series of stations have been set up around the active head cut to the east of the infilled channel and some nearby control sites to assess the progression of erosion between Salty Lagoon and Salty Creek. The specific locations of all sites sampled are presented in **Table 2.2** and **Illustration 2.1**.

The stations were set up in July 2017 at the head cut (Stations 4, 5 and 6), with control sites at points where lateral tributaries from Salty Creek lead towards Salty Lagoon (Stations 1, 2 and 3). At each site the monitoring involves a fixed-point photo and a measurement from a fixed peg to the nearest point of the head cut.

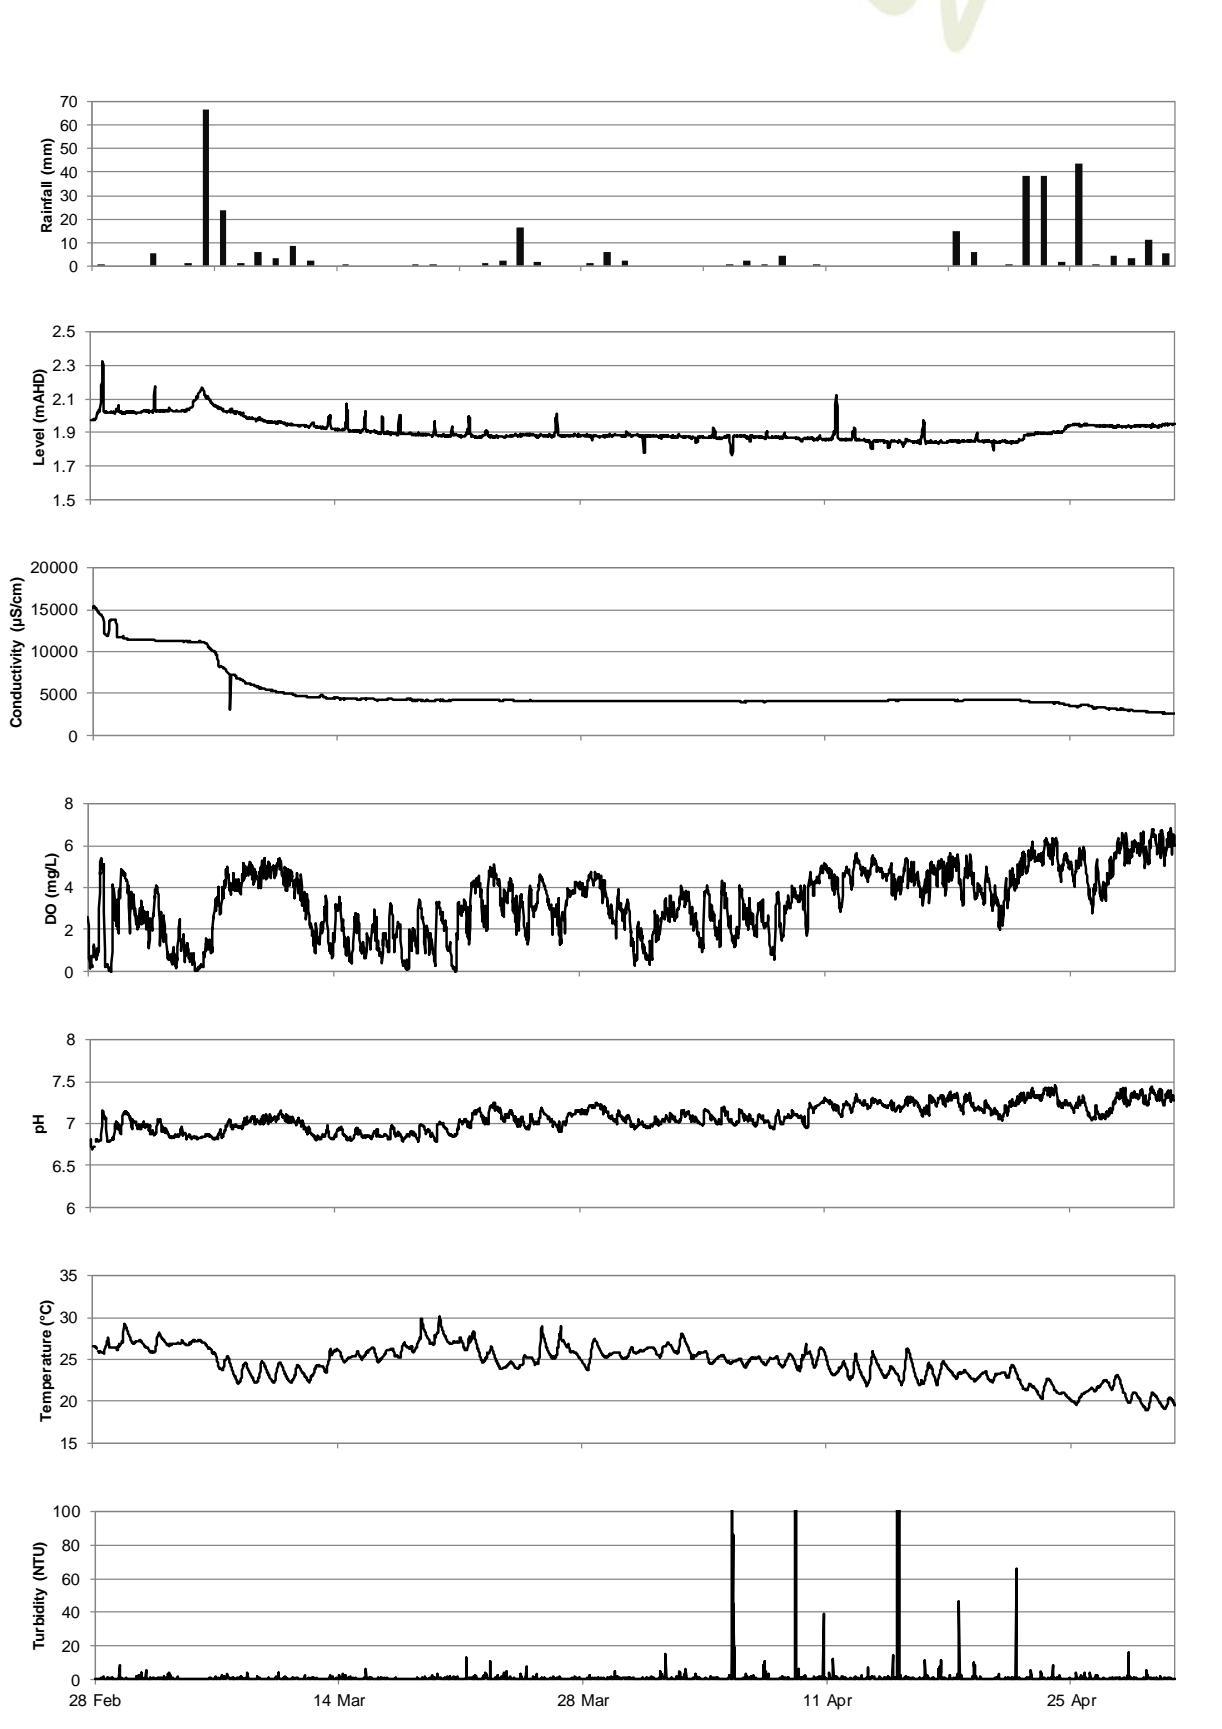
Illustration 3.1 Salty Lagoon Rainfall and Water Quality Monitoring Station Data 28 February 2018 to 30 April 2018

The water quality and level data collected at the PWQMS, and rainfall data correlating to the reporting period are presented in **Illustration 3.1** and **Illustration 3.2**.

Conductivity measurements from the PWQMS in Salty Lagoon and Salty Creek clearly show the impact of rainfall, seawater ingress and saline water movements on Salty Creek and Salty Lagoon. Conductivity in Salty Lagoon reduced gradually from high levels at the beginning of the reporting period to values approximately five per cent of seawater in response to continued rainfall. At the time of the site inspection the water column was well mixed at the Salty Lagoon sites. Results from the Salty Creek PWQMS show that the conductivity in Salty Creek fluctuated dynamically throughout the reporting period in response to rainfall, entrance conditions and tidal movements. On 1 May 2018, at the Salty Creek site, the water column was distinctly stratified into a fresh upper layer and saline lower layer. This is typical in Salty Creek when seawater ingress is followed by rainfall runoff.

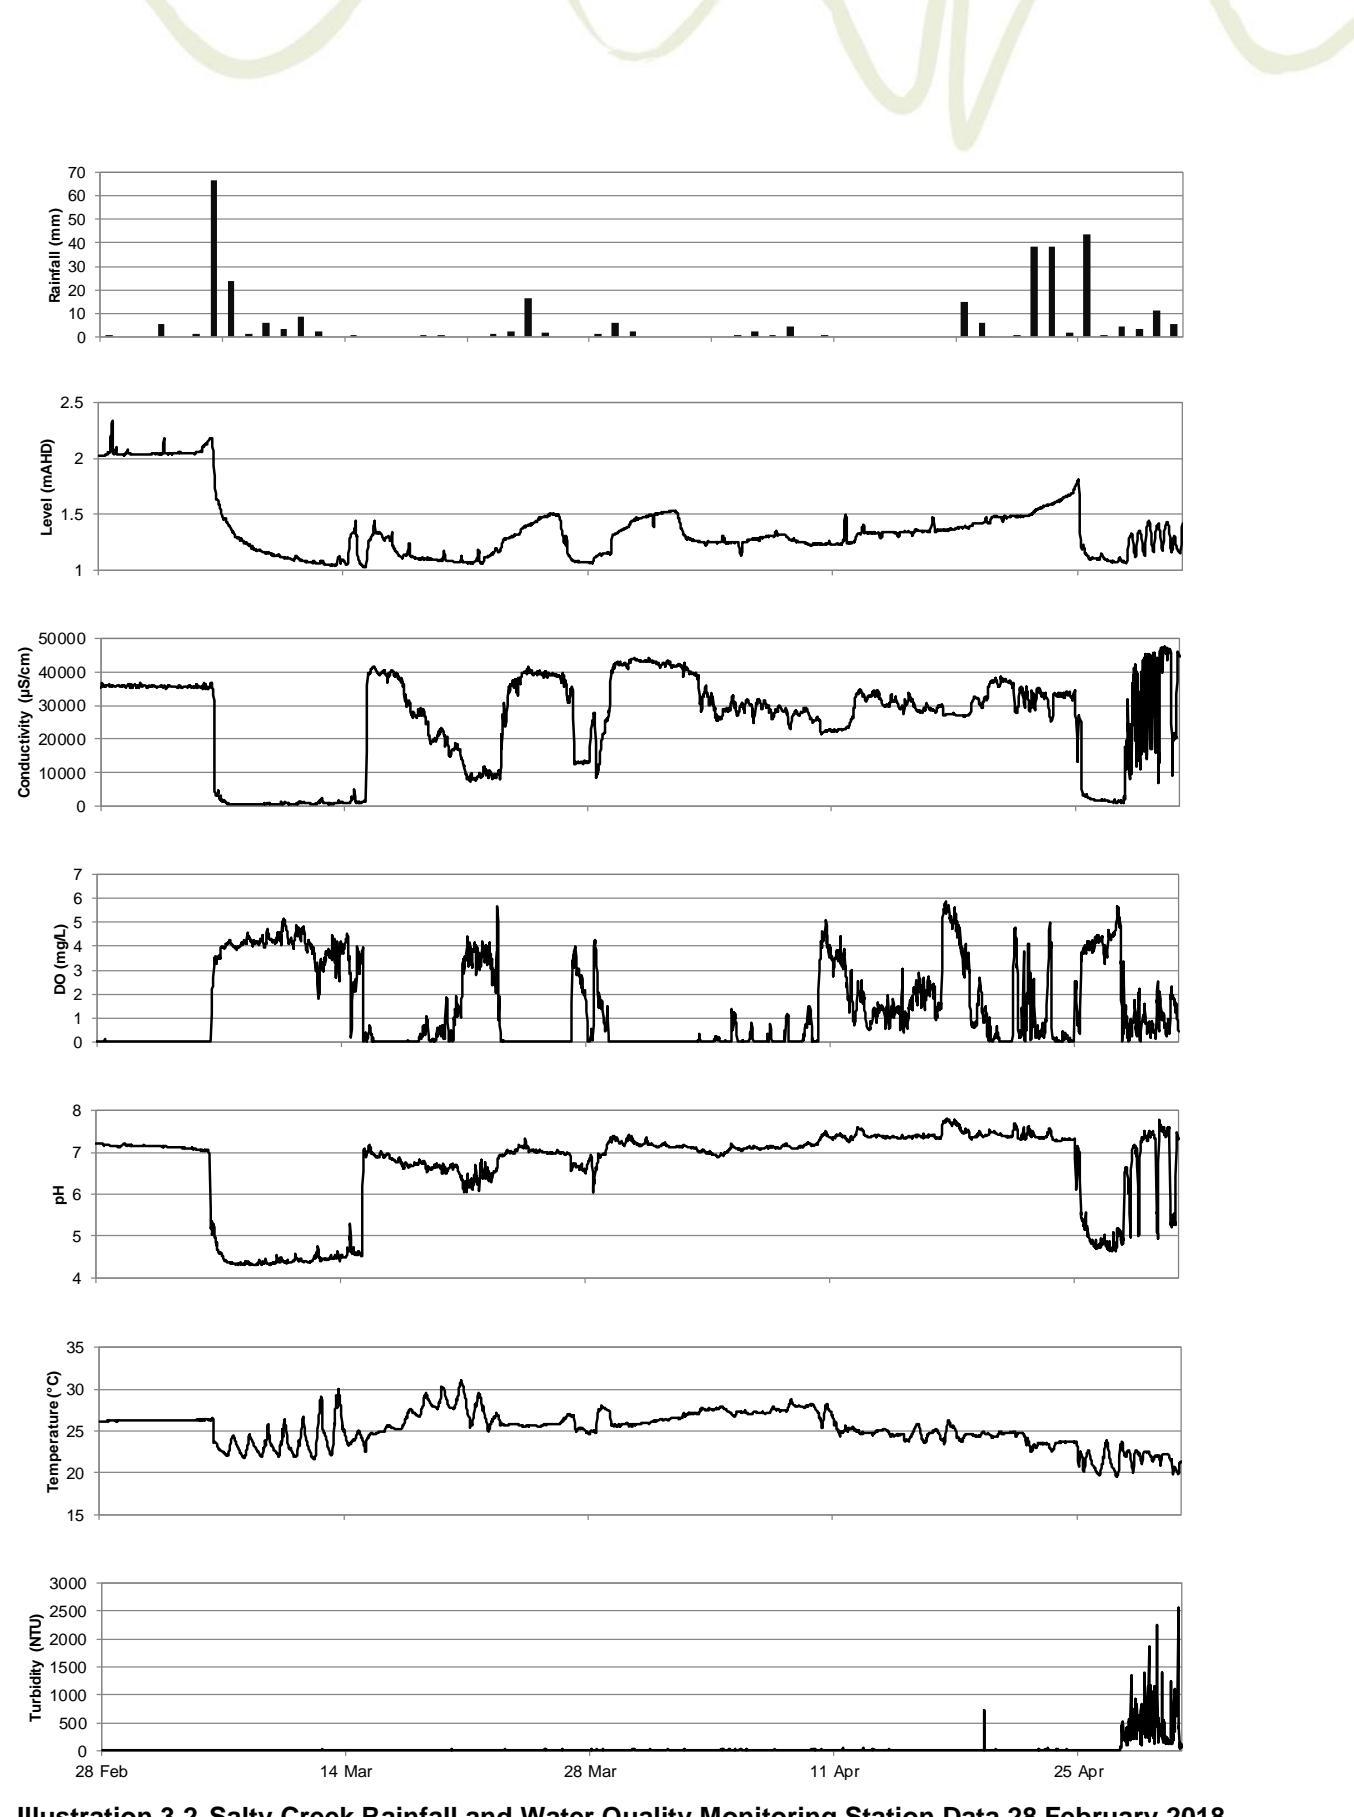
Illustration 3.2 Salty Creek Rainfall and Water Quality Monitoring Station Data 28 February 2018 to 30 April 2018

There were two periods of moderate to heavy rainfall during this reporting period and a large number of dispersed small to moderate rainfall events. The rainfall had an impact upon water levels and quality in Salty Lagoon and Salty Creek. The data from the Salty Creek PWQMS indicates that the entrance to Salty Creek was open for much of the reporting period and that tidal movements and seawater ingress were also strong determinants of water quality in Salty Creek. Water levels in Salty Lagoon remained high for the entire reporting period while water levels in Salty Creek were highly variable. With the exception of one short period after heavy rainfall in the first week of March 2018 water appears to have flowed out of Salty Lagoon into Salty Creek for the entire monitoring period. At the time of the site inspection on 1 May 2018 the entrance to Salty Creek was open and water levels was draining rapidly.

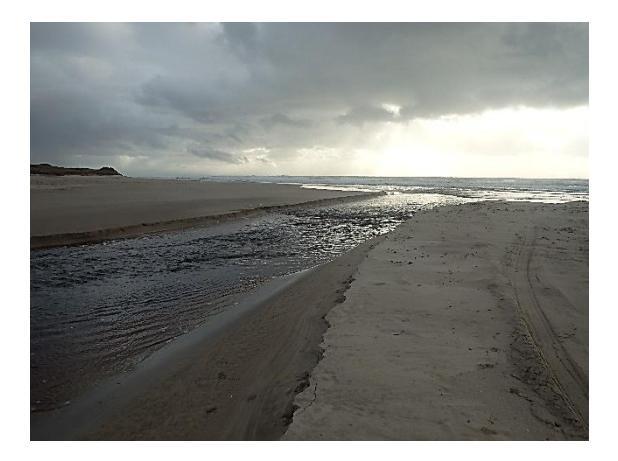
The entrance to Salty Creek was open on 1 May 2018 (**Plate 4.1**). A variety of birds were observed incidentally during the site inspection including Pacific Black Duck, Australasian Grebe, Eurasian Coot, Purple Swamphen, Black Swan, Great Egret and Little Black Cormorant.

Plate 4.1 Water draining rapidly from the open entrance to Salty Creek on 1 May 2018

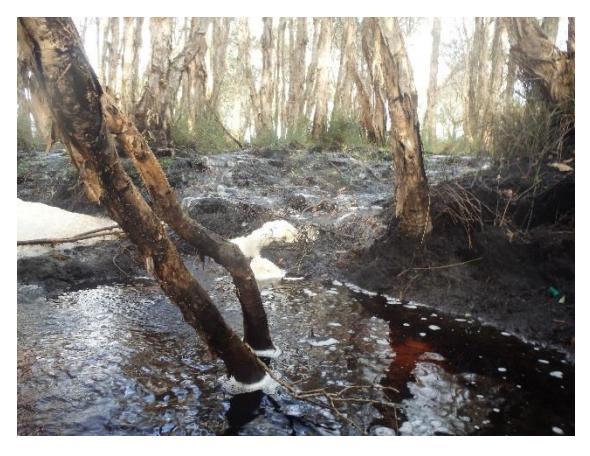
Erosion monitoring indicated that the head cut has advanced between 0.6 and 2.6 m since July 2017 in three distinct locations. These measurements indicate that the head cut advanced significantly during this reporting period, up to two metres at one site. There has been little or no advancement of the head cuts at the control sites. This indicates that, either the control sites are inherently more stable or that water is leaving Salty Lagoon preferentially through the pathway to the east of the old artificial channel.

The impact headcuts advanced significantly during this monitoring period while there was no movement at the control headcuts. There has been a total advance of between 0.6 m and 2.6 m in the impact headcuts since the monitoring points were established in July 2017.

Plate 4.2 The erosive headcut advanced in response to water flowing from Salty Lagoon into Salty Creek
