Salty Lagoon Post Closure Monitoring

Project Management and Ecosystem Health Report February 2020

Prepared for: Richmond Valley Council © GeoLINK, 2020

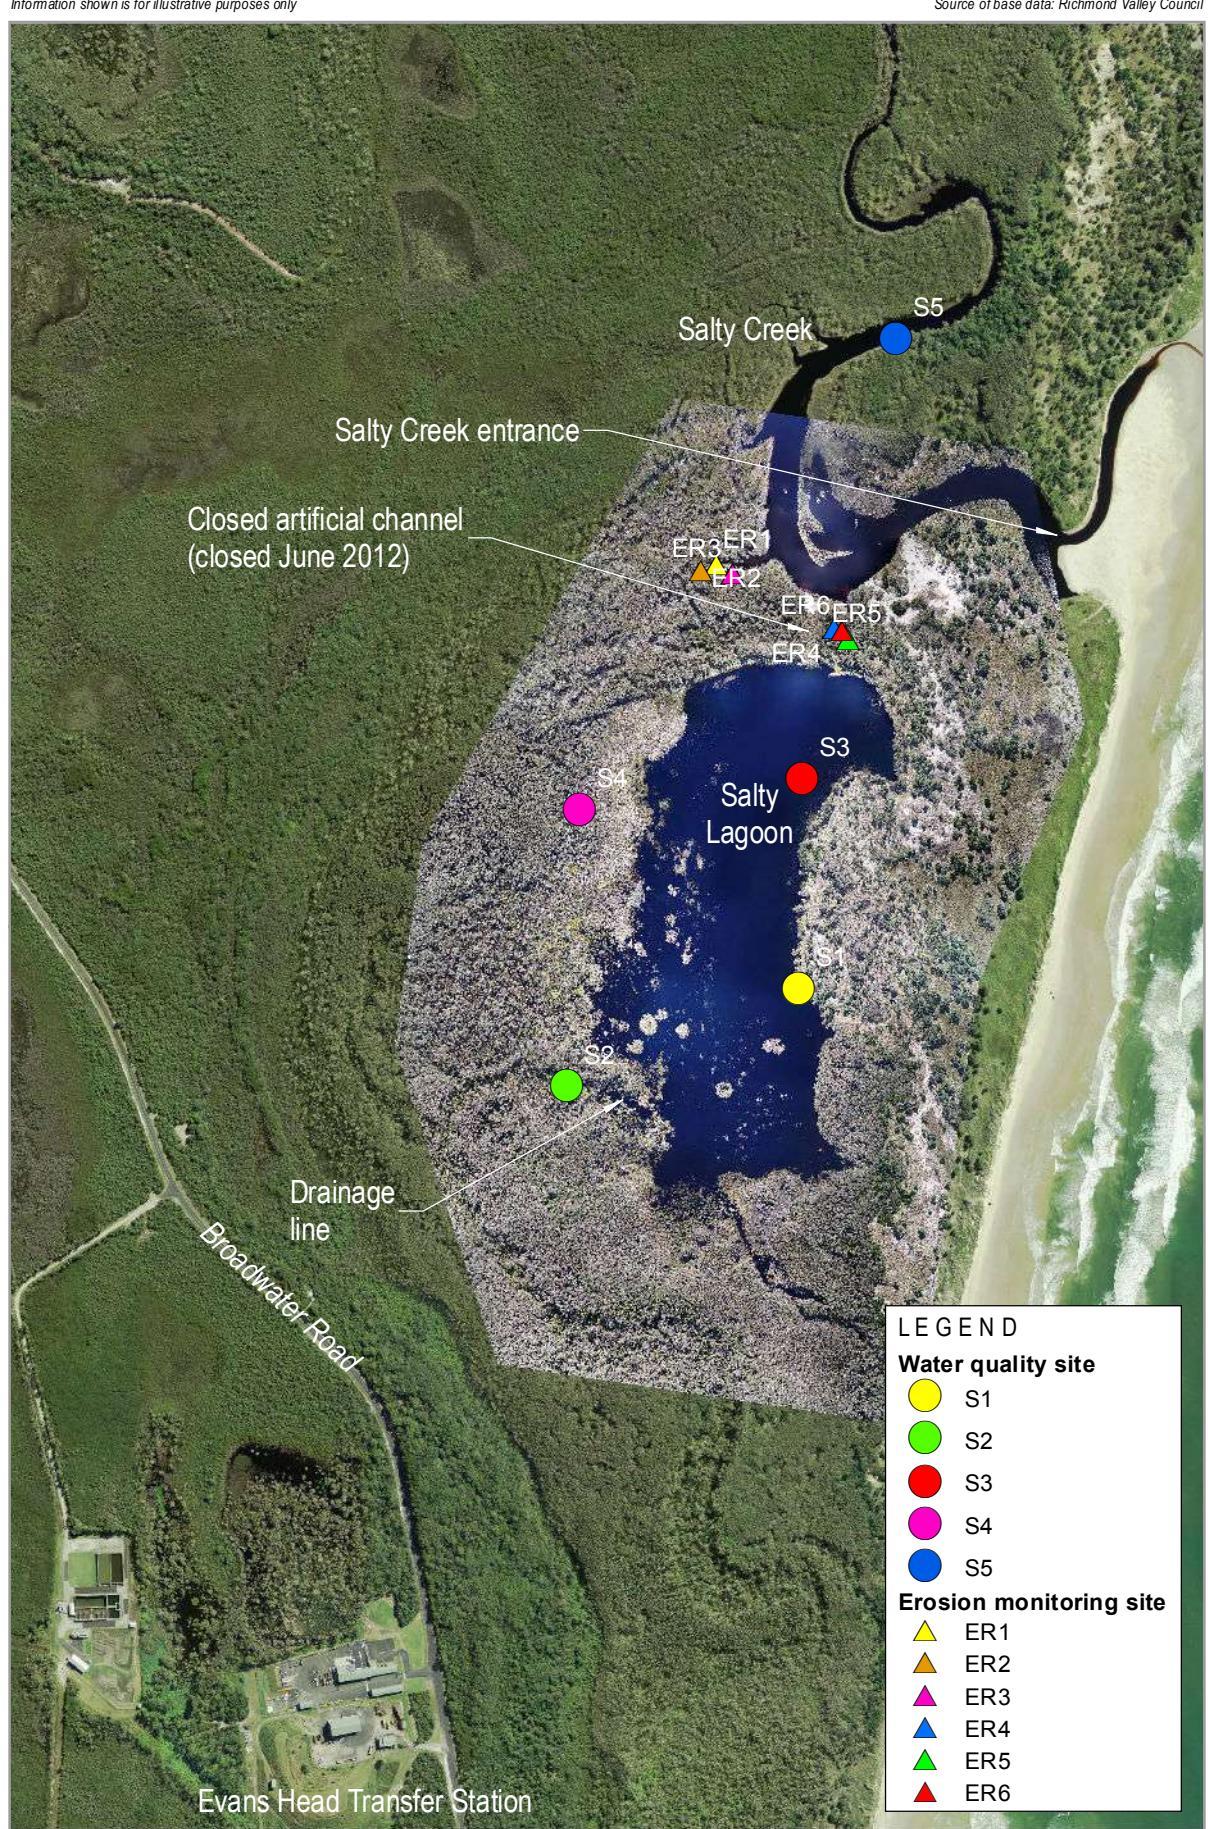
Water Quality and Erosion Monitoring Site Locations

A series of stations have been set up around the active head cut to the east of the infilled channel and some nearby control sites to assess the progression of erosion between Salty Lagoon and Salty Creek. The specific locations of all sites sampled are presented in **Table 2.2** and **Illustration 2.1**.

The stations were set up in July 2017 at the head cut (Stations 4, 5 and 6), with control sites at points where lateral tributaries from Salty Creek lead towards Salty Lagoon (Stations 1, 2 and 3). At each site the monitoring involves a fixed-point photo and a measurement from a fixed peg to the nearest point of the head cut.

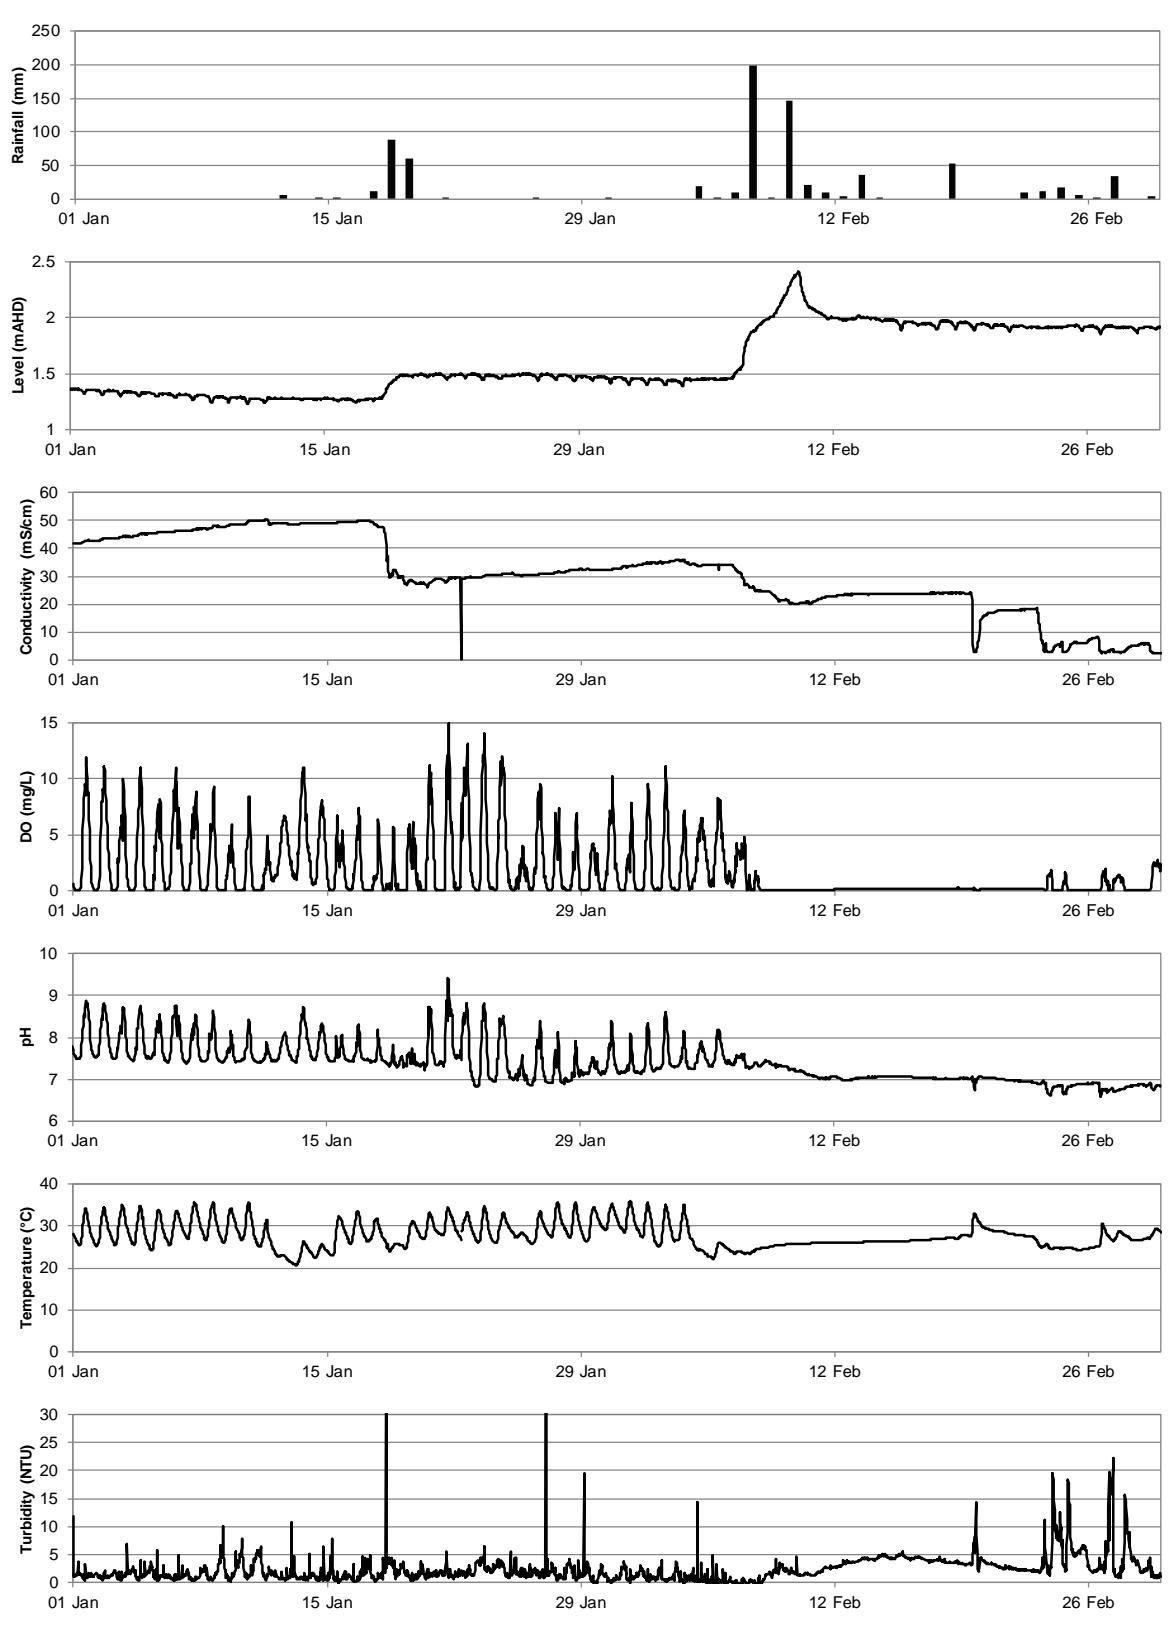
Illustration 3.1 Salty Lagoon Rainfall and Water Quality Monitoring Station Data 1 January 2020 to 29 February 2019

The data collected at the PWQMS, and rainfall data correlating to the reporting period are presented in **Illustration 3.1** and **Illustration 3.2**.

The conductivity measured at the Salty Lagoon and Salty Creek PWQMS decreased significantly over the course of the monitoring period, indicating that dilution by rainfall runoff was a major factor driving water quality. At the time of the site inspection on 4 March 2020 the water in Salty Lagoon and Salty Creek was brackish, although tidal movements were delivering salt water upstream in Salty Creek. The conductivity measurements collected on 4 March 2020 complied with guiding values at all sites.

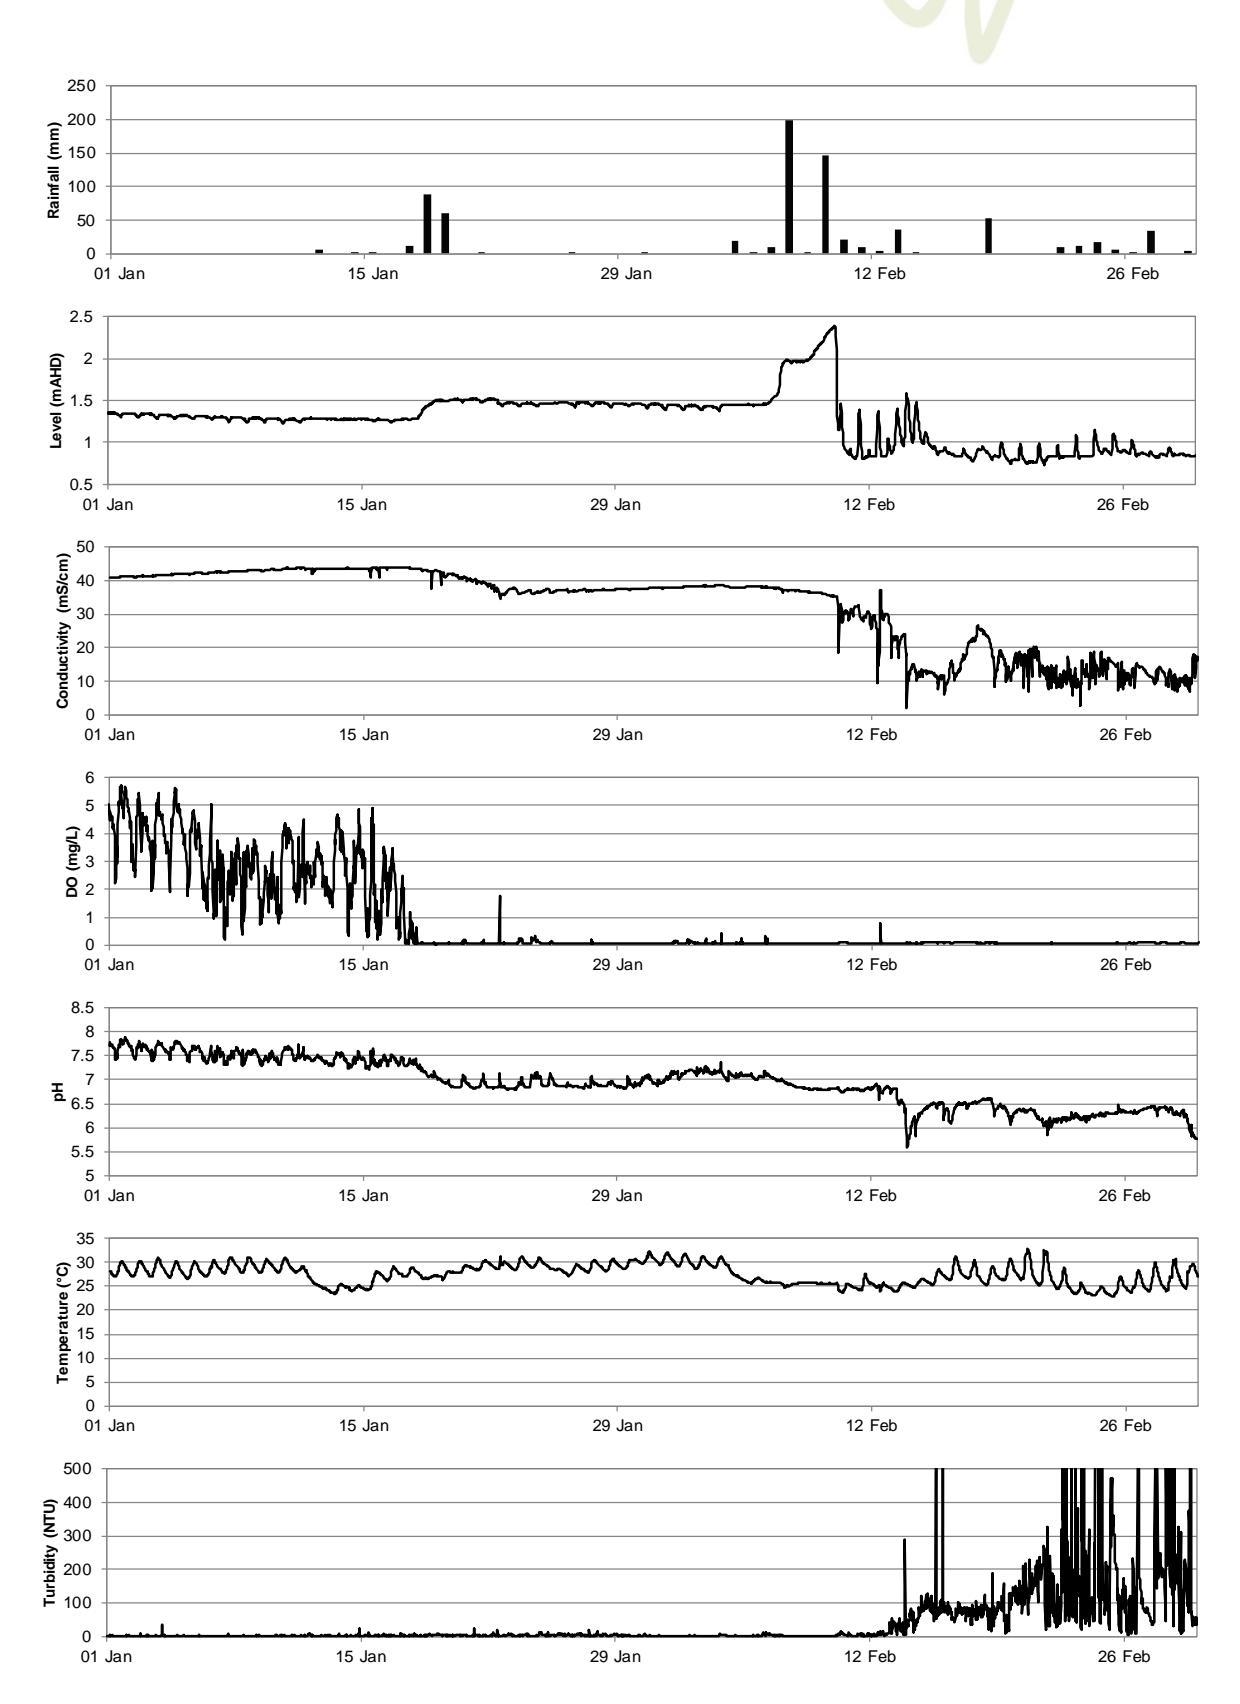
Illustration 3.2 Salty Creek Rainfall and Water Quality Monitoring Station Data 1 January 2020 to 29 February 2020

Total rainfall for this reporting period was above average, falling in two very large events, a large event and several small to moderate events. The conductivity and level data from the Salty Creek PWQMS indicate that the entrance to Salty Creek remained closed from the beginning of the reporting period until it opened on 10 February 2020 when the water level in Salty Creek and Salty Lagoon reached 2.39 mAHD. The water in Salty Creek drained very rapidly and the water level reduced by more than 1.5 m in less than 15 hours. The water levels in Salty Creek fluctuated tidally for the remained of the reporting period, the effect of the tide diminishing towards the end of the reporting period. At the time of the site inspection on 4 March 2020, the entrance to Salty Creek was still open and flowing (Plates 4.1 and 4.2). The water level in Salty Lagoon also fluctuated significantly during this monitoring period. The levels in Salty Lagoon were very low at the beginning of the reporting period and increased in response to rainfall until a peak of 2.41 mAHD was reached prior to Salty Creek opening and draining. The water levels in Salty Lagoon then stabilised at approximately 1.9 mAHD, at which point the two waterways become hydrologically separated. Aside from the response to rainfall, daily water level fluctuations of more than 5 cm were measured in Salty Lagoon and Salty Creek on the hottest days when water temperatures were fluctuating by as much as 10 °C. It is likely that the dark tannin staining and large surface area to depth ratio of the water contributes to these fluctuations through expansion and contraction but also that they may reflect groundwater fluctuations in response to evapotranspiration.

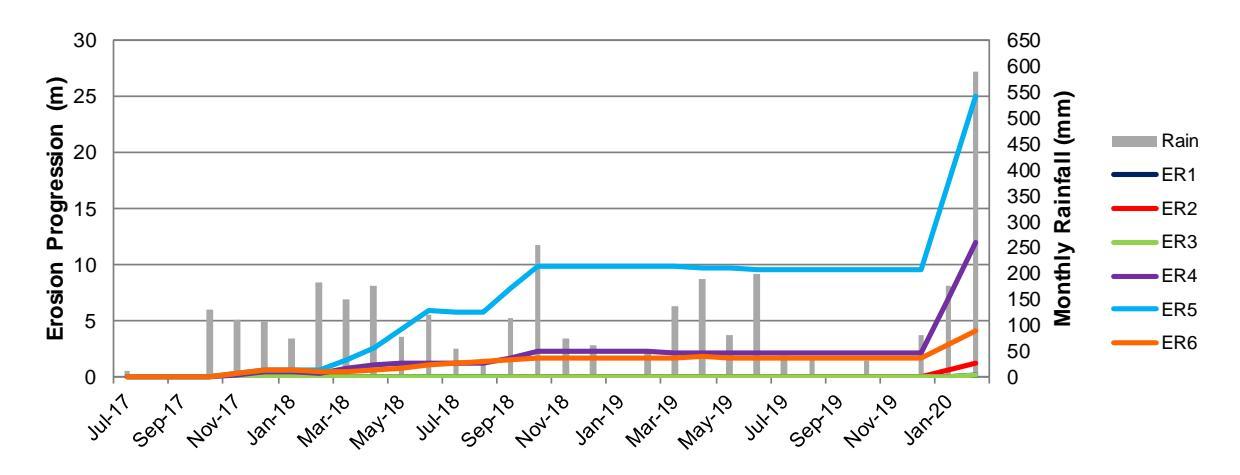
The data collected at the erosion monitoring stations is presented in **Table 3.2**. There was a significant advance of the head cuts at the three impact stations in relation to the previous measurements on 22 January 2020, marking the first notable change in the head cut position since October 2018. The head cut has advanced at least 25 m towards Salty Lagoon since the monitoring began in July 2017.

Erosion monitoring indicated that the head cut advanced significantly during this reporting period and the movements were the largest individual changes recorded since monitoring began. There was a small measured advance of the head cuts at two of the three control sites (**Illustration 4.1**). The erosion resulted from heavy, sustained flow from Salty Lagoon to Salty Creek. The head cut is now approximately 20 m from the current banks of Salty Lagoon. If it reaches Salty Lagoon, the channel formed is highly likely to increase in size when tidal movements occur and some of the conditions that, historically, led to fish kill will be restored.

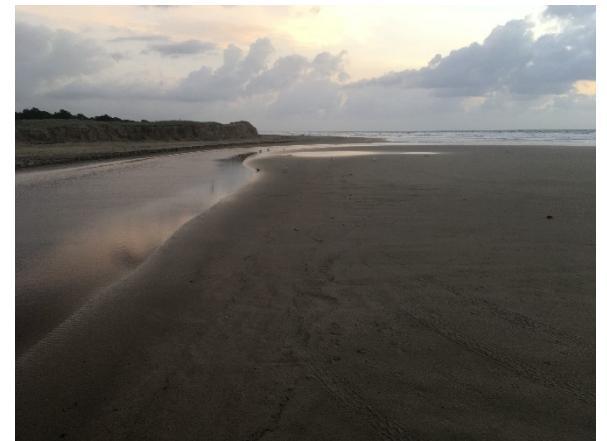
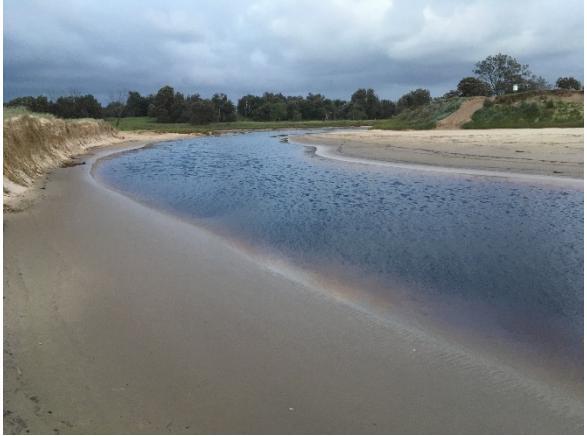
The entrance to Salty Creek was open on 4 March 2020. The entrance opened approximately 200 m to the south of the last observed opening. A large number and wide variety of birds were observed incidentally during the site inspection including Pacific Black Duck, Pelican, Black Swan, Dusky Moorhen, Pied Cormorant and Little Black Cormorant. Large fish were observed on several occasions.

Plate 4.1 The open entrance to Salty Creek on 4 March 2020

Plate 4.2 The open entrance to Salty Creek on 4 March 2020

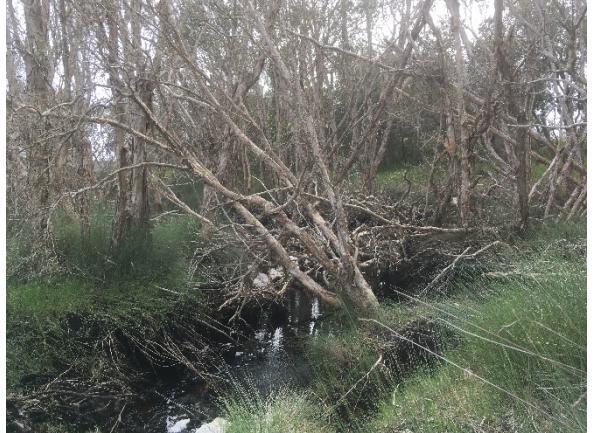
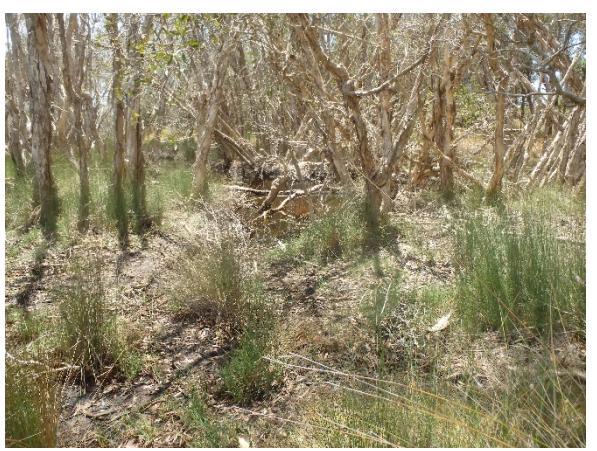
Plate 4.3 Fixed point photo from ER4 on 4 March 2020

Plate 4.4 Fixed point photo from ER4 on 22 January 2020

- 4. The erosive headcut to the east of the old channel between Salty Lagoon and Salty Creek advanced approximately 15 m towards Salty Lagoon during this reporting period. There is a significant possibility that the eroding channel will break into Salty Lagoon during the next heavy rainfall, or if moderate rainfall conditions persist for an extended period.

Due to the recent progression of the head cut between Salty Lagoon and Salty Creek, the risk of a channel forming between the two water bodies has heightened. Should the channel eventuate, the system would return to a more dynamic ecosystem and potentially conditions that historically led to fish kills. In accordance with the project *Environmental Response Protocol* (GeoLINK 2017b), the risk rating for the Salty Lagoon Response Protocol is uncertain. Adaptive management site visits are recommended for periods of potential head cut progression, with the following triggers:

- >50 mm of rainfall with 24 hrs.
- >200 mm of rainfall within a week.
- Other high risk events, for example >100 mm of rainfall within 72 hours, significant storm surge, atypically large tides, etc. Due consideration would be given to rainfall intensity and volume, and the Salty Creek entrance status when known as appropriate.

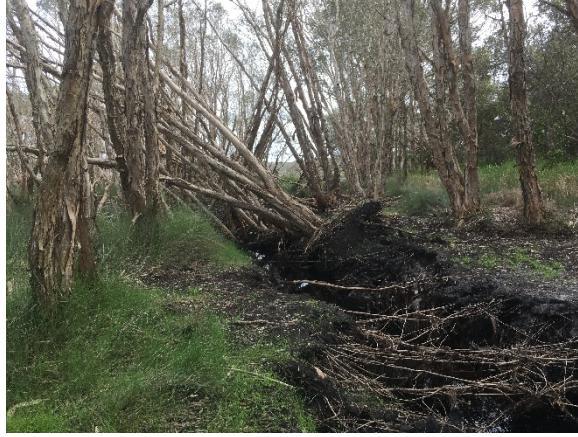
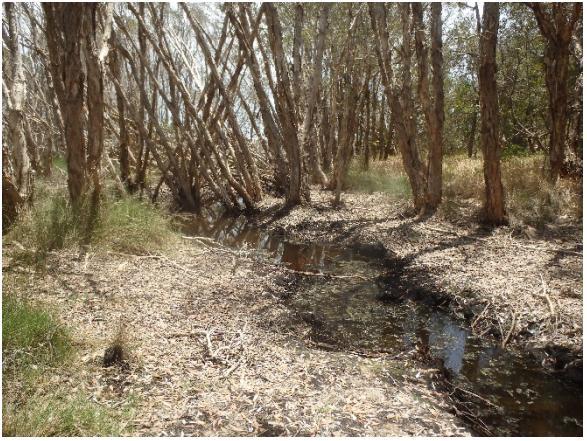
Plate 5.1 Fixed point photo from ER5 on 4 March 2020

Plate 5.2 Fixed point photo from ER5 on 22 January 2020
